June 7, 2012

Subject: INCIDENT REPORT

- Mrs. Work informed Ms. Julie Szymanek, TRIAD's Northwest Regional Radiation Safety Officer (RSO), and Mr. Roger Simar, supervisor for Mr. Rausch, that a portable nuclear gauge had been hit by a bulldozer on a construction site in Fairmont, West Virginia near the ISR Building.

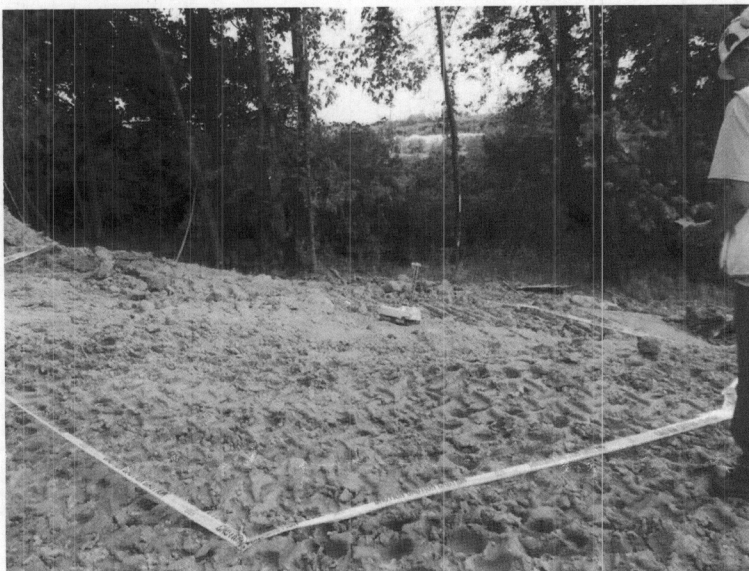
No readings were detected four feet or greater from the portable nuclear gauge. Therefore, caution tape was placed approximately ten feet around the perimeter of the gauge. Readings on the surface of the gauge where the damage had occurred were 10 mR/hr, readings were 0.3 mR/hr at approximately one (1) foot away from the gauge, and readings were 0.1 mR/hr at approximate three (3) feet away from the gauge. Visual observations were made of the damaged portable nuclear gauge. The gauge was in the locked position and the source appeared to be in good condition with no signs of damage. The only damage appeared to be on the exterior housing of the gauge. The shield was still intact. The portable nuclear gauge is Model 3430, Gauge Serial Number 32412 with a Transport Index of 0.3 mR/hr. Refer to attached photographs.

View of gauge and perimeter.

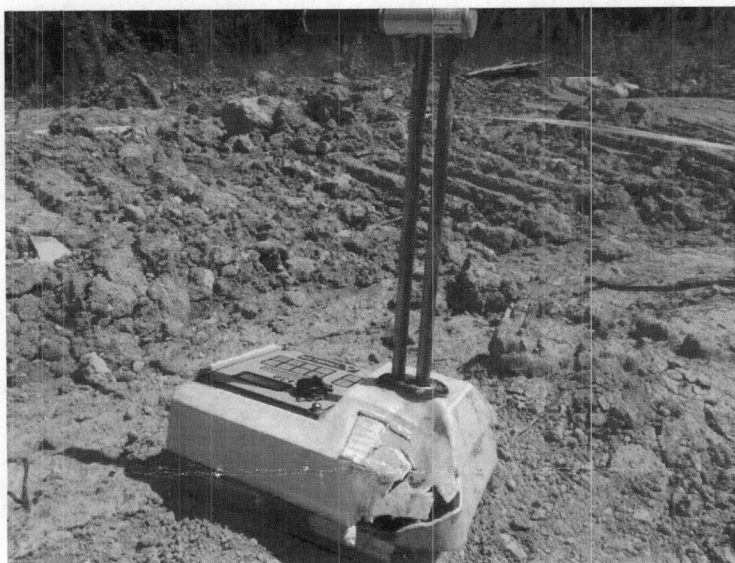
- June 5, 2012 at 9:30am, the portable gauge was re-inspected. Safety devices including the shielding were intact and a leak test was performed.
- June 7, 2012, the leak test was returned from Troxler and the leak test confirmed the gauge is not leaking. Refer to attached leak test.

View of damaged portable nuclear gauge.

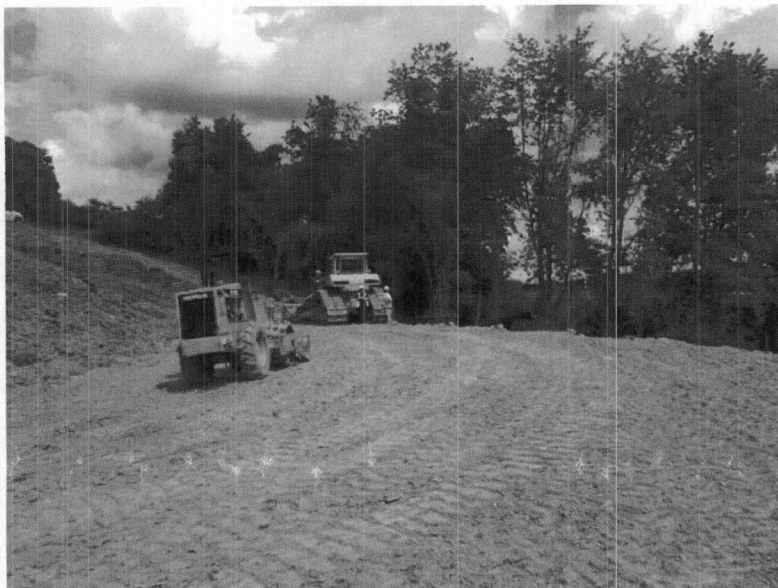
- *3:30pm:* Mr. Johnny Carson and Mr. Rausch met Ms. Szymanek and Mr. Simar at the construction site. Mr. Rausch informed Ms. Szymanek and Mr. Simar of the events that had led up to the portable nuclear gauge incident.
- *3:40pm:* Ms. Szymanek took the monitor and surveyed the following areas:
 - the bulldozer (specifically, where the gauge was hit and part that hit the gauge);
 - the area the bulldozer was working after it hit the gauge;
 - the gauge;
 - the perimeter surrounding the gauge (zero to ten feet);
 - the area the gauge was placed on the ground after it was hit.

View of bulldozer and monitored area.

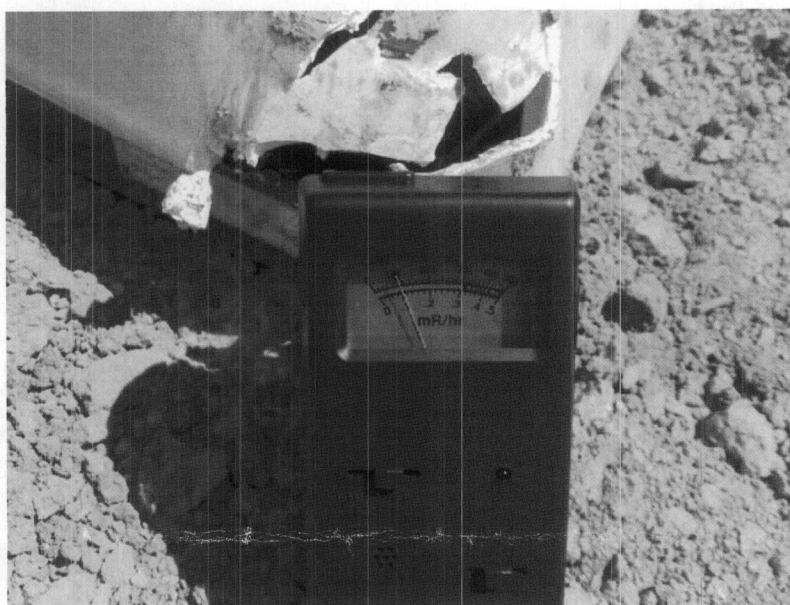
- *4:30pm:* Ms. Szymanek contacted Troxler (1-919-549-9539). Ms. Robin Myers stated that 10 mR/hr near the back of the gauge was normal readings and not evident of leaking based on the operator's manual. Ms. Myers also stated that since the readings were below the Transport Index of 0.3 at 1 meter (~3.2 feet) that is was safe to transport back to the TRIAD's Morgantown office. Ms. Myers also stated that a leak test would need to be performed and pictures taken of the gauge before it is sent for repair. Mr. Simar and Mr. Rausch had placed the gauge back in the shipping case and into a 55-gallon drum. No readings were detected outside of the drum or on the ground where the gauge was staged after the incident. (Please note: According to the Operator's Manual for gauge, normal readings at the surface of the gauge on the back is 26 mR/hr.)

View of Radiation Alert Monitor Reading at the surface of the damaged gauge.
