**UNITED STATES
NUCLEAR REGULATORY COMMISSION**
REGION II
245 PEACHTREE CENTER AVENUE NE, SUITE 1200
ATLANTA, GEORGIA 30303-1257

**SUBJECT: SHEARON HARRIS NUCLEAR POWER PLANT - NRC SPECIAL INSPECTION
REPORT 05000400/2012008**

The special inspection reviewed the circumstances surrounding the failure of two safety-related main steam isolation valves (MSIVs) to close which occurred on April 21, 2012, and examined activities conducted under your license as they relate to safety and compliance with the Commission's rule and regulations and with the conditions of your license. The inspection started on May 7, 2012, and the preliminary inspection results were discussed with you and members of your staff on May 11, 2012. Subsequent onsite inspections were conducted May 16 – 18, 2012, to observe MSIV testing following your maintenance repairs, and further in-office reviews of post-maintenance testing results were conducted May 21 – 25, 2012.

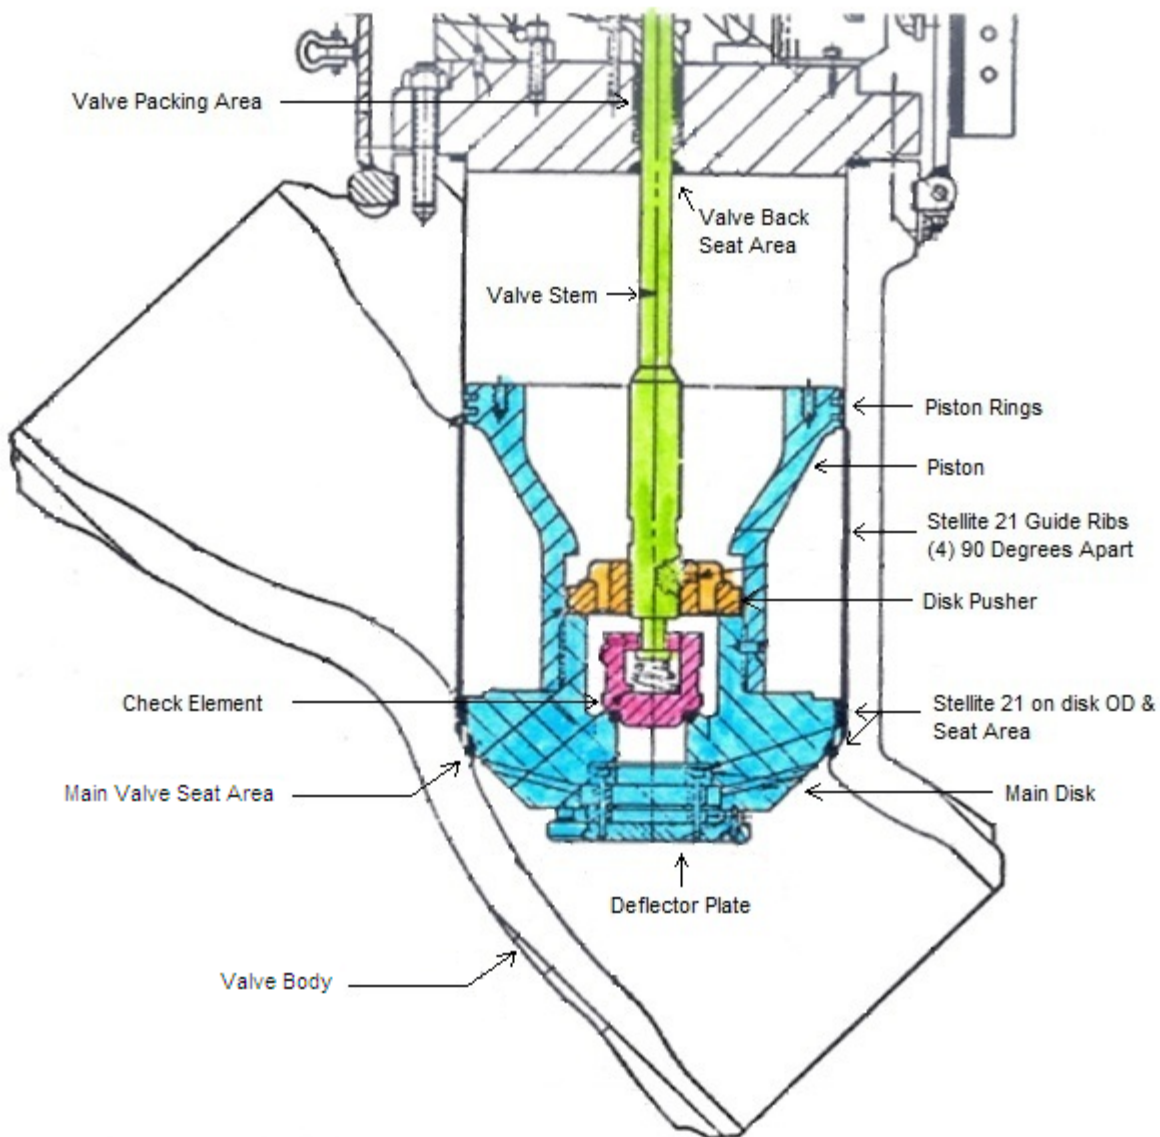
Figure 1

- Valve Body – The basic valve is a “Y” pattern cast steel globe design where the bonnet of the valve is at 45 degrees. Internal to the valve are guide ribs of stellite #21 which provides a surface for the lower portion of the disk-piston assembly, which is also treated with stellite #21. The hard stellite #21 material resists corrosion and wear and reduces side loading.
- Main Valve Seat – The main valve seat area is an integral hardfaced seat of stellite #21. The hard material resists erosion and wear under high velocity flow conditions.

- **Back Seat** – The back seat is also treated with stellite #21. It provides positive shut off between the bonnet and stem and allows packing to be replaced with the valve in service and under pressure.

- **Main Disk** – The main disk provides the seal between the upstream and downstream sides of the valve. The disk has an internal check element assembly, the primary function of which is to act as a one way passage between the pressure under the disk and the piston balancing chamber. The check element is forced closed via internal conical spring when the pressures below and above the disk are equal. An imbalance of 2 psi will cause the check element to open. The check element is attached to the stem just below the pusher assembly. The check element disk and seat areas are also treated with stellite #21. Below the main disk check element area is a deflector plate assembly. The deflector plate assembly is designed to control excessive pull down forces generated by high velocity and mass flow rates with underseat flow.

- **Piston** – The top of the piston is hardfaced with stellite #21 to provide a wear resistant surface. In addition, there are two rows of piston rings located at the top of the piston which provides a guiding surface for the piston to move while providing a sealing action. They are comprised of an inner and outer ring for maximum sealing and made of a carbon impregnated cast iron which provides self lubrication. The piston is the last component assembled to complete the valve internal make up. The main disk has the deflector plate assembled onto its lower portion. Once fitted, the stem, stem pusher and check element assembly is lowered onto the upper portion of the main disk. The piston is then lowered over the stem and screws onto the main disk assembly. When the piston is tight, it is secured with a locking pin. Once assembled, the stem-piston-disk assembly is inserted into the main valve body bore.
