# Department of Environmental Quality

**RE: North Butte ISL Operation, Permit No. 632, 2012 Annual Inspection Report**

## 2012 ANNUAL INSPECTION REPORT

**SUBJECT:** Cameco Resources' North Butte Project

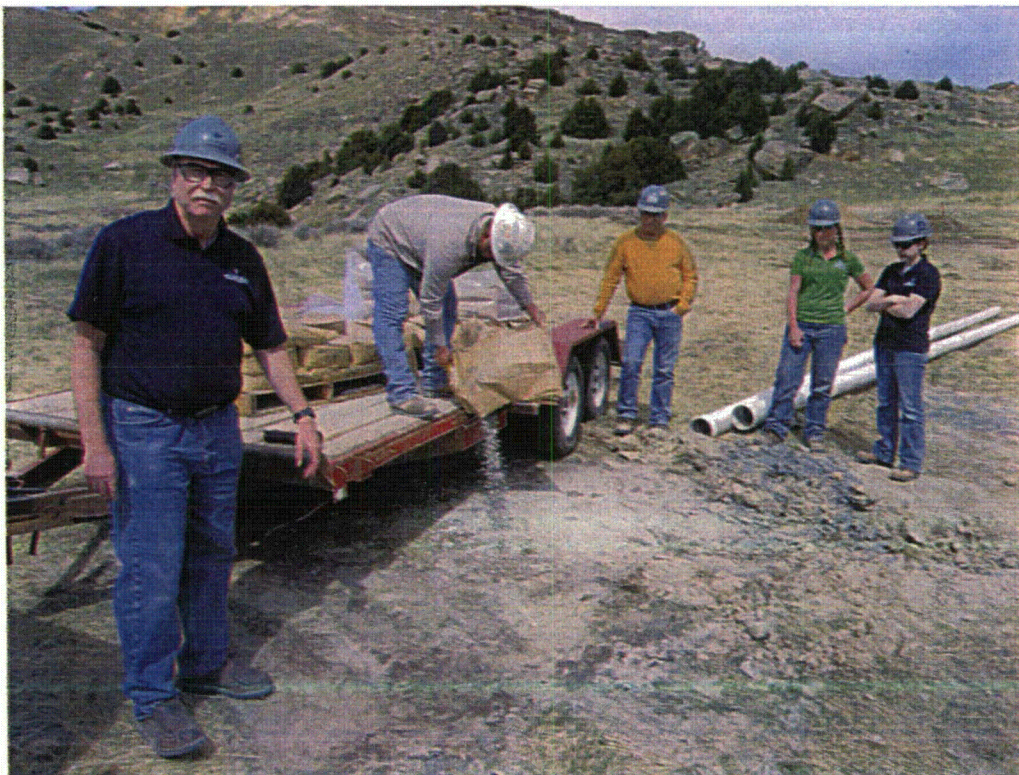
As seen below in Photo No. 4, one of the drill holes recently completed was observed being abandoned and sealed by pouring 3/8" bentonite chips down hole from bags. It was earlier filled with abandonment mud which was allowed to

**Photo No. 4** Drill hole being abandoned by filling with 3/8" bentonite chips.

settle overnight. The chips are then used to fill the hole to the surface.

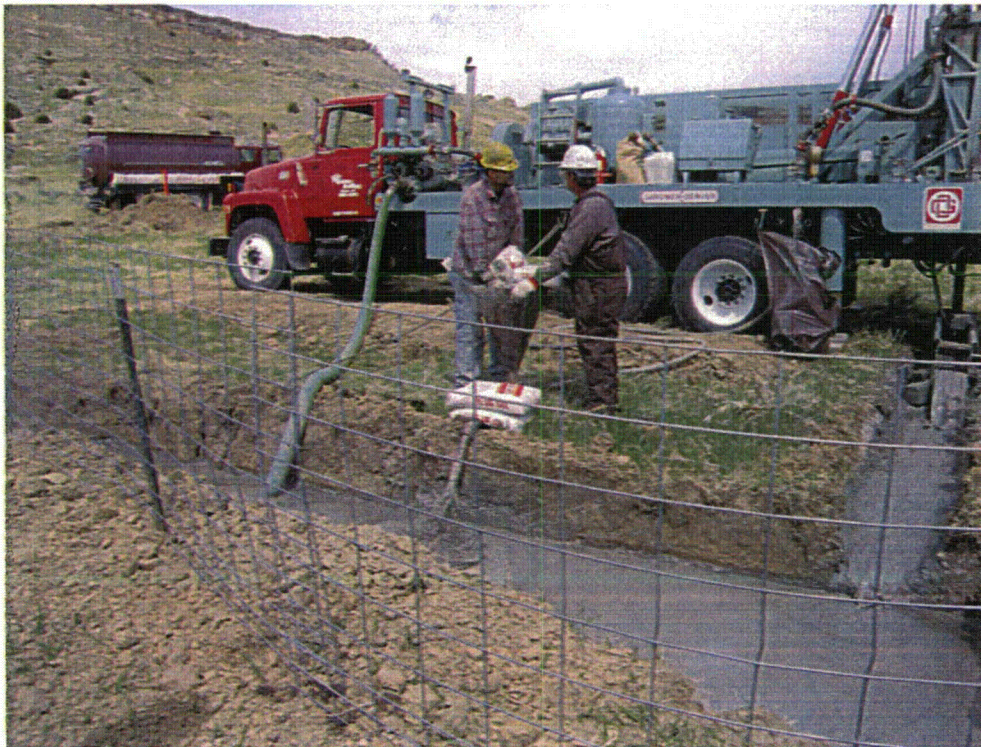
**Photo No. 5** "Mudding up" – Abandonment mud is being added to mudpit as part of drill hole abandonment

As seen above, another hole was being abandoned by "mudding-up" with "Plug-Gel." Following filling a drill hole with abandonment mud, it is left overnight and then filled to the surface using 3/8" bentonite chips as seen in Photo No. 5 above.

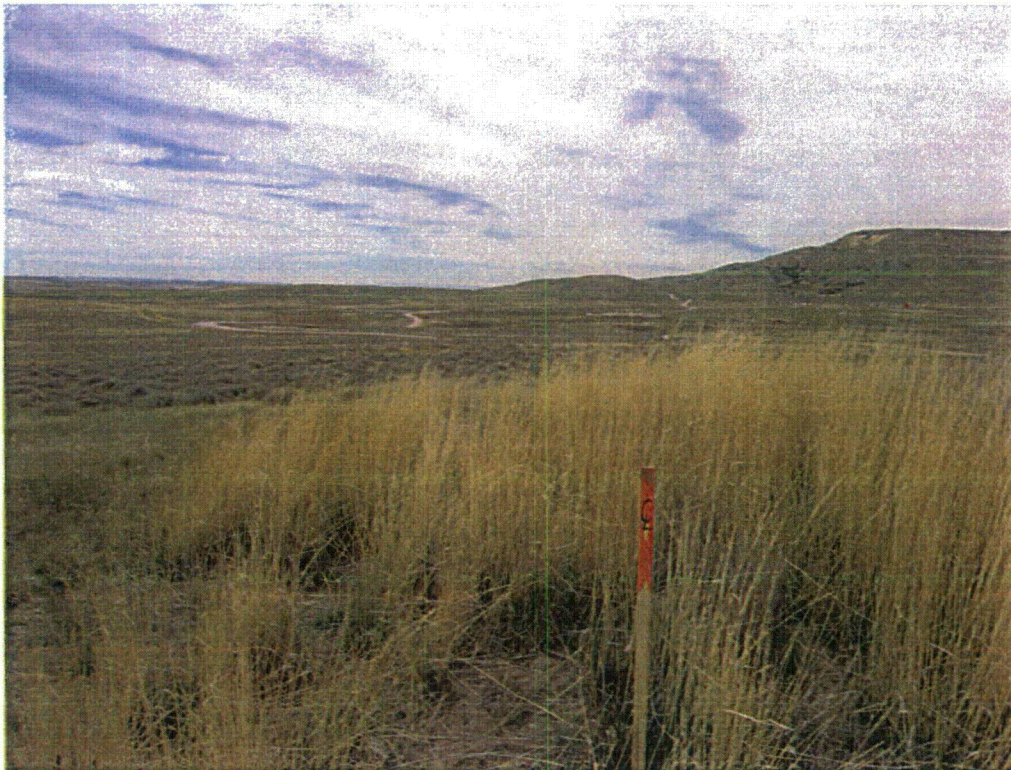
The location of the new access road extension was viewed and photographed. The centerline of the future road was marked with survey stakes as were the edges of the corridor (Photos 7 and 8 below).

**Photo No. 7** Looking west at area where eastern extension of new access road will be constructed following future approval of an Incidental Boundary Revision. A survey stake marking the centerline of the future road is seen at front-center. This portion of the road corridor is located on the permit area.

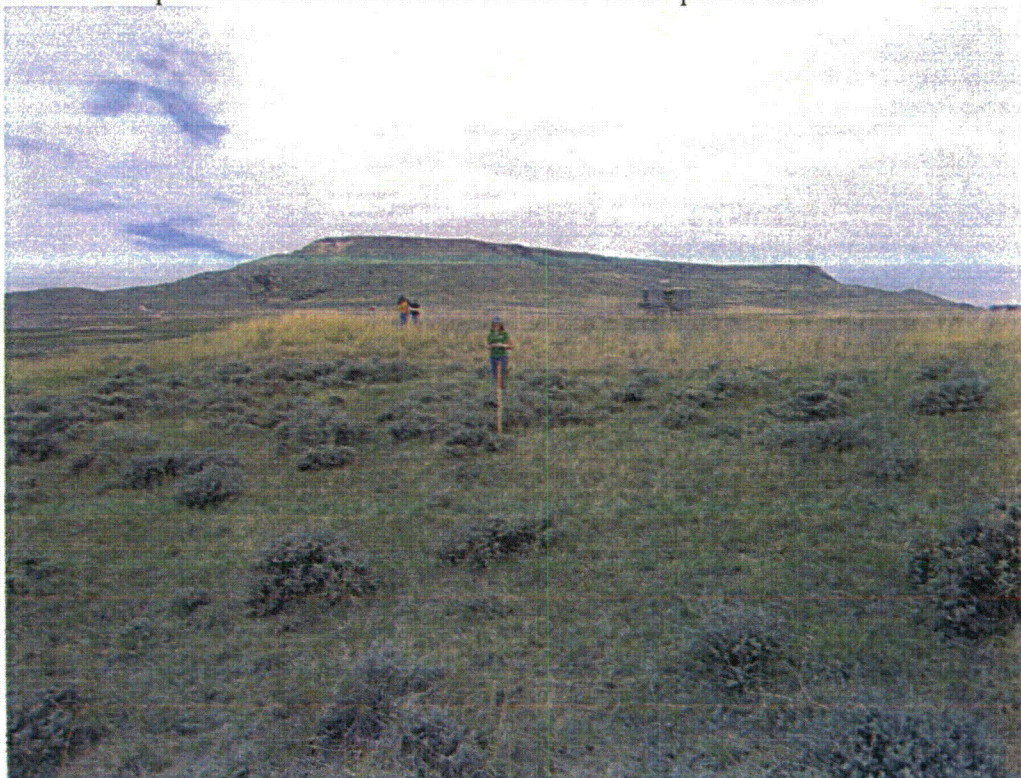
**Photo No. 8** Looking west along centerline of proposed new access road with a survey stake visible at center.

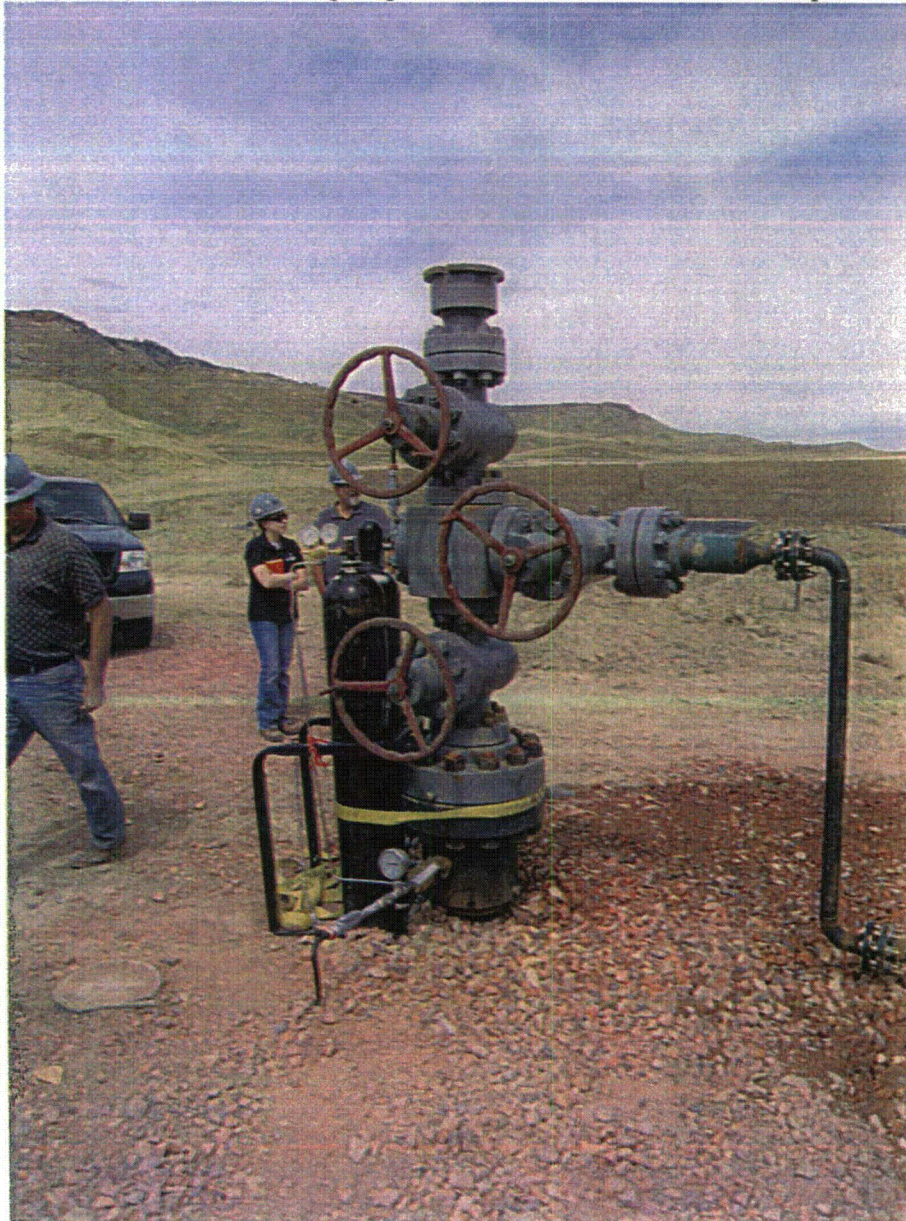
#### Photo No. 9

Close-up view of the Class I disposal well drilled this winter in the eastern part of Mine Unit 2. The well has been undergoing testing.

A portion of the stockpile of topsoil salvaged from the well pad can be seen behind wellhead. The sign on the topsoil stockpile is also visible.

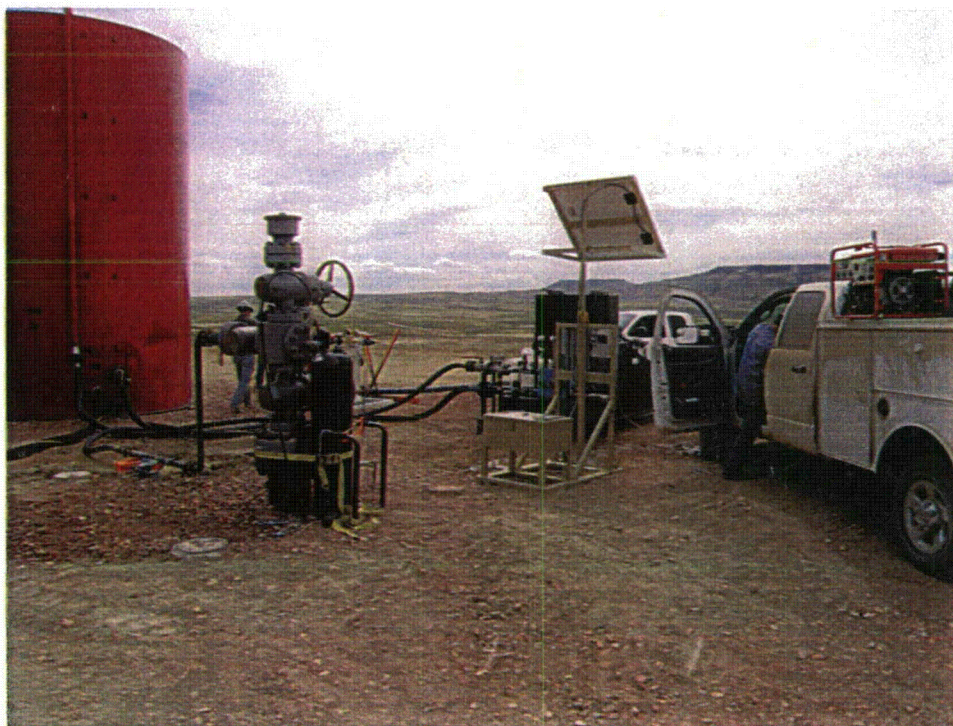
**Photo No. 10** Another view of the Class I disposal well along with a temporary tank used during the testing process. The black nitrogen tanks are used to pressurize the well annulus to about 300 psi.

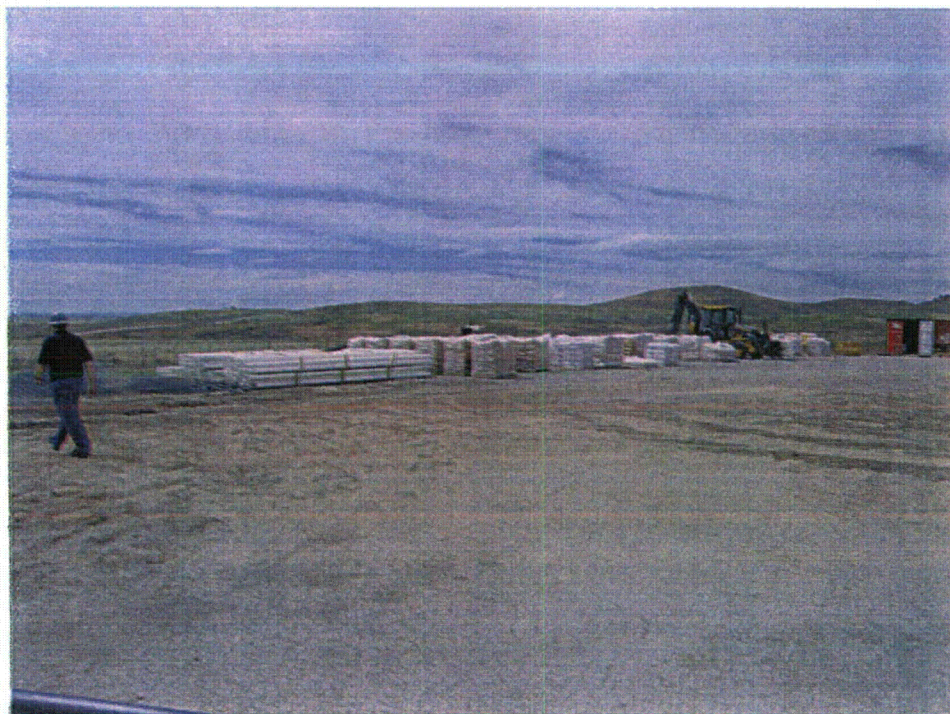
As shown below in Photo No. 11, the pad is also being used to store well casing and sacks of drilling mud, abandonment mud and lost circulation material.

**Photo No. 11**  
Looking southwest across deep disposal pad at stacks of SDR-17 PVC well casing and pallets of drilling and abandonment mud and other drilling supplies.

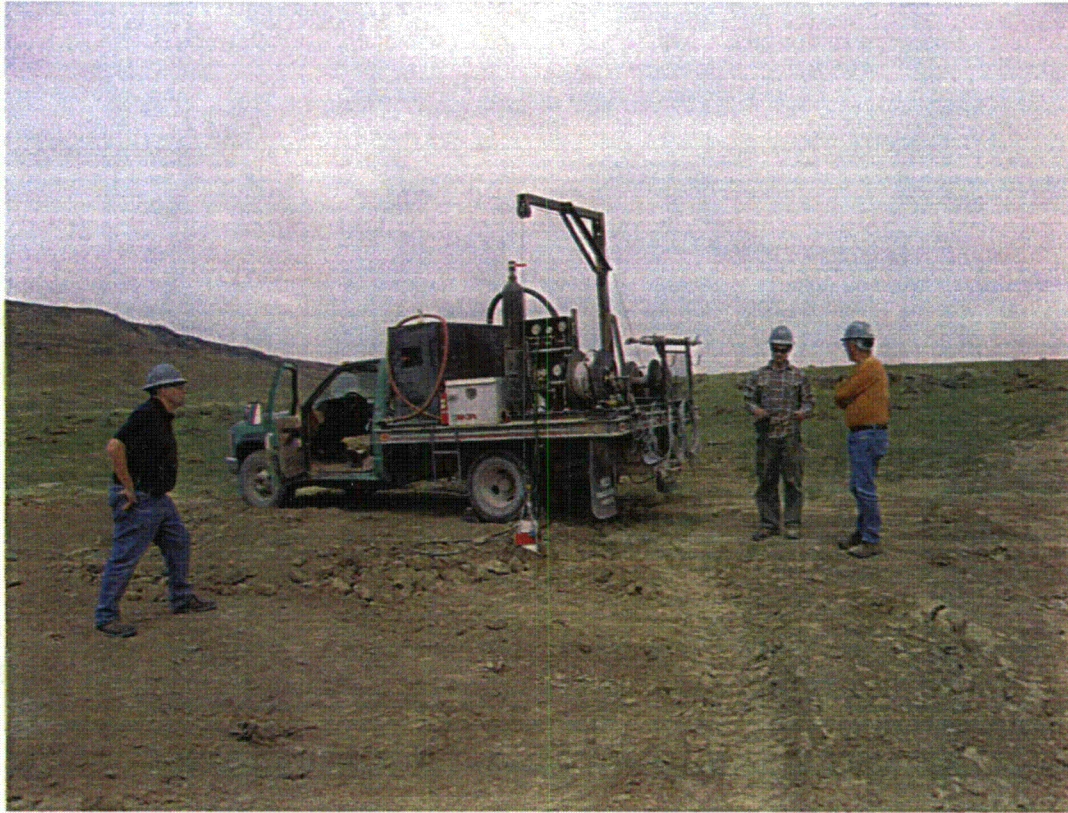
**Photo No. 12** MIT in Mine Unit 1

As seen above, a monitor well in the eastern end of Mine Unit 1 was undergoing Mechanical Integrity Testing (MIT). The well passed.

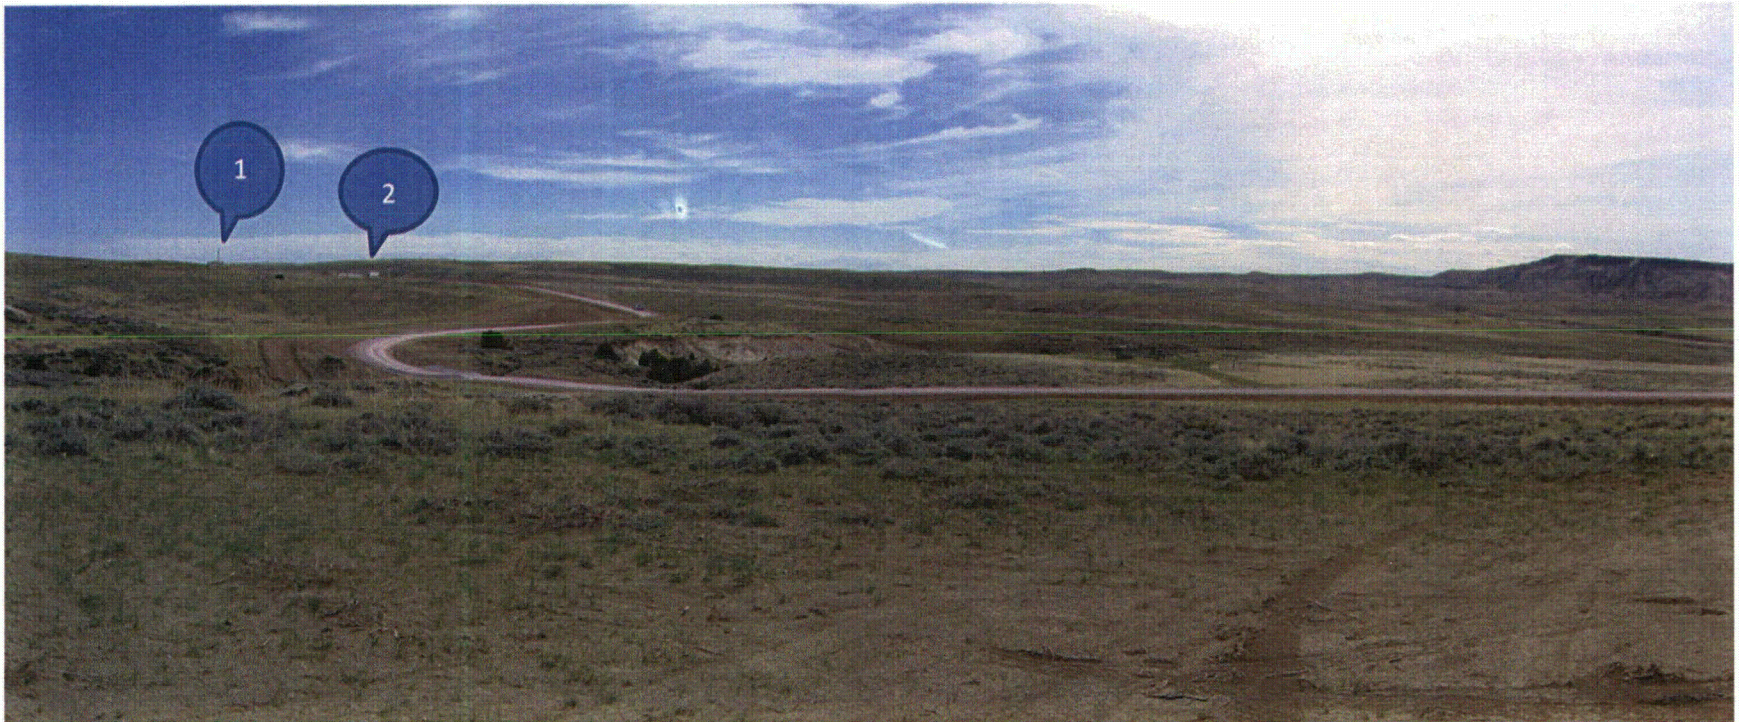
A high quality road has been built to connect the water supply area with the eastern portion of the permit area (Photo No. 1). This new road, surfaced with crushed limestone, runs eastward past the pad under construction for the satellite plant building, the southern side of Mine Units 2 and 1, the new deep disposal well and terminates for now at the eastern permit boundary.

**Photo No. 1** Looking southeast to south at new access road recently constructed east-west across permit area. The mast of the drilling rig drilling the plant water supply well can be seen at site marked by No. 1. No. 2 points to location of plant pad. Photos for panorama taken from position next to drilling water water supply well and lagoon.

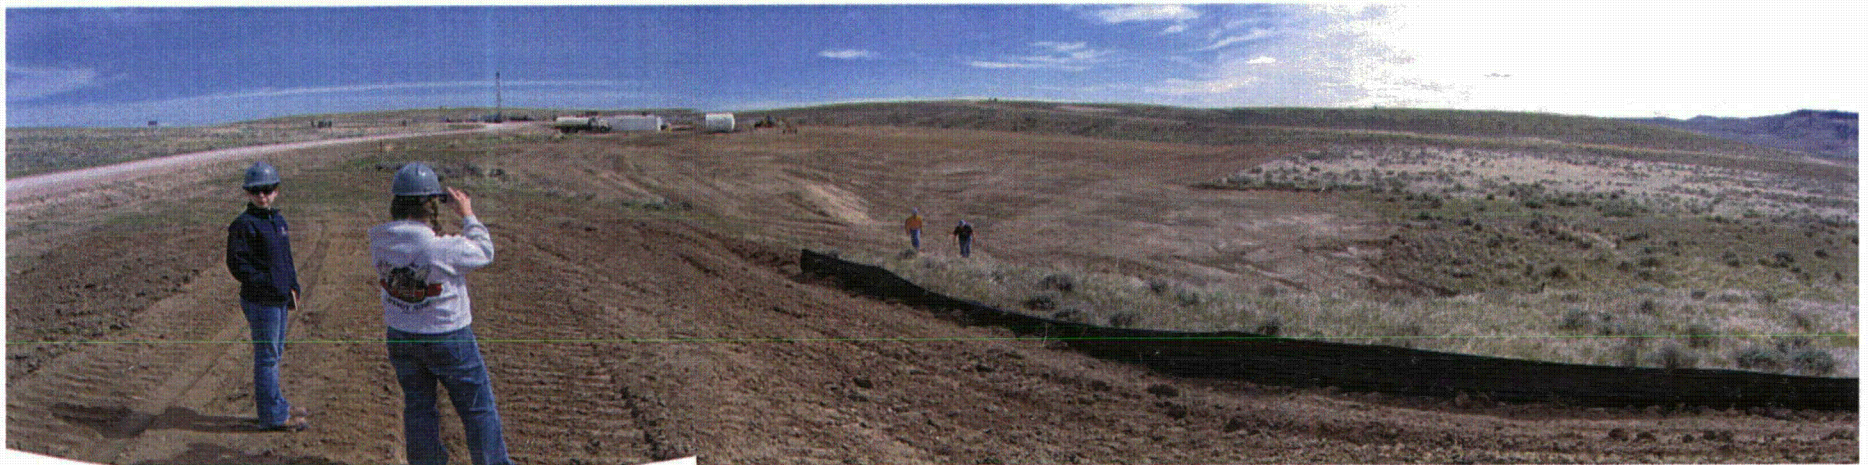
The pad for the satellite plant building has been partially constructed (Photo No. 2). More work on the pad area by the dirt work contractor, Oftedal Construction, is planned.

**Photo No. 2** Looking northeast at pad visible in center distance constructed this spring for satellite plant building. The new access road is visible at far left as is the drill rig drilling the plant water supply well. A staging area fenced with chain link fencing is located beyond tanks and trucks in distance. Note the sediment fence at bottom of slope at lower right.

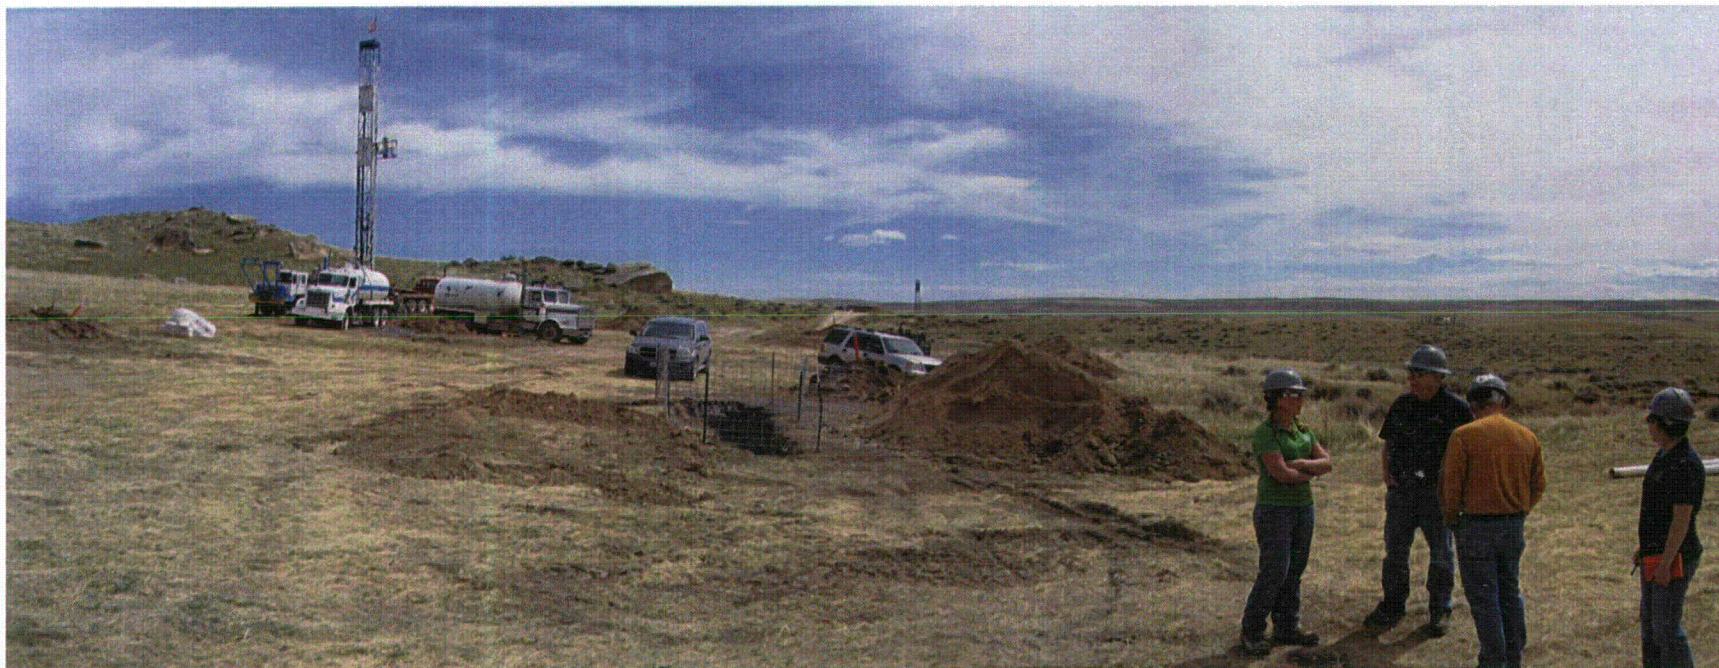
**Photo No. 3** Looking northeast at drilling operations in Mine Unit 2 where delineation drilling was on-going.

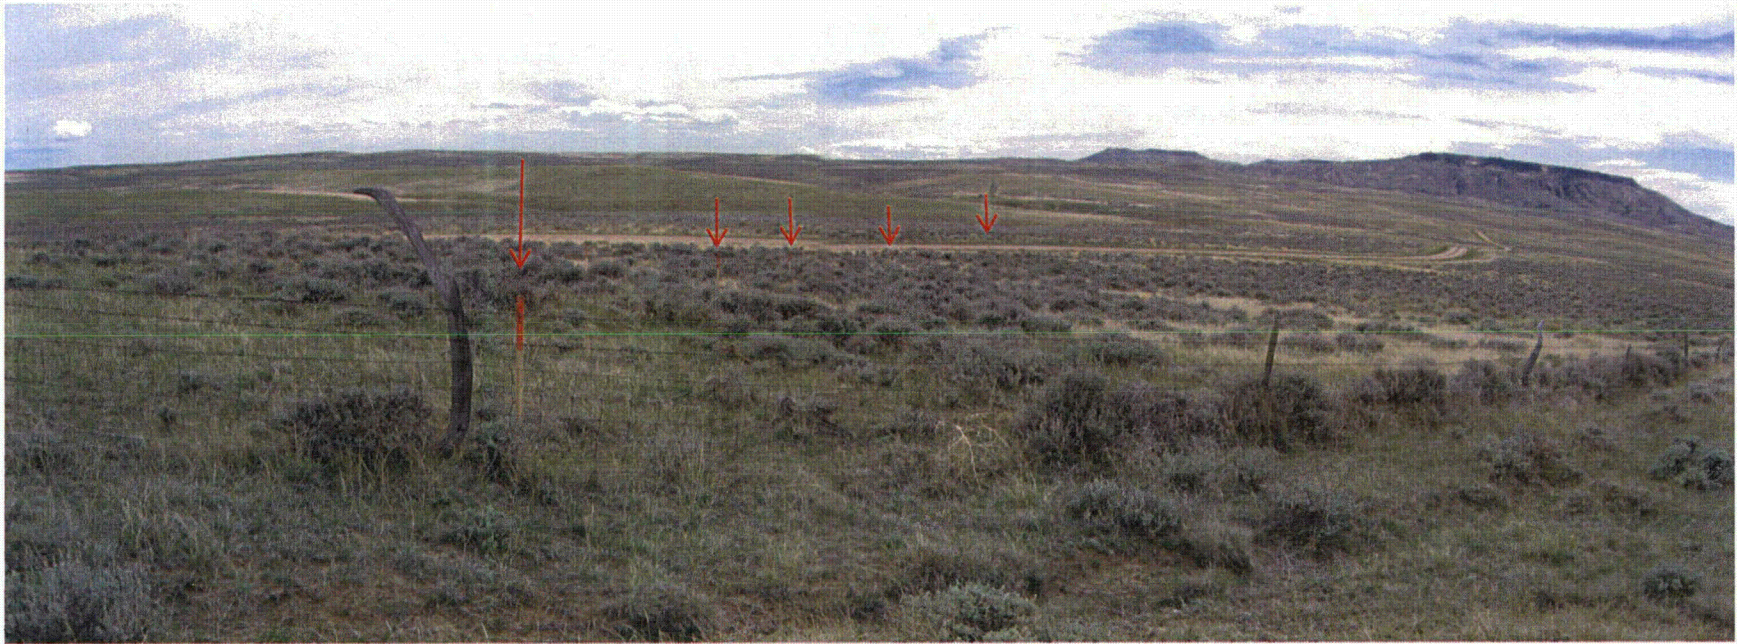
Cameco plans to construct a new access road on the east side of the permit area that will lead to an existing oilfield road located a few hundred feet to the east of the permit area. As noted above, the new access road that has been recently completed across the permit area has been built up to the eastern permit boundary (Photo No. 6).

**Photo No. 6** Looking east to southeast at Incidental Boundary Revision area at far eastern end of permit area. The main mine access road will be extended through fence (note centerline stake in fence line) to link up with established oilfield road visible in the center distance.

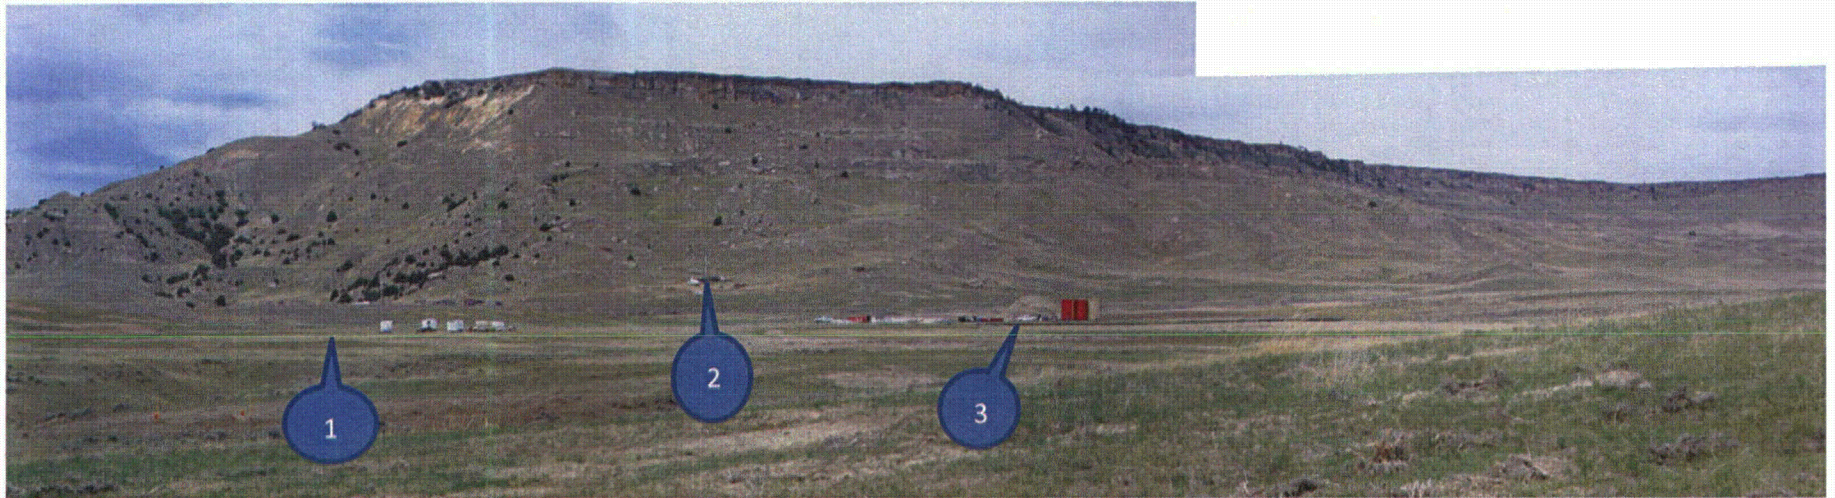
**Photo No. 13** Looking northwest to north at permit area as seen from regional access road to south near Pfister ranchhouse. No. 1 points to location of satellite plant pad, No. 2 points to drilling operations in Mine Unit 2 and No. 3 points to deep disposal well location.
