BWRVIP / NRC Technical Update

Dissimilar Metal Weld Update for BWRs

**Chuck Wirtz, First Energy
BWRVIP Integration Chairman
July 20, 2012**

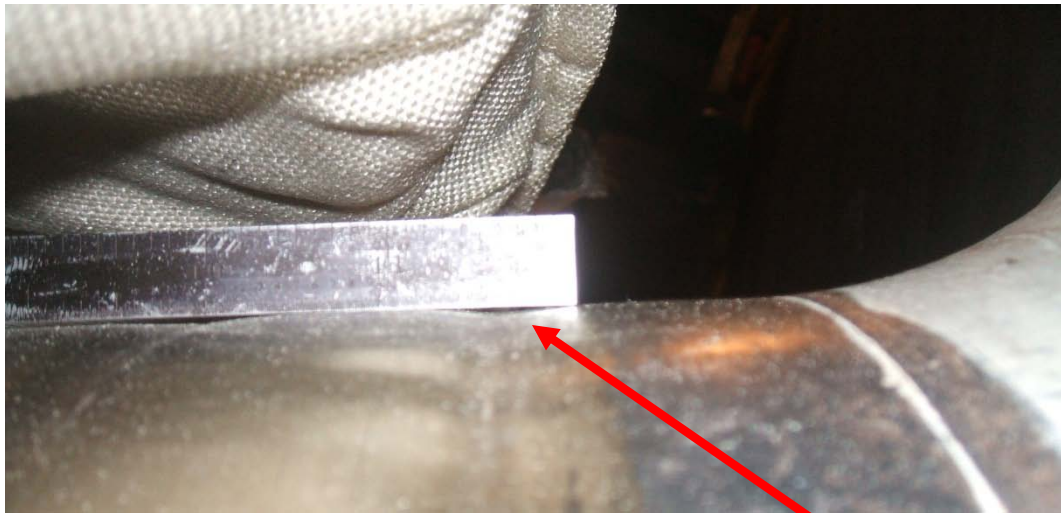
One of the Main Reasons for Newly Discovered Indications

- Surface contour of weld region appears to be the major factor affecting accurate detection and sizing

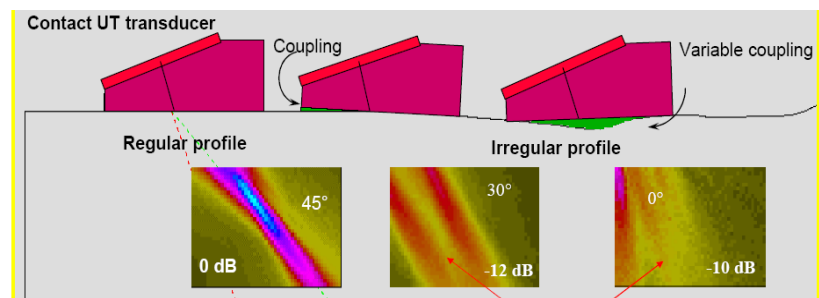
Factors affecting detection & sizing

- Irregular profile/surface condition
 - Presence of weld crowns
 - Radial shrinkage near the weld
- Inadequate probe coupling

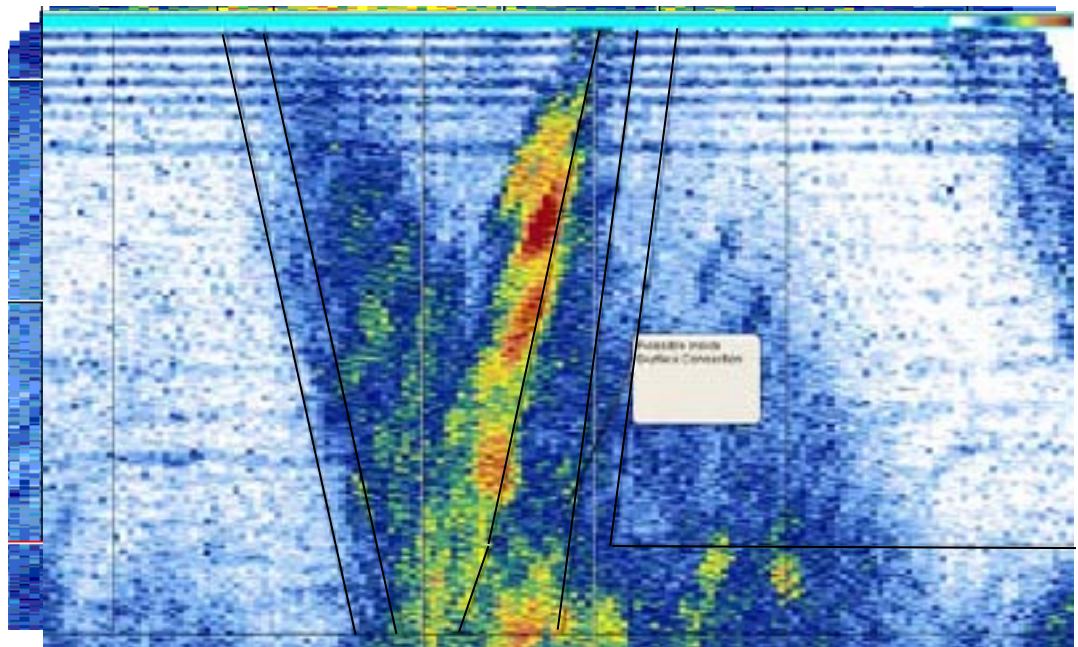
Example of Data Loss From a UT Examination

- Incomplete probe contact resulting in loss of signal
- Following weld resurfacing, weld was re-examined
- Indication was determined to be ID connected
