POEF-2086  
ORNL/TM-11988

## Investigation of Breached Depleted UF<sub>6</sub> Cylinders

Date Published: September 1991

Prepared by the  
OAK RIDGE NATIONAL LABORATORY  
and  
URANIUM ENRICHMENT  
Oak Ridge, Tennessee 37831-6285  
managed by  
MARTIN MARIETTA ENERGY SYSTEMS, INC.  
for the  
U.S. DEPARTMENT OF ENERGY  
under contract DE-AC05-84OR21400 and  
DE-AC05-76OR00001

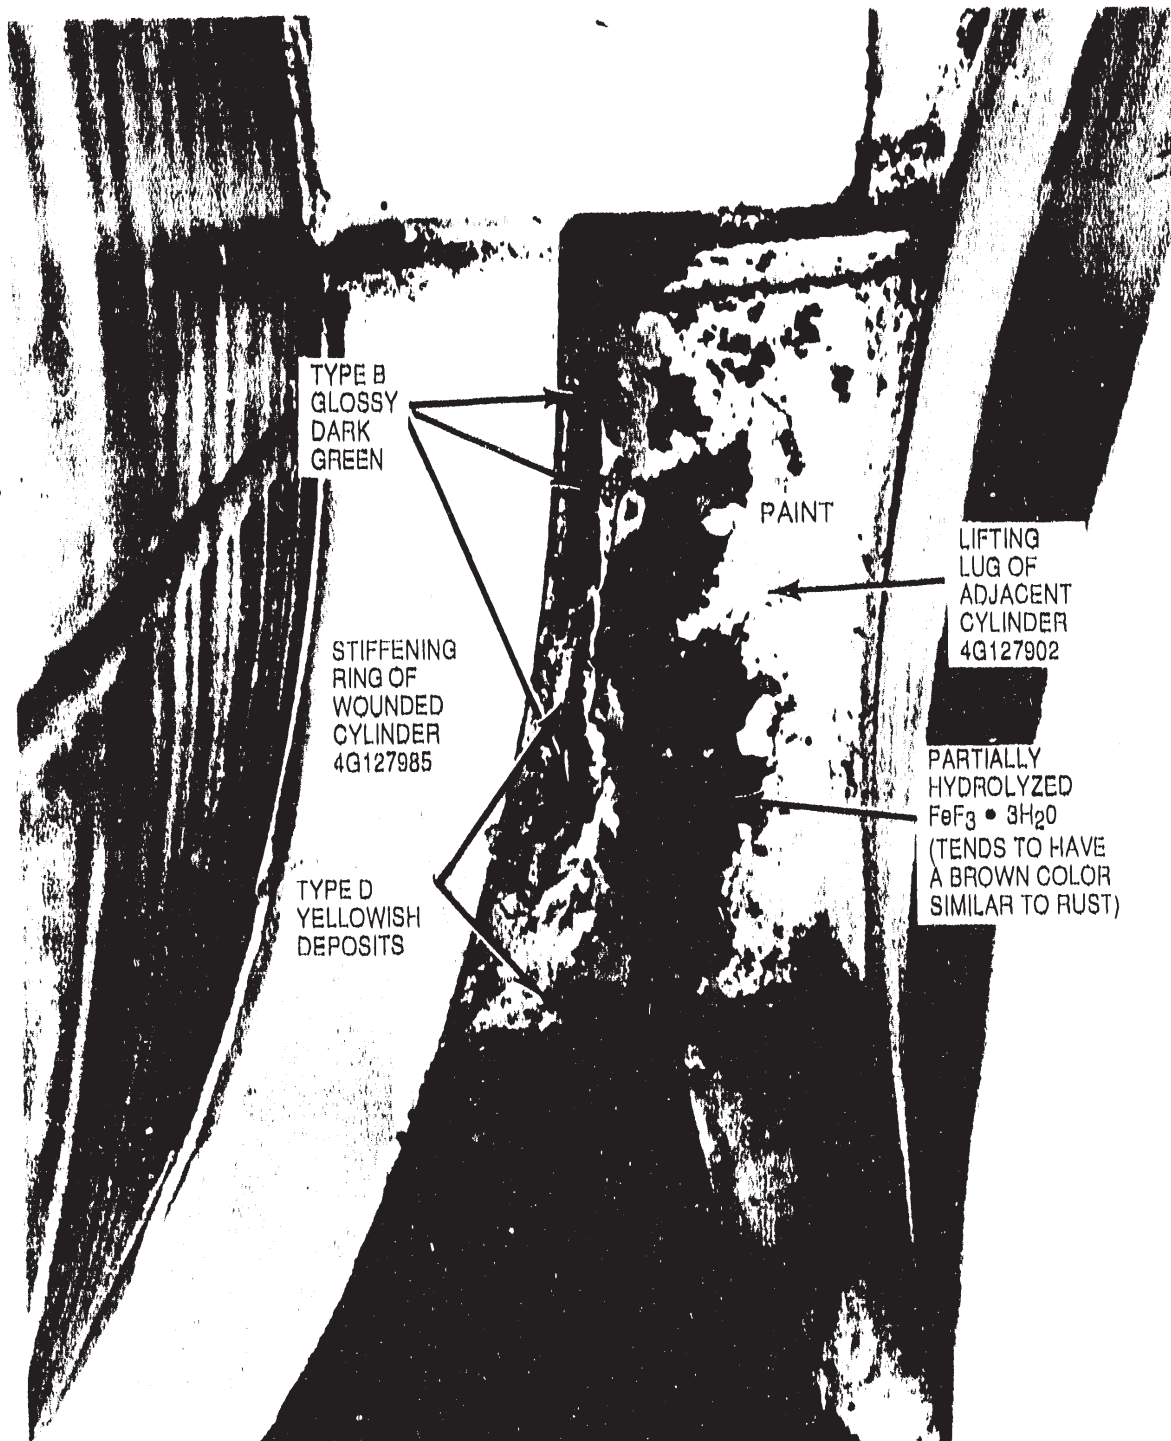
Fig. B1.1. Location of materials taken from surface of stiffening ring of cylinder 4G127985 and lifting lug of cylinder 4G127902. Photograph taken before separation of the cylinders. The hole is just above the longitudinal weld and on the other side of the stiffening ring.

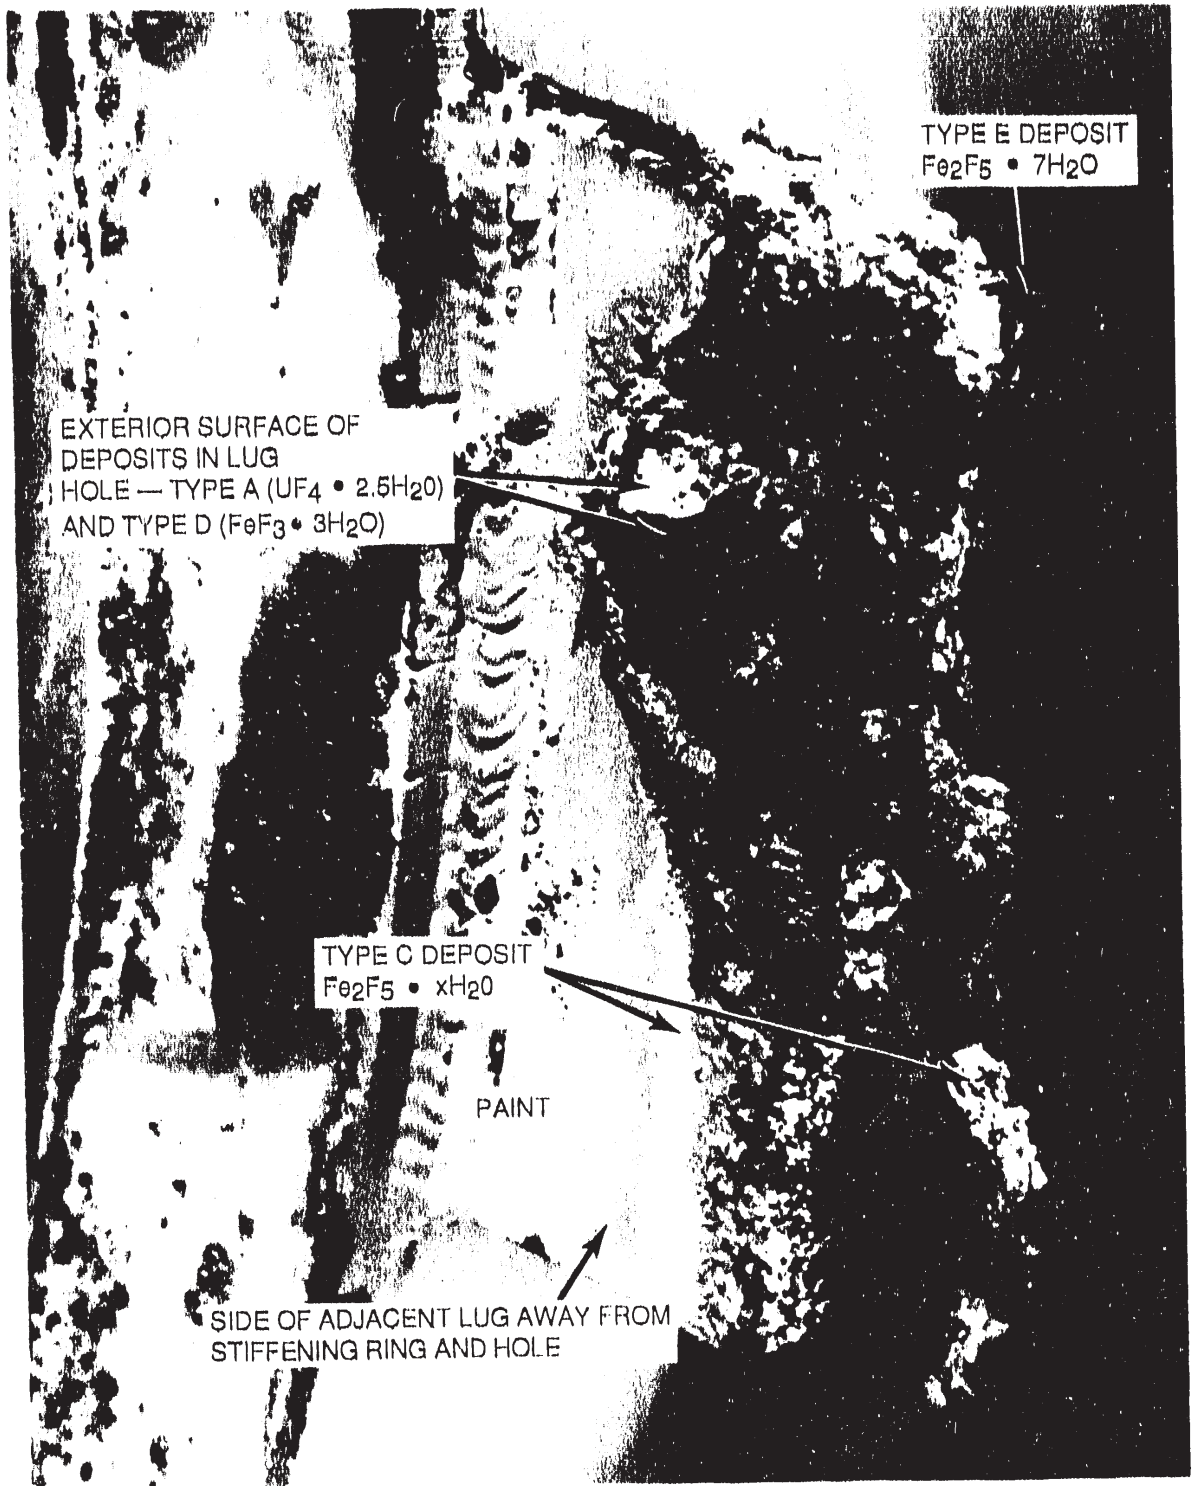
Fig. B1.2. Location of various materials in the lifting lug of cylinder 4G127902 as seen from the side away from the stiffening ring of cylinder 4G127985 after separation from cylinder 4G127985.

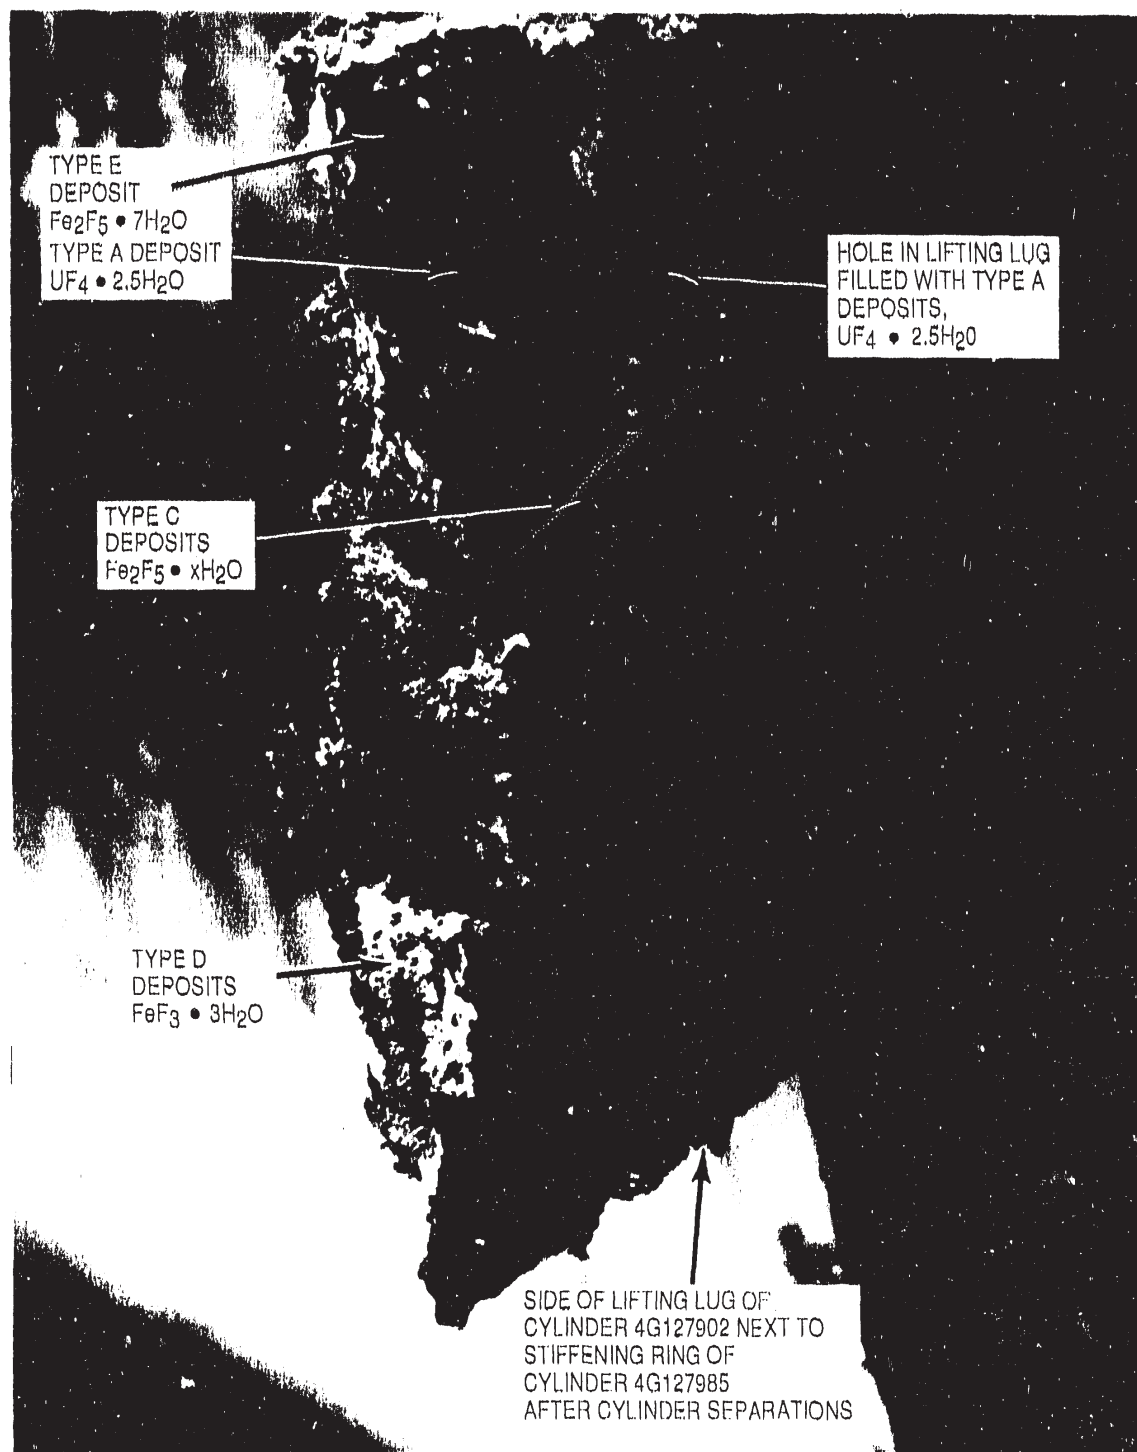
Fig. B1.3. Location of various materials on the lifting lug cylinder 4G127902 as seen from the side adjacent to the stiffening ring of cylinder 4G127985 after separation.

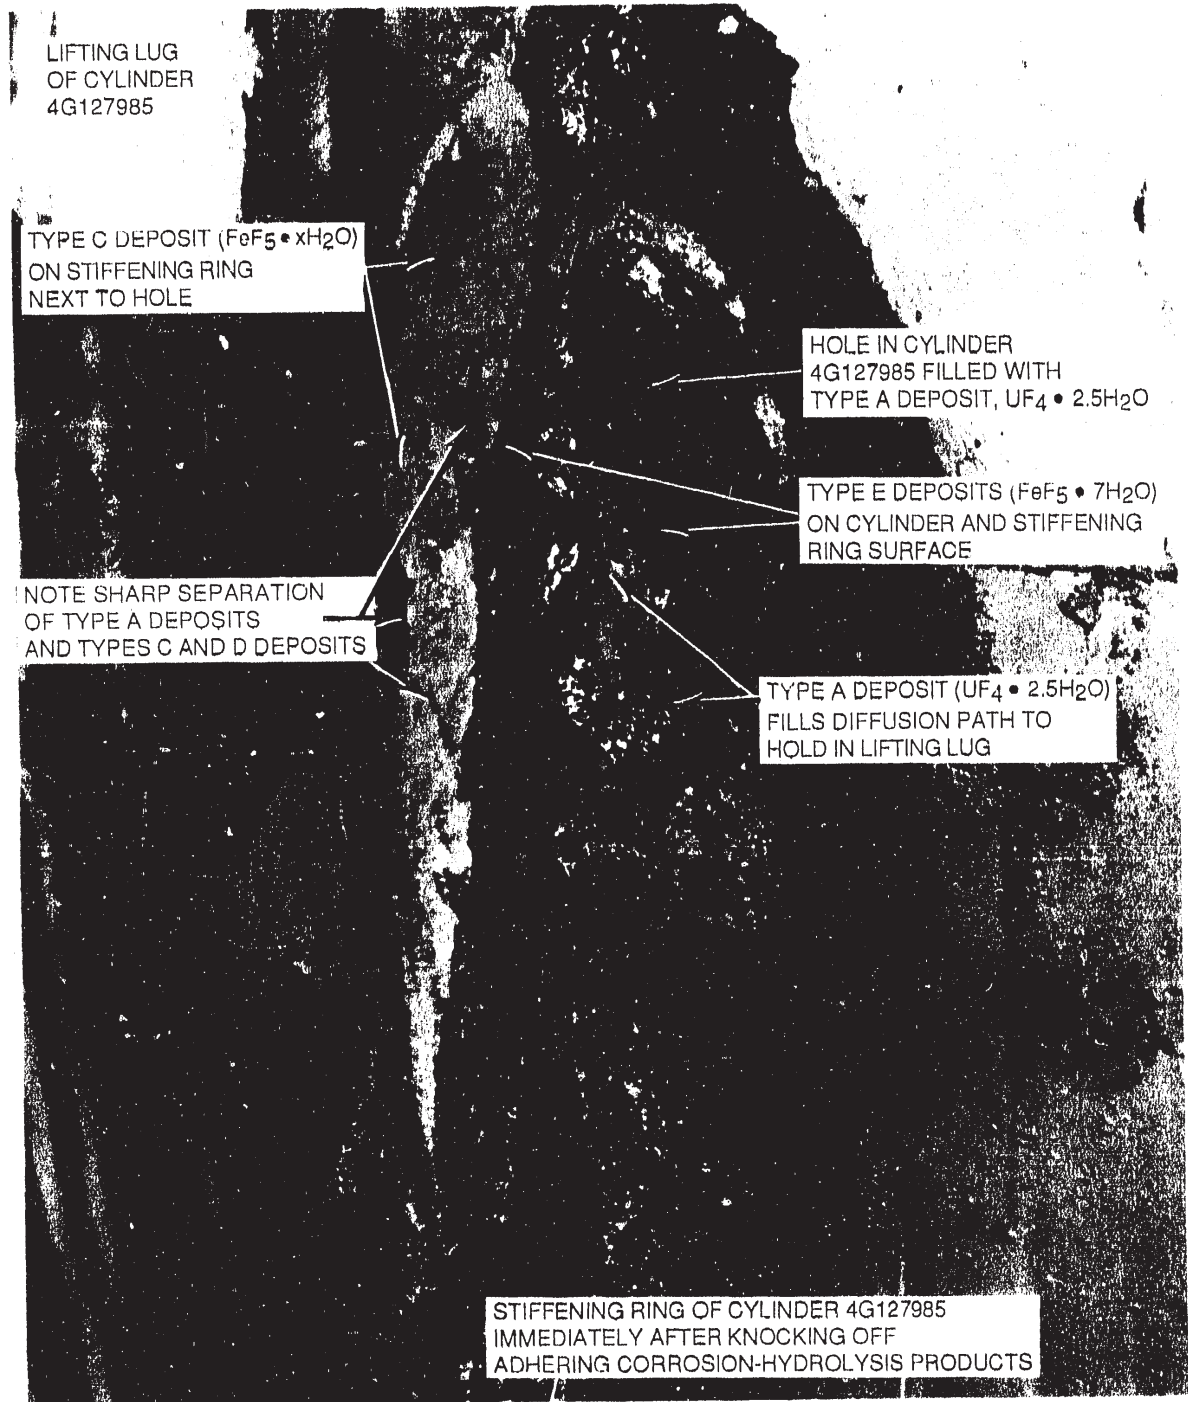
Fig. B1.5. Similar view as in Fig. B1.4 after the corrosion deposit was knocked off revealing the hole.

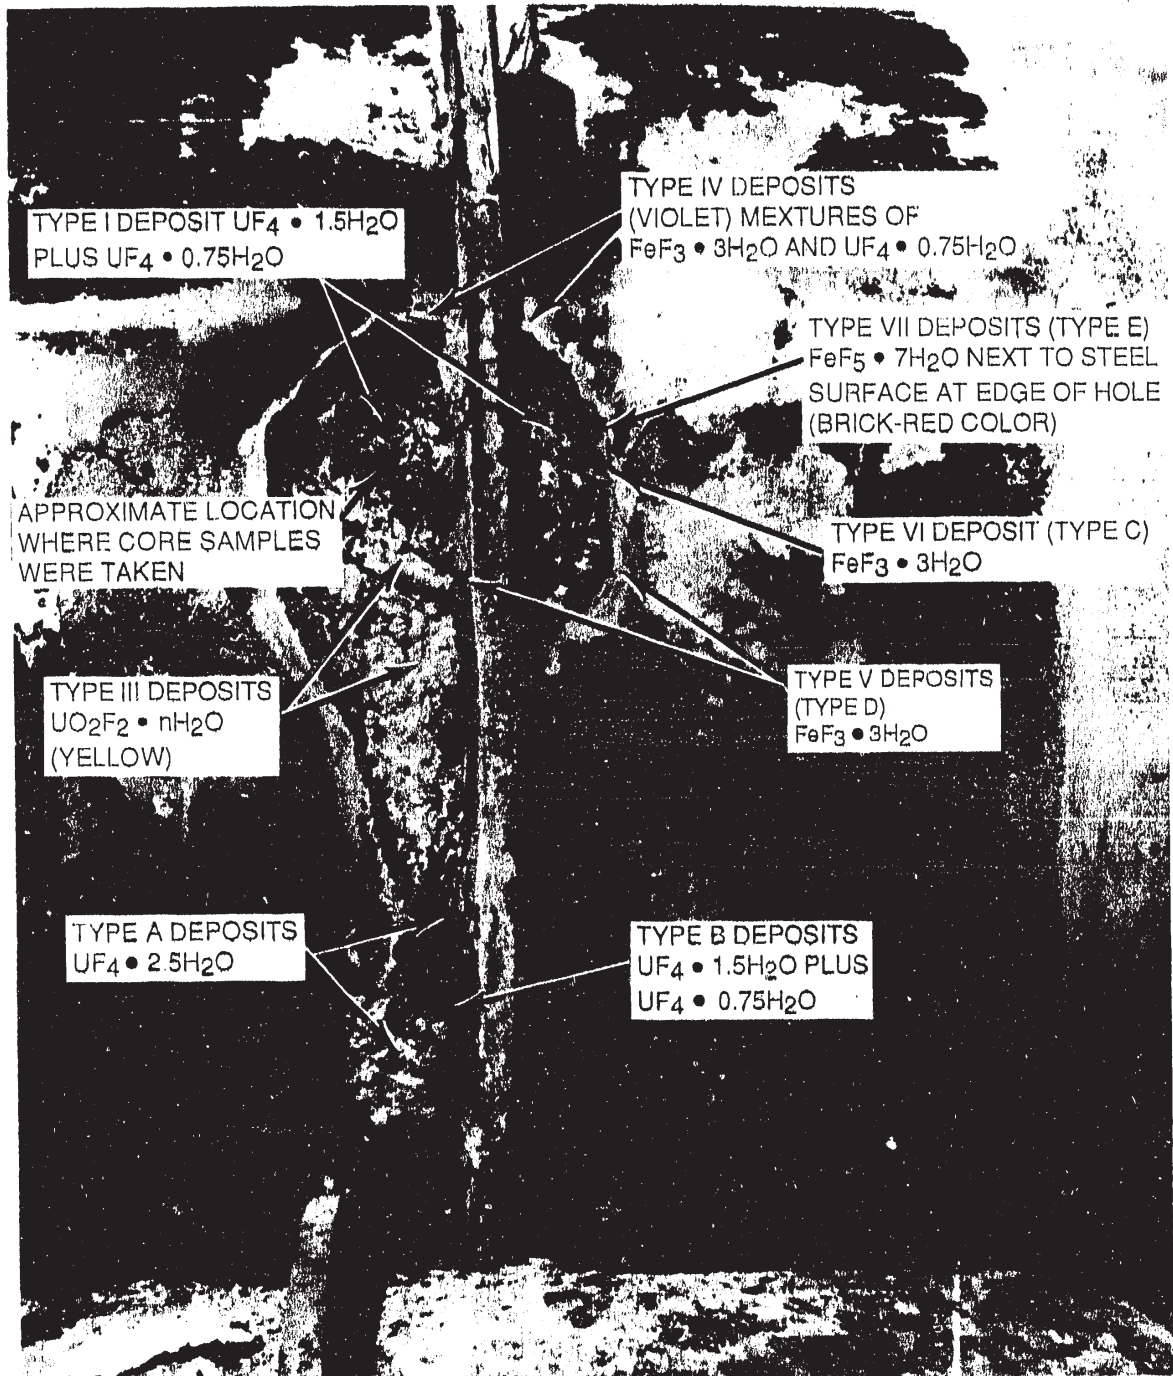
The locations from which the various materials associated with the deposits within the hole of cylinder 4G115688 were taken are shown in Fig. B1.6.

Fig. B1.6. Location of materials in and around the hole in cylinder 4G115688 like those examined by chemical analyses.
