# A Review of Criticality Accidents

## 2000 Revision

**LA-13638**

**Issued: May 2000**

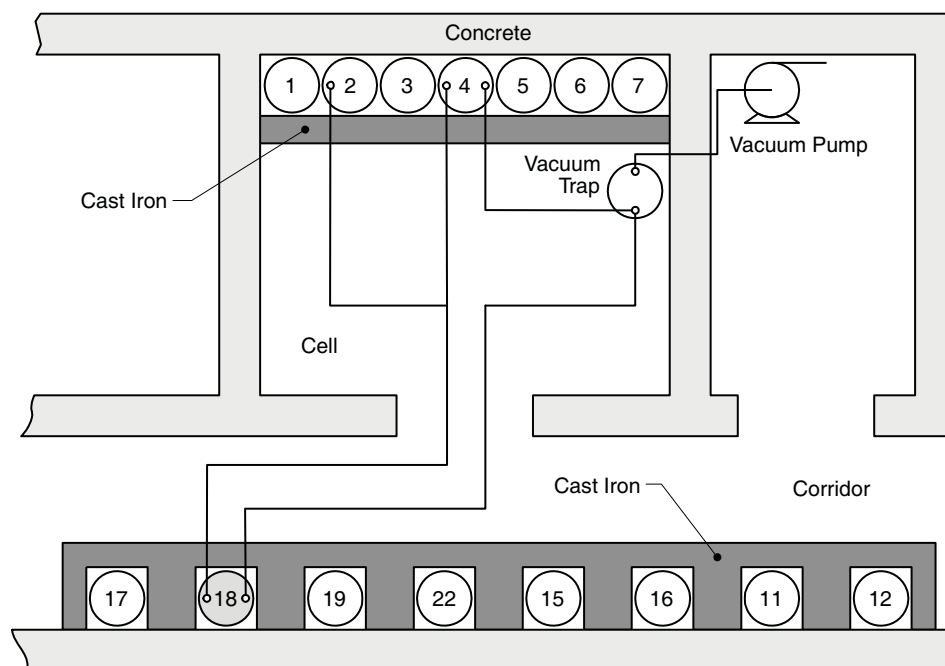
The staging area contained 15 identical short right circular cylindrical stainless steel vessels, each with a unique identification number. The vessels were 400 mm in diameter and 320 mm high with the cylindrical axis oriented vertically. The staging area was not equipped with radiation monitoring instruments. Criticality control was implemented by a 500 gram plutonium mass limit per vessel. Criticality

Figure 6. Layout of vessels and equipment in the staging area.

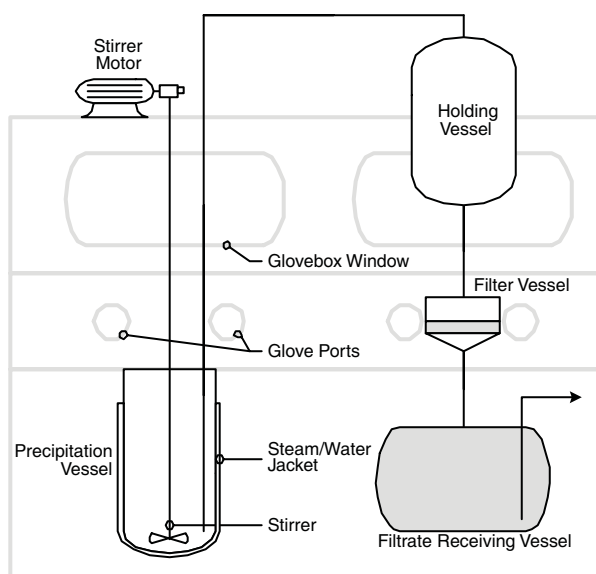
Figure 7. Equipment layout for the oxalate precipitation and filtration process.

- While not known for sure, it was suspected that minor defects in the filter fabric might also have contributed to an increased rate of precipitate accumulation in the filtrate vessel. Procedures called for the filter fabric to be replaced based on either visual evidence of defects or unusually high flow rates through the filter.

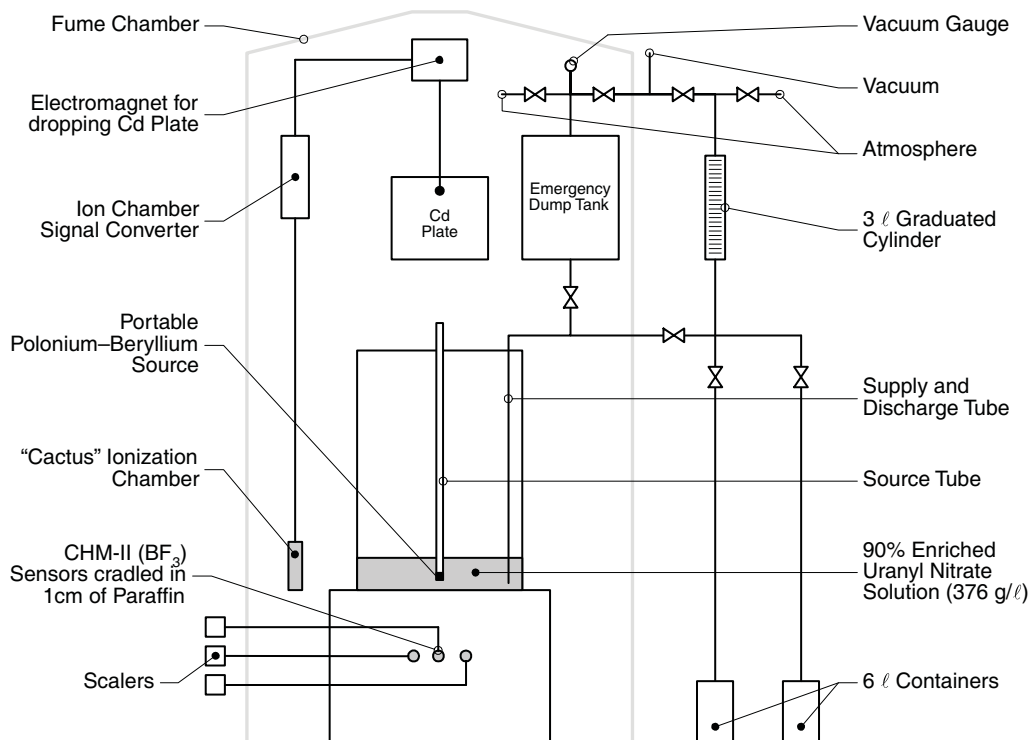
Figure 8. Layout of the experimental equipment.

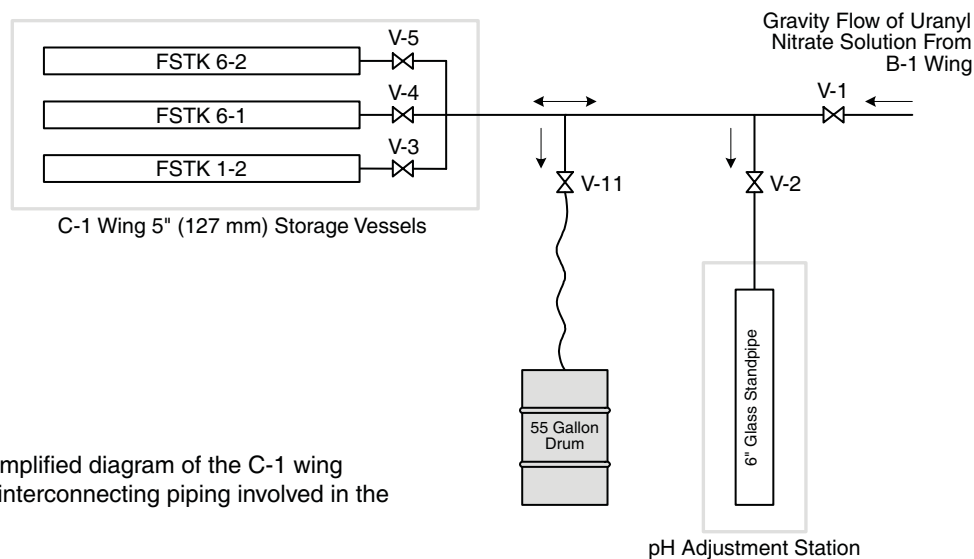
Figure 9 is a simplified diagram of the C-1 Wing vessels and equipment involved in the accident. The inventory required the disassembly and cleaning of the three, 5 inch (127 mm) diameter vessels\* (FSTK 1-2, FSTK 6-1, FSTK 6-2) used to store uranyl nitrate solution. Before resumption of operations, it was necessary to reassemble and to leak test the vessels. This entire process usually required several, 8-hour shifts to complete.

Unknown to anyone at the time, uranyl nitrate had been leaking from the B-1 Wing through valve V-1 from the early hours of the previous shift until about 13:30, when one of the operators checked it (and by applying pressure completely closed the valve), as instructed by the supervisor. Before this, the uranyl nitrate had been collecting in vessel FSTK 1-2, because valve V-3 had also been open.

Figure 9. Simplified diagram of the C-1 wing vessels and interconnecting piping involved in the accident.

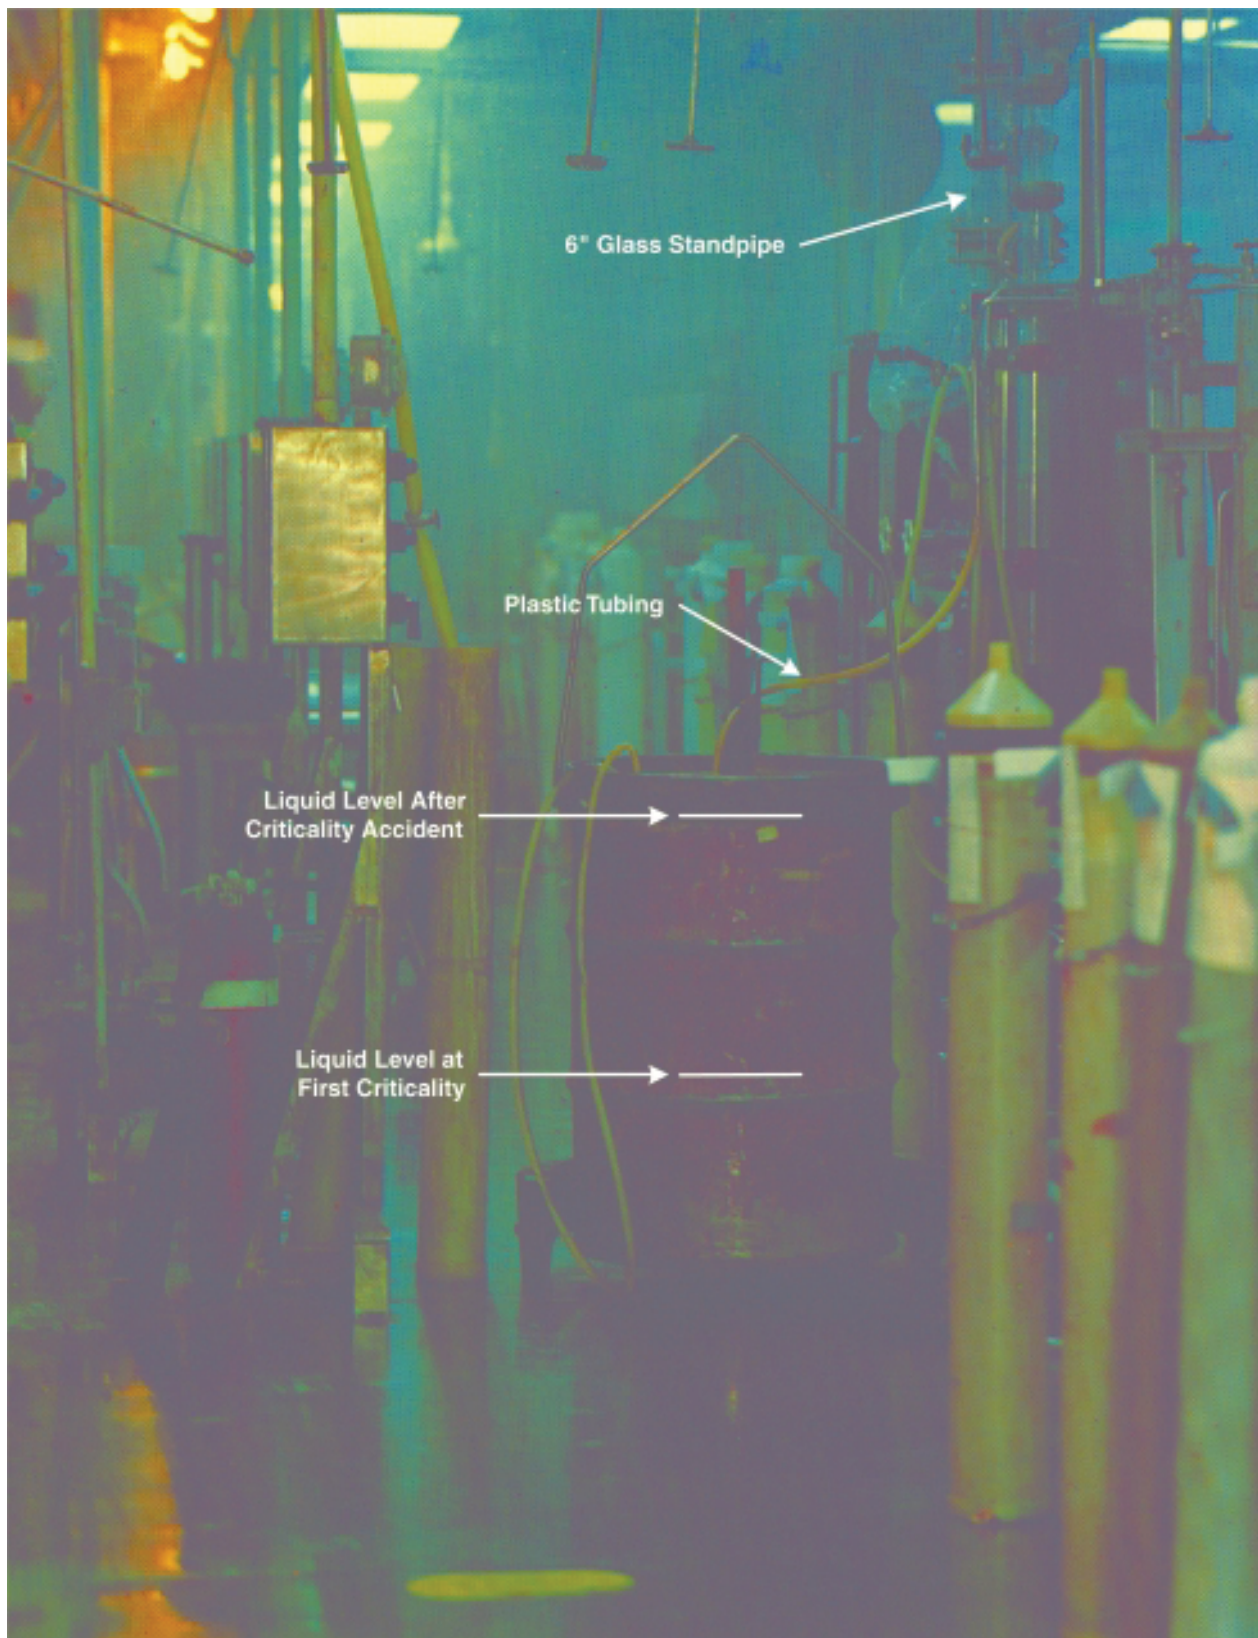
Figure 10. Drum in which the 1958 Y-12 process criticality accident occurred.

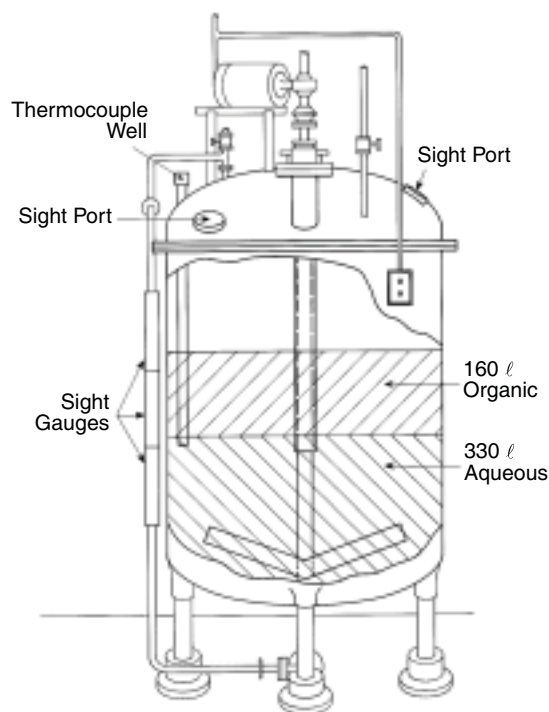
Figure 11. Configuration of solutions (aqueous and organic) in the vessel before the accident.

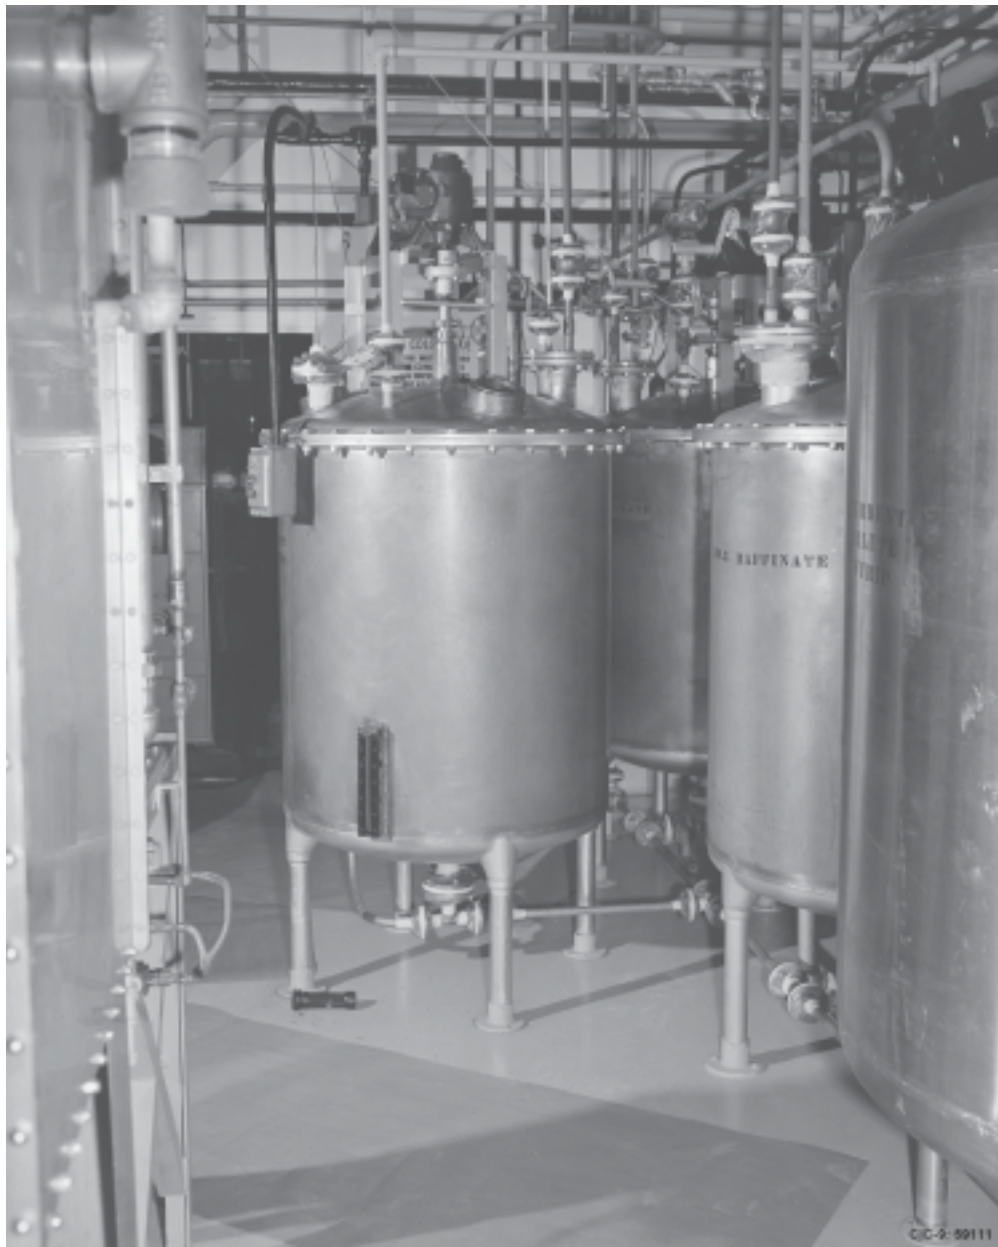
The accident resulted in the death, 36 hours later, of the operator who was looking into a sight glass when the motor was turned on. The dose to his upper torso was estimated to have been  $12,000 \pm 50\%$  rem. Two other persons apparently suffered no ill effects after receiving radiation doses of 134 and 53 rem. No equipment was contaminated or damaged even though the shock associated with off-axis bubble generation displaced the tank about 10 mm at its supports.

Figure 12. Vessel in which the 1958 Los Alamos process criticality accident occurred.

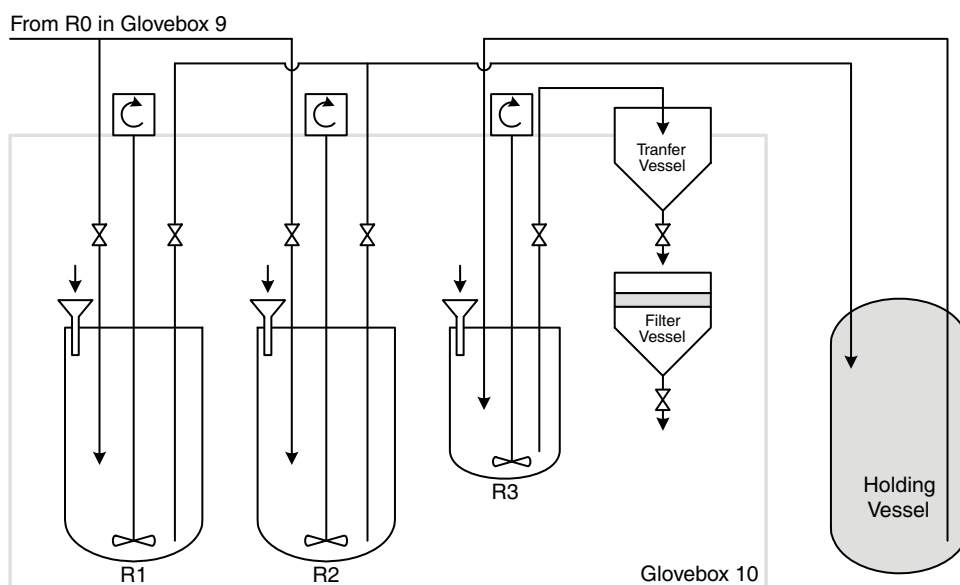
Figure 13. Layout of vessels in Glovebox 10 and the holding vessel external to the glovebox.

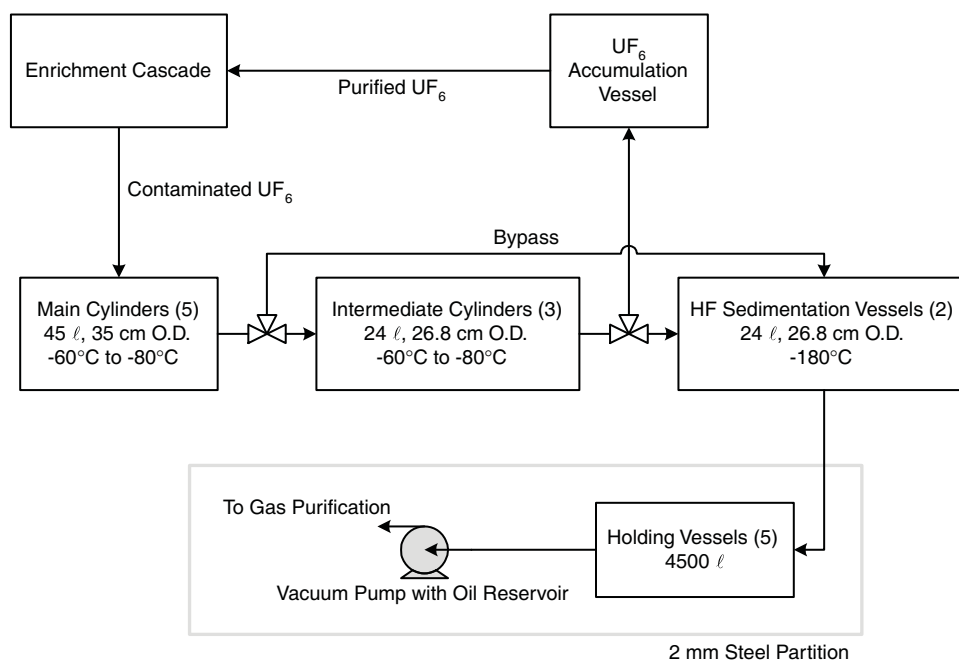
Figure 14. Layout of DSS-6.

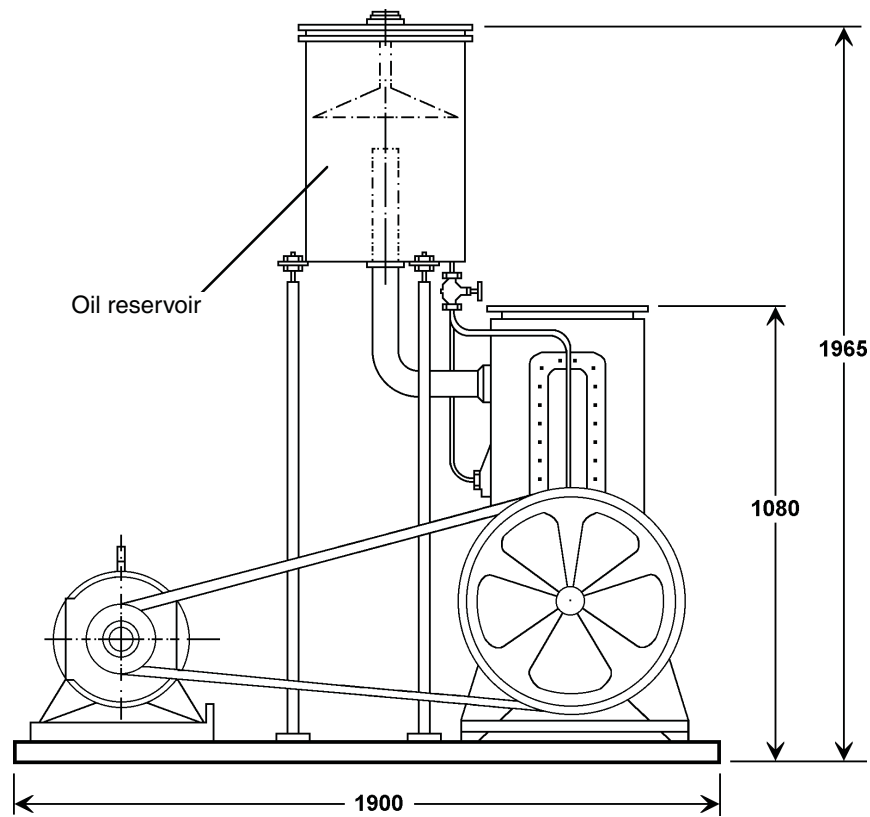
Figure 15. Vacuum pump diagram showing oil reservoir (Dimensions are in mm).

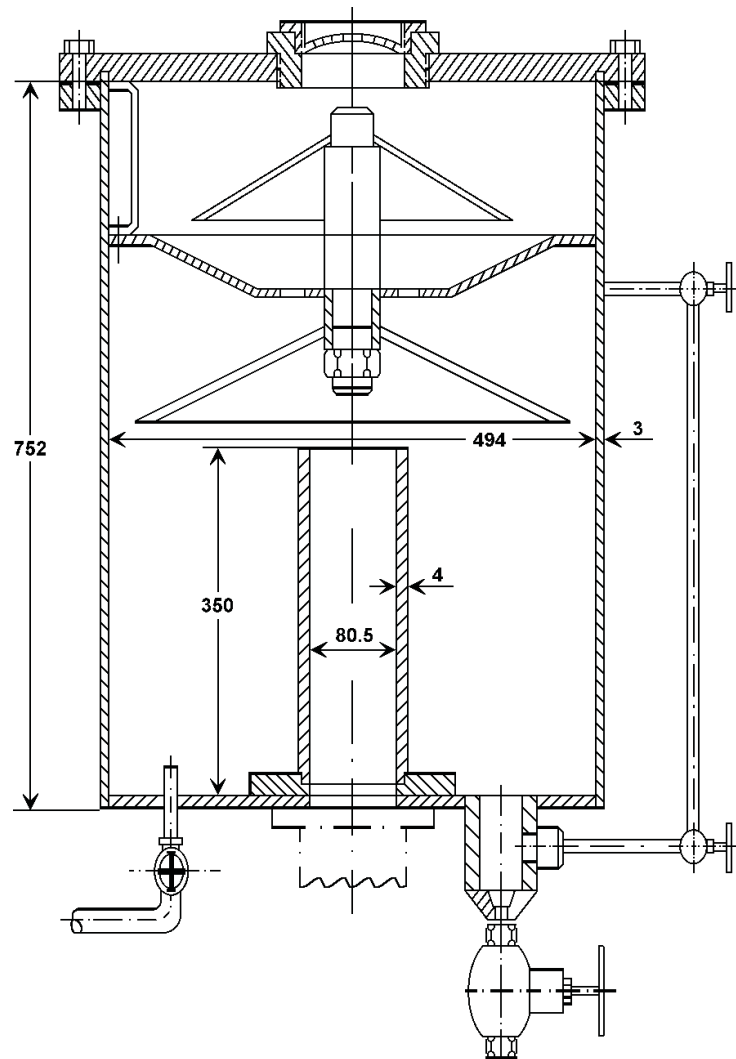
When the pump was turned on at 07:30, the oil in the pump's cavities was forced out into the central pipe of the oil reservoir. This sudden injection of oil containing uranium led to the second and much larger excursion. The shutdown of this excursion was due to a combination of temperature rise and radiolytic gas generation, which caused ejection of the oil from this central pipe back into the pump's cavities and the gas purification equipment. As with the first excursion, the

Figure 16. Oil reservoir (Dimensions are in mm).

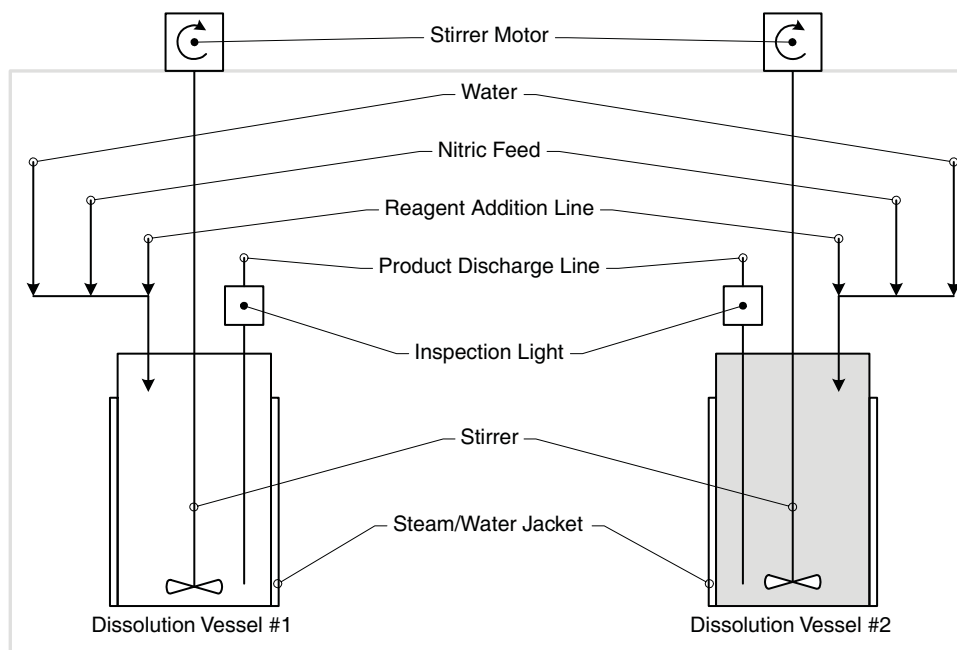
Figure 17. Layout of glovebox equipment.

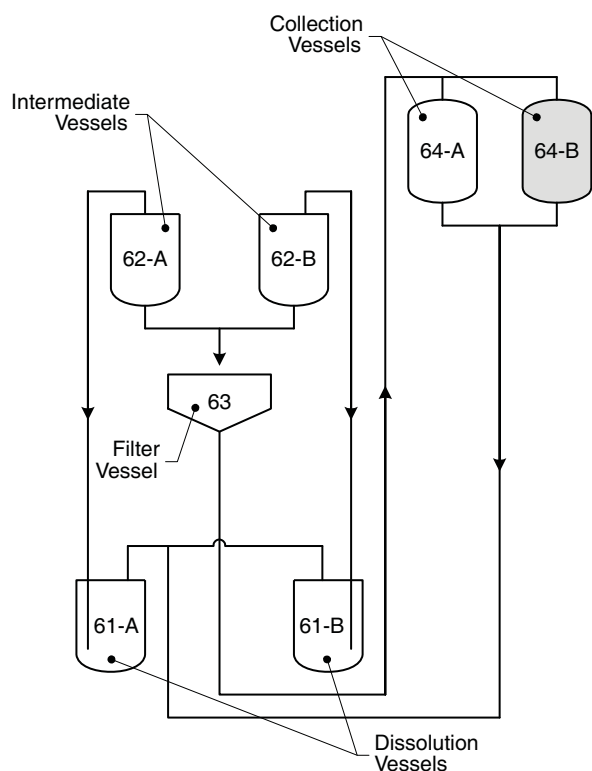
Figure 18. Process vessels and material flow diagram.

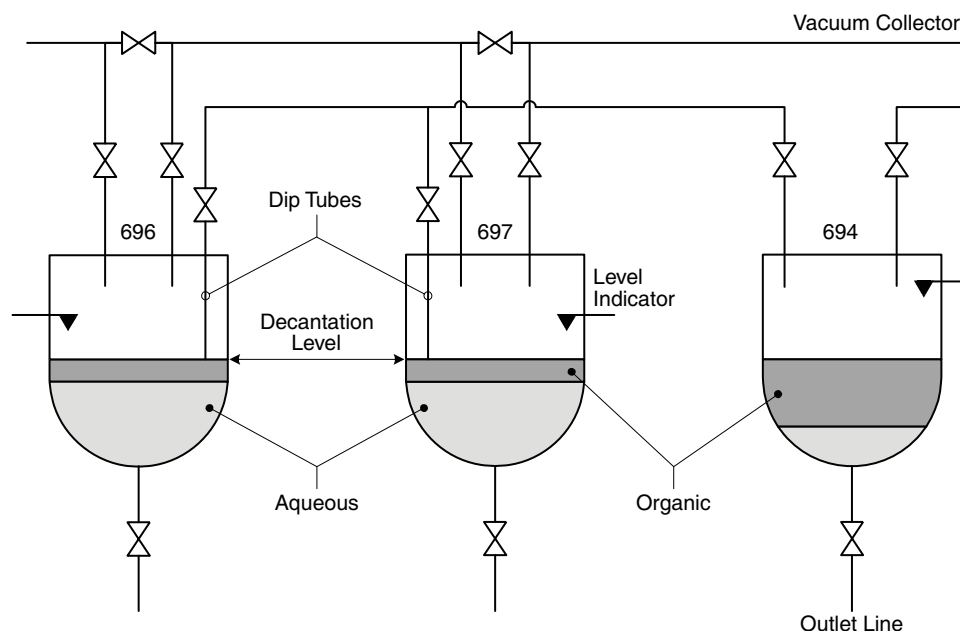
During typical operations, sufficient quantities of aqueous solutions would accumulate in vessels 696 and 697, causing the automatic decanting to occur up to four times per day. The elevation difference between the level indicator and the dip tube was slight, thus causing only 1 or 2 ℓ to be transferred at a time.

Figure 19. Schematic of vessels showing organic and aqueous solutions (not intended to imply the exact conditions at the time of the accident).

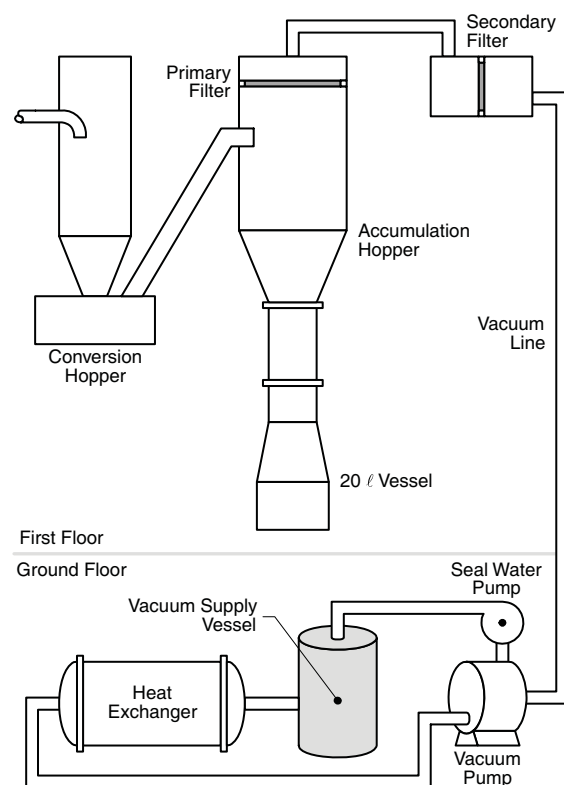
Figure 20. Layout of  $\text{UF}_6$  to uranium oxide conversion equipment and associated vacuum system.

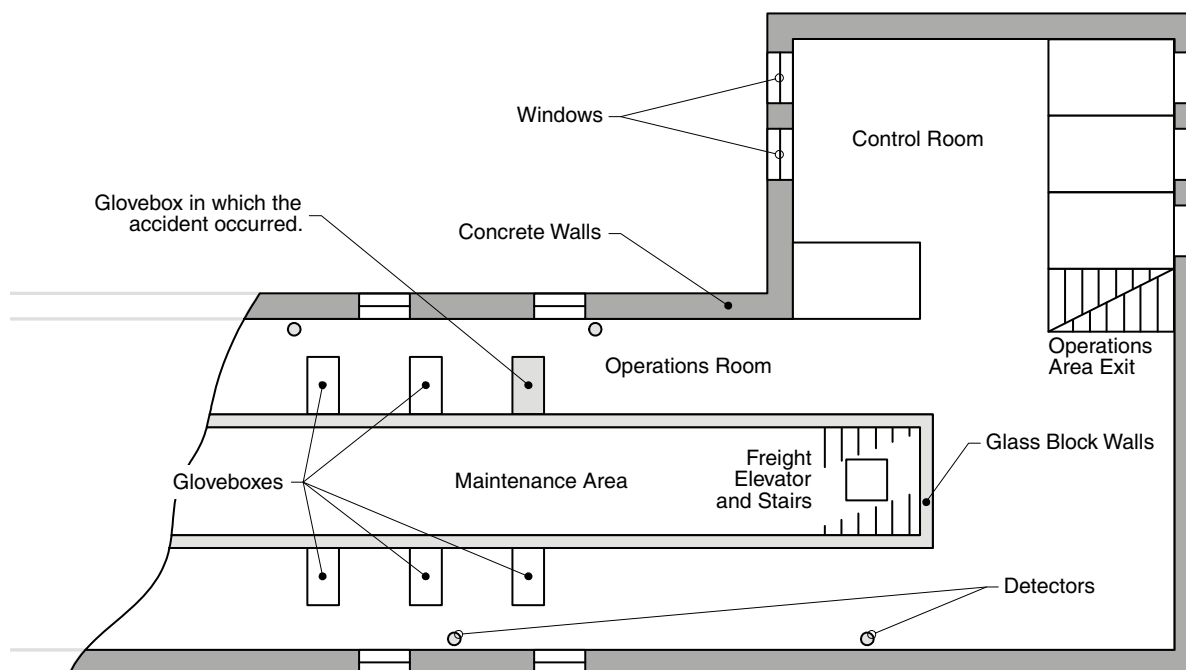
Figure 21. Residue recovery area layout.

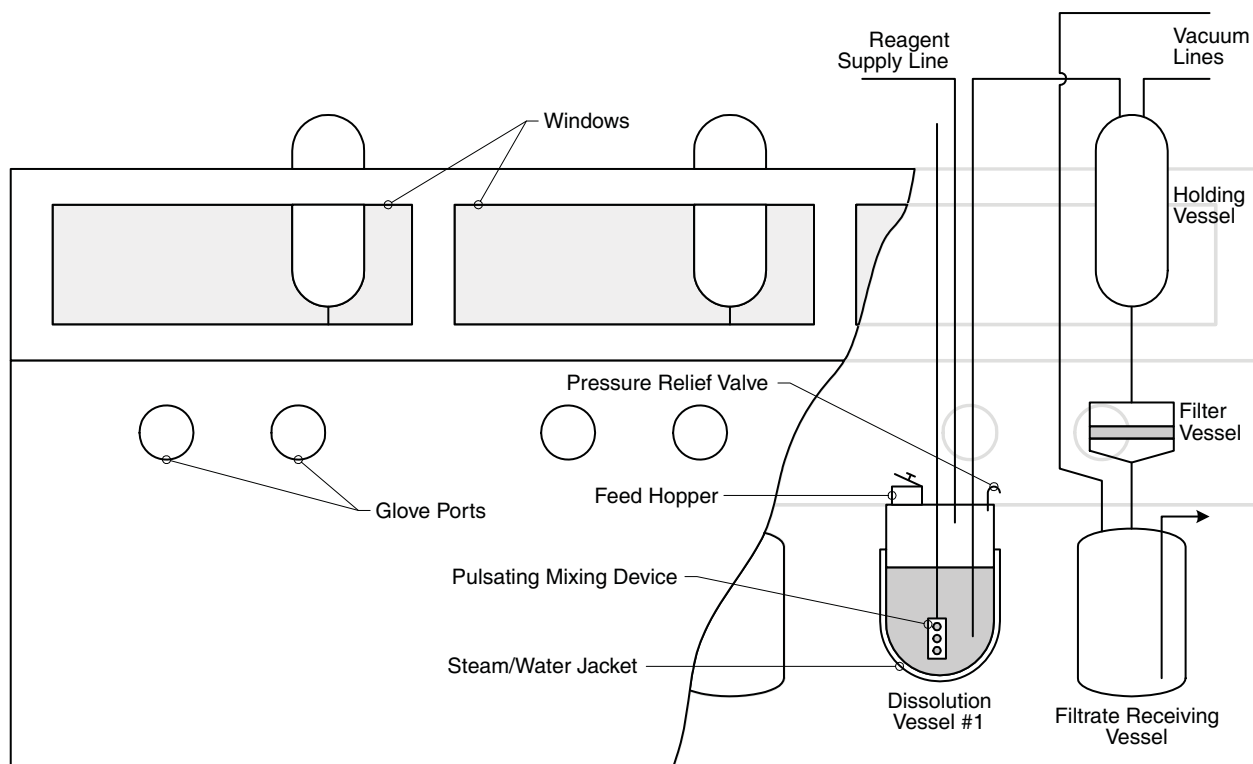
Figure 22. Layout of dissolution glovebox.

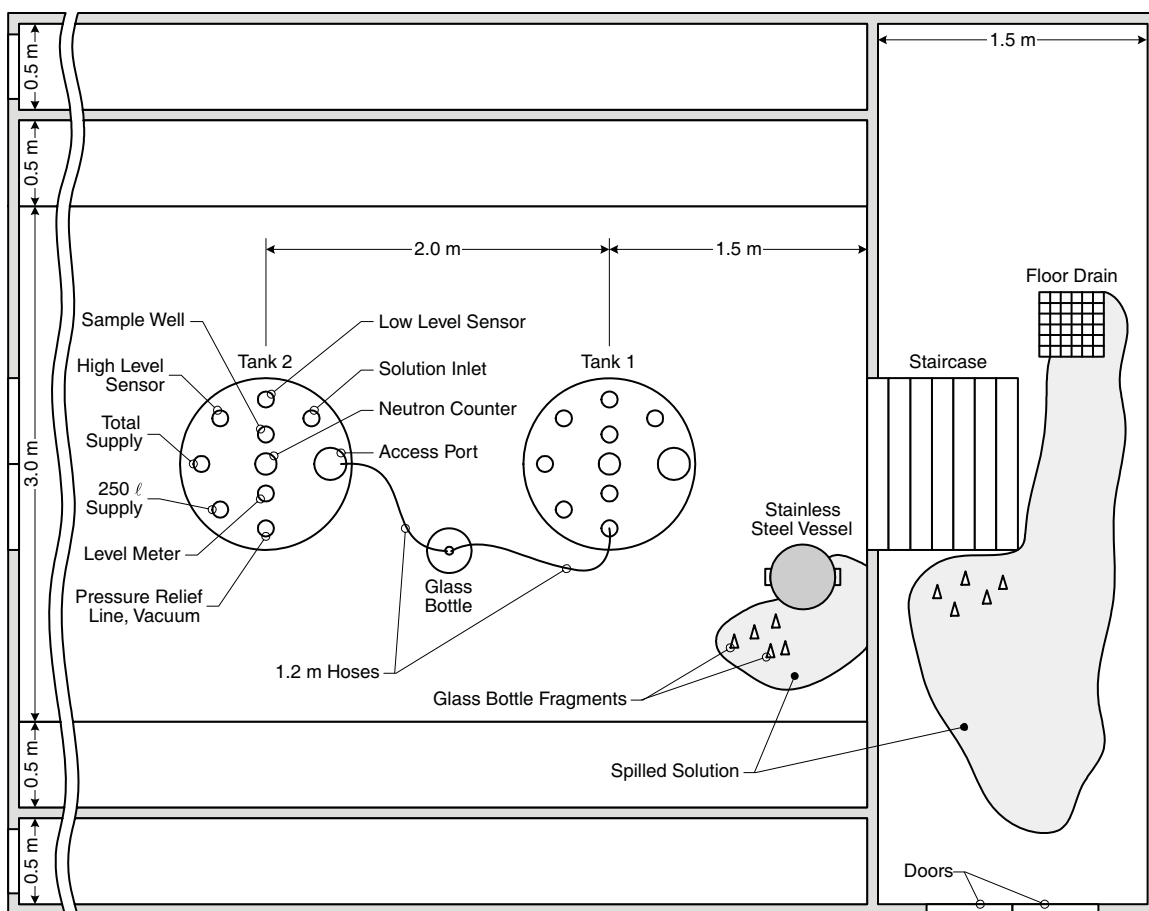
Figure 23. Plan view of the tanks involved in the accident.

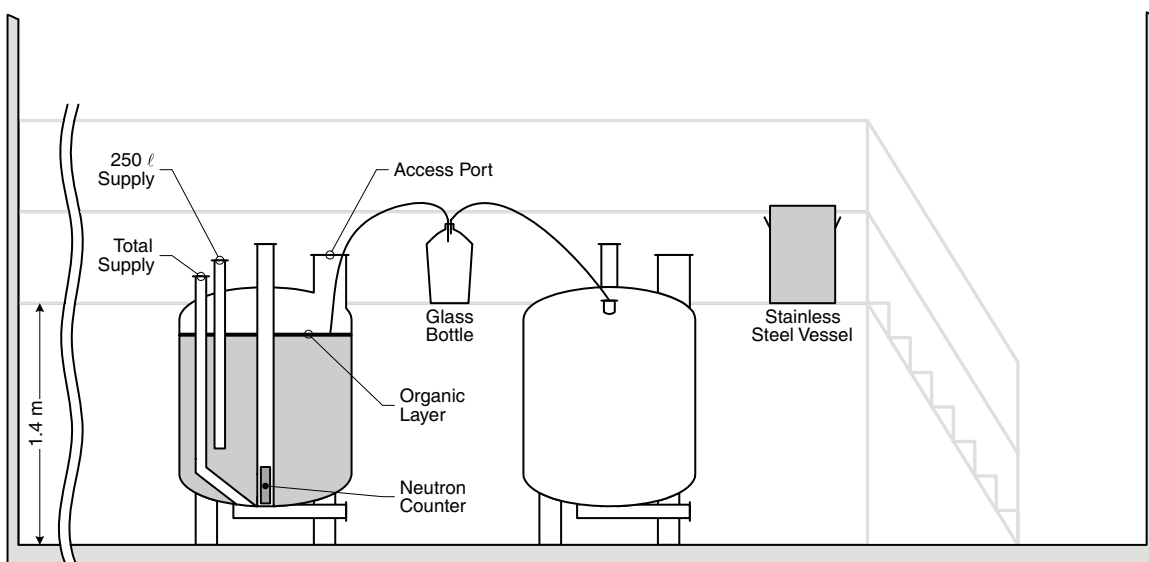
Figure 24. Elevation view of the tanks involved in the accident.

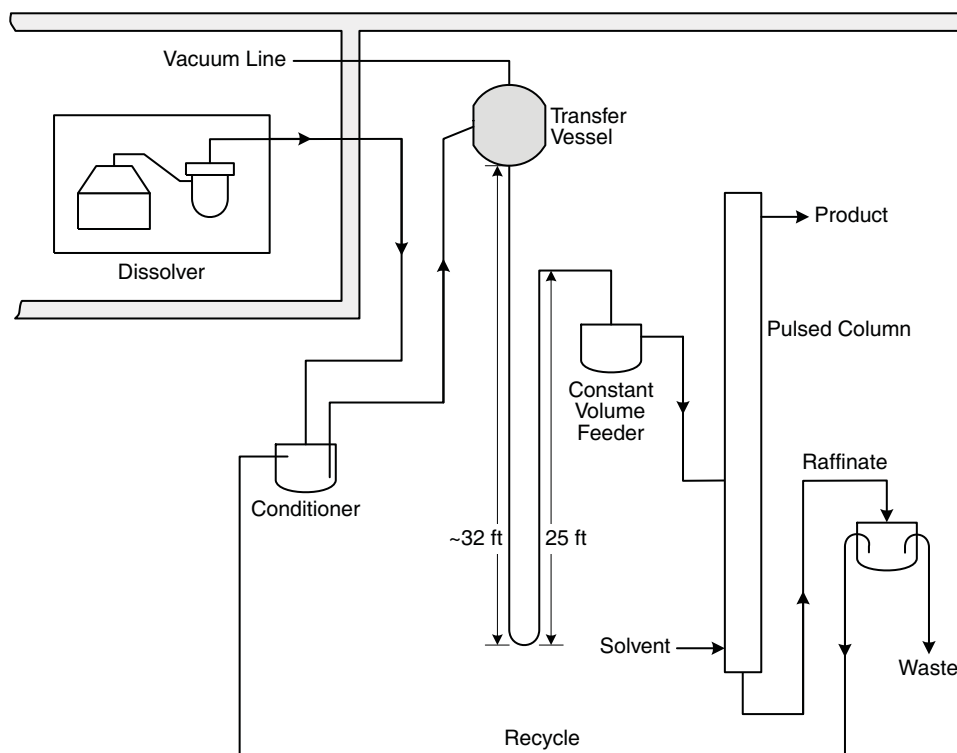
Figure 25. Process equipment related to the criticality accident.

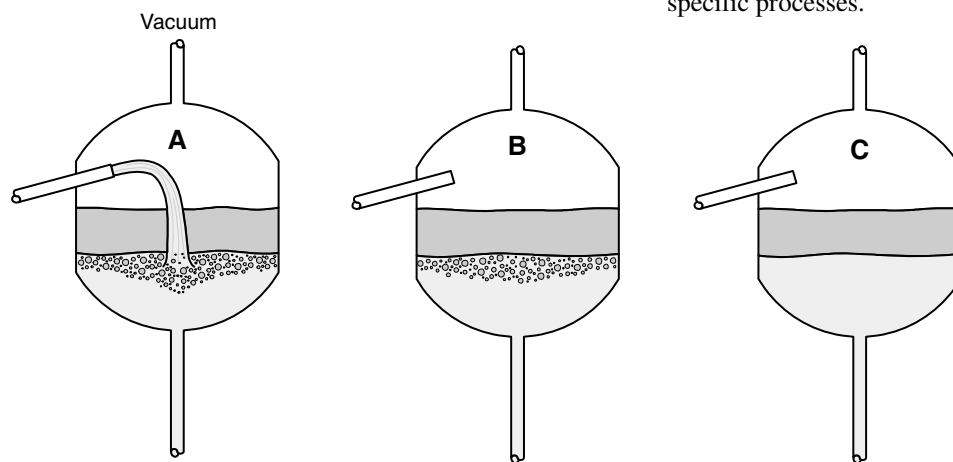
This excursion illustrates the subtle ways in which accidents can occur during solution processing. Although the deep trap was considered a safety feature for the control of contamination, it contributed directly to the criticality accident. The difficulty of understanding what had happened, even after it was known in which vessel the excursion occurred, is an excellent example of the impracticability inherent in attempting to calculate criticality accident probabilities for specific processes.

Figure 26. Solution transfer as reconstructed from the transparent plastic mockup of the transfer vessel. Configuration (B) is the postulated state at the time of the accident.

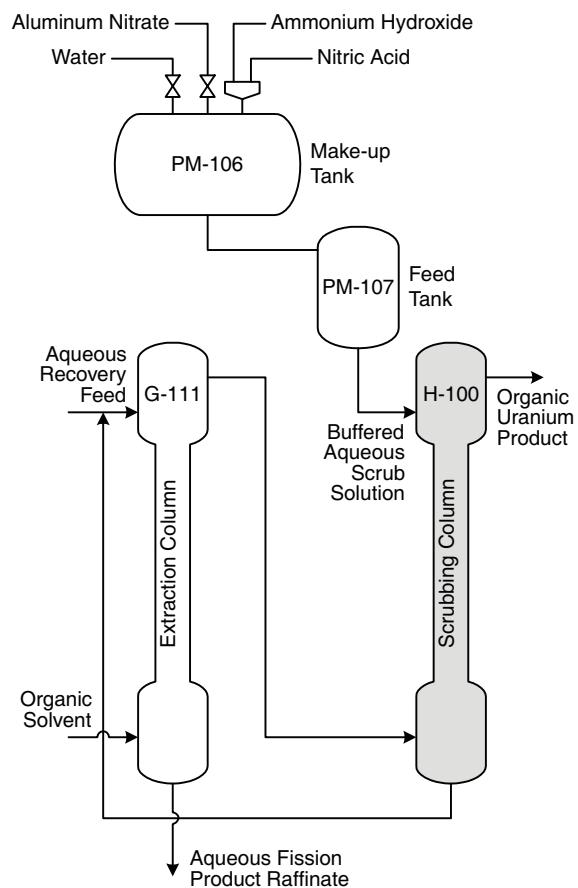
for the scrubbing column, H-100, had been leaking for about a month prior to the accident. Over time, this leak caused a dilution of the feed solution from 0.75 M to 0.08 M. The 13,400 ℓ make-up tank was equipped with a density alarm that would have indicated the discrepancy, but the alarm was inoperable. A density alarm was scheduled to be installed on the 3,000 ℓ process feed tank (PM-107) that was filled, as necessary, from the make-up tank, but this had not been done. The make-up tank was instrumented with a strip-chart recorder showing the solution level in the tank. However, the leak into the tank was so slow that the change in level would have not have been discernible unless several days worth of the chart was analyzed. To complicate matters, the chart recorder had run out of paper on 29 September and it was not replaced until after the accident. Furthermore, procedures that required the taking of samples from the feed tank, PM-107, to confirm the density, were not being followed.

Figure 27. First cycle extraction line equipment. The accident occurred in the lower disengagement section of the H-100 column.

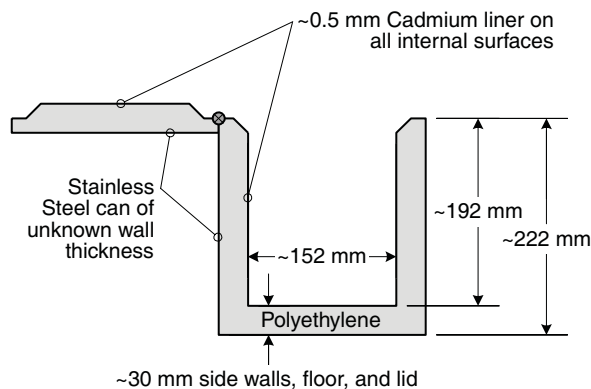
Figure 28. Storage container.

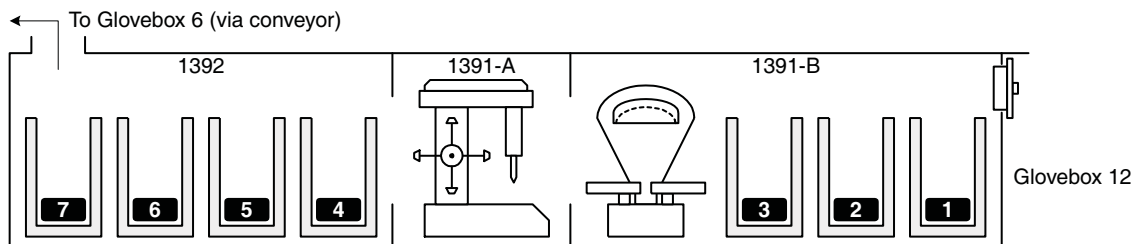
Figure 29. A simplified layout of Glovebox 13.

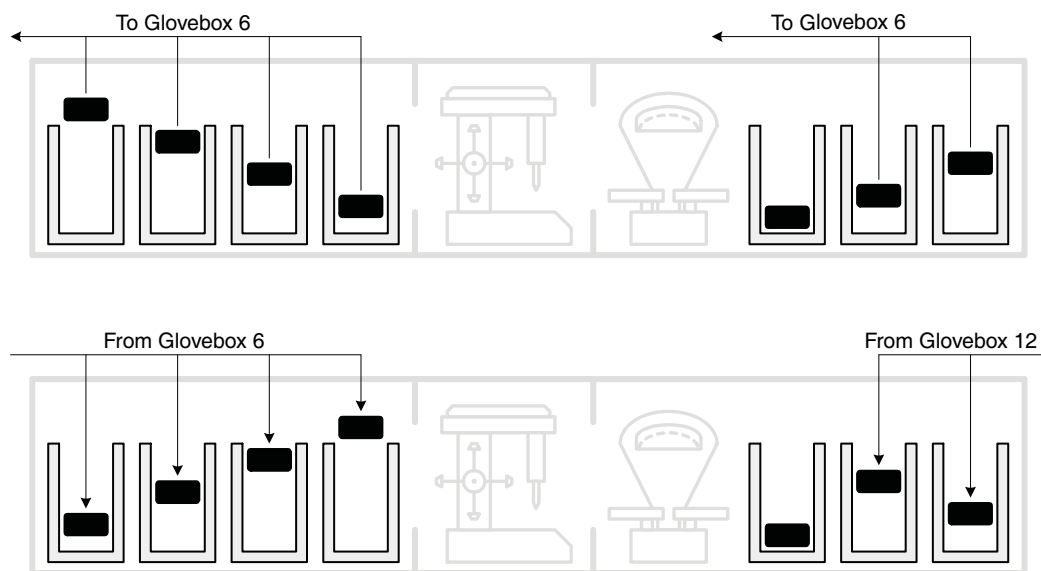
Figure 30. Intended sequence for the transfer of ingots from and to Glovebox 13.

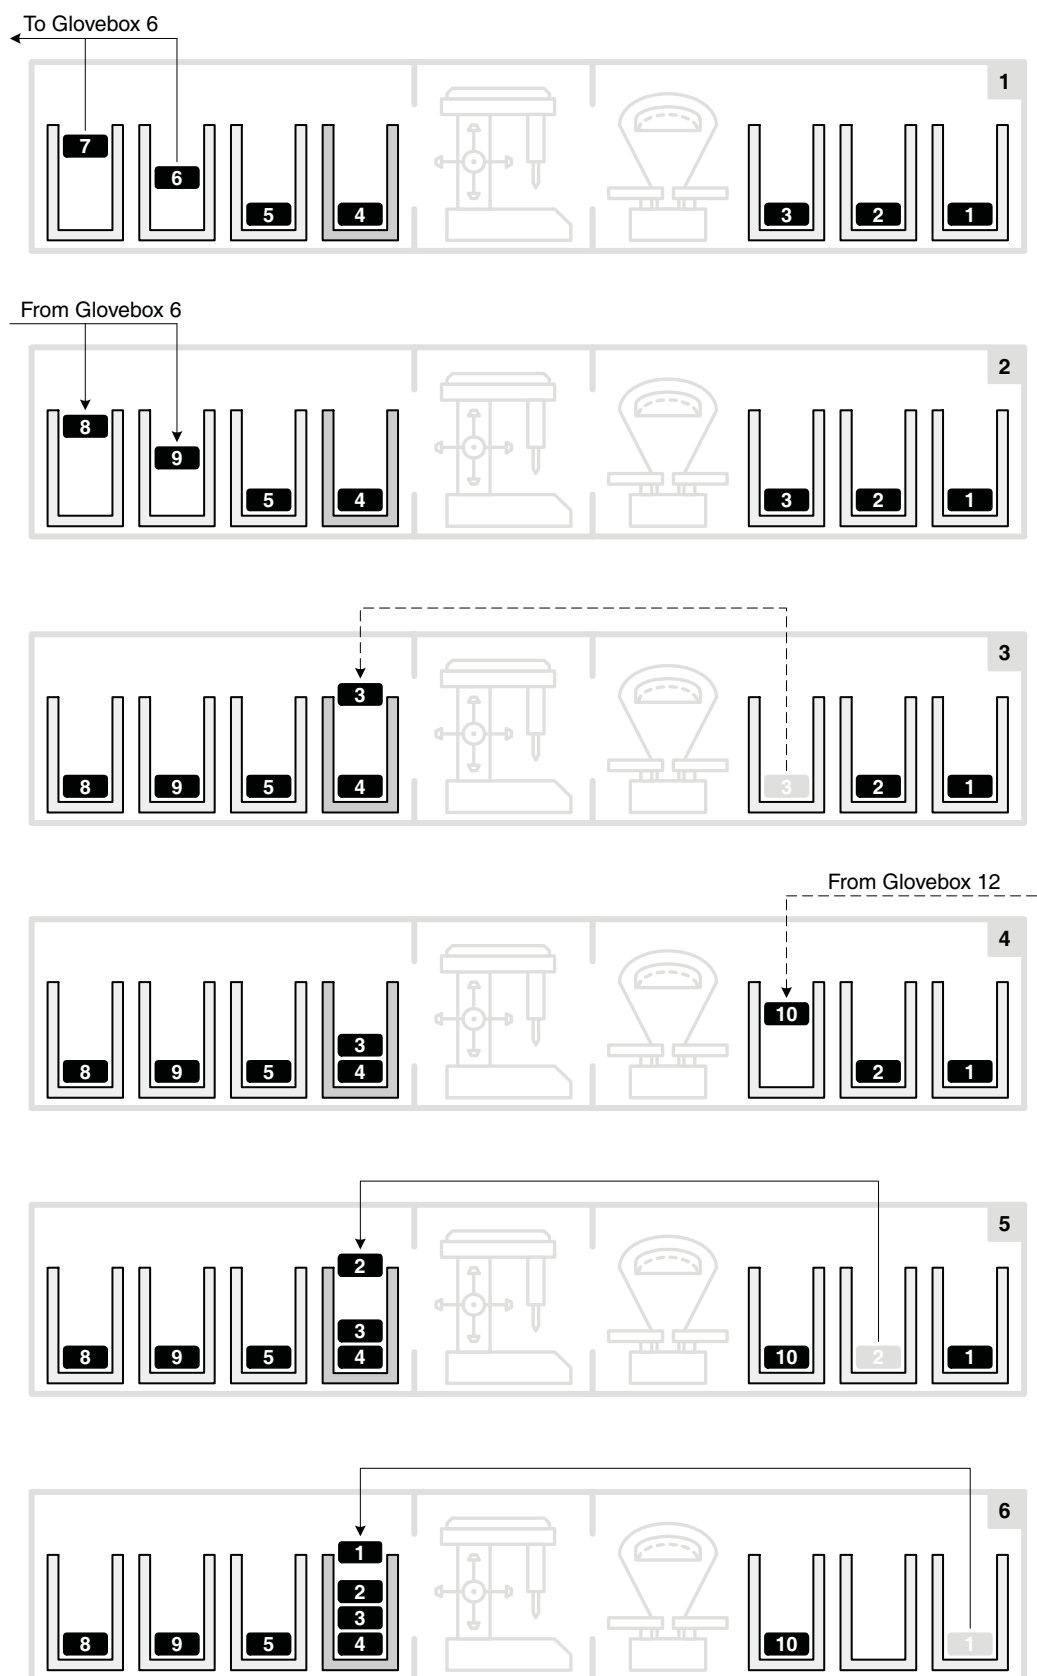
Figure 31. Actual order of ingot transfers from and to Glovebox 13. The solid lines represent the actions of operator A and the dotted lines the actions of operator B.

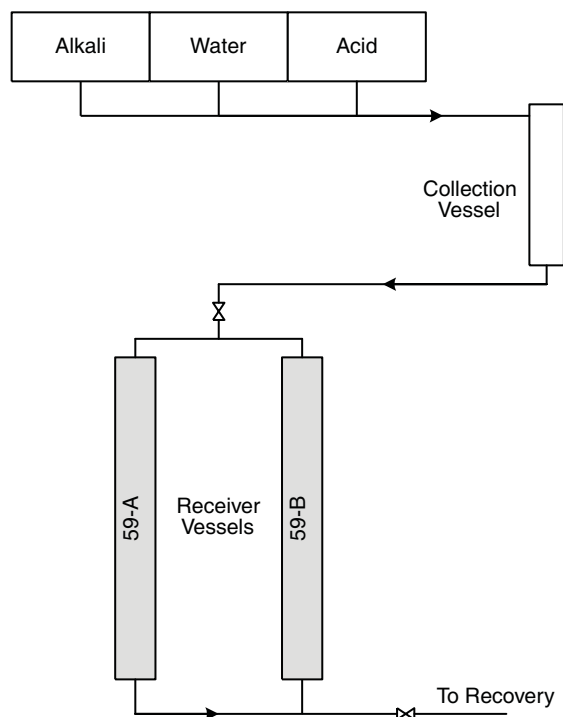
Figure 32. Major components of the chemical-etching process.

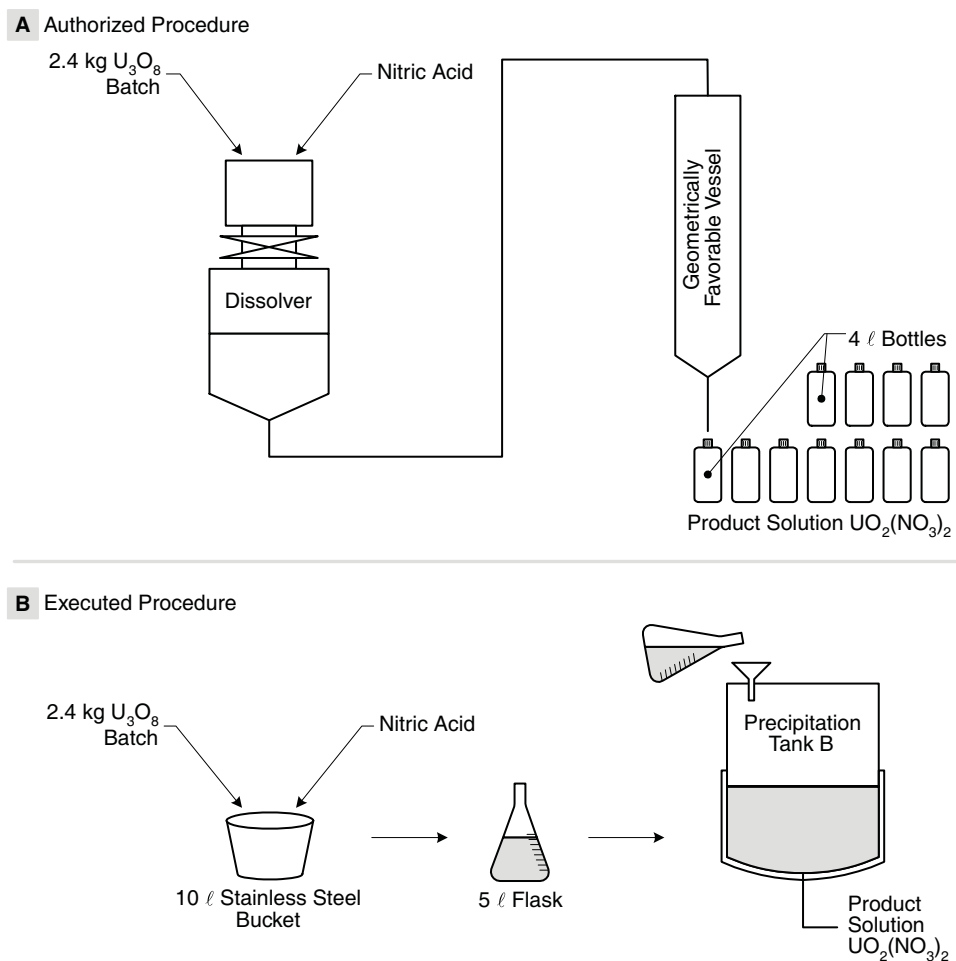
Figure 34. Authorized and executed procedures.
