# A Review of Criticality Accidents

## 2000 Revision

**LA-13638**

**Issued: May 2000**

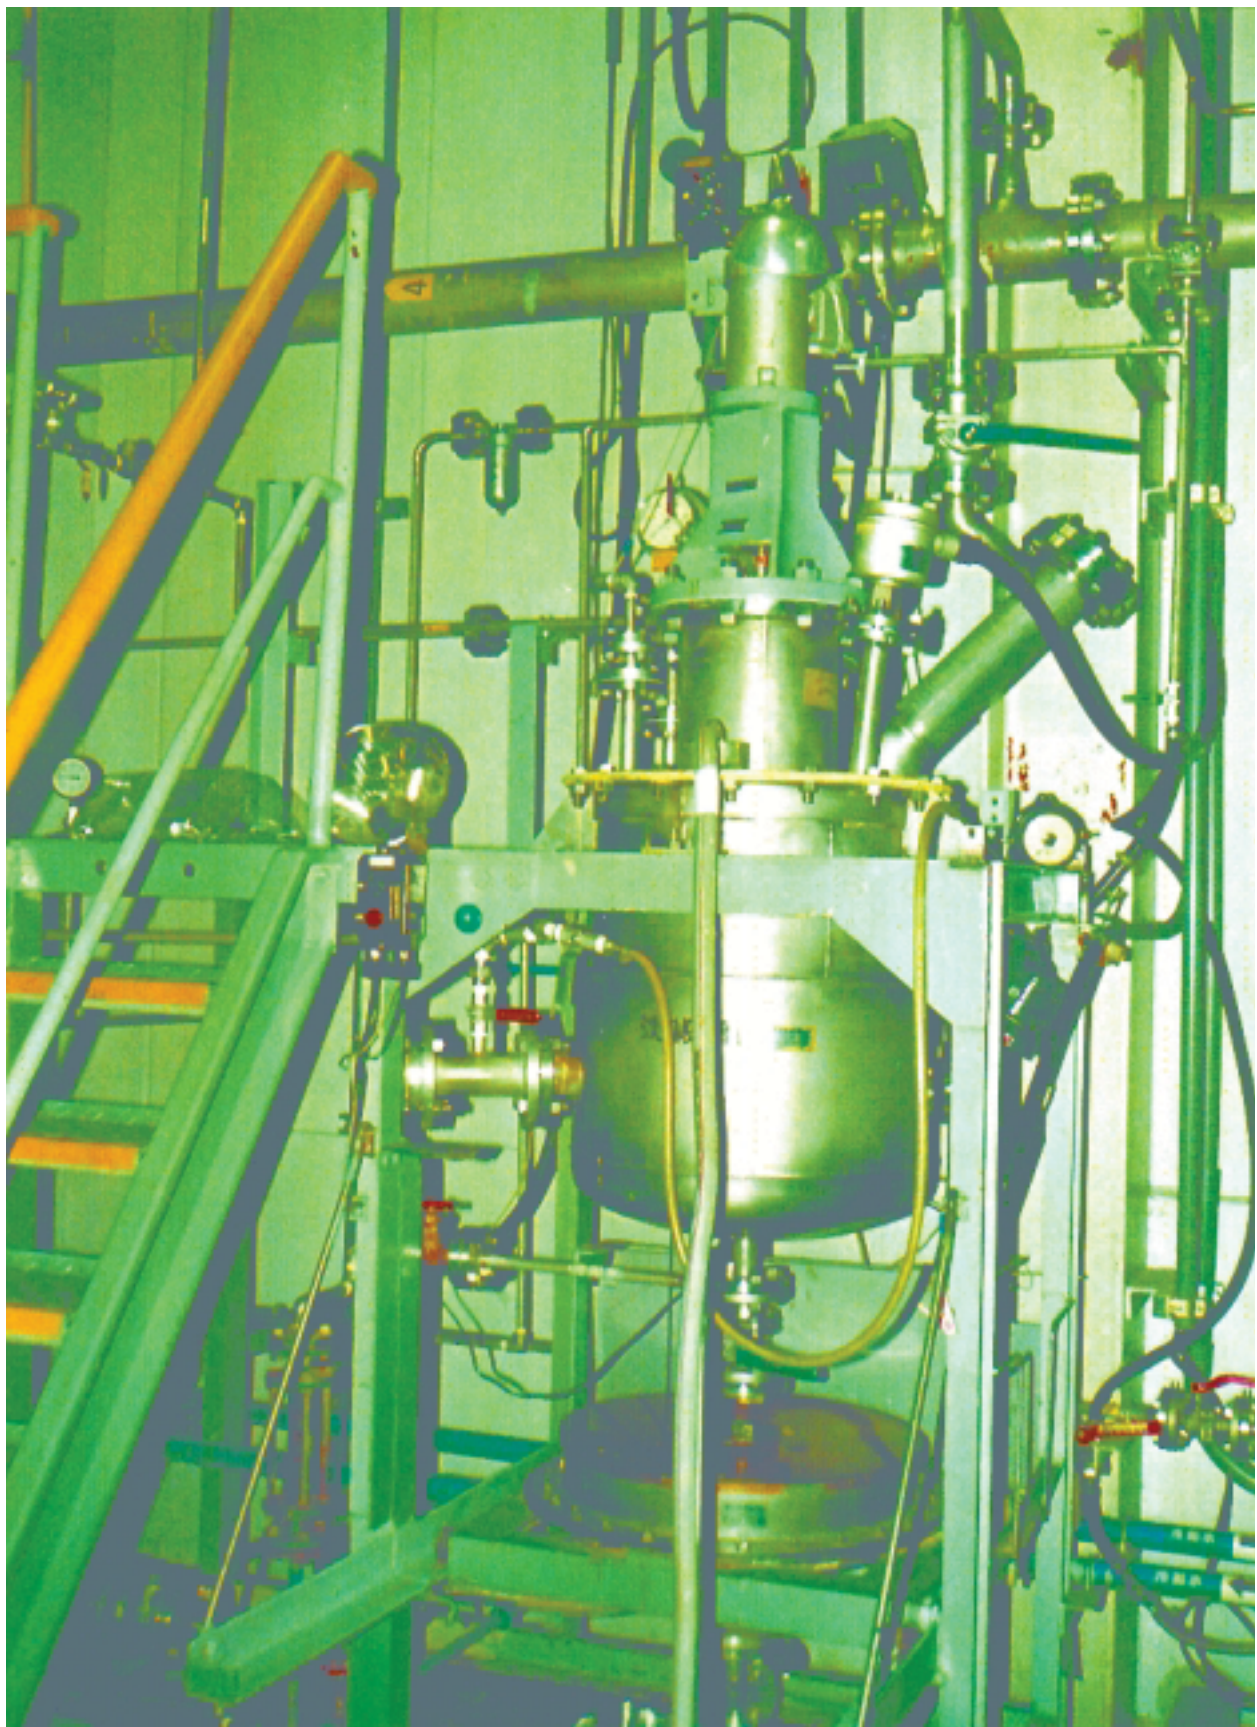
Figure 35. The precipitation vessel in which the process criticality accident occurred.
