# Walker Run Geomorphic Assessment

**PPL Bell Bend Nuclear Power Plant**  
Salem Township, Luzerne County, PA

April 2009

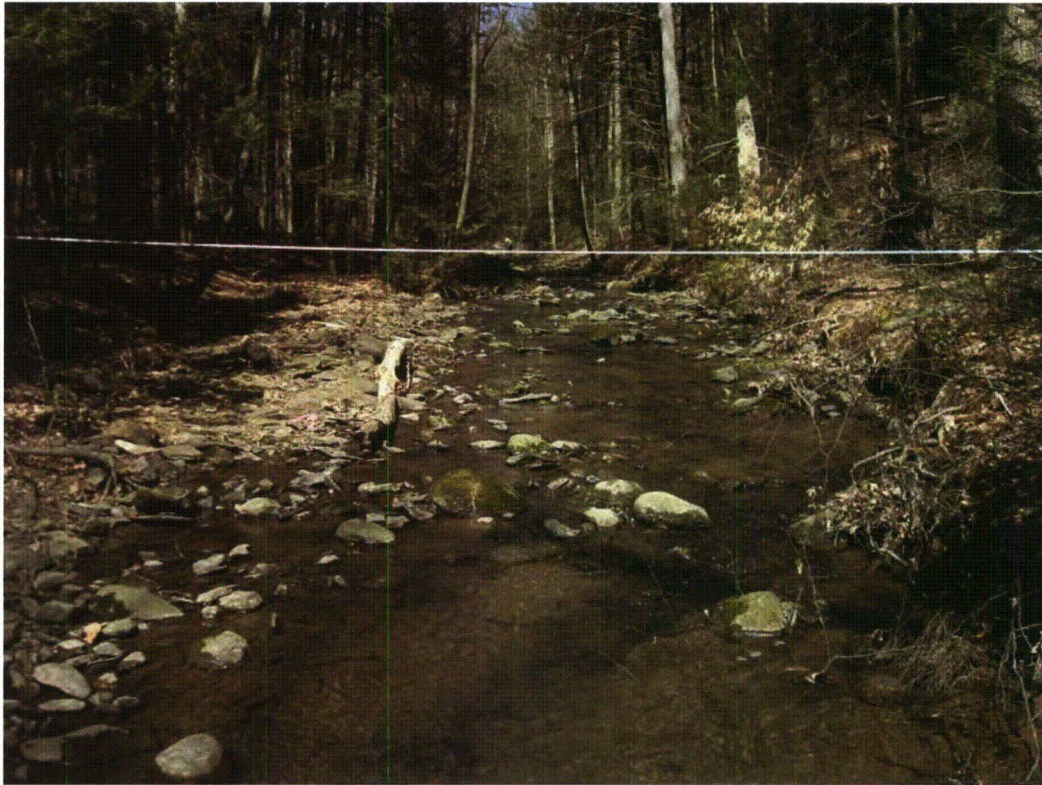
*Figure 12.* Reference condition for the Walker Run stability assessment would be classified as a B4c stream type in a Valley Type II. Located approximately 1,000 ft upstream of Beach Grove Road.

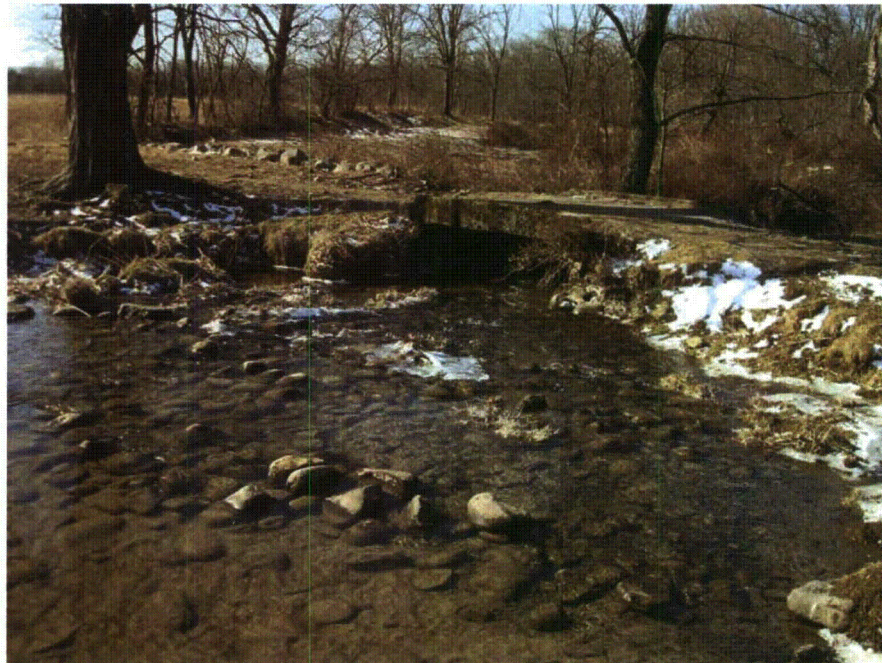
Farther upstream, a private farm road crossing over Walker Run consists of a 10-foot span concrete bridge with a vertical opening of approximately 24-36 inches. See *Figure 14* for private bridge crossing.

*Figure 14. Private farm road crossing downstream of Denms Road.*

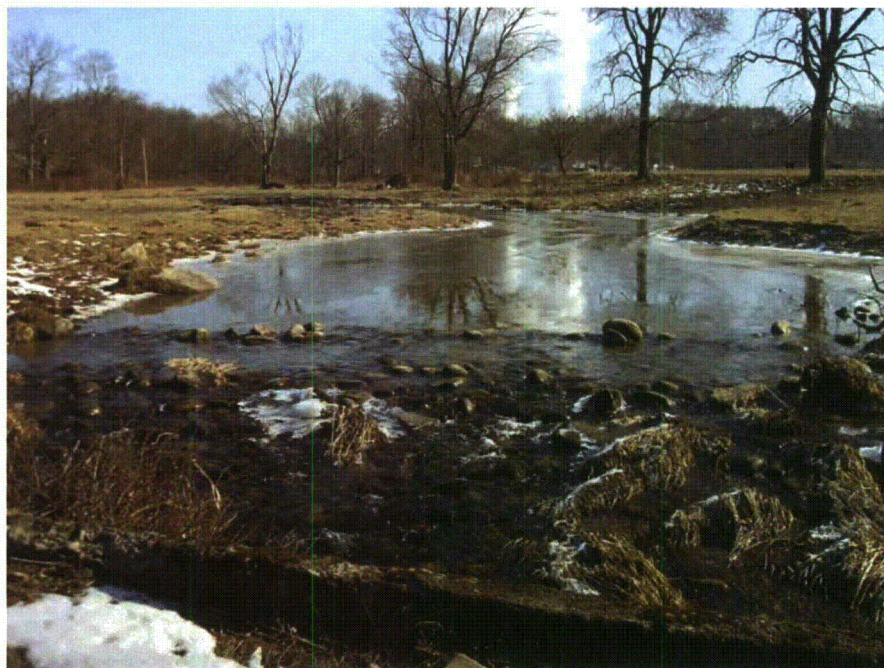
The stream in and around the private crossing is in a state of streambed aggradation on the upstream side and lateral adjustment and vertical degradation on the downstream side. The downstream degradation is a result of both lateral and vertical adjustments moving headward from the downstream direction. Above the private road crossing, channel aggradation is evident, as seen in *Figure 15*. The streambed aggradation is a result of the larger gravels and cobbles transported from the upstream-incised reach depositing there because they cannot be transported through the private crossing.

*Figure 15. Picture of Walker Run looking upstream from private road bridge deck. Note streambed substrate deposition immediately upstream of bridge crossing.*

The aggradation process flattens out the stream slope and creates a backwater condition that further reduces the energy available to move the bedload and prevents additional material from being transported downstream. The process of bedload deposition in this area is also promoting lateral adjustments in order to accommodate the flows and sediment from upstream as material is being deposited and reducing conveyance in the channel. If the bridge is removed or fails, there will be significant adjustments in the longitudinal profile and the planform in both the upstream and downstream directions.

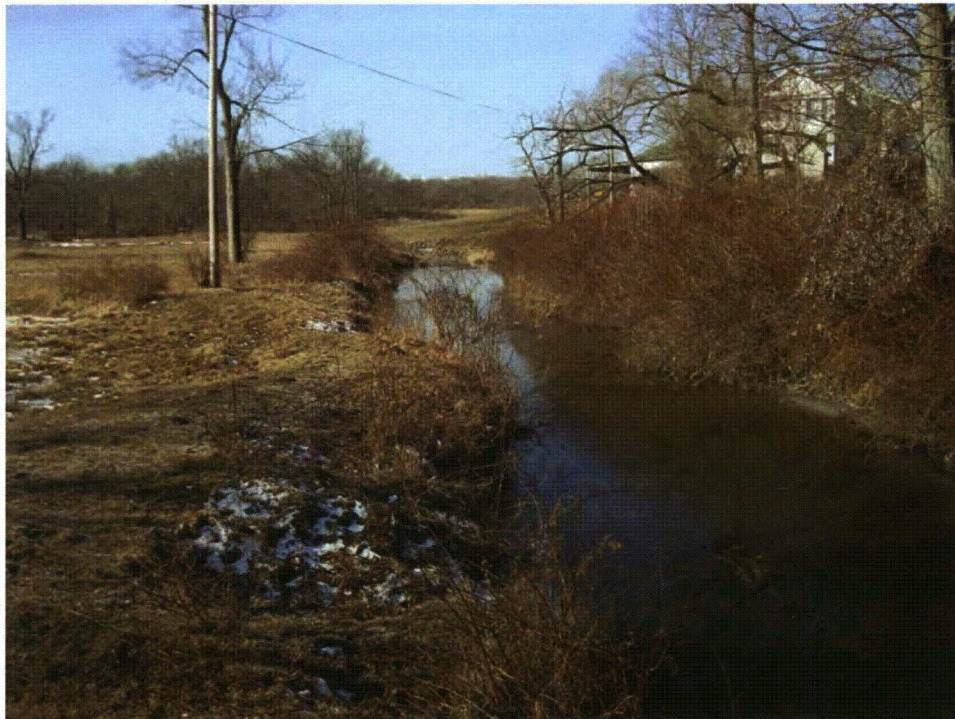
The backwater condition created by the local aggradation near the private bridge crossing extends approximately one thousand feet upstream. The backwater conditions of this reach create a long, flat pool with minimal vegetative cover that does not lend itself to a diverse macro-invertebrate community. In addition, the kind of streambed substrate required for a diverse benthic macro-invertebrate community is minimal in this reach. The majority of the streambed substrate consists of sands and silts. See *Figure 16* for typical backwater conditions. Throughout this reach, the channel is somewhat entrenched and, during higher flow events, the existing streambed material is being scoured because of the incision of the channel and is being mobilized and re-deposited at the downstream bridge crossing. This scour action also minimizes the potential for long-term stability and reduces the high-quality biological habitat.

*Figure 16. Backwater condition extending upstream for approximately 1,000 from private road crossing. Somewhat incised C5 or F5 stream type.*

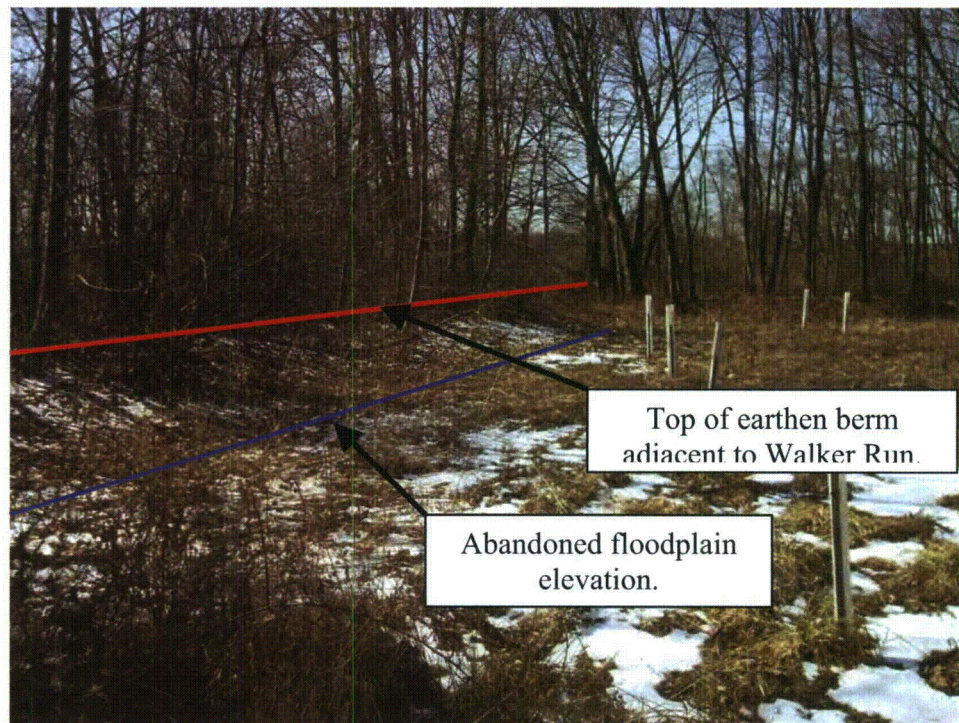
*Figure 17. Three-foot earthen berm located immediately adjacent to Walker Run beginning approximately 100 feet upstream of Dennis Road and extends another 500 feet upstream. Walker Run is located on the opposite side of earthen berm.*

Within this reach of Walker Run, where the channel runs parallel with earthen berm, the channel is somewhat entrenched, straightened, and/or channelized and would probably be considered an incised C5/E5 stream type that is losing its connection with a functional floodplain. It may even be considered and entrenched G5/F5 stream type based on the elevation of the bankfull stage. The existing instability of the reach is compounded by the fact that the three-foot earthen berm prevents flood flows from accessing the right floodplain. Additionally, the streambed substrate is mainly composed of silts and sands; very little gravel is present in Walker Run throughout this reach, which extends upstream to the Market Street bridge. The stream channel is fairly straight throughout this reach, probably as a result of ditching and channelization to drain wetlands that were present to accommodate the agricultural activities adjacent to Walker Run. Again, within this reach, gravel substrate was very sparse and consisted of less than five percent of this reach; the majority of the reach consisted of silts and sands.

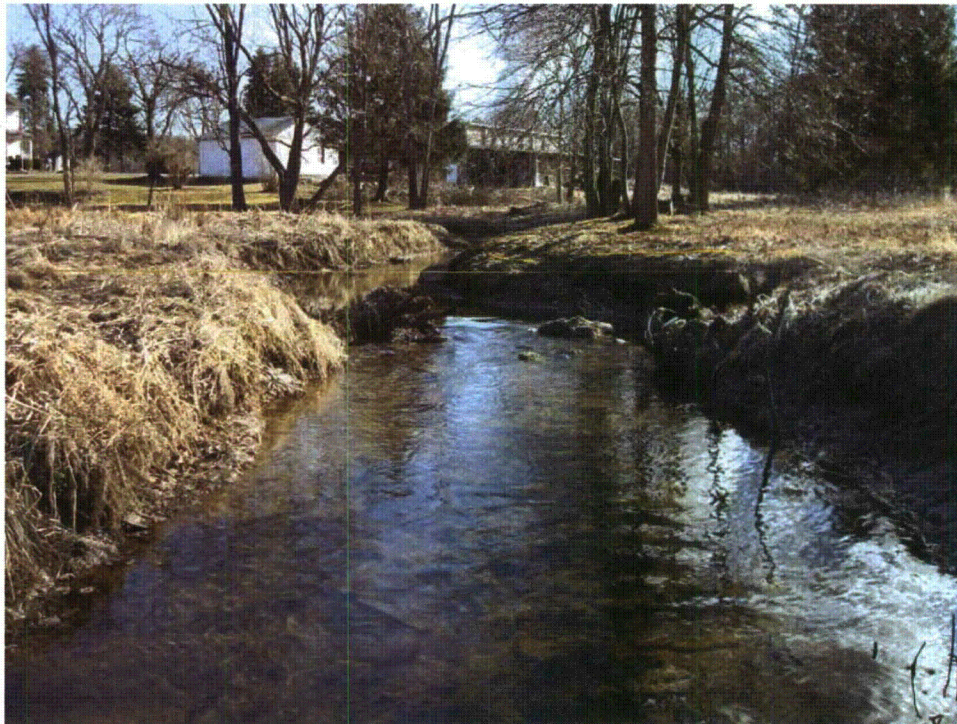
Continuing upstream from the lower Market Street bridge crossing, Walker Run undergoes varying changes in morphology, such as increased bank heights, changes in entrenchment, particle size distribution of streambed substrate, and profile adjustments. In this lower section of Walker Run, consisting of approximately 1,000 feet, Walker Run would be considered an incised and entrenched F4/F5 stream system. The cross section surveyed along this reach is identified as Cross Section #5 and shown in *Figure 18*. This reach is located within an existing meadow area and appears to have been used for historical agricultural practices, such as cattle grazing. The streambed is planar with very little change in stream features, i.e. riffles, runs, pools, and glides. The majority of the reach consists of long flat pools with short riffles. However, within this reach the streambed substrate consists of gravels and cobbles for the majority of the reach, although there are some sections along this reach where the streambed consists of only silts and sands. See *Figure 18* for typical conditions within this lower reach.

*Figure 18. Typical incised conditions within lower reach of Walker Run. Surveyed cross section #5 showing planar streambed and long flat pools.*

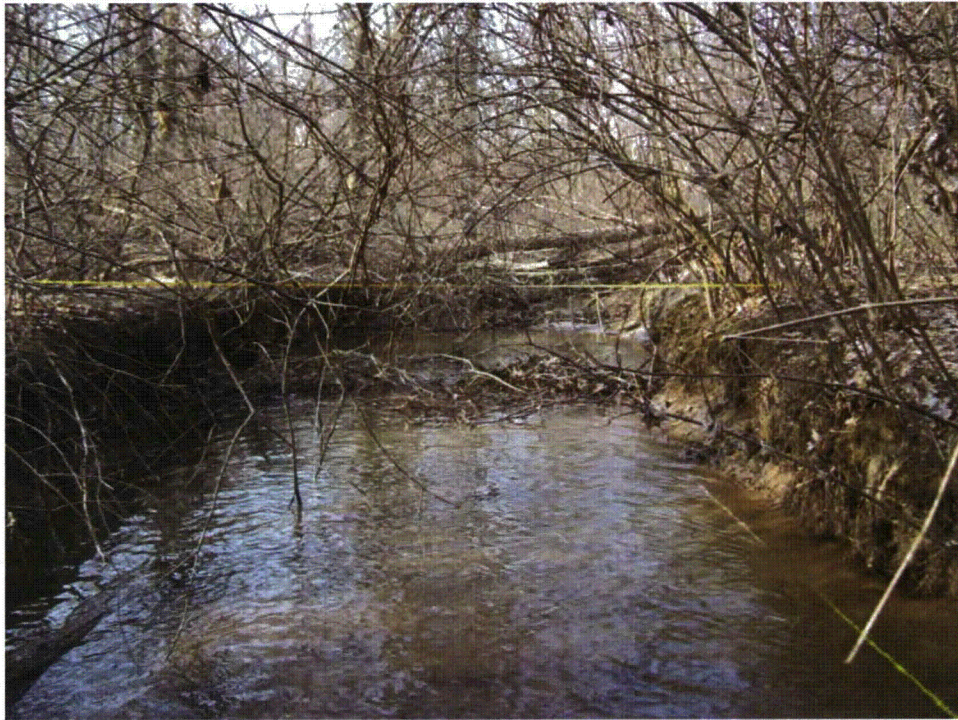
Upstream of the culvert, Walker Run continues to become significantly entrenched and incised. The stream flows through a mature stand of trees for approximately 600 feet before it enters into an open meadow setting and agricultural fields. The forested section has degraded vertically to match the elevation of the downstream culvert; however, an existing beaver dam is controlling the upper section of this forested reach. You will notice from the longitudinal profile, included in Appendix A, the streambed maintains a fairly consistent average slope through the beaver dam; however, the beaver dam significantly affects the water surface elevation. The streambanks below the beaver dam range from two to four feet high and are composed of fine alluvial silts and sandy material. See *Figure 19* for typical conditions within the forested reach where a cross section was surveyed and *Figure 20* for the existing beaver dam showing the three-foot elevated water surface.

*Figure 19. Typical conditions within forested section of Walker Run where Cross Section #4 was surveyed.*

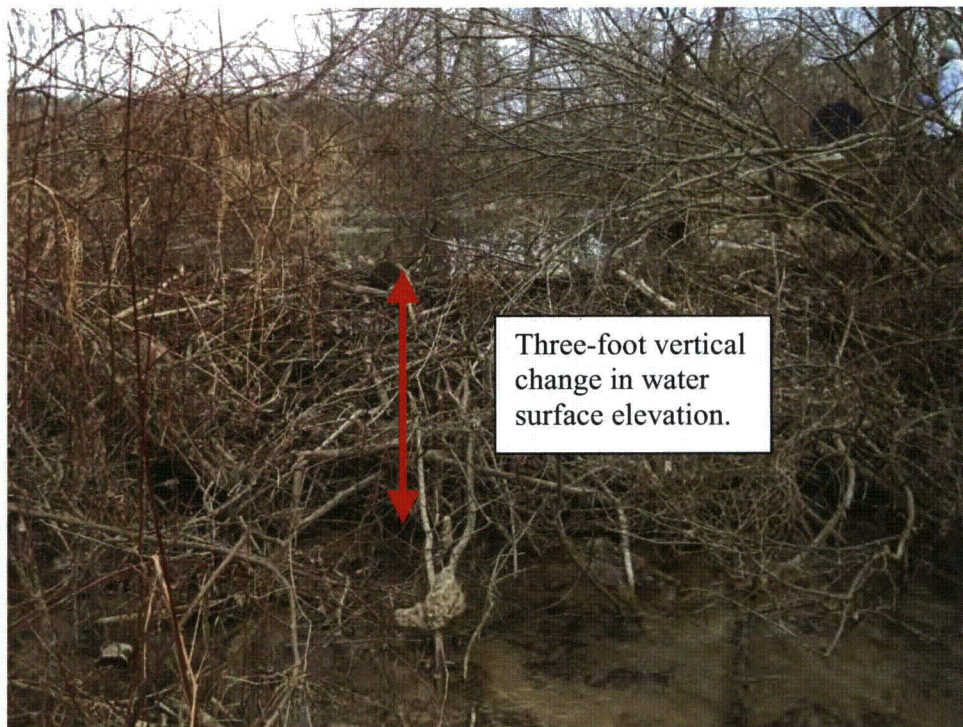
*Figure 20. Existing beaver dam near the upstream edge of forested area.*

The beaver dam is naturally elevating the water surface throughout the middle portion of the site. This, in turn, is reducing the average water surface slope and therefore reducing the shear stress within the channel and reducing the potential for vertical channel degradation. However, if – and, more importantly, when – the beaver dam is washed away during a significant rain event, the average stream slope will again steepen and shear stresses will exceed the threshold of mobility, which will lead to both vertical and lateral degradation. All the sediment now being stored upstream of the beaver dam will be flushed downstream, which will compound the existing instabilities in the downstream incised and entrenched reach and will lead to excessive sedimentation in the channel and the degradation of the existing biological community.

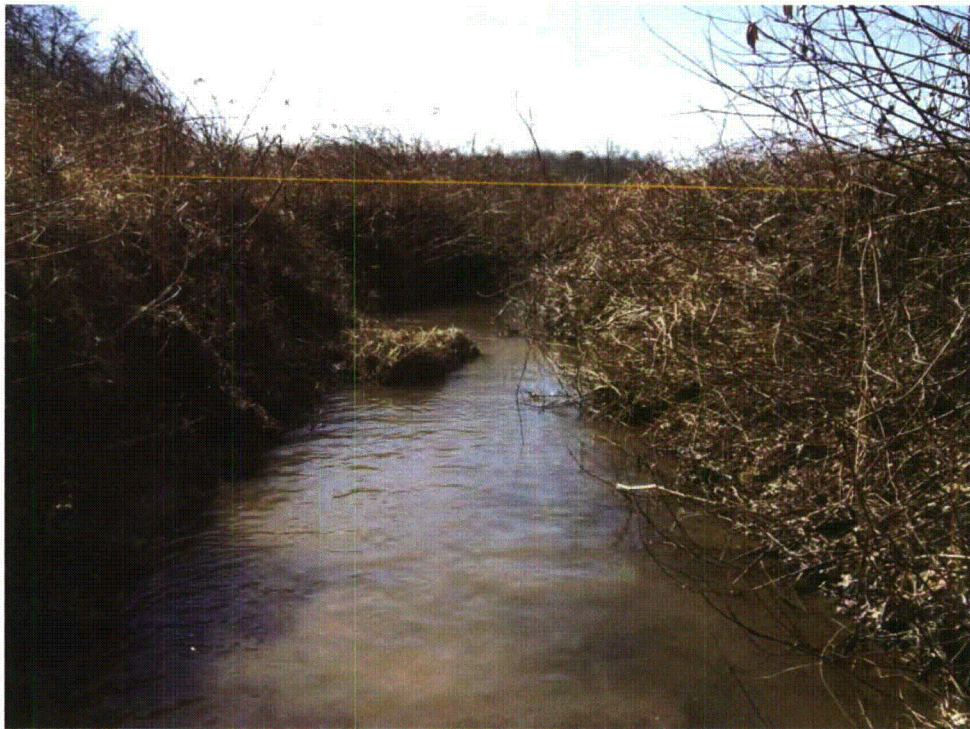
*Figure 21. Typical conditions upstream of farm road with four to five foot streambanks.*

Even though the streambanks appear to be fairly well vegetated, the stream channel has lost its connection with a functional floodplain, which leads to further vertical and lateral adjustment. Because of the high entrenchment conditions within this reach, habitat conditions are not ideal for sustaining a diverse biological habitat and macro-invertebrate community. Additionally, the streambed substrate consists mainly of silts and sands with the occasional large cobble and or boulder, most likely from being exposed as a result of being moved to the eastern fringe of the valley.

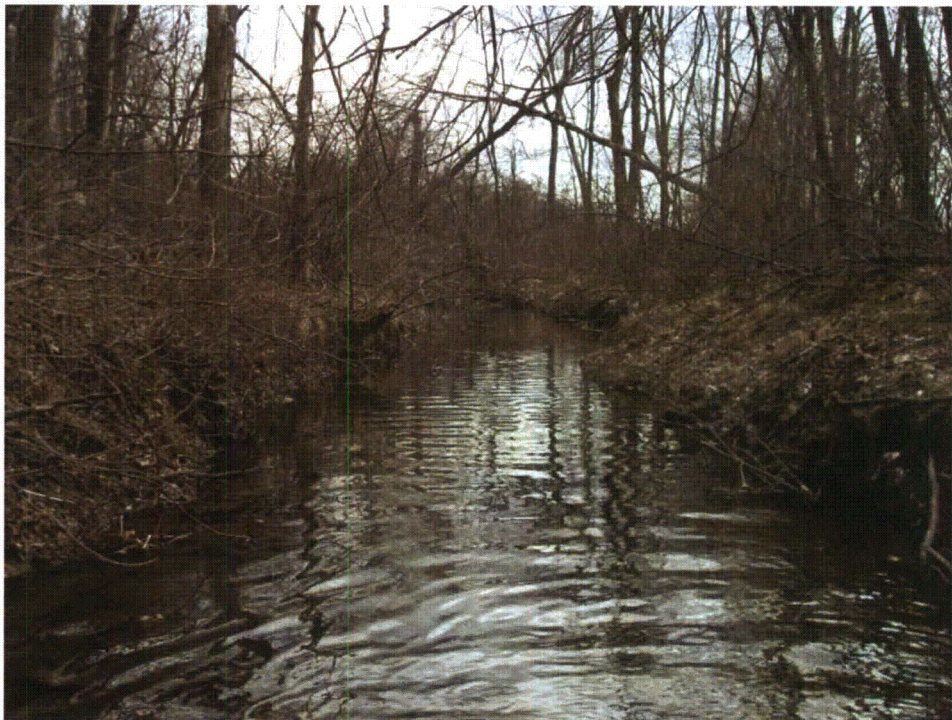
Continuing upstream near the Market Street bridge crossing, Walker Run becomes more incised and entrenched. The channel has been pinched up against the eastern valley slope. There are short, steep riffles where the bed appears to be perched on the larger colluvial material at the base of the valley slope that was exposed as a result of the historical channelization. This perched streambed condition creates a long backwater condition immediately downstream of the Market Street bridge crossing. This reach consists of an incised and degraded F5 stream type. The streambed substrate consists of silts and sands, most likely as a result of the flattened stream slope leading to sediment deposition. See *Figure 22* for incised F5 stream system consisting of a long flat backwater condition and planar streambed.

*Figure 22. Photograph looking downstream near the upstream Market Street bridge crossing. Incised F5 stream type along Walker Run consisting of long flat pool.*

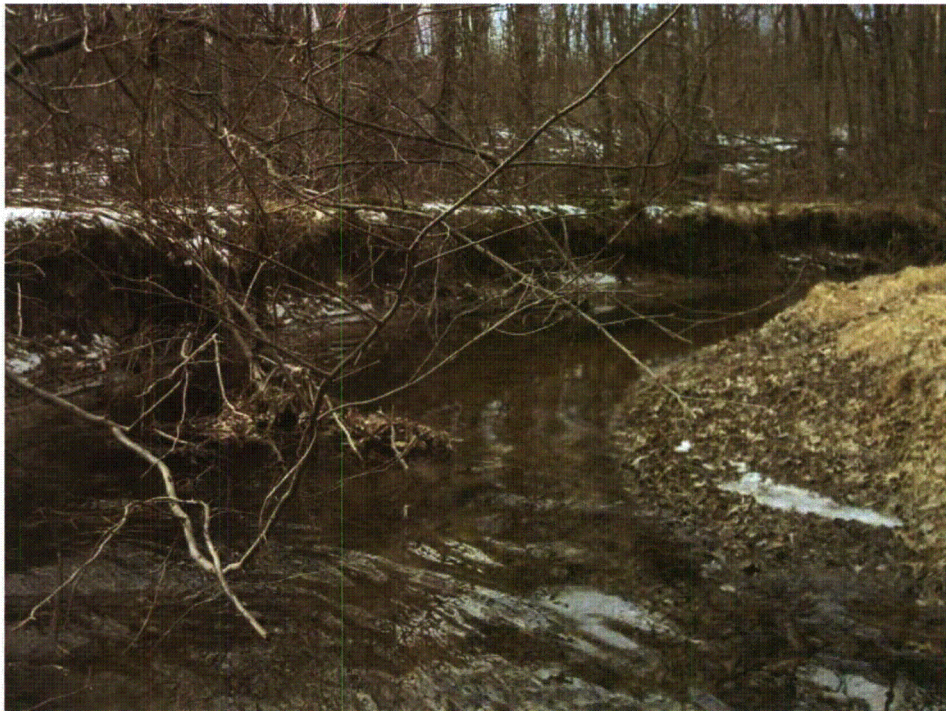
Throughout the entire reach from the Market Street to the Beach Grove Road crossing, Walker Run is significantly incised and entrenched. The existing streambanks range in height from three to five feet and are composed of fines silts and sands. The existing valley bottom consists of a fairly mature stand of trees with minimal rooting depths, as can be seen in *Figures 23 and 24*. This condition of increased bank heights in conjunction with fine alluvial streambanks and elevated root systems does not provide adequate protection for long-term stream stability during higher flow events and leads to accelerated streambank erosion. Trees are being undermined and are falling into the stream, promoting streambed scour. Throughout this reach, the majority of the streambed consists of fine alluvial silts and sands, most likely a result of the ongoing streambank erosion. However, in the upper 200 feet immediately downstream of the Beach Grove Road crossing, the streambed consists of small to medium sized gravels. See *Figures 23 and 24* for typical conditions throughout this reach.

*Figure 23. Typical condition of eroding streambanks upstream of the Market Street bridge.*

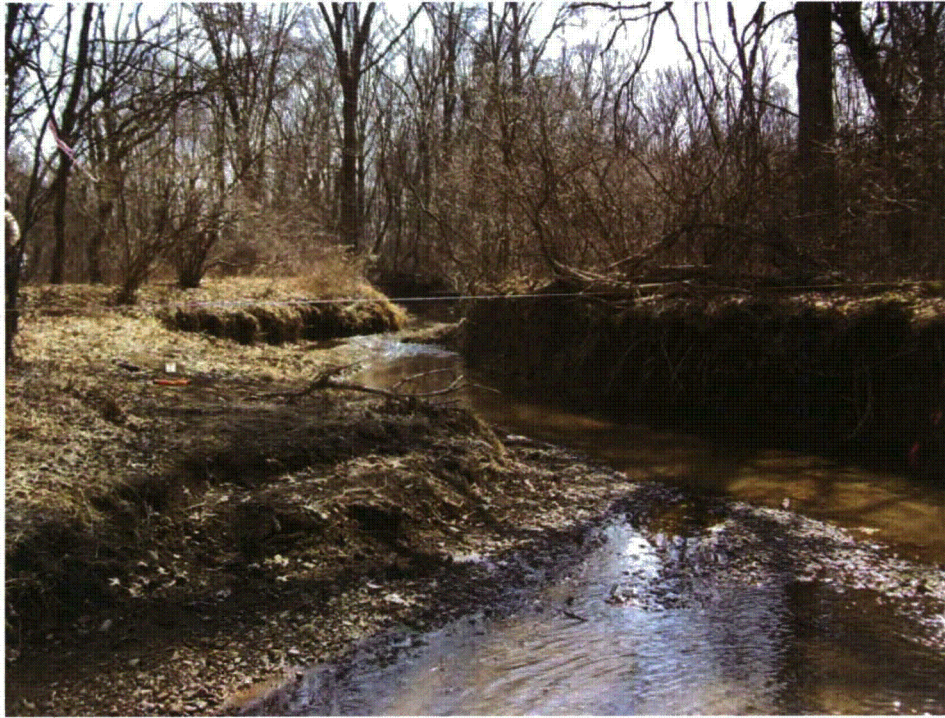
*Figure 24. Typical stream conditions near bank erosion cross-section #2 with high eroding streambanks.*

Within the reach between the Beach Grove Road and the Market Street bridge crossing, three cross sections were surveyed and additional geomorphic data were collected to assess the bank erosion potential within this reach, such as bank angle, rooting depths, root density, bank heights, bank material, and to determine if there is any surface protection along the banks to evaluate the Bank Erosion Hazard Index rating. Along with the surveyed cross section, the Near-Bank Shear Stress was evaluated to predict long-term stability and the potential for lateral adjustment. The information associated with the Bank Erosion Hazard Index Rating and long-term erosion potential is discussed in the next section.

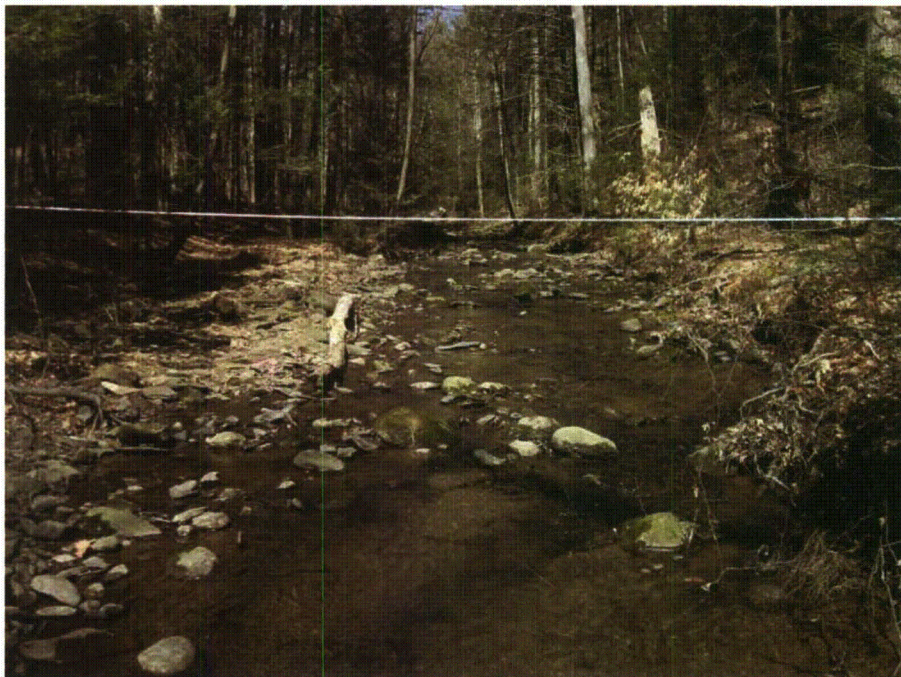
*Figure 25. Assessment reach Cross Section #1 looking upstream.*

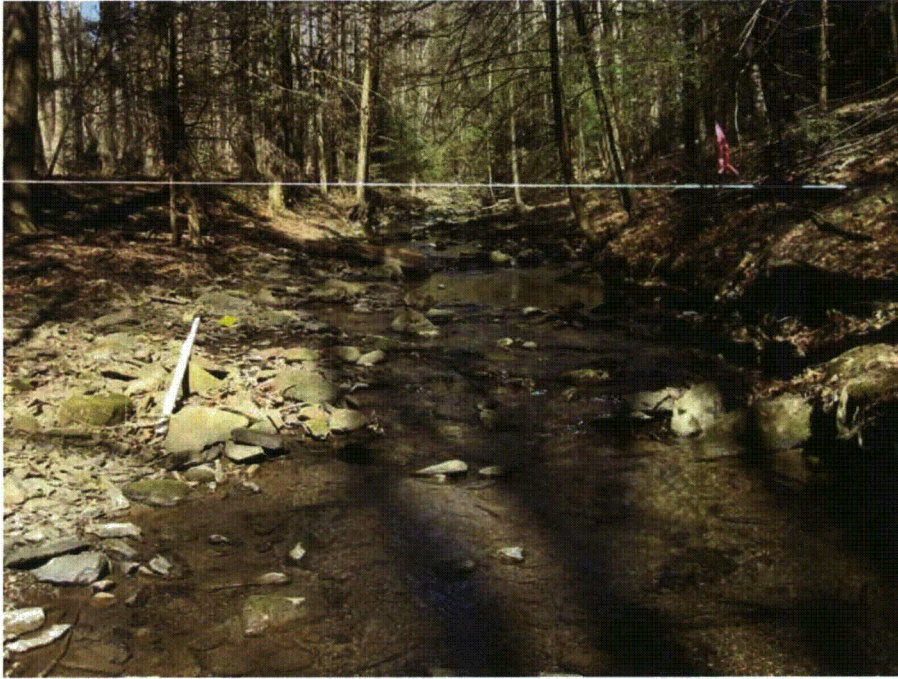
Figure 26. Assessments reach Cross Section #2, looking upstream.
