CALVERT CLIFFS
NUCLEAR POWER PLANT

SUBJECT: Calvert Cliffs Nuclear Power Plant
Independent Spent Fuel Storage Installation
Material License No. SNM-2505, Docket No. 72-8
Response to Request for Supplemental Information, RE: Calvert Cliffs
Independent Spent Fuel Storage Installation License Renewal Application (TAC
No. L24475)

**CALVERT CLIFFS INDEPENDENT SPENT FUEL STORAGE
INSTALLATION LEAD AND SUPPLEMENTAL CANISTER
INSPECTION REPORT**

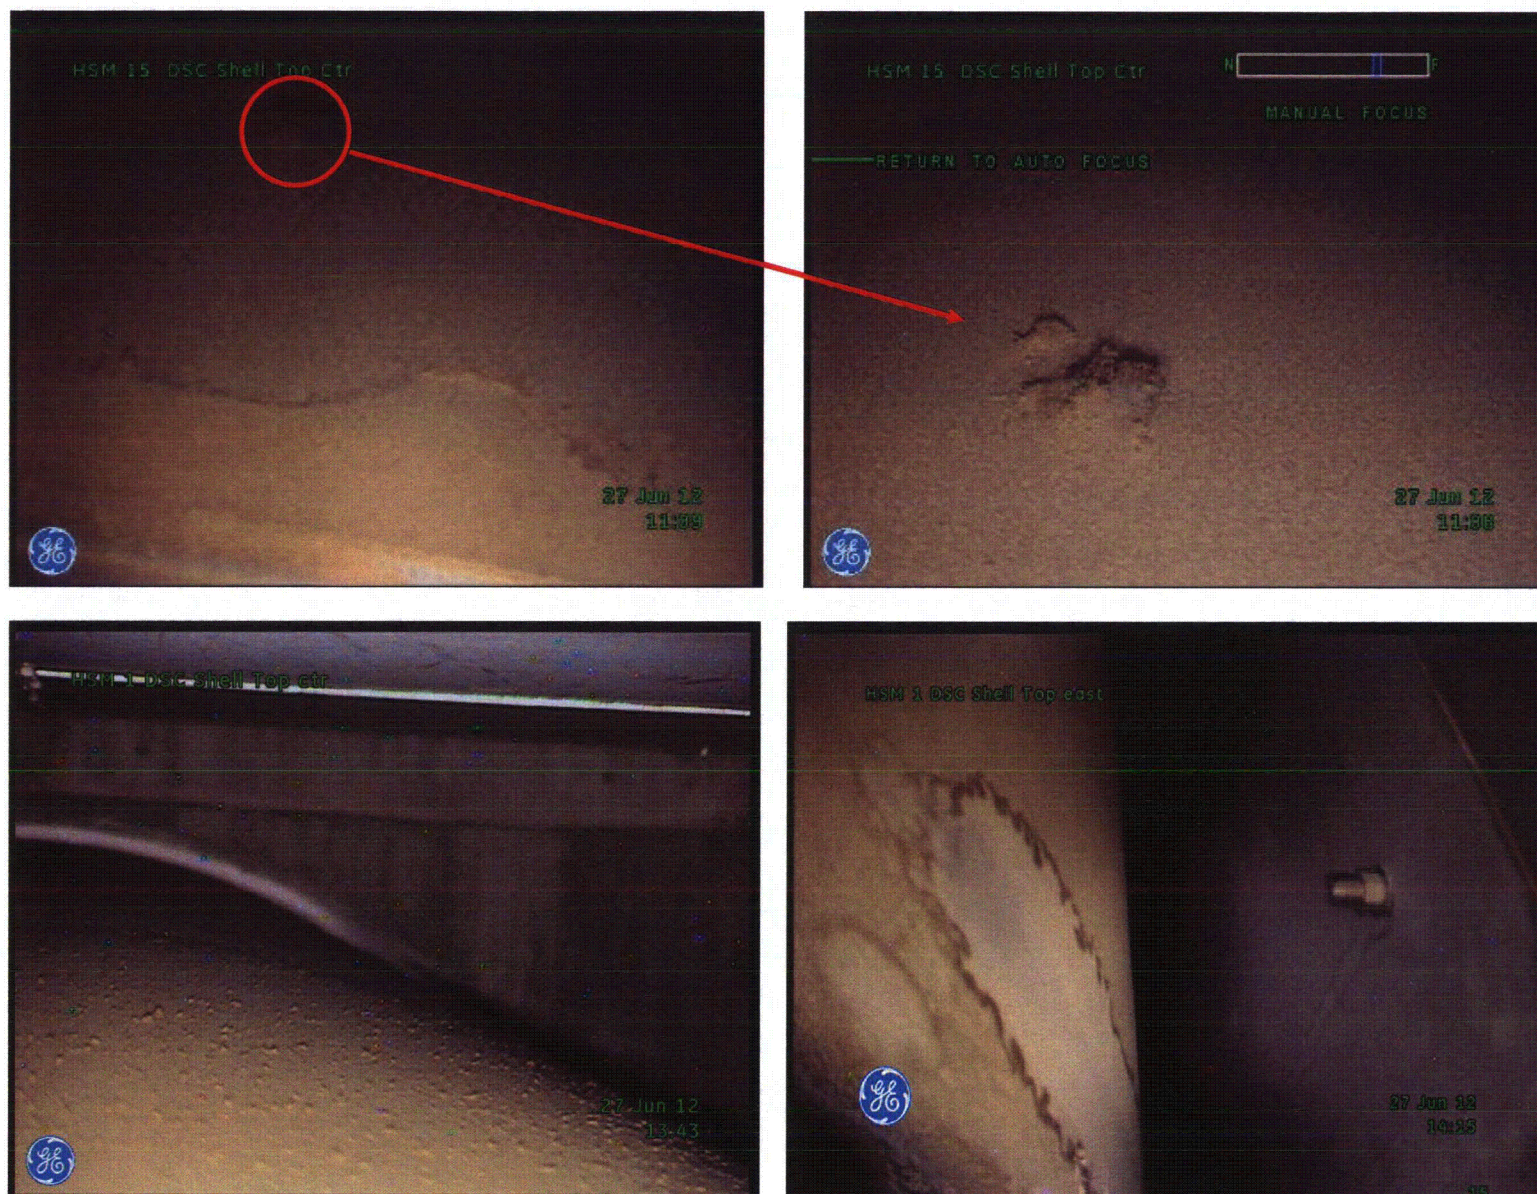
On the upper shell of both DSC-6 and DSC-11, a thick coat of dust and small clumps of unknown material were observed, as shown on Figure 2, except near the outlet vent where there is evidence of water coming in contact with the DSC. As these water marks were observed only near the rear outlet vent, they are likely created by wind driven rain water entering the module via the rear outlet vent. In the case of DSC-11, the heat shield fastener on the ceiling directly above the water mark was observed to have a white stain around it. No signs of rust were seen in areas where water marks were observed. In the case of DSC-11, a sample of the dust deposited on the top surface was collected from a known area as part of the EPRI scope of the inspection. The analysis of the composition and salt concentrations measured will be presented in their report later this year.

Figure 2 – Views of DSC-6 (HSM-15) and DSC-11 (HSM-1) showing dust and signs of and water contact from rear outlet vent

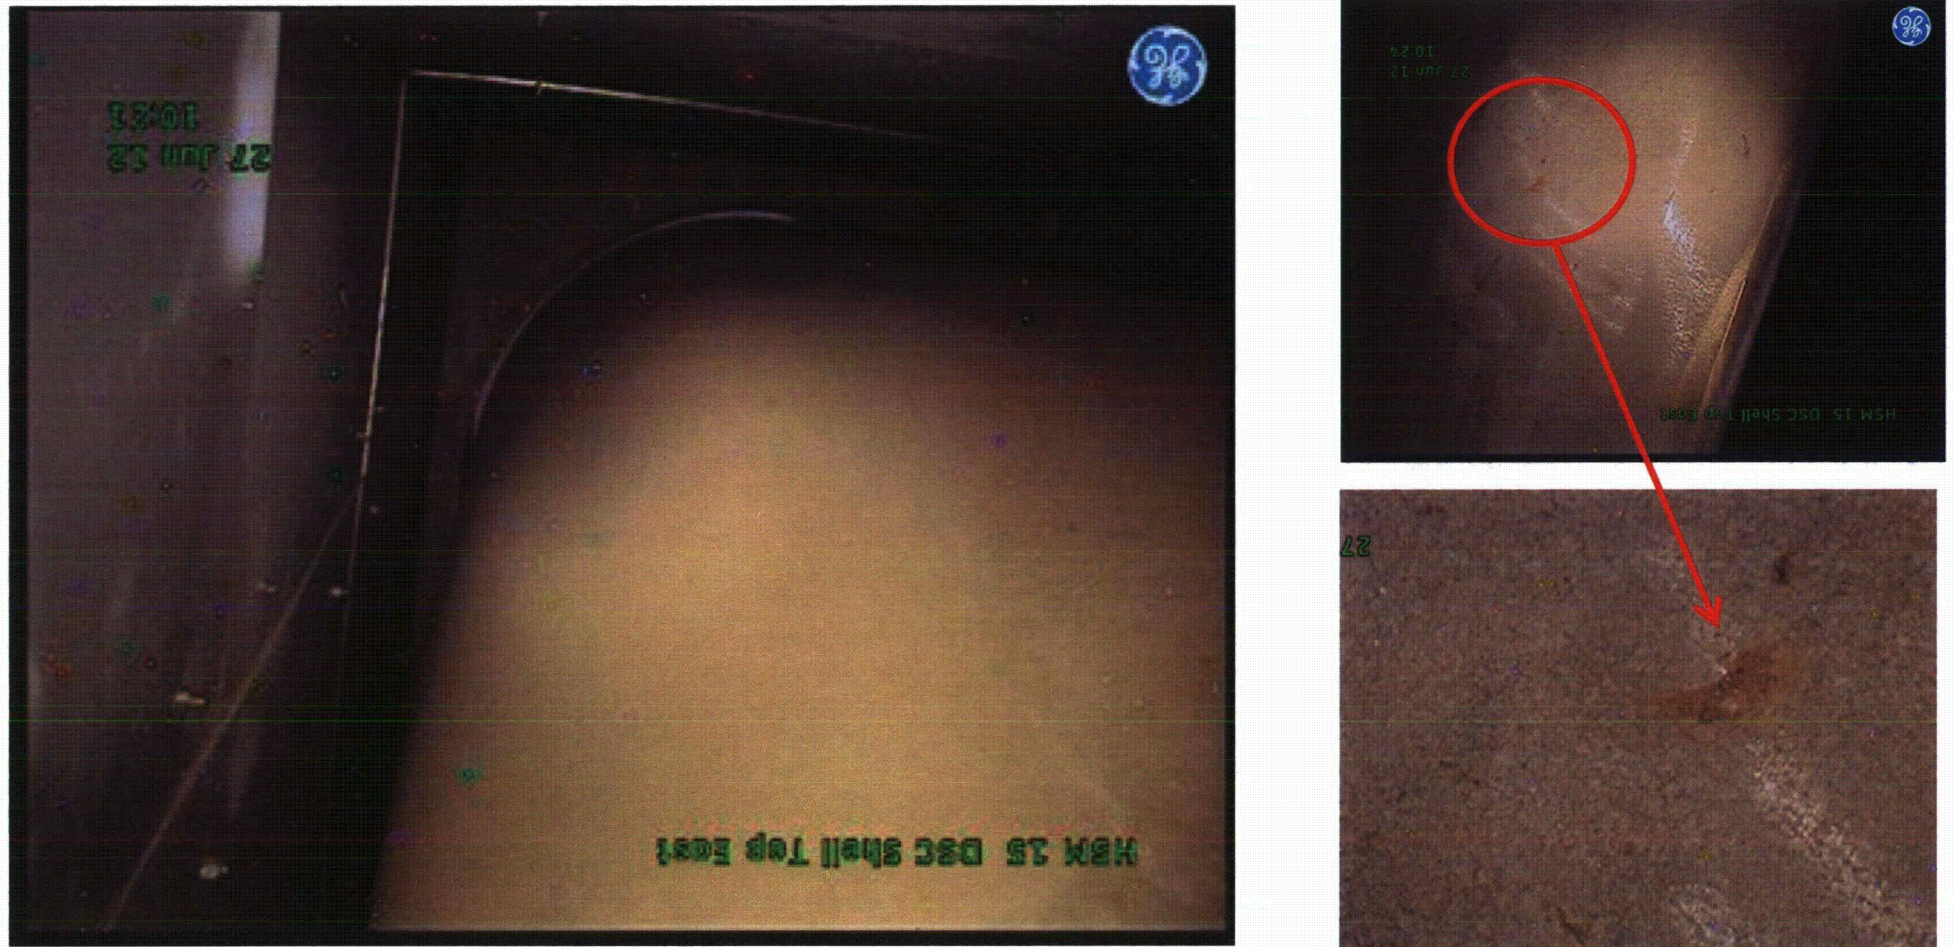
The shell of DSC-6 was observed to be in good general condition. The center circumferential weld and longitudinal welds were examined and no rust spots or signs of cracking were noted. The bottom shield plug circumferential weld was not able to be observed as it was obscured by the steel sleeve of the HSM doorway opening. A few small surface rust spots were noted on the DSC shell base metal, as shown in Figures 3 through 6. The images were compared against those from uncleaned Type 304 stainless steel U-bend samples exposed to a salt-fog and known to have suffered stress corrosion cracking (Reference 5 Section 4.1). The level of corrosion seen in Figures 3 through 6 appears relatively light in comparison to those images. While these visual observations cannot conclusively confirm or deny the existence of stress corrosion cracking at these locations, Calvert Cliffs believes that a more plausible explanation for these few small spots of light rust is that the shell was contaminated with free iron in these locations at some point during fabrication or handling prior to being placed in service. Free iron contamination can occur when carbon/low-alloy steel tools come into contact with the surface (which may explain Figure 4) or particles from grinding, welding, or cutting of carbon/low-alloy steel are transferred to the stainless steel surface (which appears characteristic of Figures 3, 5, and 6). Rusting of such free iron would be expected to have occurred fairly quickly once the outside surface of the DSC was exposed to water, which happens during the normal course of loading when the transfer cask annulus is filled with demineralized water. The resulting light coating of surface rust would be cosmetic in nature and would not result in degradation to the stainless steel shell of the DSC in the sheltered environment of the HSM, and thus are not believed

Figure 3 – Highlights of Upper East Shell of DSC-6 in HSM-15

to be a current challenge to the confinement function of DSC-6. However, Calvert Cliffs has initiated CR-2012-006782 to evaluate these locations in further detail to determine if additional and/or more frequent monitoring is required to conclusively ascertain their nature, and take appropriate corrective action if their presence is determined to represent a potential challenge to the confinement function of the DSC.

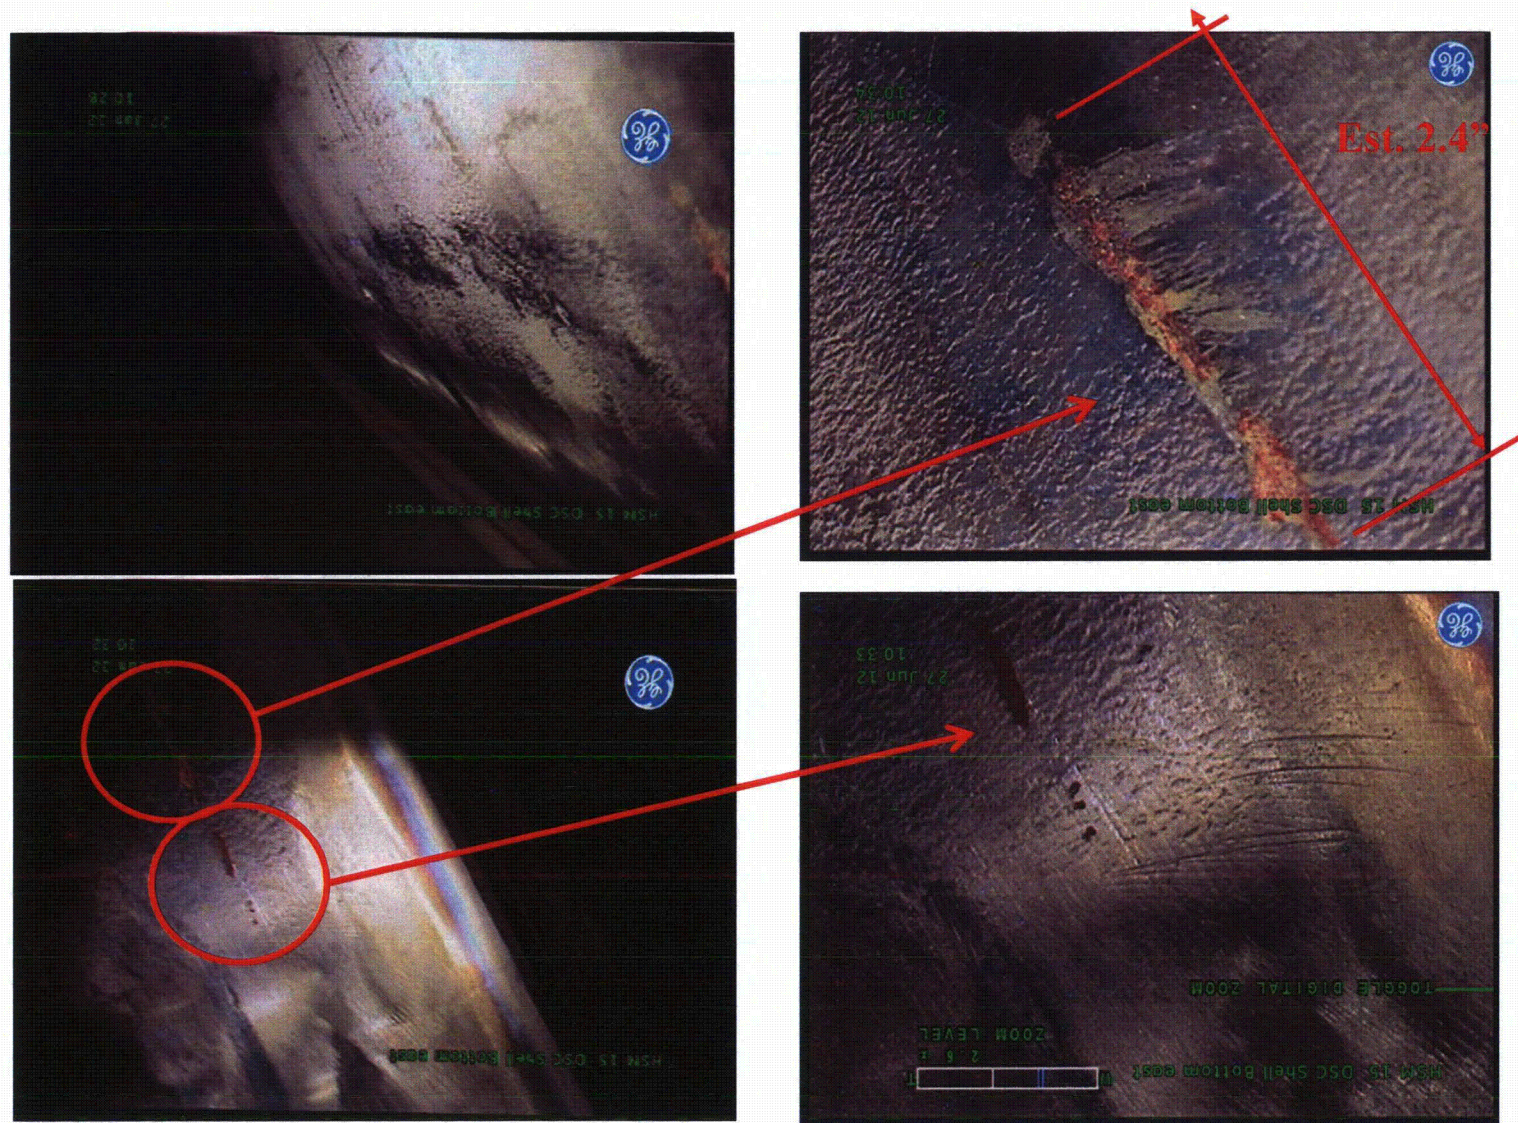
Figure 4 – Views of the Lower East Shell of DSC-6 in HSM-15

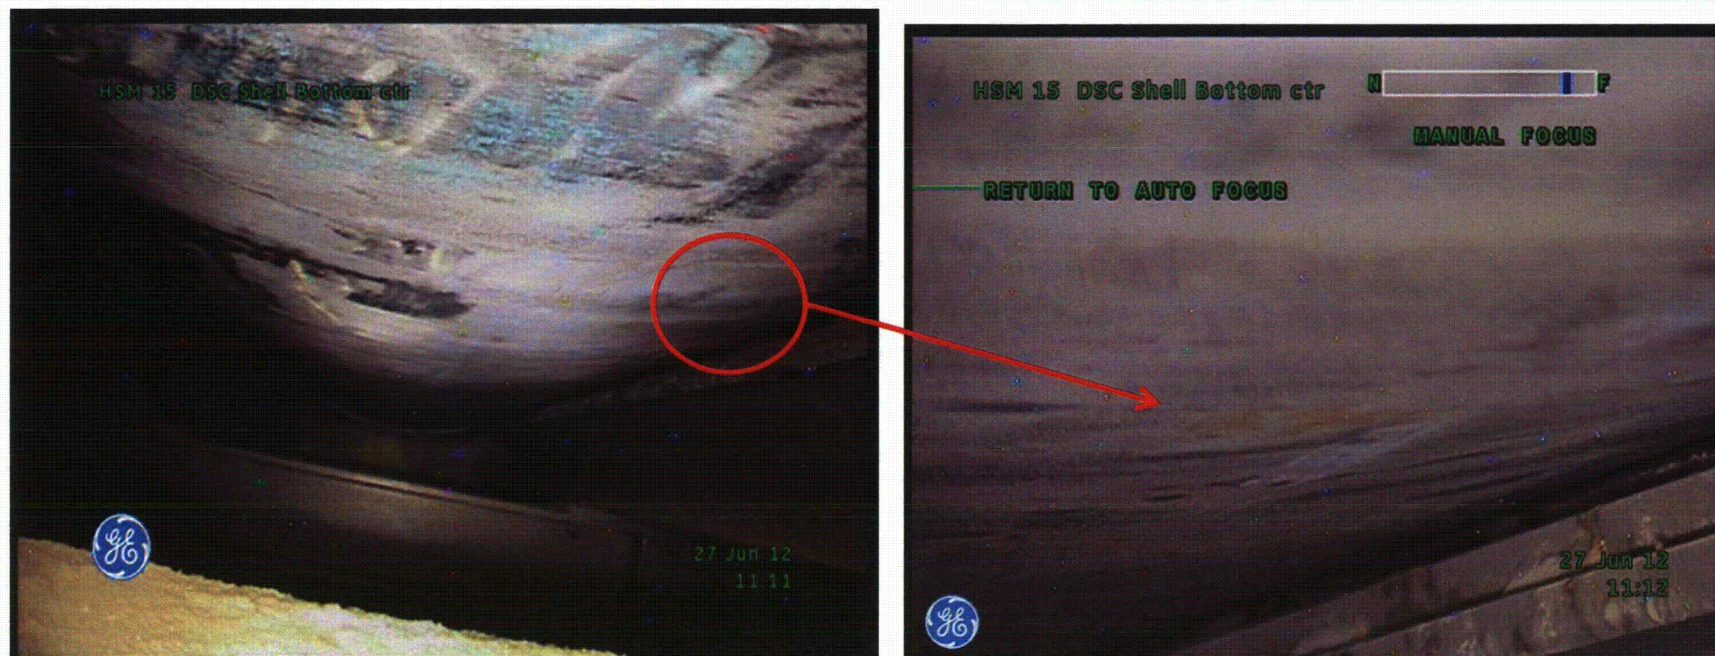
Figure 5 – Views of the Bottom of DSC-6 Shell between rails in HSM-15

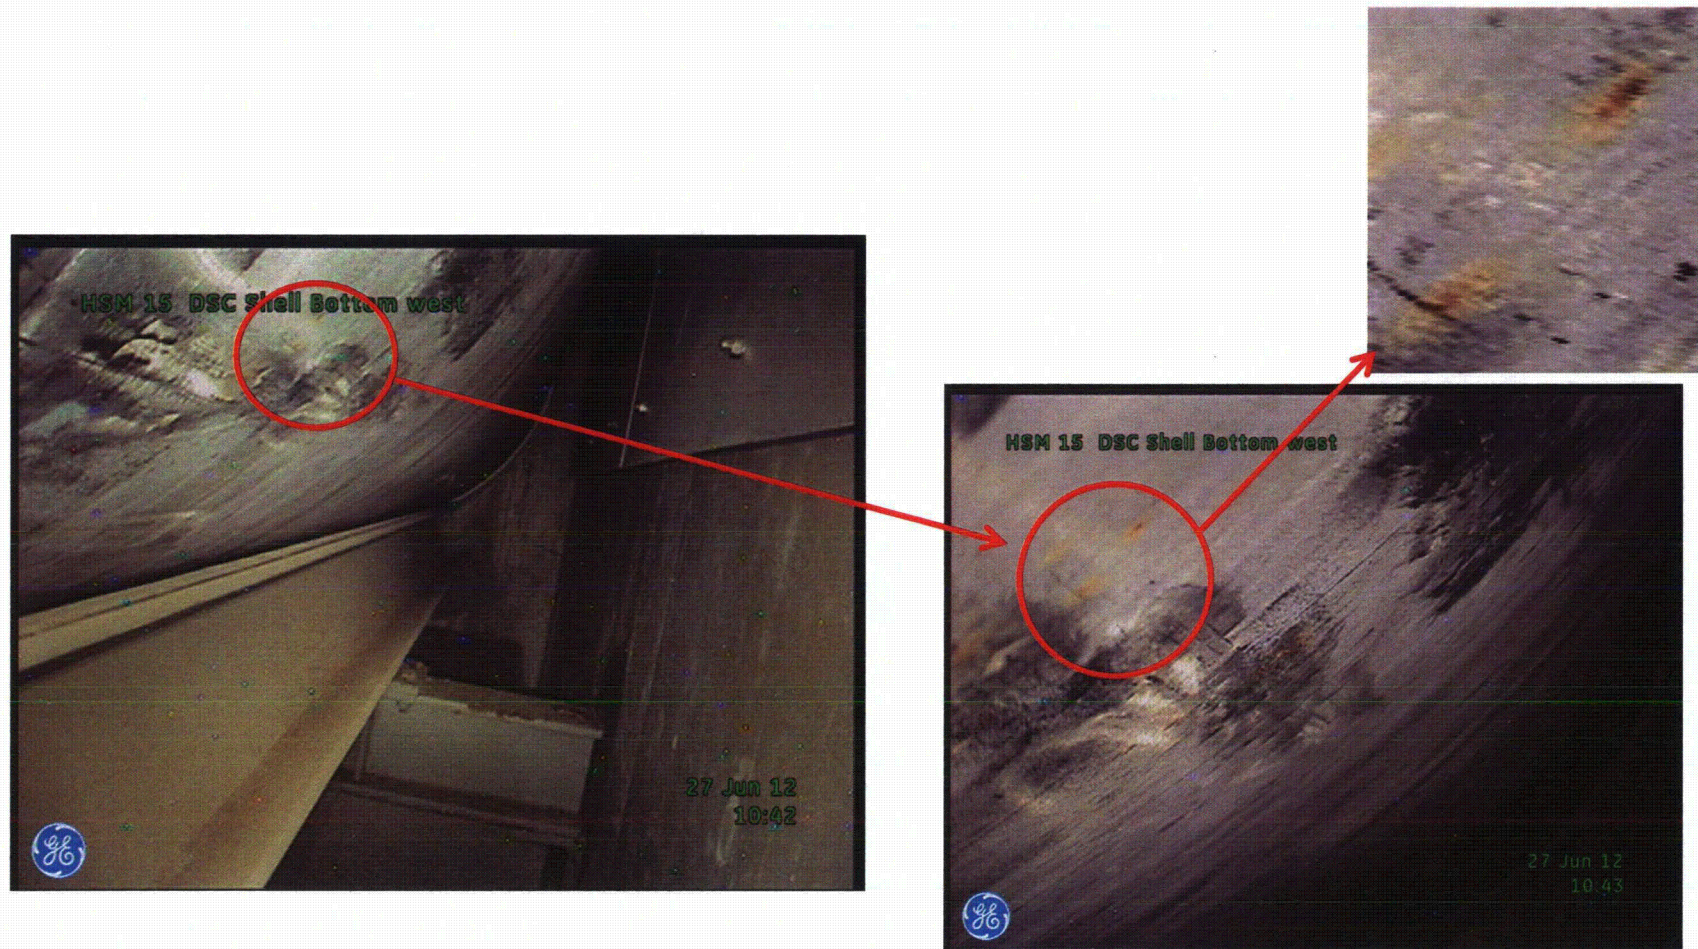
Figure 6 – Views of the Lower West Shell of DSC-6 in HSM-15

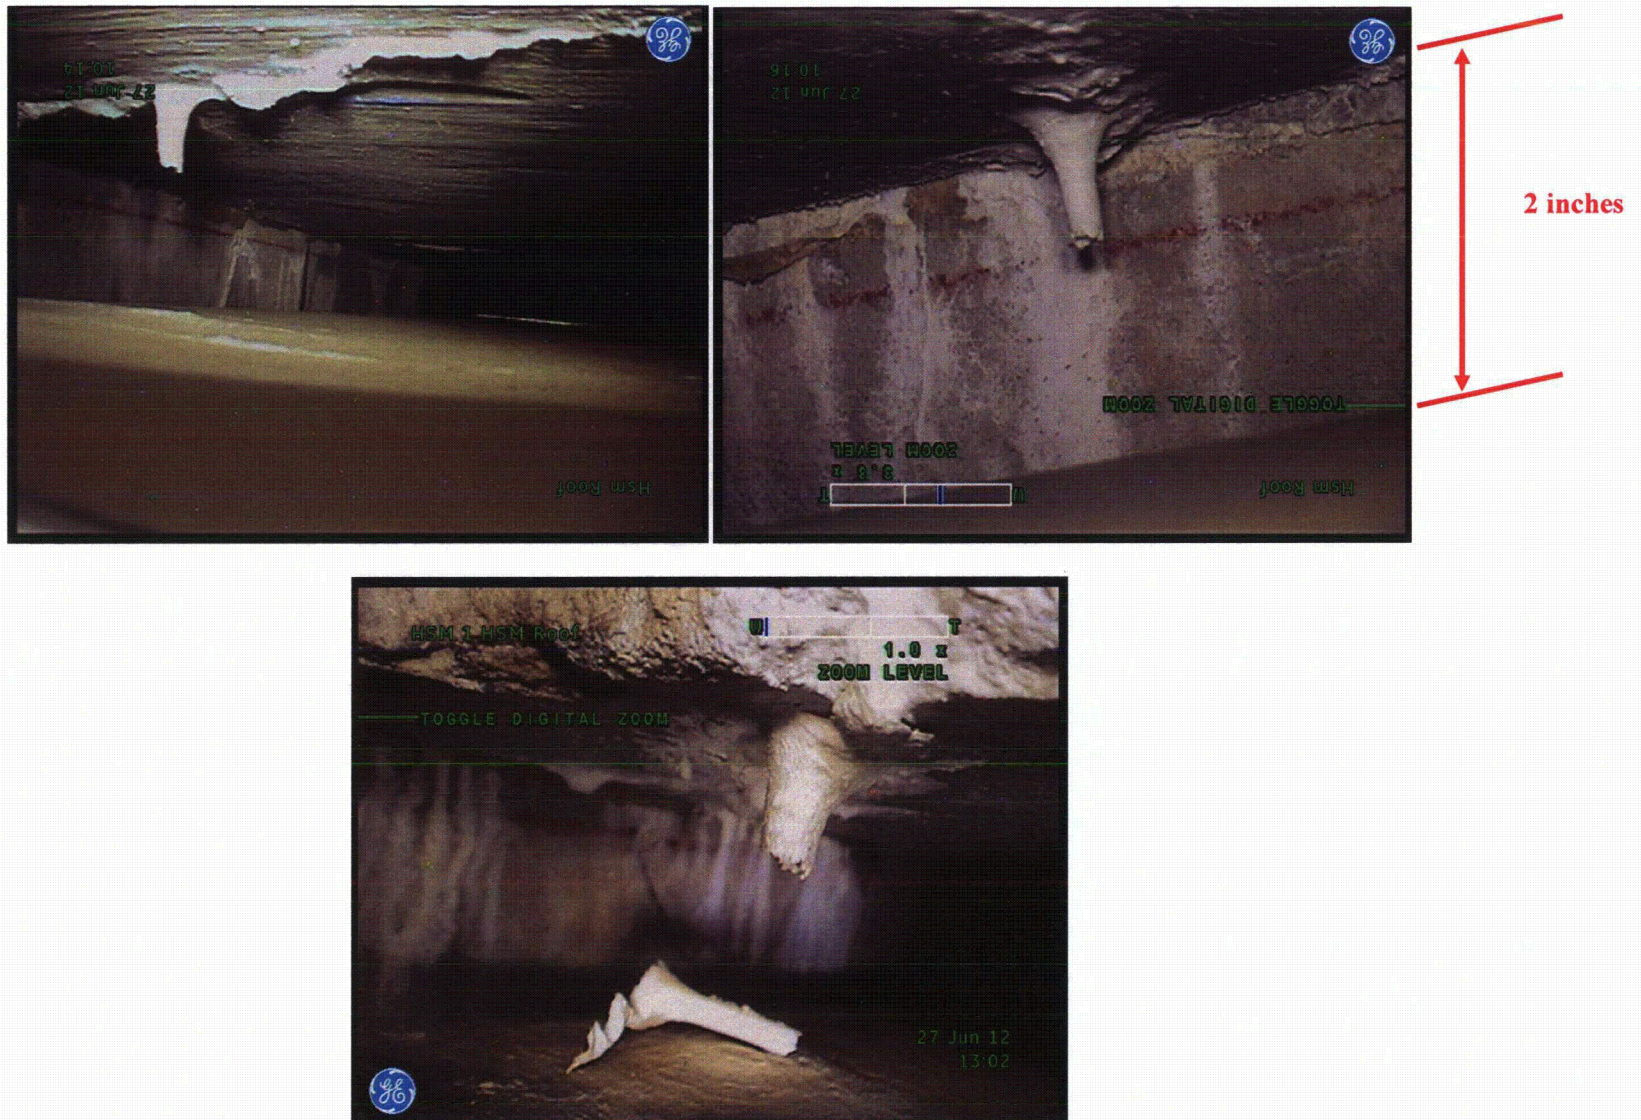
The accessible surfaces of the concrete walls, roof, and floor all appeared to be in good condition with little to no signs of spalling or cracking. There was additional evidence of localized water intrusion to the interior of the module in the form of a few concrete stalactites, which were seen in the 2-inch gap between the heat shield and the concrete ceiling of both HSM-15 and HSM-1 (see Figure 7). These stalactites were seen only near the rear outlet vent, which suggests that the source of the water intrusion is the outlet vent stack. They are formed when water leaches calcium hydroxide out of the concrete, and precipitates it as calcium carbonate on contact with carbon dioxide in the air. There was some indication that the water flowed inward along a surface crack for a few inches, but the pure white color of the stalactites suggests that water has not penetrated to the rebar. Calvert Cliffs does not believe that these few

Figure 7 – Views of ceiling in HSM-15 (above) and HSM-1 (below) showing concrete stalactites

stalactites represent a current operability issue for the HSM, but has initiated CR-2012-006781 to evaluate whether their presence could have implications for performance of the intended functions of the HSM prior to the next aging management inspection. A coating of dirt/dust was present on the floor of both HSMs, but no debris or standing water was noted.

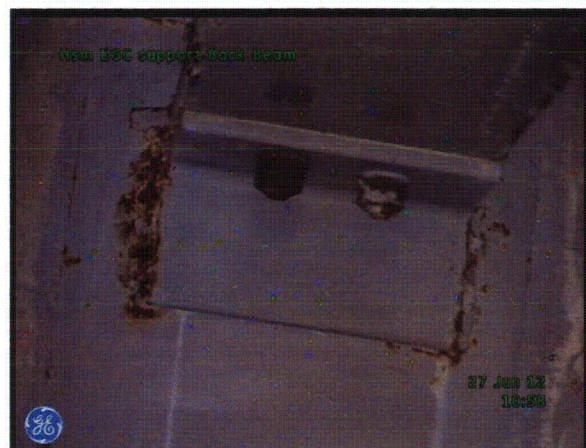
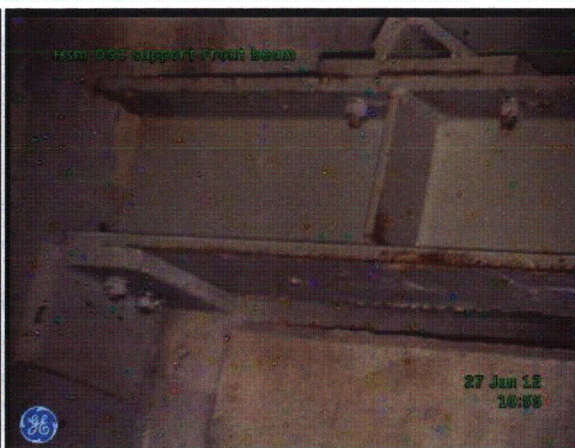
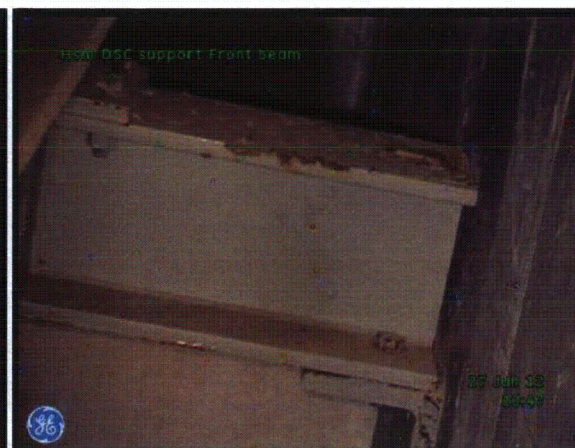
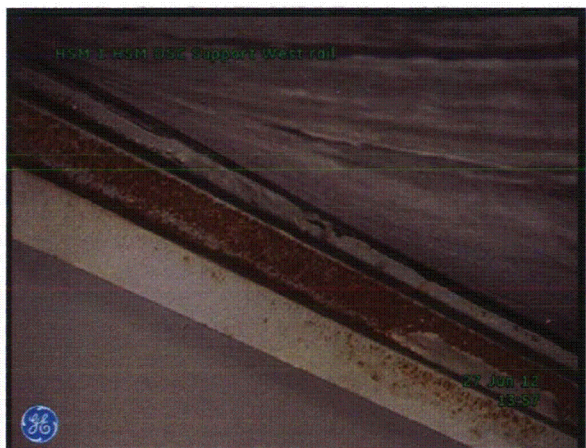
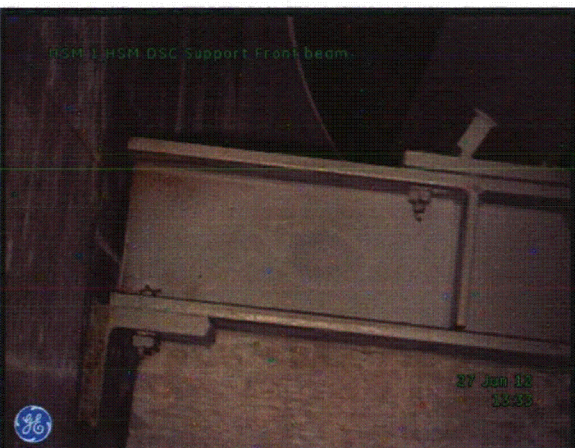
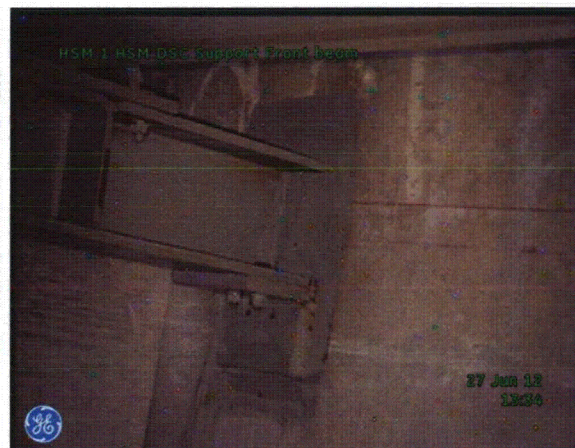
In both HSM-15 and HSM-1, the DSC structural support beams and rails were in good condition, with the coating intact in most areas. There was a large build up of dust on the transverse support beams horizontal surfaces particularly on the beams at the back end of the module. There were no signs of loose or missing bolting or fasteners. The areas shown in Figure 8 represent the only significant areas of coating failure seen and where general corrosion of the carbon steel surface or bolting hardware was observed. As noted in our Reference 3 response, signs of small areas of coating failure and surface corrosion on DSC supports were expected in these particular modules since they are part of Phase 1 and were not subject to recoating following the November 1999 condition report on this issue (IR3-028-233) due to having already been loaded. The small areas of general surface corrosion observed do not represent a current challenge to the function of the DSC structural supports. However, Calvert Cliffs has initiated CR-2012-006783 to evaluate whether the level of general corrosion seen is consistent with the conclusions of the evaluation performed 12 years ago, and determine if additional corrective actions or increased monitoring frequency are needed to ensure they can continue to perform their intended function for the duration of the extended license.

Figure 8 – Views of the DSC Support Structure in HSM-15 and HSM-1 showing locations of coating failure
