Rupture of Model 48Y UF₆ Cylinder and Release of Uranium Hexafluoride

Cylinder Overfill, March 12-13, 1986
Investigation of a Failed UF₆ Shipping Container

**U.S. Nuclear Regulatory
Commission**

This report, NUREG-1179, Volume 2, presents the findings made by the Augmented Investigation Team of the March 13 incident and the report of the detailed metallurgical examination conducted by Battelle Columbus Division of the cylinder damaged on January 4, 1986.

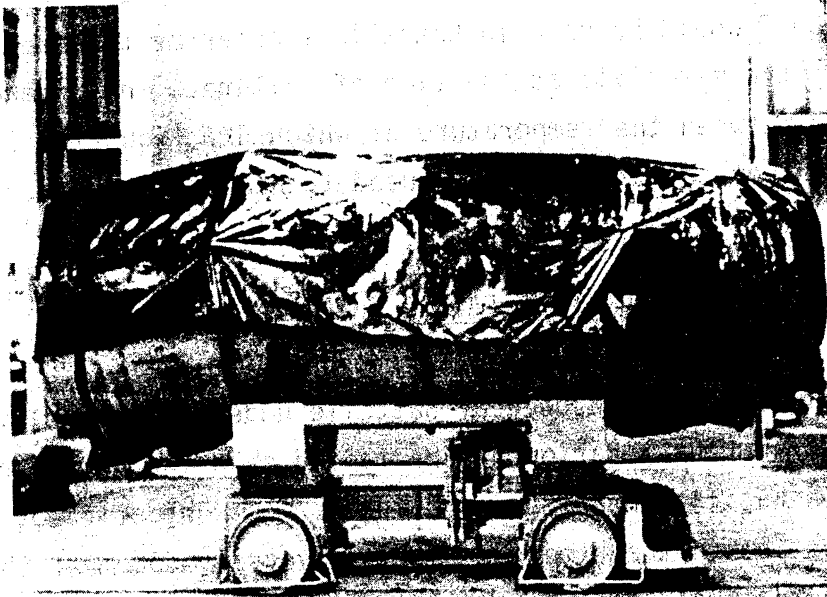
5M536

FIGURE 3. APPEARANCE OF THE VESSEL UPON ARRIVAL FOR THE ONSITE INSPECTION

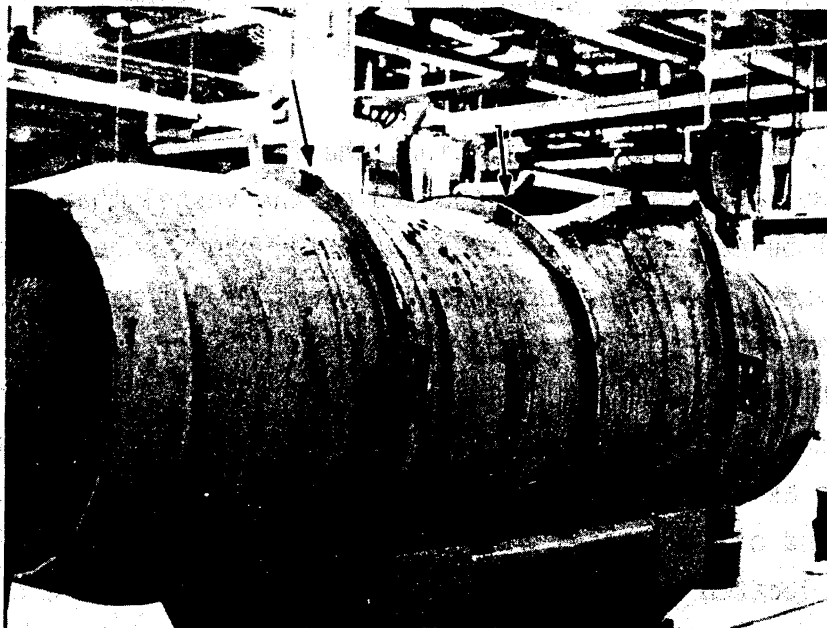
5M539

FIGURE 6. VESSEL WITH RUPTURE LOCATED TOWARD THE DRAIN END

The arrows point to the cracks in the drain-end and middle stiffener rings.

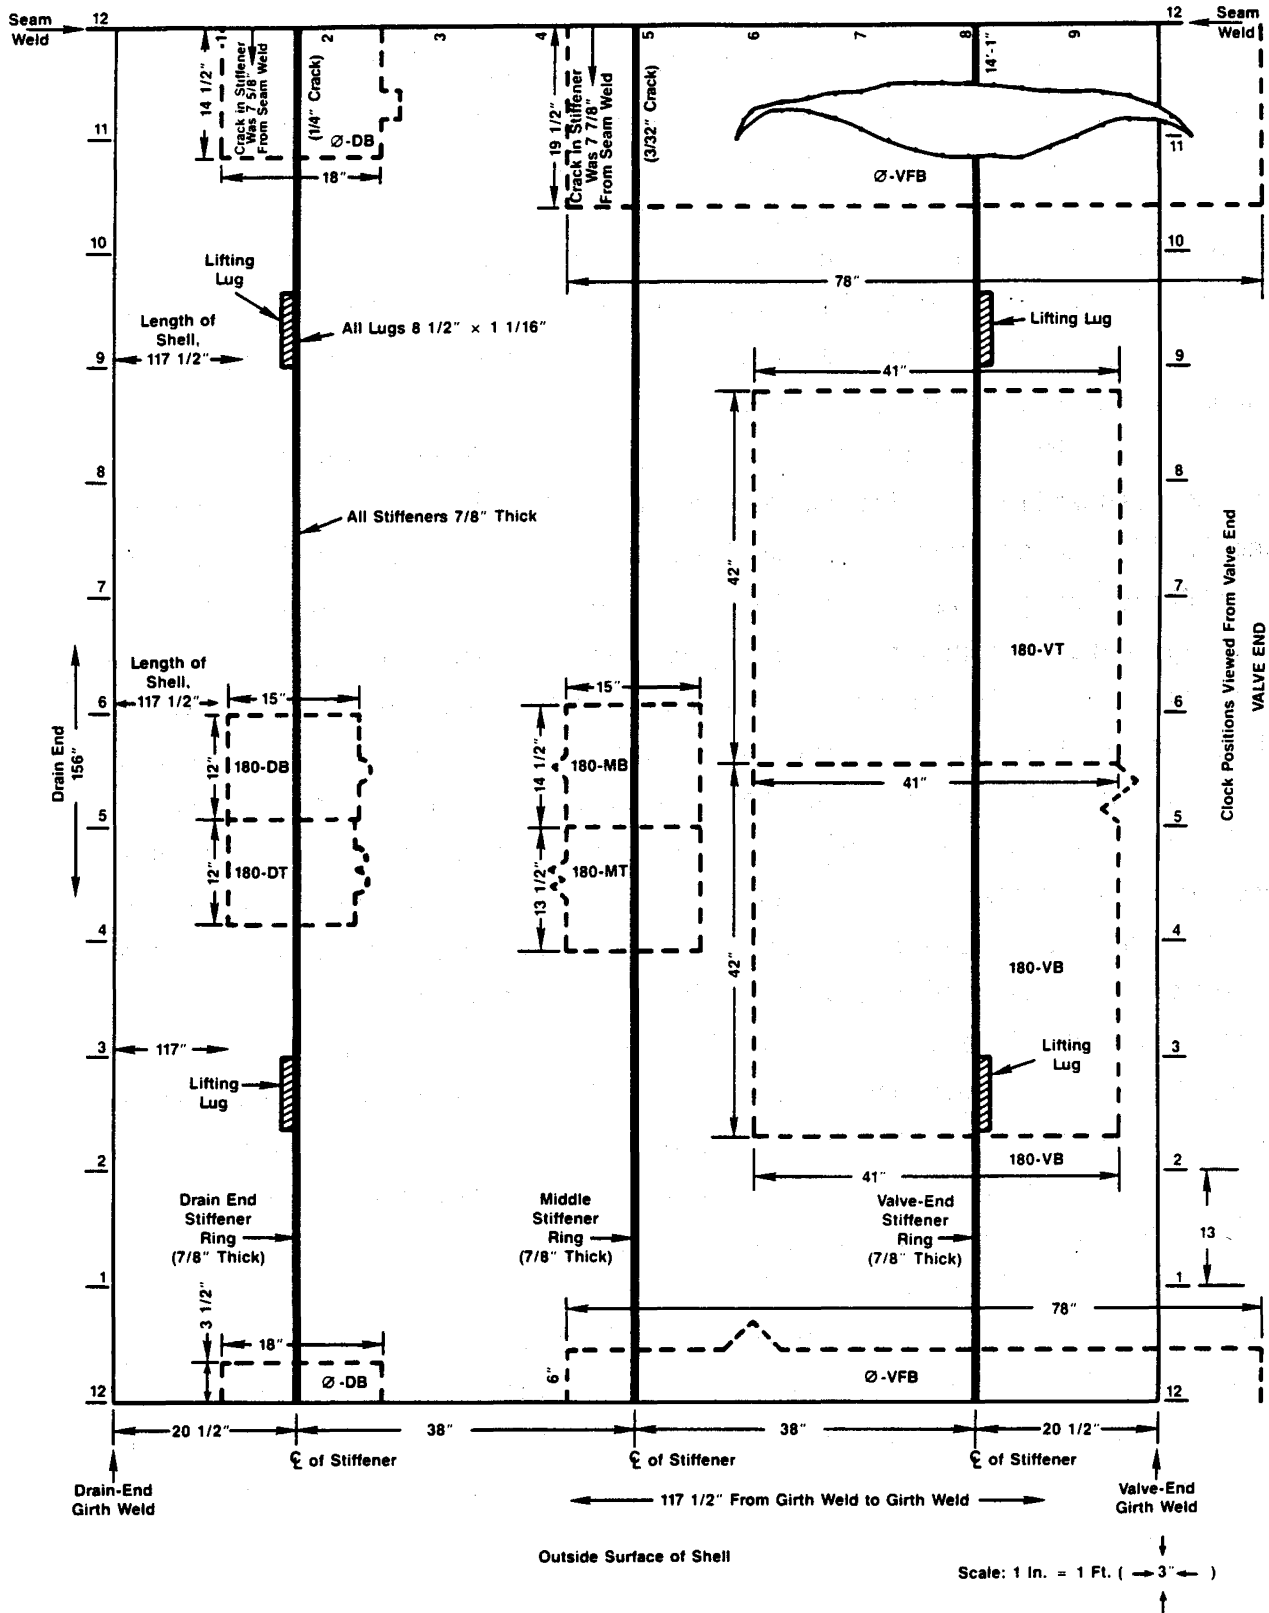
FIGURE 7. MAP OF VESSEL SHELL SHOWING THE APPROXIMATE LOCATION OF THE RUPTURE, THE STIFFENER RINGS, LIFTING LUGS, AND THE LOCATIONS OF SECTIONS REMOVED FROM THE VESSEL FOR EXAMINATION IN THE LABORATORY

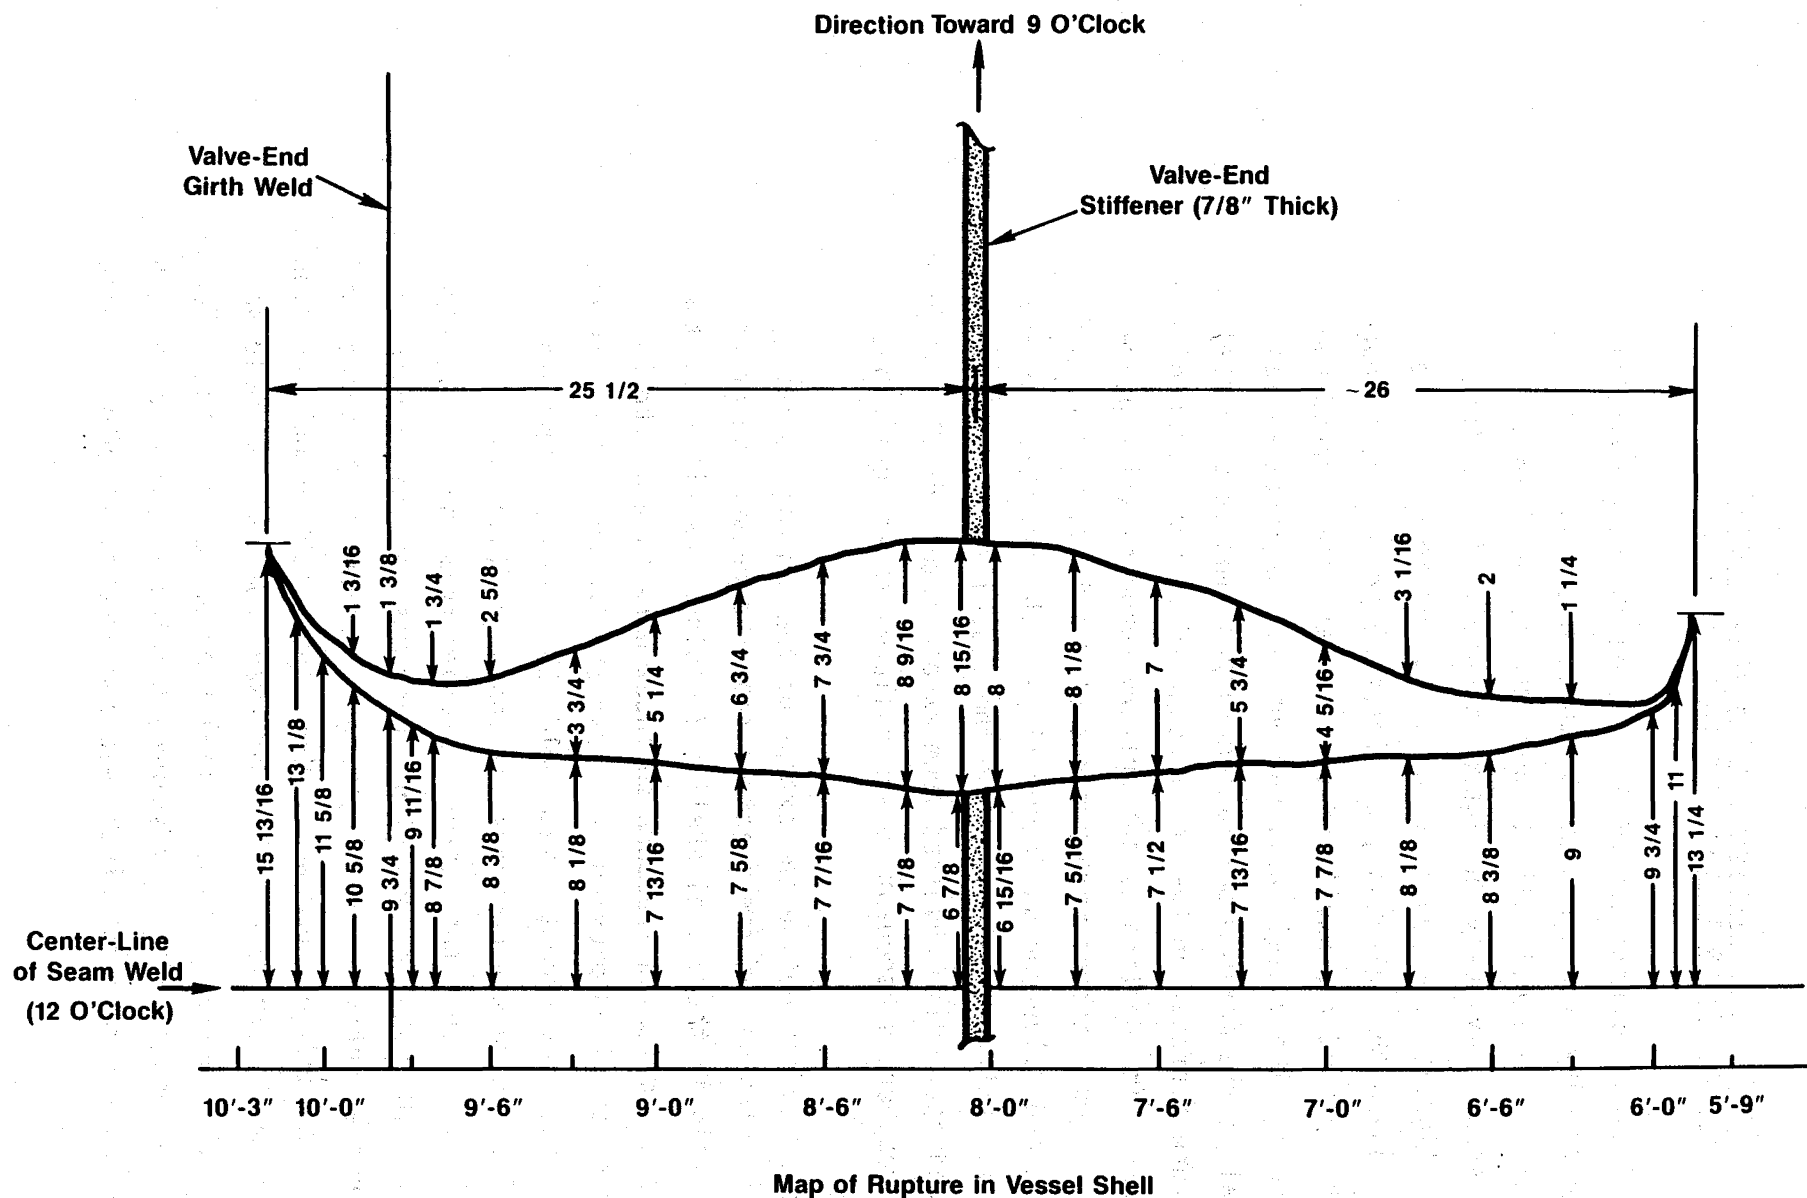
Figure 10 shows that the rupture extended from the 5 ft-10-1/2-inch position to the 10 ft-2-inch position. Over most of that length, the fracture was aligned essentially axially, ranging between 6-7/8 inches and 9 inches from the longitudinal seam weld (about the 11:30 o'clock position). At about the 6-foot mark, the fracture turned away from the seam weld and extended about 4 inches nearly circumferentially prior to arresting. Toward the valve end of the vessel, the crack started turning at about the 9-ft-8-inch location, extended through the girth weld and propagated into the head

FIGURE 10. MAP OF RUPTURE IN VESSEL SHELL SHOWING THE LOCATION OF THE RUPTURE AND THE SEPARATION OF THE FRACTURE SURFACES WITH RESPECT TO THE LENGTH MEASUREMENTS, AND THE LONGITUDINAL SEAM WELD

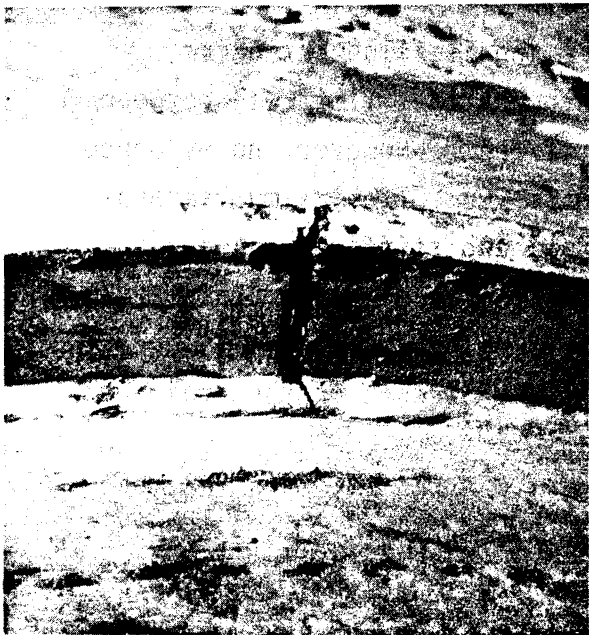
FIGURE 12. CRACK THROUGH THE BUTT WELD IN THE MIDDLE STIFFENER RING

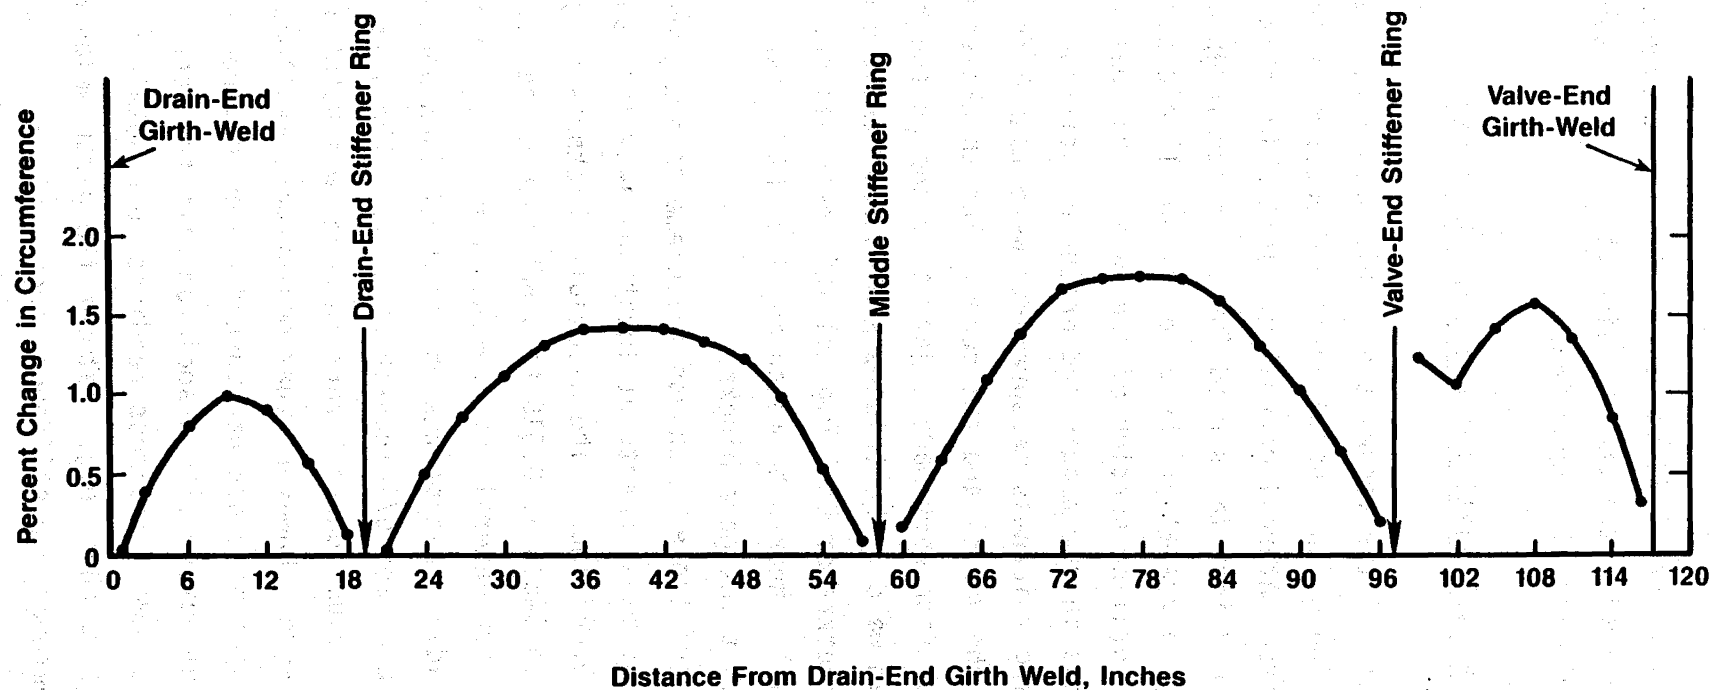
FIGURE 14. PERCENT CHANGE IN CIRCUMFERENCE ALONG THE LENGTH OF THE FAILED SHIPPING CONTAINER

The circumference measured at the 1-inch position was assumed to be the nominal circumference of the vessel prior to failure.

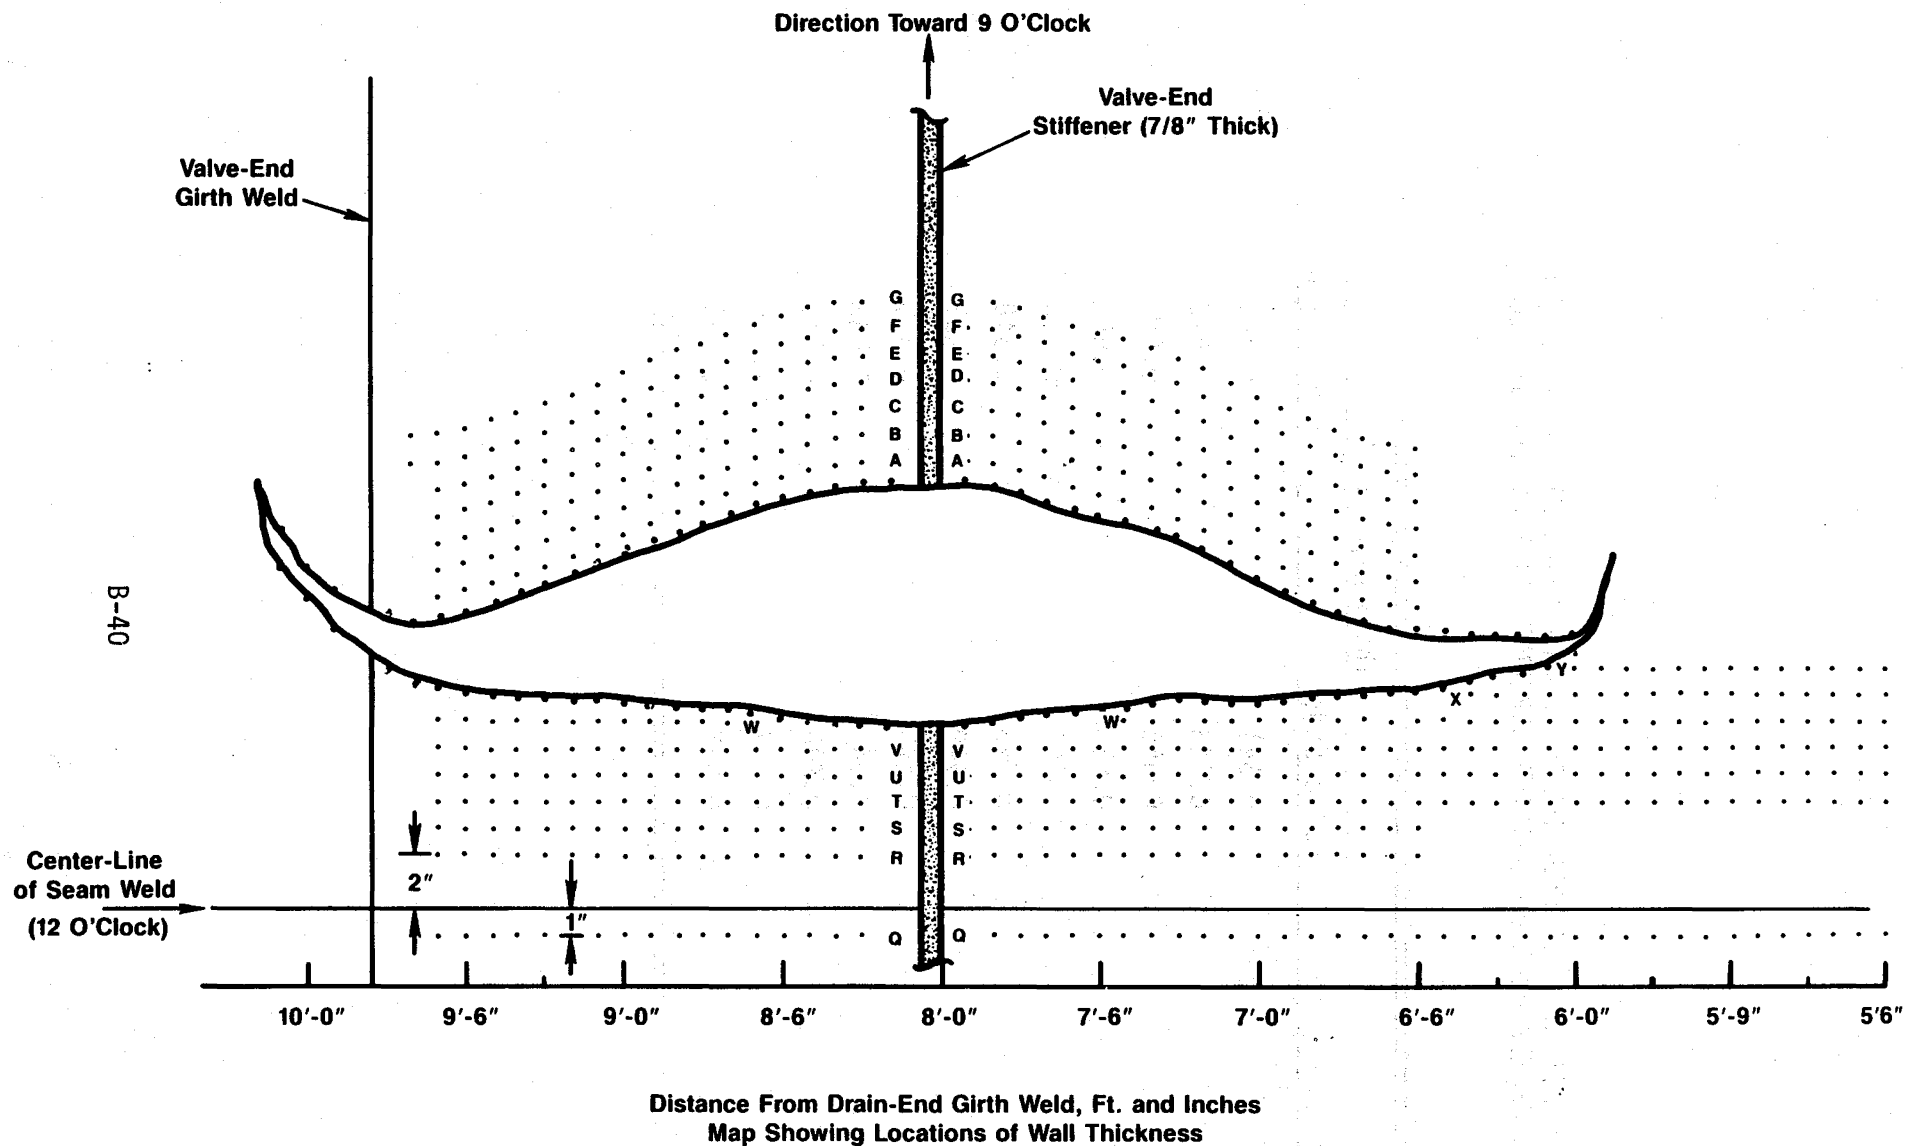
Clock Position	Thickness, inch	
	Valve Side	Drain Side
1	0.641	0.646
2	0.648	0.646
3	0.655	0.654
4	0.650	0.653
5	0.650	0.653
6	0.645	0.648
7	0.649	0.651
8	0.643	0.645
9	0.643	0.648
10	0.645	0.651
11	0.637	0.639
12	0.643	0.644

FIGURE 15. MAP SHOWING LOCATIONS OF VESSEL-SHELL WALL THICKNESS MEASUREMENTS ON EITHER SIDE OF THE RUPTURE

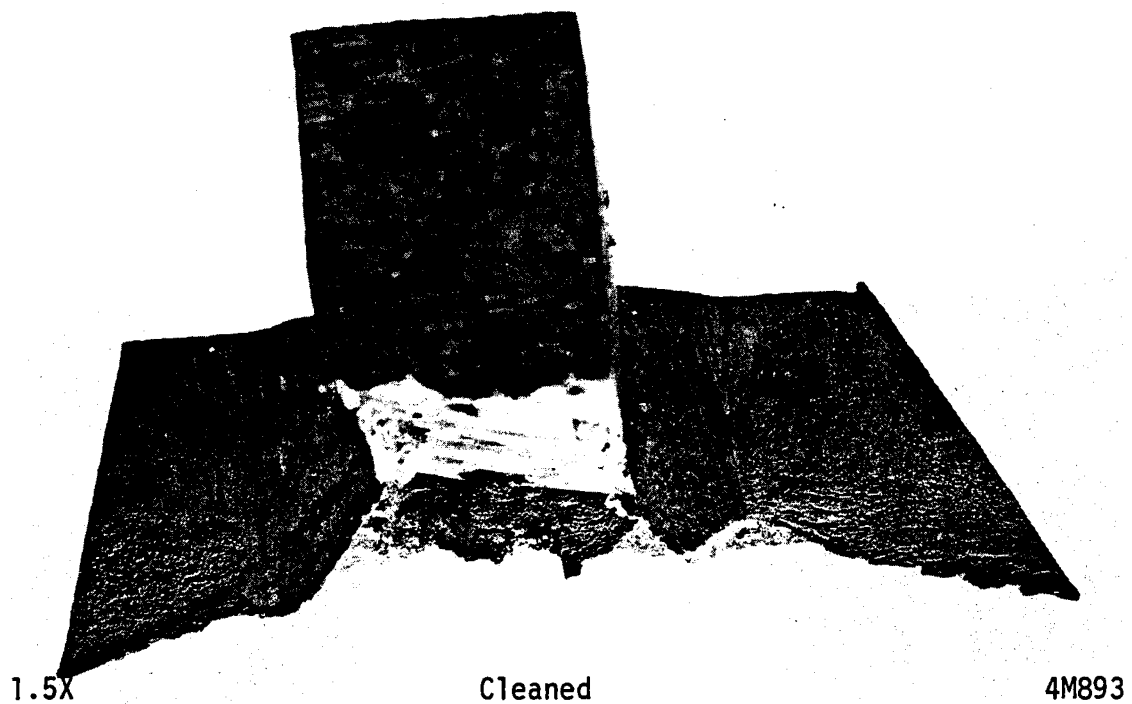
FIGURE 30. CRACK IN THE VESSEL SHELL SURFACE ON SPECIMEN OVFB-W
Half of butt weld of valve-end stiffener ring viewed
from top.

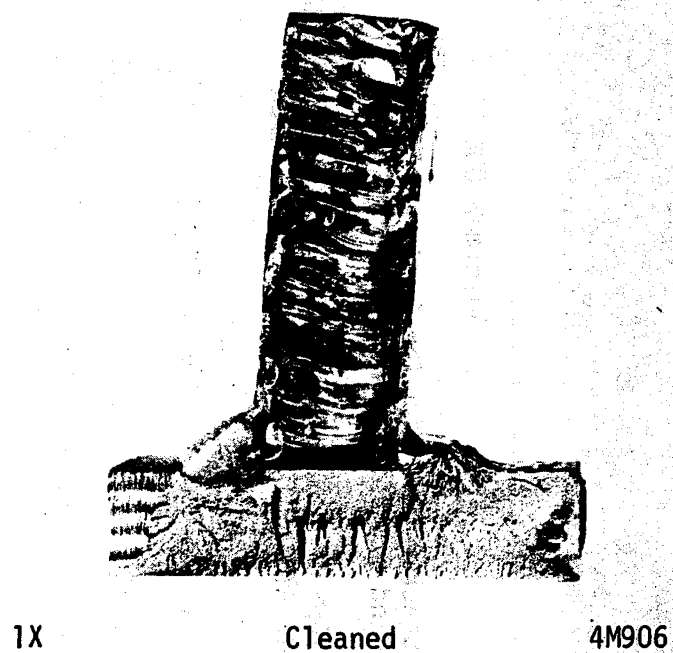
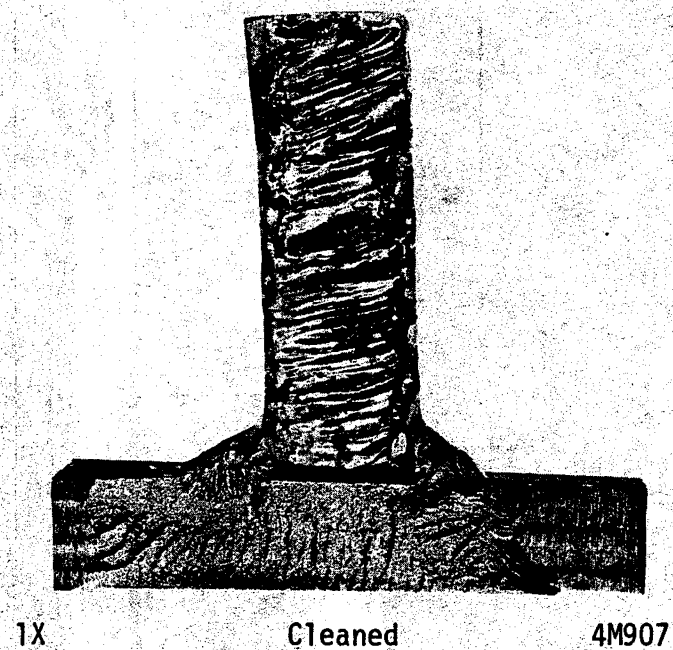
FIGURE 33. MATCHING FRACTURE SURFACES ON SPECIMENS OMB AND OMB-W FROM THE CRACK THROUGH BUTT WELD OF THE MIDDLE STIFFENER RING

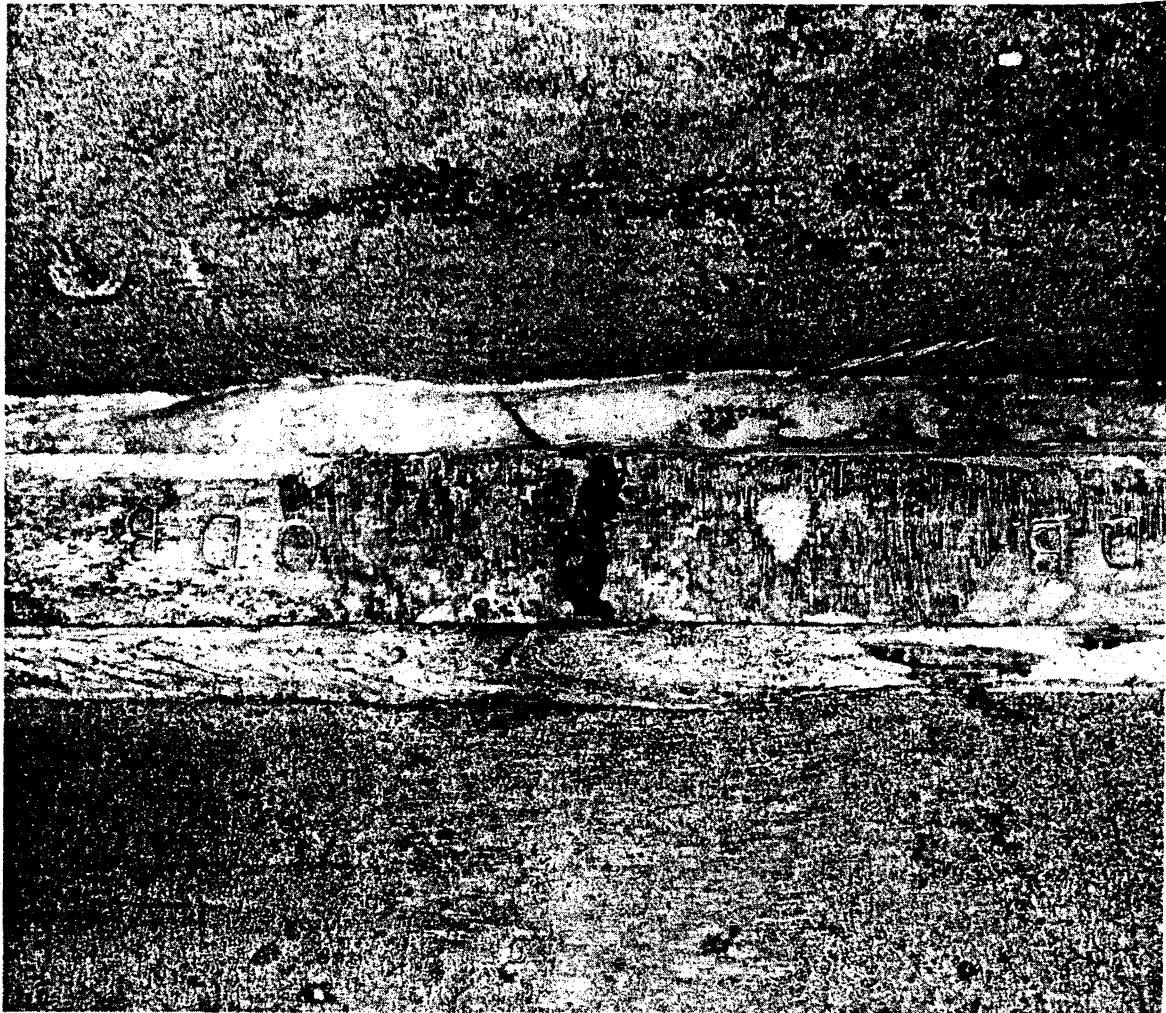
FIGURE 34. PHOTOMACROGRAPHS OF THE CRACK AT THE BUTT WELD IN THE
STIFFENER RING AT THE DRAIN-END OF THE CYLINDER

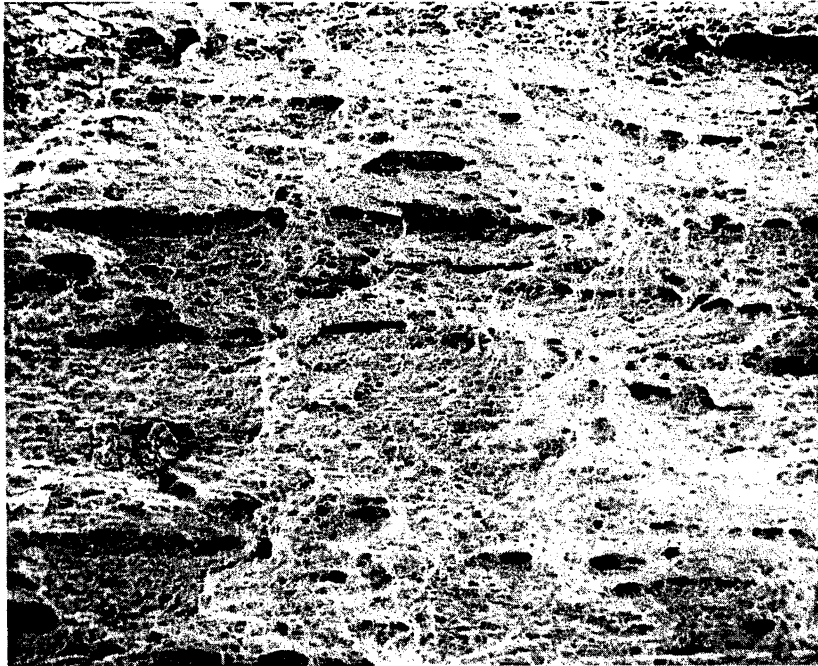
FIGURE 37. TYPICAL DUCTILE FRACTURE APPEARANCE IN AREA 2
ON FIGURE 36 OF THE FRACTURE SURFACE OF THE
VESSEL SHELL

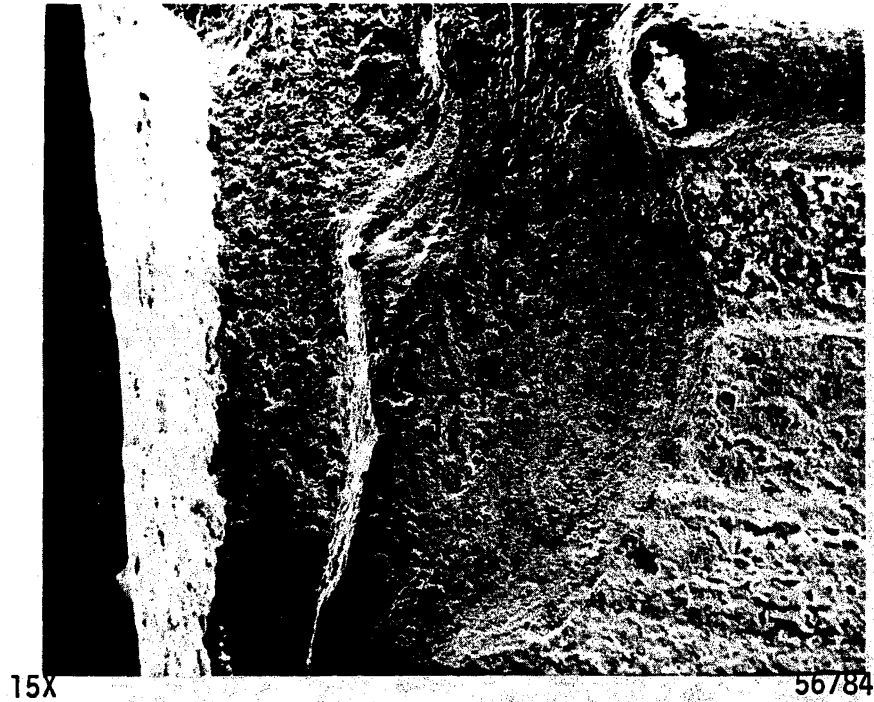
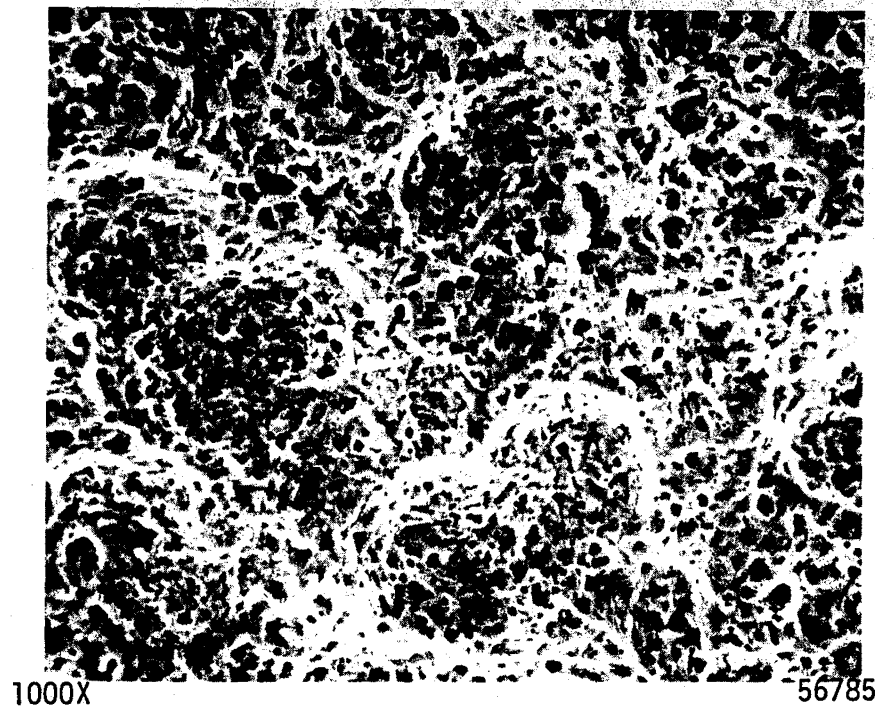
a. Fracture Through Area 13 and the Unbonded Surface of the Weld Nugget in Area 14 Shown on Figure 36.

b. Ductile Rupture in Area 13

FIGURE 40. FRACTURE APPEARANCE IN AREA 13 AND THE SURFACE OF A WELD NUGGET (AREA 14)

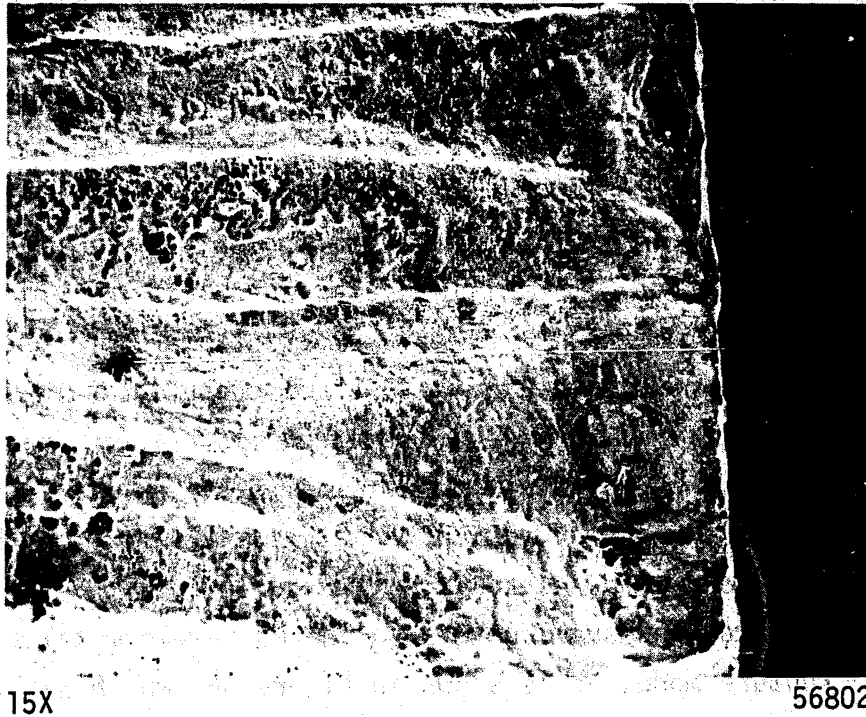
Figure 41 shows the flame cut surface on the end of the stiffener ring in Area 21. There appeared to be no weld metal from the butt weld over the bulk of this region.

FIGURE 41. APPEARANCE OF AREA 21 INDICATING LACK
WELD METAL OVER A PORTION OF THE END
OF THE VALVE-END STIFFENER RING

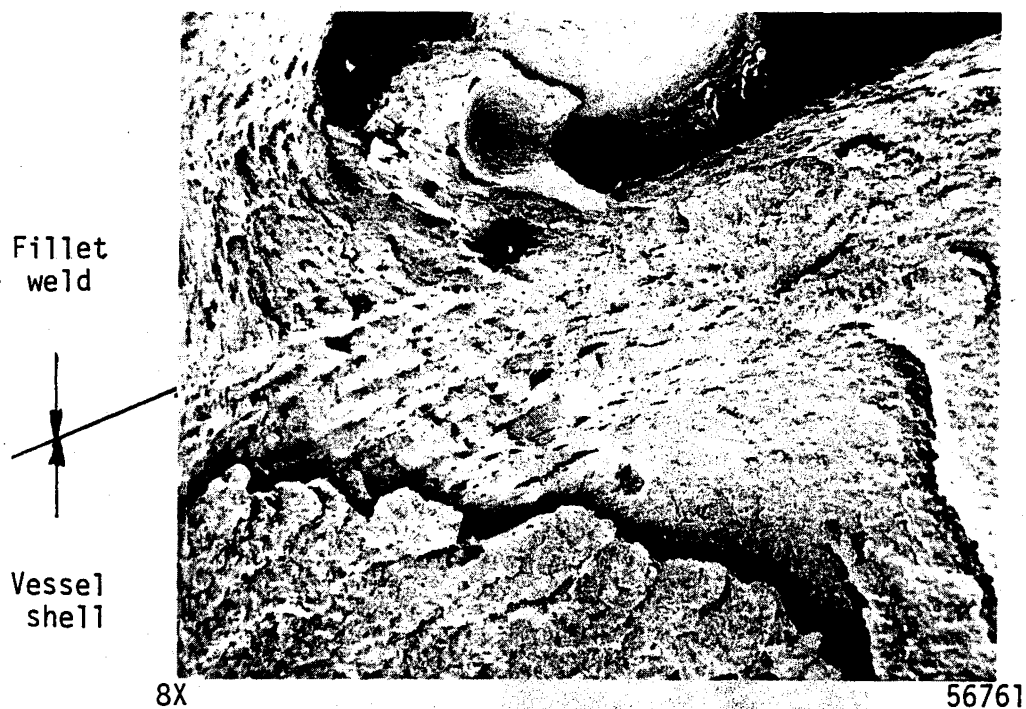
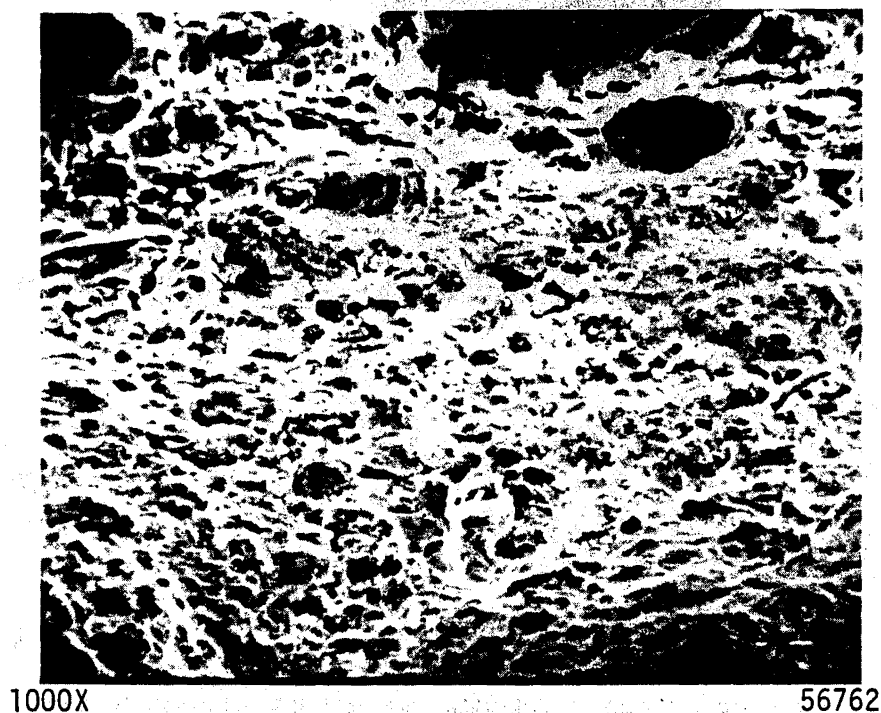
a. Appearance of Area 13 on Figure 42. The Ductile Rupture in the Vessel Shell is in the Left-Central Portion of the Figure

b. Ductile Rupture in Area 13

FIGURE 43. DUCTILE CRACK GROWTH IN THE VESSEL SHELL BELOW THE FILLET WELD ON THE VALVE-END SIDE OF THE MIDDLE STIFFENER RING

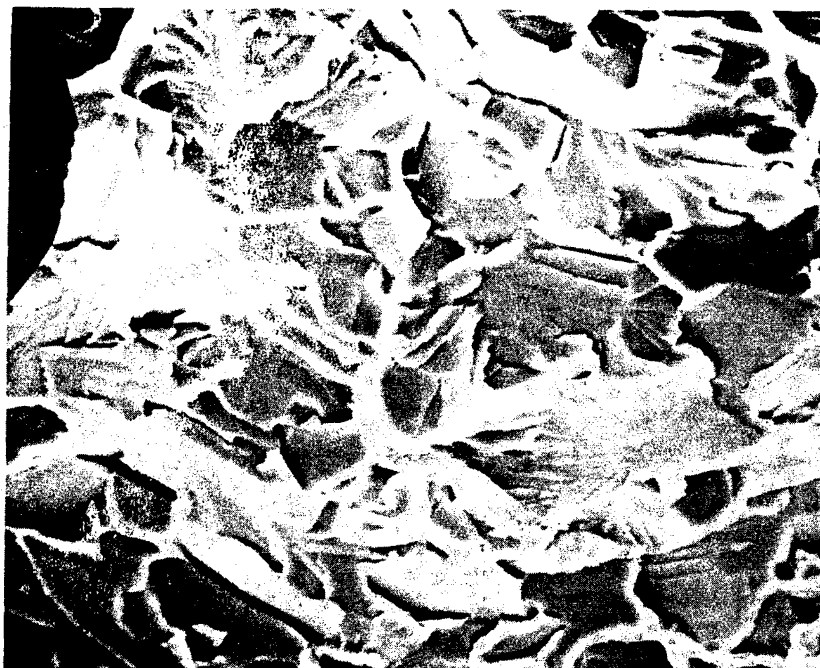
FIGURE 44. TYPICAL CLEAVAGE FRACTURE OBSERVED ON THE FRACTURE SURFACE THROUGH THE VESSEL SHELL PRODUCED IN THE LABORATORY (AREA 5 ON FIGURE 42)

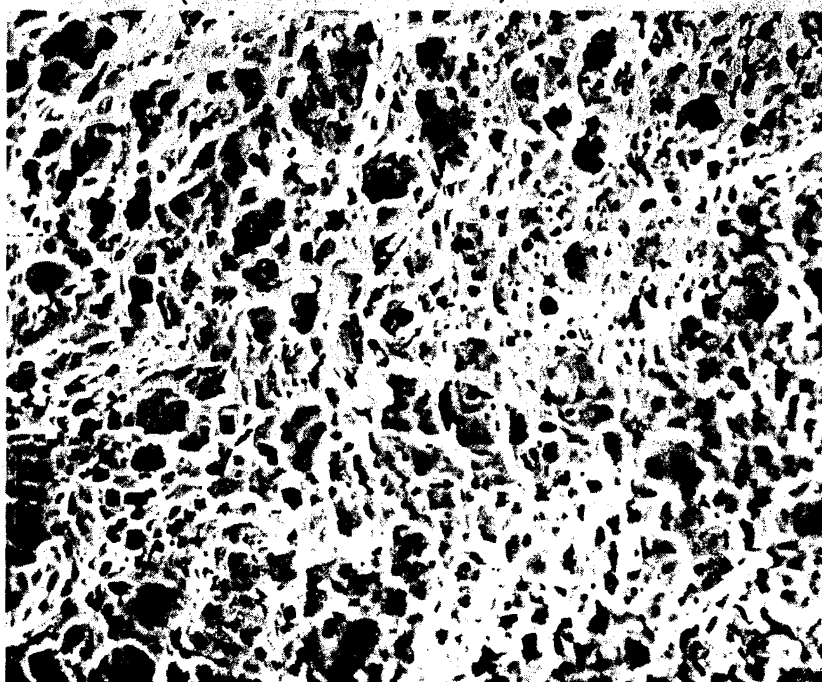
FIGURE 45. TYPICAL DUCTILE RUPTURE THROUGH THE FILLET WELD ON THE VALVE-END SIDE OF THE MIDDLE STIFFENER RING (AREA 14 ON FIGURE 42)

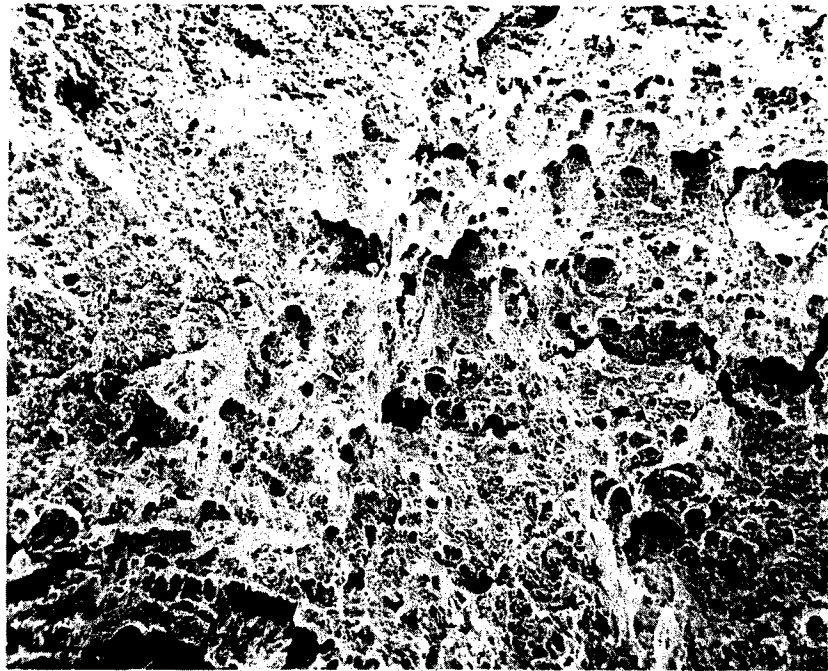
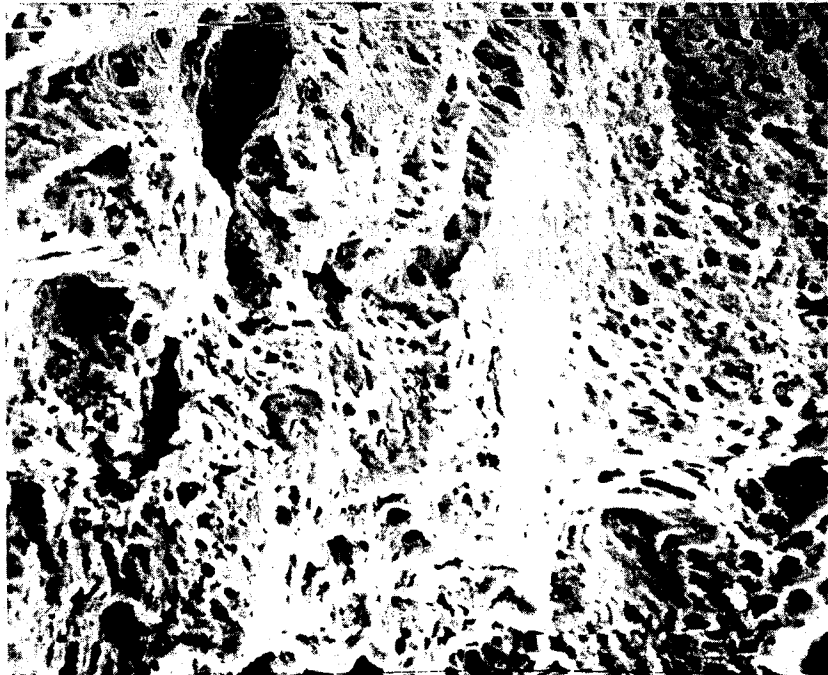
a. Appearance of Area 4

b. Ductile Rupture in the Vessel Shell in Area 4

FIGURE 50. DUCTILE CRACK EXTENSION INTO THE VESSEL SHELL ADJACENT TO THE FILLET WELD ON THE DRAIN-END STIFFENER

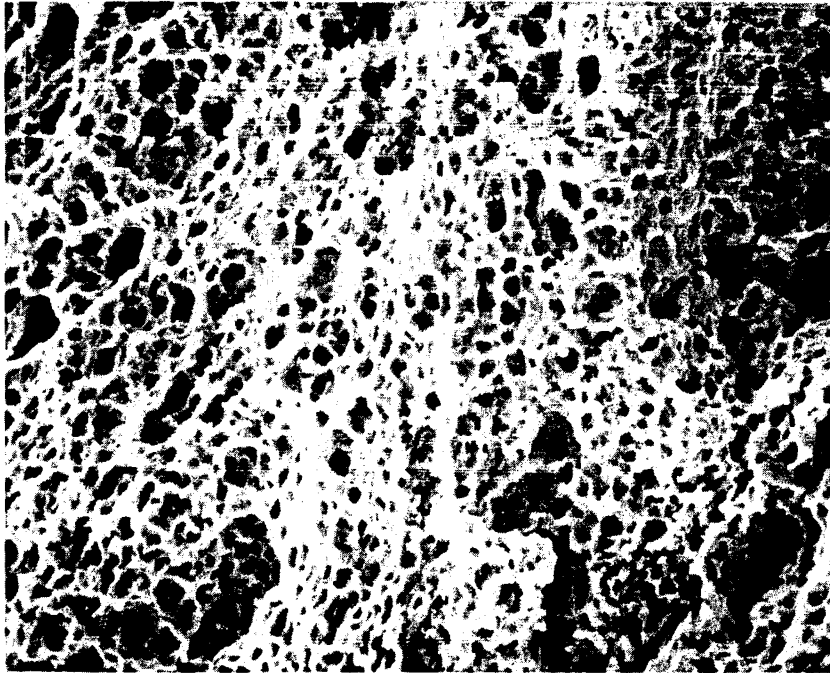
FIGURE 51. TYPICAL DUCTILE RUPTURE OBSERVED ON THE
FILLET WELDS IN SPECIMEN ODBW FROM THE
DRAIN-END STIFFENER RING

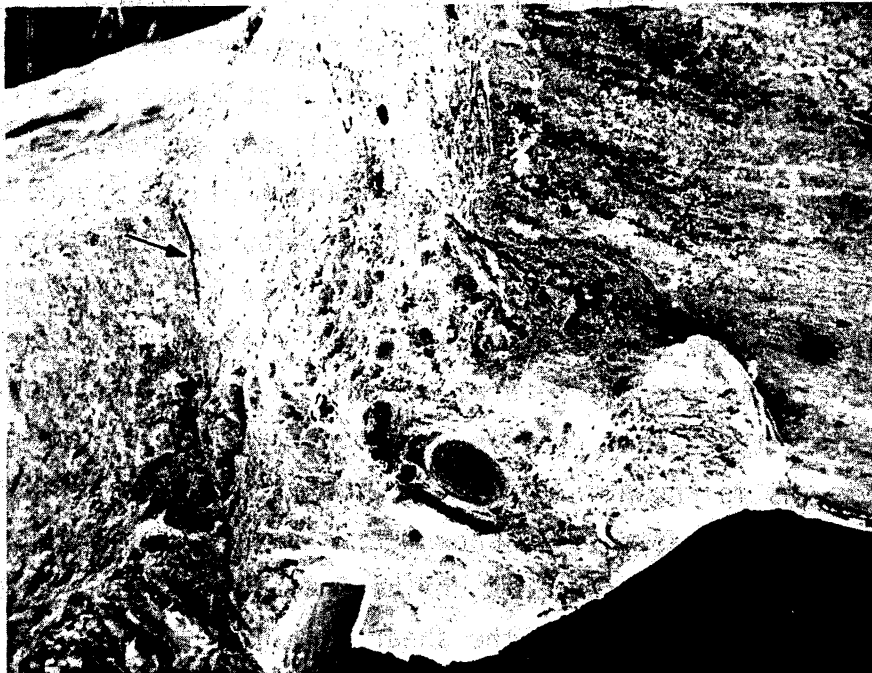
FIGURE 52. CRACK EXTENDING CIRCUMFERENTIALLY IN THE FILLET WELD ON THE DRAIN-END SIDE OF THE DRAIN-END STIFFENER RING

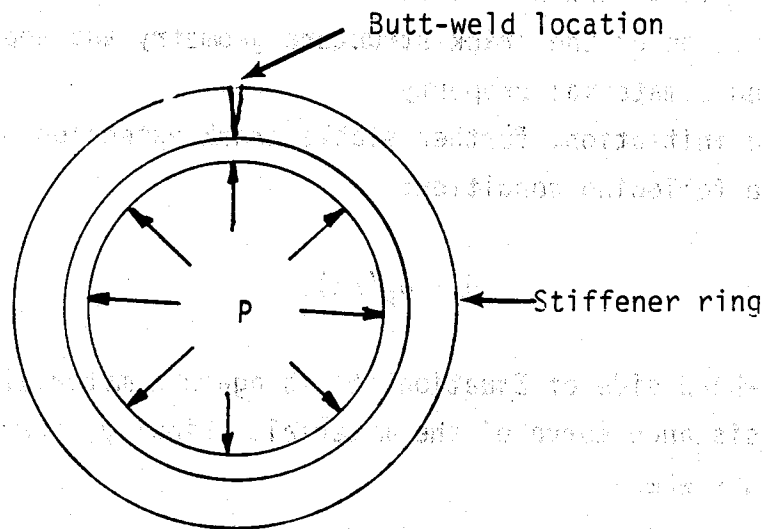
FIGURE 68. POSTULATED CONDITION OF CONTAINER WITH CRACK THROUGH THE STIFFENER RING BUTT WELD AT INTERNAL PRESSURES GREATER THAN 500 psi

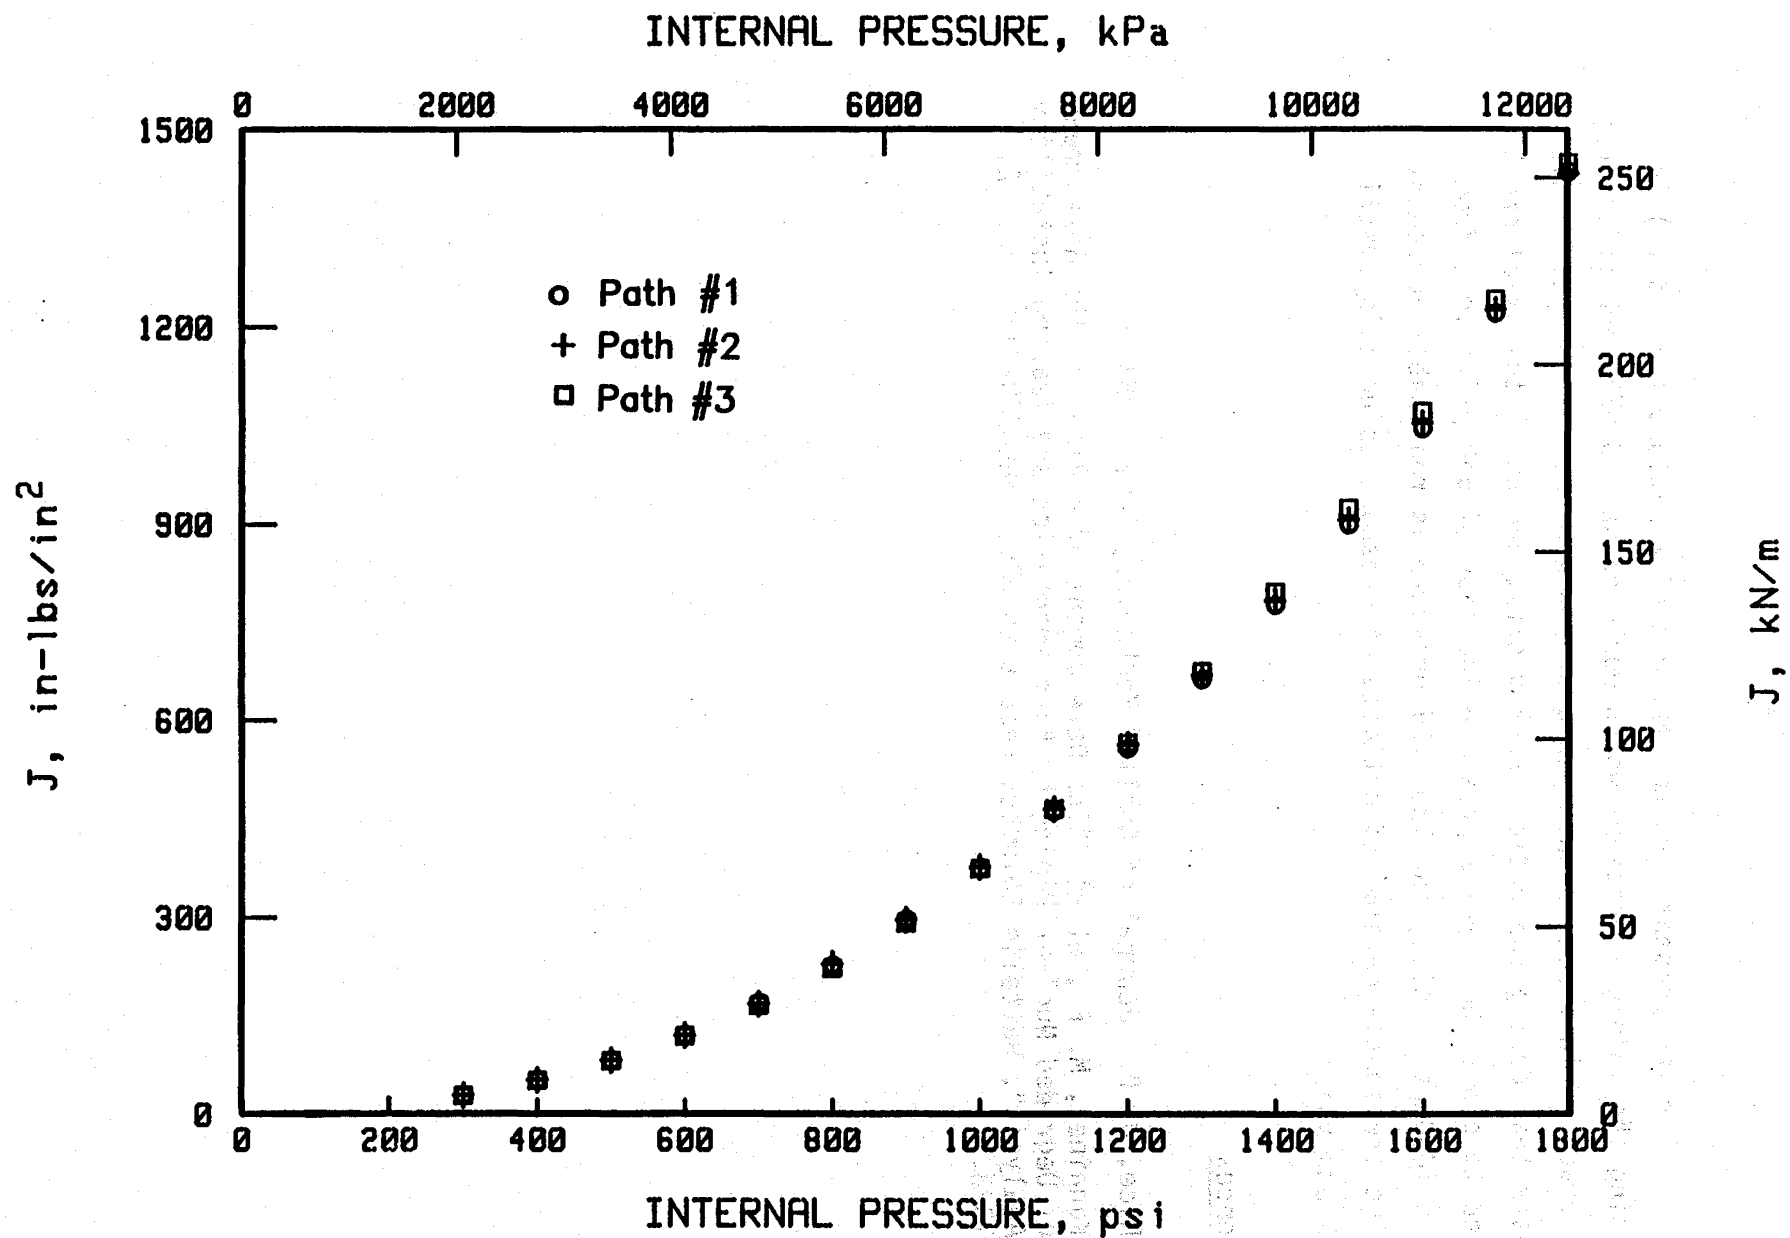
The elastic-plastic analysis shows that the internal pressure at rupture was greater than 1750 psi. The results of this analysis indicate that the maximum pressure was approximately 1775 psi. However, the analysis was performed using the minimum material properties. Thus, the actual pressure at rupture may have been greater than 1775 psi.

FIGURE 71. RESULTS OF THE ELASTIC-PLASTIC FINITE ELEMENT ANALYSIS
