# **Boiling Water Reactor Vessel & Internals Project (BWRVIP)**

## **BWR Operating Experience**

**Charles Wirtz, FirstEnergy**  
BWRVIP Integration Committee Chairman  
**Industry/NRC Executive Meeting on Materials Program**  
July 31, 2012

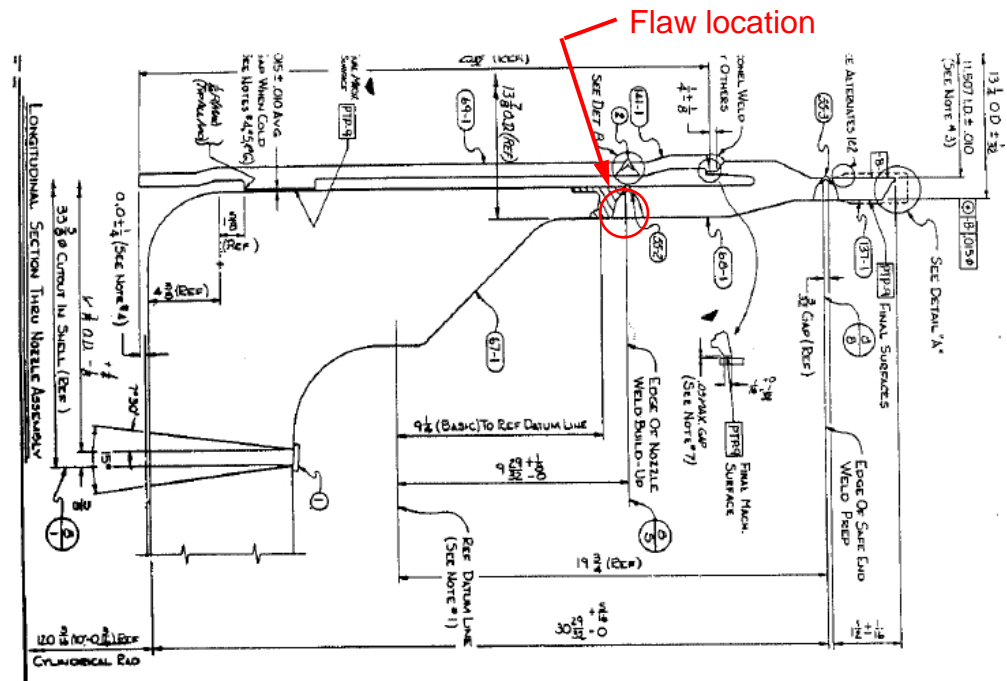
- During Spring 2012 outage Grand Gulf found an axial flaw in their N6B Low Pressure Core Injection Nozzle to Safe-End DM weld.
    - Flaw approx. 0.47" deep (0.90" remaining ligament), 0.95" long, and in the 182 butter

- Weld was stress-improved by Induction Heating Stress Improvement (IHSI) in 1990
    - Examination was one of 13 GL 88-01 Category C weld examinations being performed in accordance with BWRVIP-222, Accelerated Inspection Program for Category C DM Welds

- Weld did not previously have a qualified Supplement 10 exam and had to be prepped prior to examination
    - Automated data from previous exam (2002) corrupt so no way to evaluate if flaw was pre-existing

- Weld overlay repaired
    - Of the 271 Category C welds in the BWR Fleet with 182 filler material exposed to the environment, only 4 remain to be examined with a Supplement 10 exam and they are scheduled for Spring of 2014

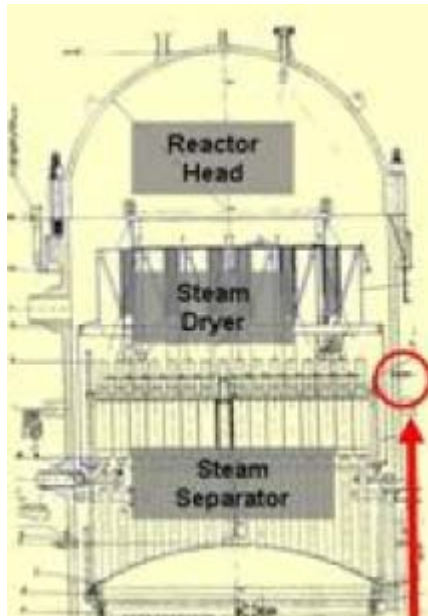
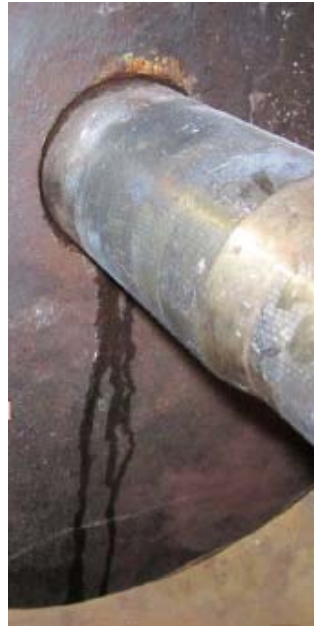
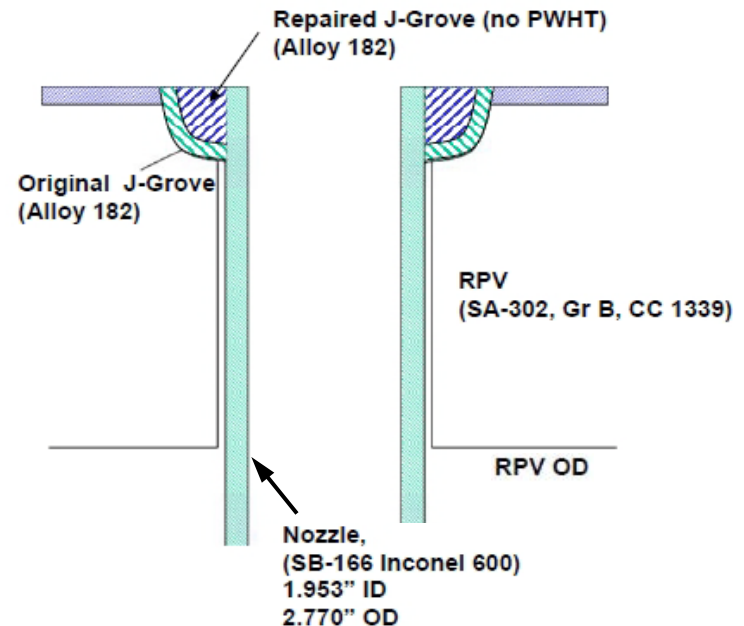
- During Spring 2012 outage Quad Cities 2 identified a leak coming from their N11B (Upper Water Level) Instrument Nozzle Penetration

- Leakage was found by VT-2 examination during the routine end-of-outage RPV Leak Test
- First instance of a BWR instrument nozzle leaking from inside the vessel or inside the nozzle penetration

- Repaired by a half-nozzle repair (typical repair for PWR partial penetration nozzles)
- Apparent cause is IGSCC in the J-groove weld or Alloy 600 instrument nozzle

- Most likely location is in J-groove weld due to repair without PWHT and the fact that no flaws or abnormal metallurgical or chemical conditions were found in the portion of the nozzle that was removed for the half-nozzle repair
