Seabrook Station

Relief Request – Proposed Alternative in accordance with 10 CFR 50.55a (a)(3)(ii)

Request RA-12-001

SEABROOK STATION UNIT 1  
RELIEF REQUEST RA-12-001, REVISION 0

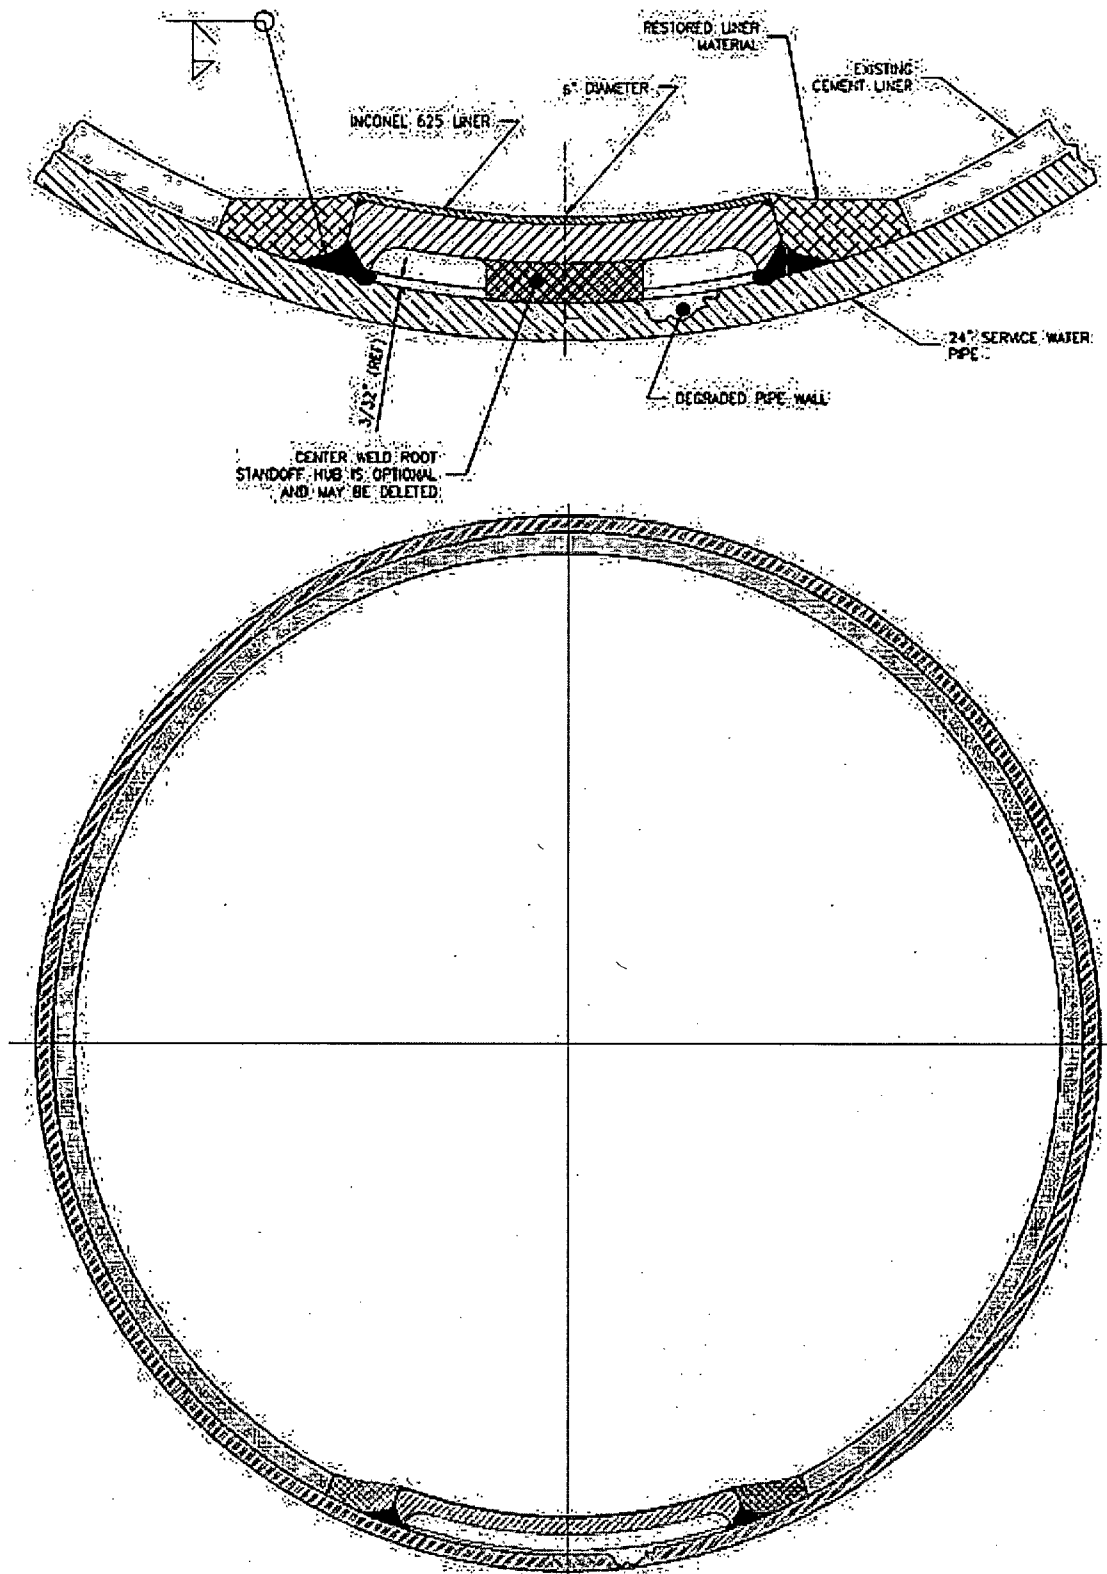
SEABROOK STATION UNIT 1  
RELIEF REQUEST RA-12-001, REVISION 0  
FIGURE A

the area will be repaired by the application of an encapsulation device (Figure A) in accordance with the provisions of IWA-4000.

The structural repair consists of a 6" diameter circular encapsulation device designed to accommodate the design pressure as well as mechanical loading. Since welding of the cap will impact the capability of the exterior wrap to preclude outer diameter (OD) corrosion due to contact with ground water, no credit will be taken for the localized external wrap in determining the service life of the repair. The encapsulation cap ID will be such that the inside diameter is greater than the maximum diameter of the defective area plus a minimum of twice the nominal thickness of the pipe.

The applied encapsulation device is a pipe restoration approach equivalent to an unstayed flat head. ASME Section III, Subsection ND Figure ND-3325-1 depicts acceptable configurations for flat heads. The relevant configuration for the encapsulation device is shown in Figure b-2 of Figure ND-3325-1. The dimension of the cap top, skirt, and full penetration weld to the pipe are based upon the metal area replacement Code methodology and considers design pressure, external soil pressure, as well as mechanical loading. The size (outer diameter) of the cap considered the conservative assumption of future metal loss due to both seawater (internal content) and groundwater (external environment) during the period of service.
