# Shield Building Crack Investigation and Root Cause Presentation

**Davis-Besse Nuclear Power Station**

August 9, 2012

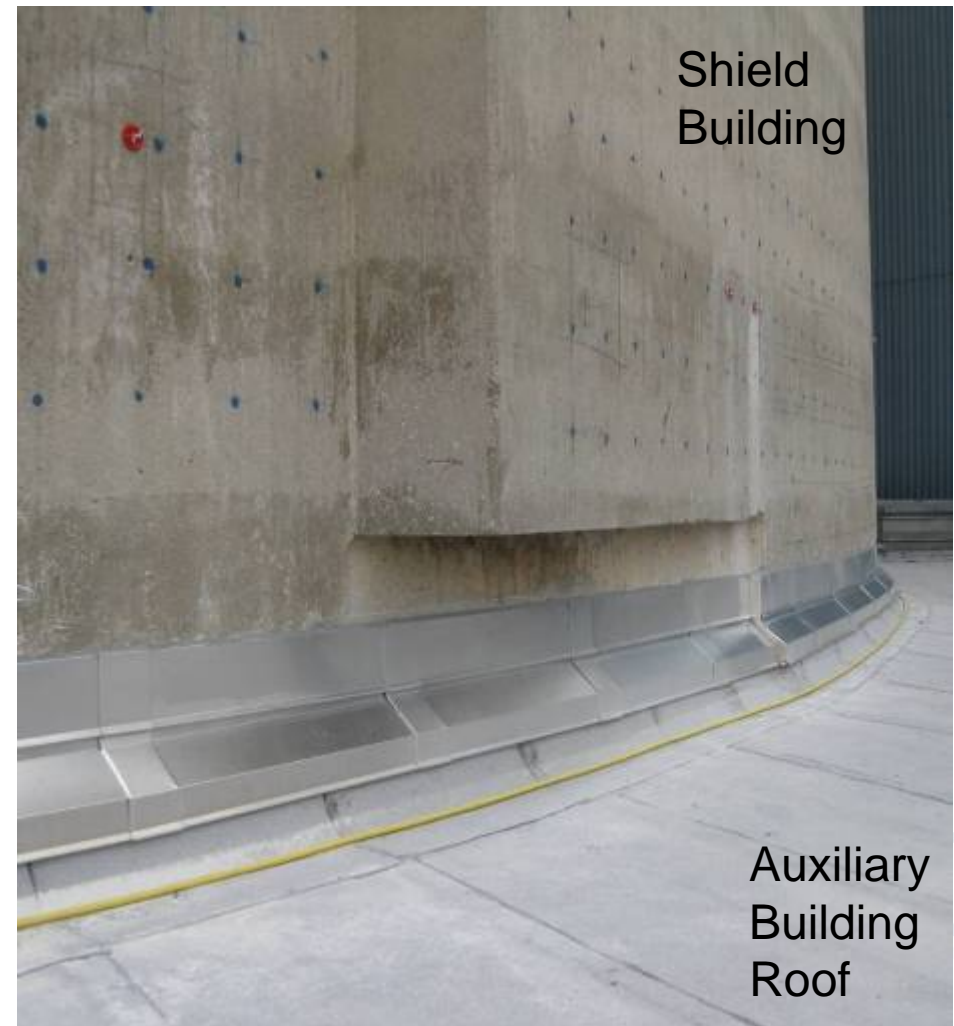
# Discovery

- Cracking found on October 10, 2011, during hydro-demolition
- NRC resident notified
- Condition Report written
- Restraint on restart established
- Team of experts to investigate issue mobilized

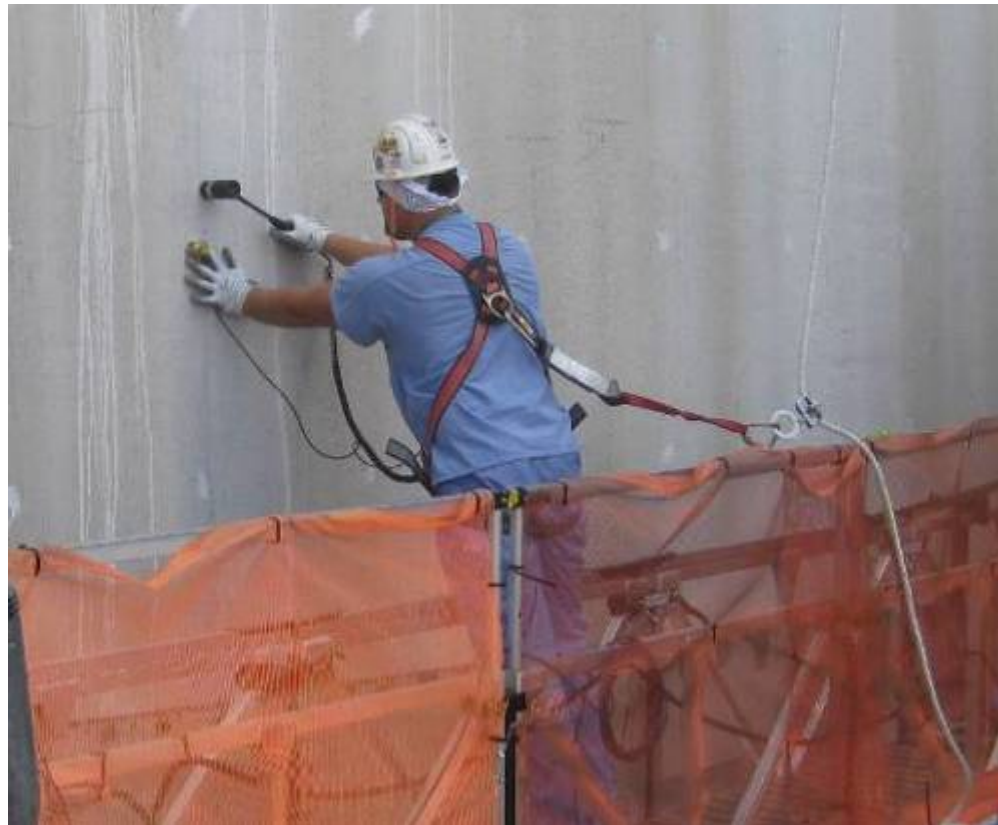
# Investigation

- Impulse Response (IR) testing methodology used to investigate extent of crack

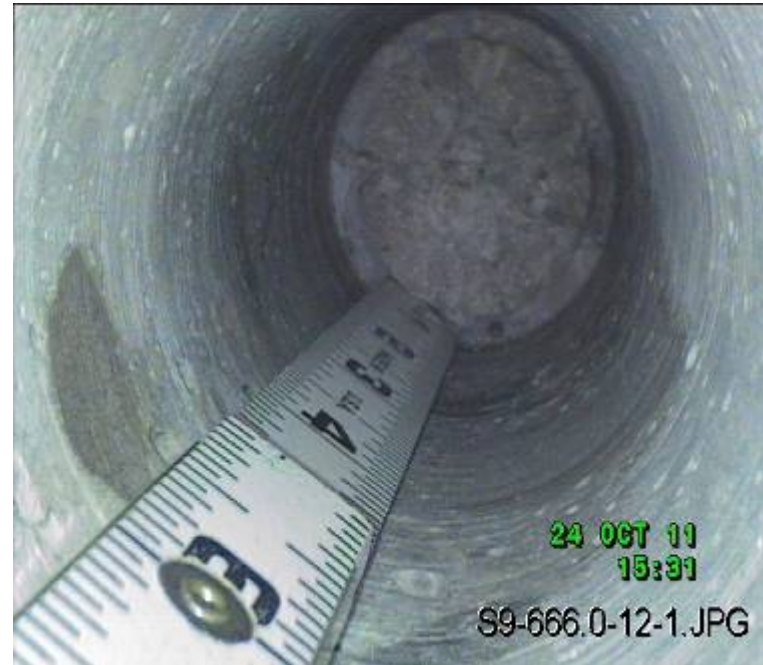
## Investigation, *continued*

- Core bores taken to validate IR testing results, to determine crack depth and to determine crack width
- Investigation results were documented in the corrective action process, and the NRC was promptly notified of findings

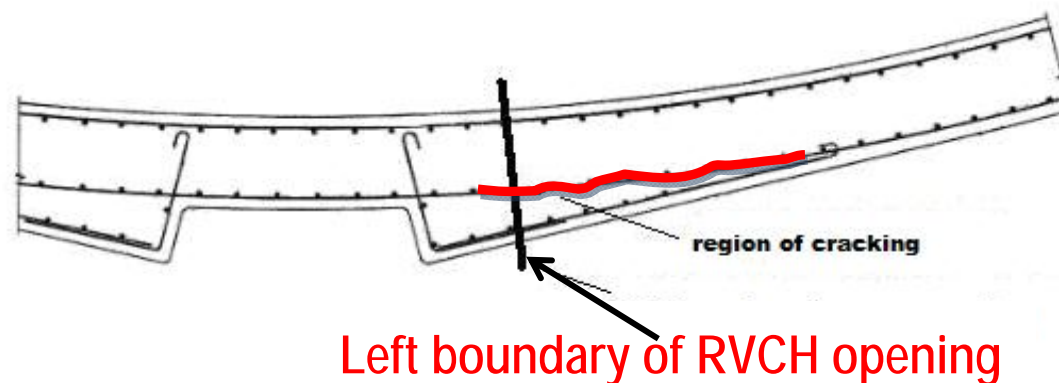
# Summary of Shield Building Condition

- Cracking is generic to flute shoulder regions and can be assumed to be present at any elevation in the flutes shoulders; cracking was observed to be more prevalent on the south side of the building
- Cracks are located near the outer reinforcing mat; no cracking observed in interior reinforcing mat

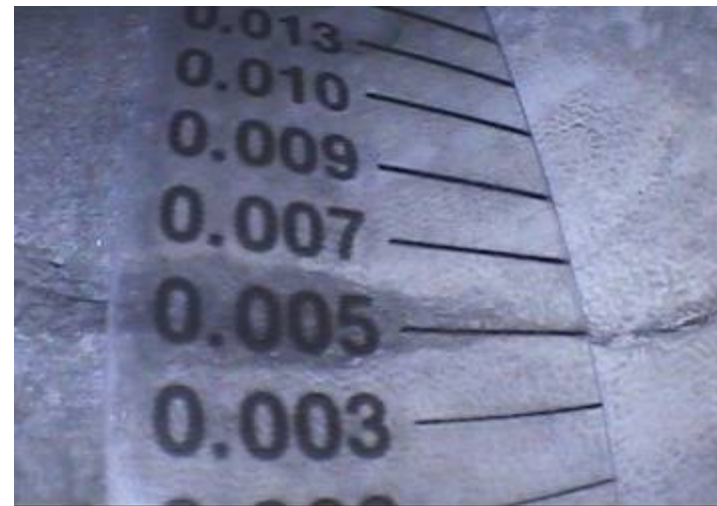
# Summary of Shield Building Condition, *continued*

- Cracking exists at the top 20 feet of the Shield Building wall outside the flute shoulder region
- Two small regions adjacent to the Main Steam Line penetration have similar cracks
  - The extent of these regions is localized and unique to these particular penetrations
- Cracks are very tight

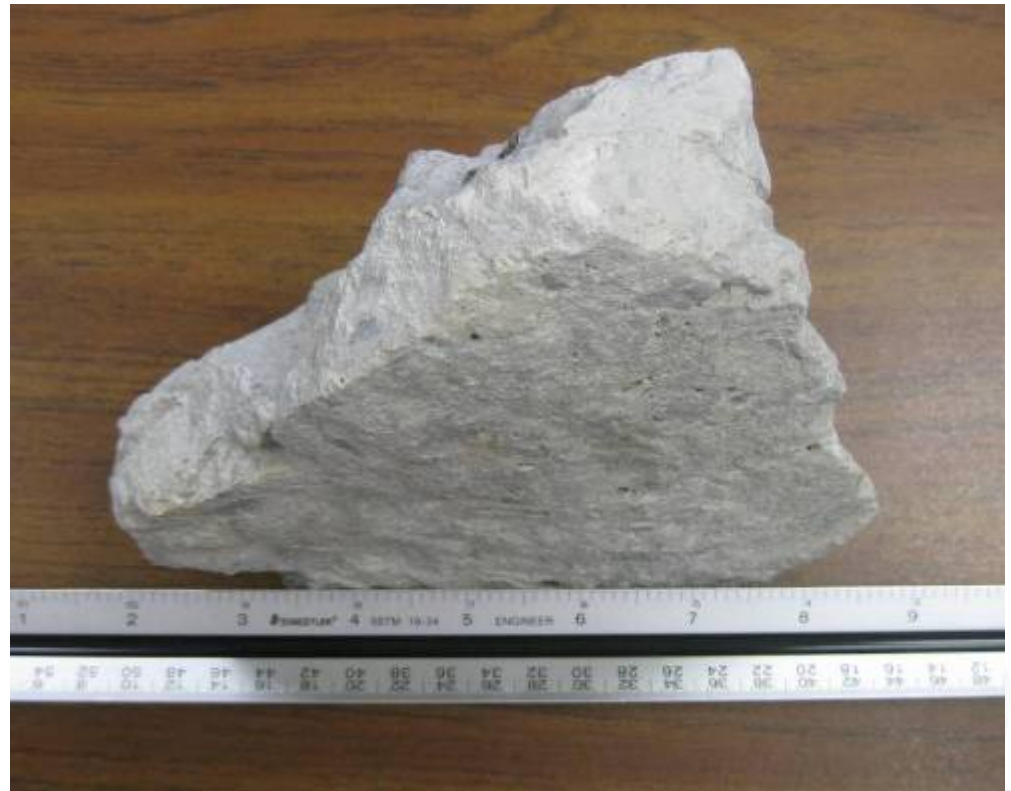
# Shield Building Concrete, *continued*

- Typical concrete sample showing the laminar crack sheared the coarse aggregate
- Therefore, laminar crack occurred after the concrete achieved its strength

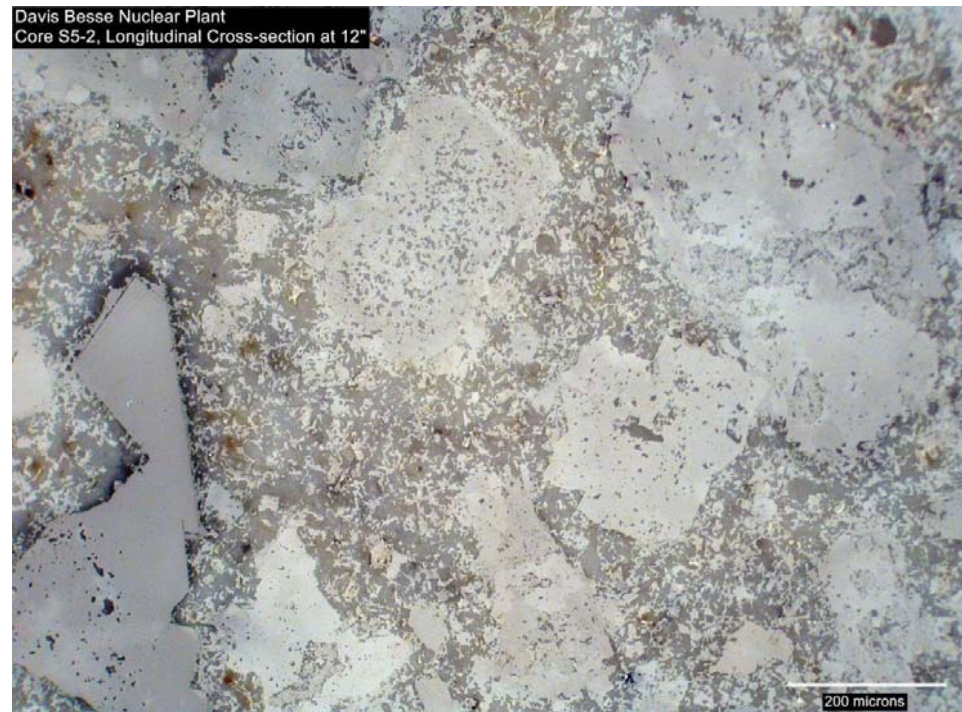
Magnification at 100 Times

# Shield Building Concrete, *continued*

- No evidence of micro cracks
- No signs of cyclic load mechanism
- No cyclic freeze-thaw mechanism
- No indication of fatigue or age related events

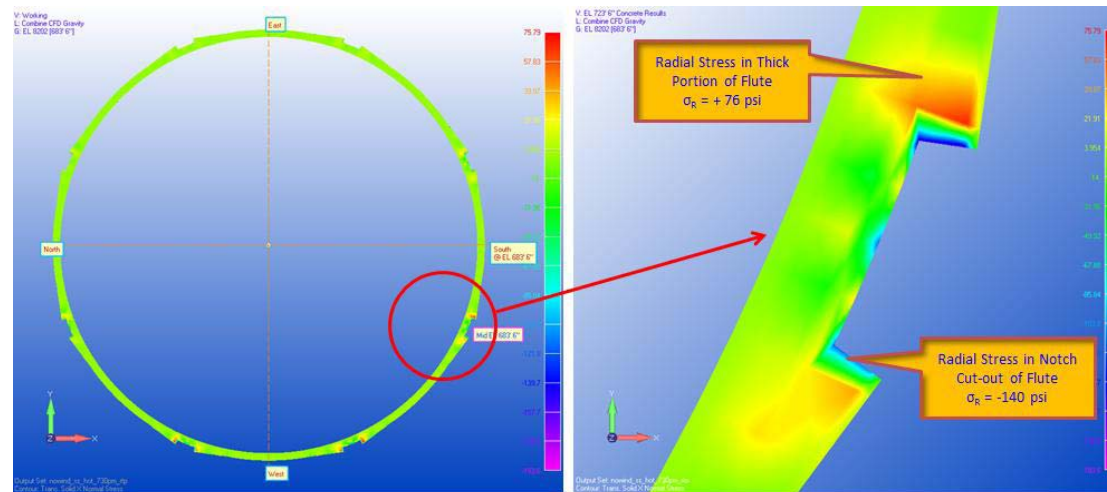
- Numerous computer analyses were performed for normal design conditions
  - Self weight, wind loads
  - Thermal analyses (summer hot and winter cold conditions)
  - Fujita Category 2 tornado
- Stresses were significantly below the normal tensile capacity of the concrete

Overall View @ EL 683' 6"

Close-Up View @ EL 683' 6"

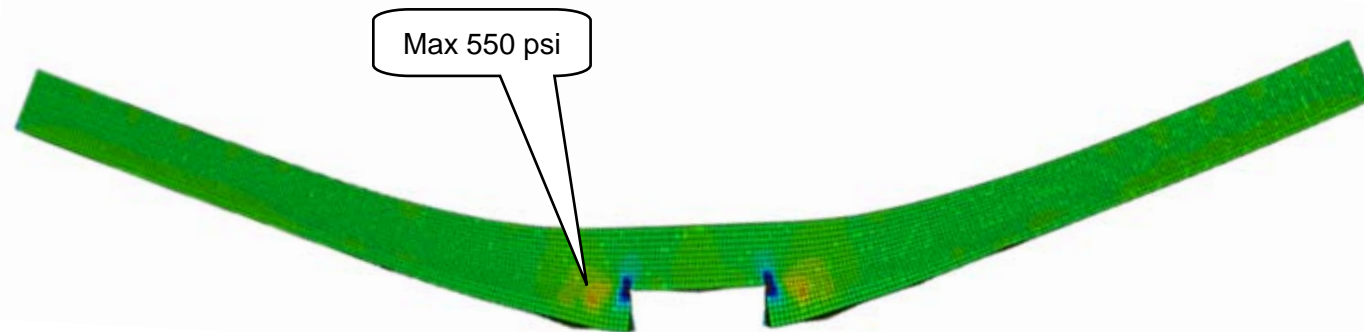
# Moisture Intrusion and Low Temperatures, *continued*

- A complex computer model of the Shield Building was developed
- Concrete properties from the concrete core tests were used
- Laboratory tests showed moisture infiltration up to four inches
- Maximum radial stress in the shoulder area were approximately the tensile capacity of the concrete
- High stresses were located in areas of observed cracking

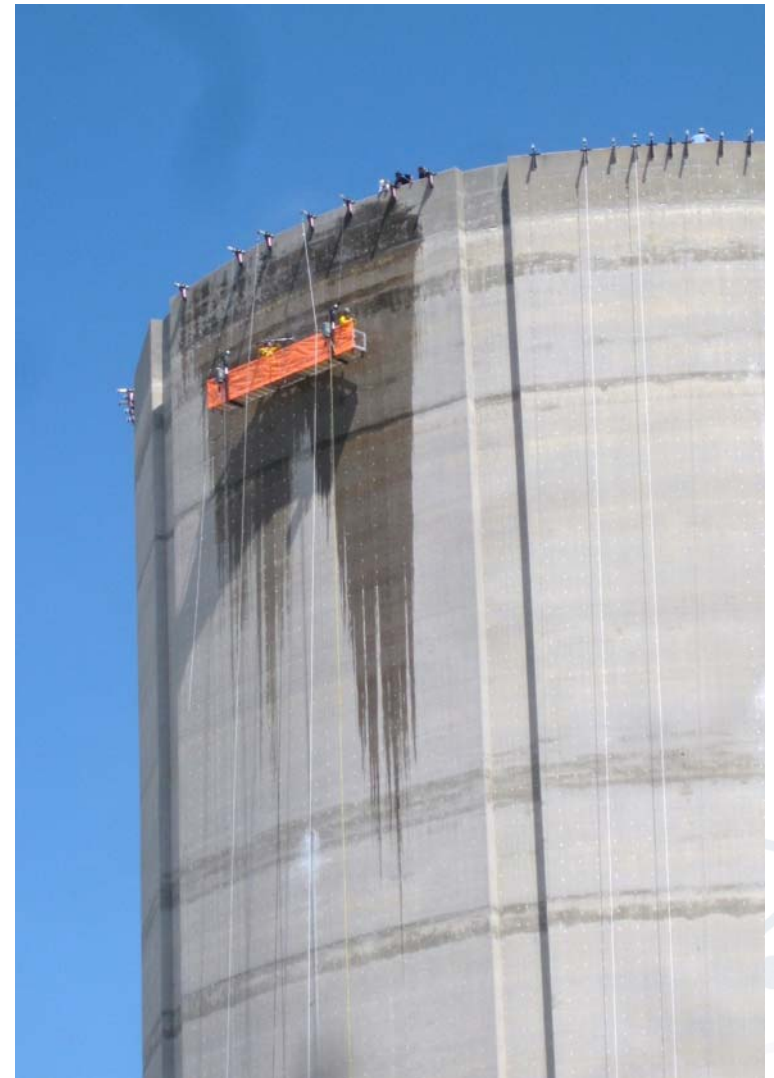
# Shield Building – Preventative Action

- **Root Cause**
  - Lack of concrete sealant
- **Preventative Action to Prevent Recurrence**
  - The exposed exterior surfaces of the Shield Building will be sealed
  - Contractor has started and is expected to be completed by the end of September of this year

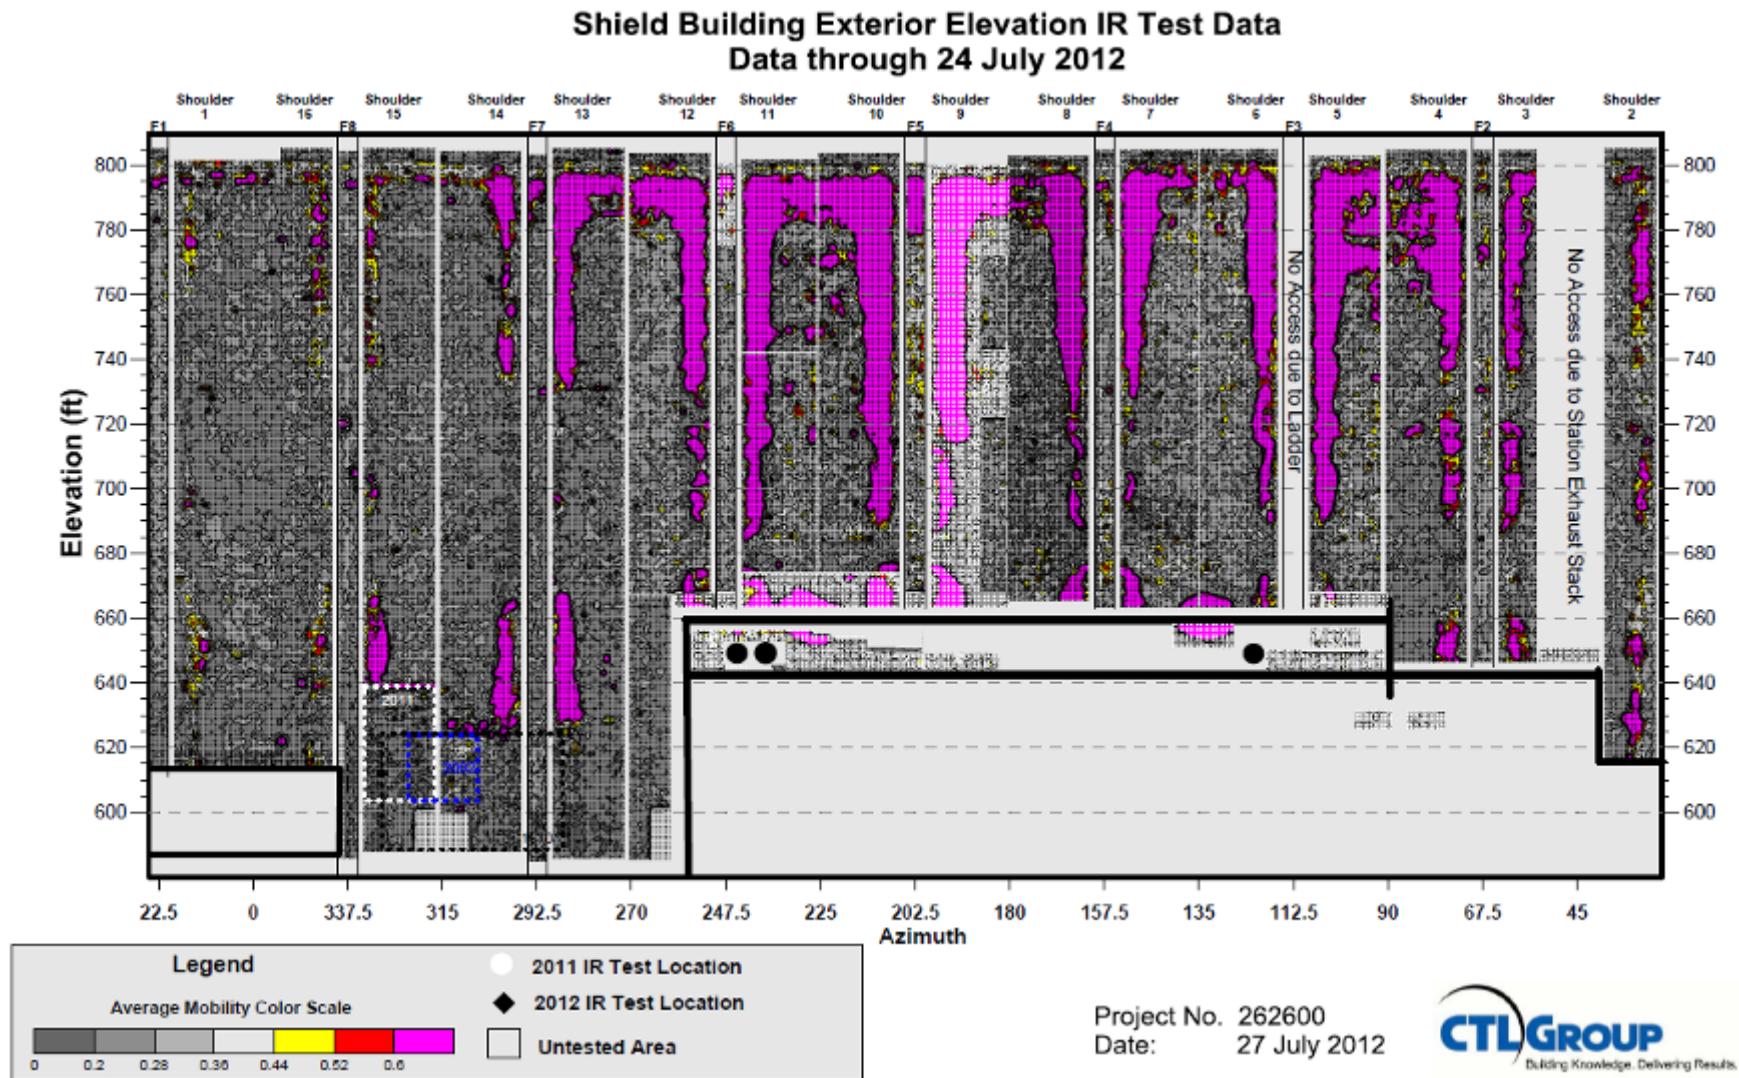
## Additional Actions - IR Mapping, *continued*

- **The IR validated our original assessment that the laminar cracks are generally confined to:**
  - The shoulder areas
  - Top of the Shield Building
  - Near one corner of the Main Steam Line penetration
- **Impulse Response reading on an independent structure validated that laminar cracks are not present**
