**Subject: June 2012 Inspection Report
Cameco Resources, Permits 603 & 633**

JUNE 2012 INSPECTION REPORT

PERMITS 603 & 633

COMPANY:	Cameco Resources
LOCATION:	North of Glenrock, Converse County (Smith-Highland Ranch Uranium Project)
DATE OF INSPECTION:	June 14, 2012
DATE OF REPORT :	July 12, 2012
INSPECTORS:	Pam Rothwell, Permit Coordinator
CO. STAFF PRESENT:	Ken Garoutte, Cameco SHEQ Manager Dave Moody, Cameco, Wellfield Operations Manager Craig Hiser, Wellfield Development Supervisor

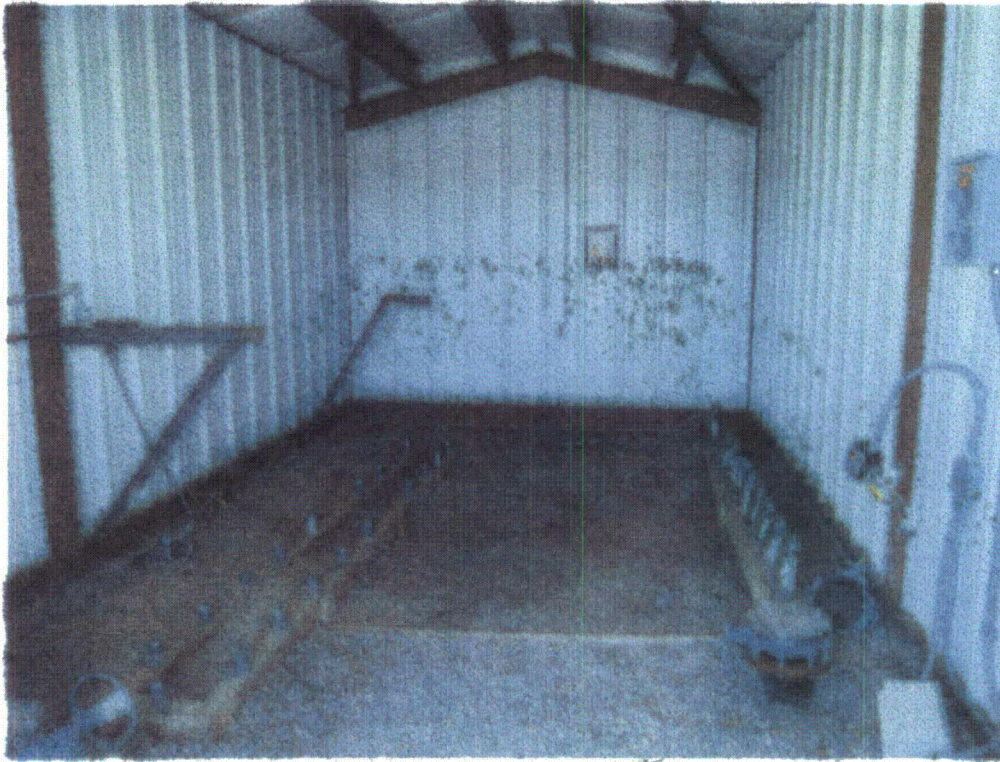
Figure 1 View of a stripped out header house in MU-5

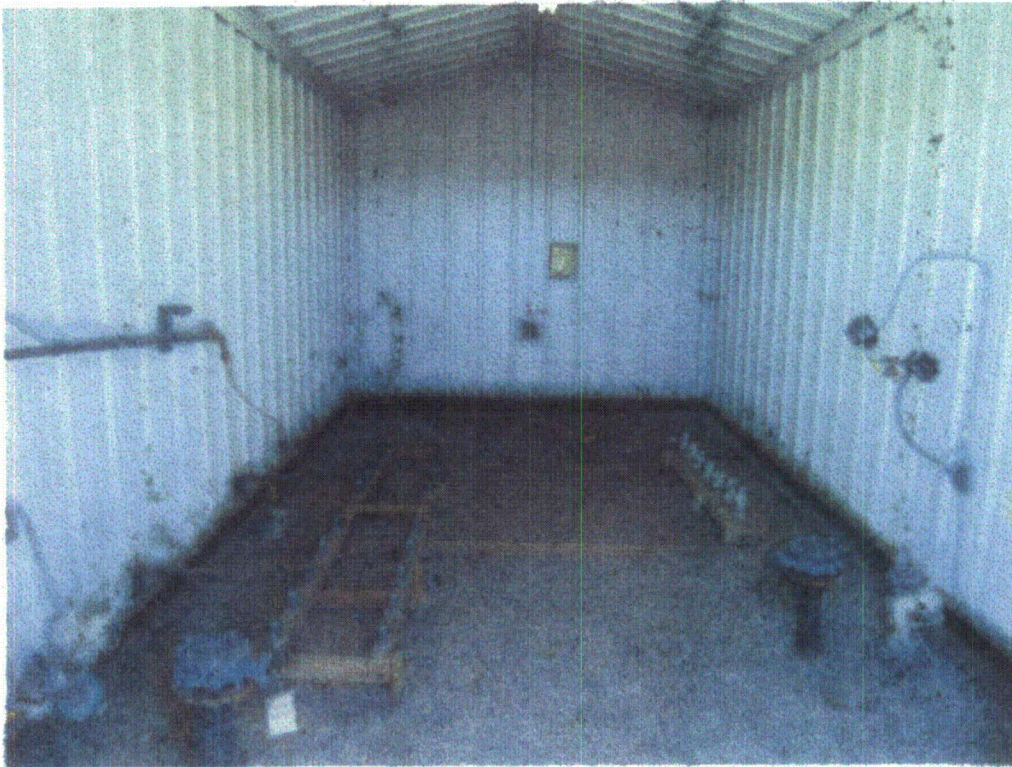
- 2 There are numerous header houses in Wellfield F that indicate a bleed is not being maintained to control the fluids of the mining zone in many pattern areas. This is indicated where the header houses are stripped of pipes and connections to the wellfields. The Noncoal Rules and Regulations (R&R), Chapter 11, Section 11(d) states, *"No operator shall construct, operate, maintain, convert, plug, abandon, or conduct any other injection or mining-related activity in a manner that allows the movement of fluid containing any contaminant into zones or intervals other than those authorized in the approved permit..."* A review of the excursion history in the wellfield indicates two confirmed excursions; one in 2002 and one in 2009. If these excursions were the result

Figure 2 View of a stripped out header house in MU-F

The lack of operational and maintained facilities through the life of the wellfield is considered a violation of these citations. CR should provide a detailed plan for all pattern areas and header houses within Wellfield F. This plan must be submitted within 90 days of receipt of this report. The annual reports have not provided sufficient detail to evaluate the status of patterns or header houses in operation. Upon receipt of the report, LQD will evaluate the operational status of all of the header houses for compliance with the regulatory requirements.

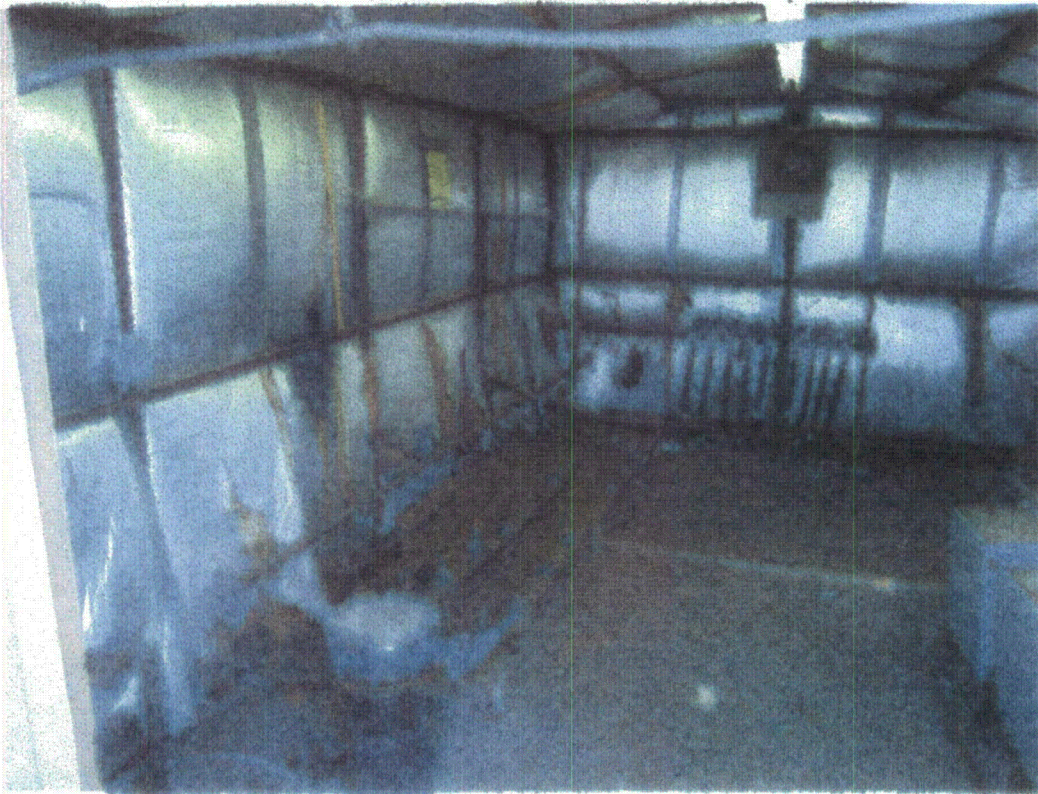
Figure 3 View of a stripped out header house in MU-F

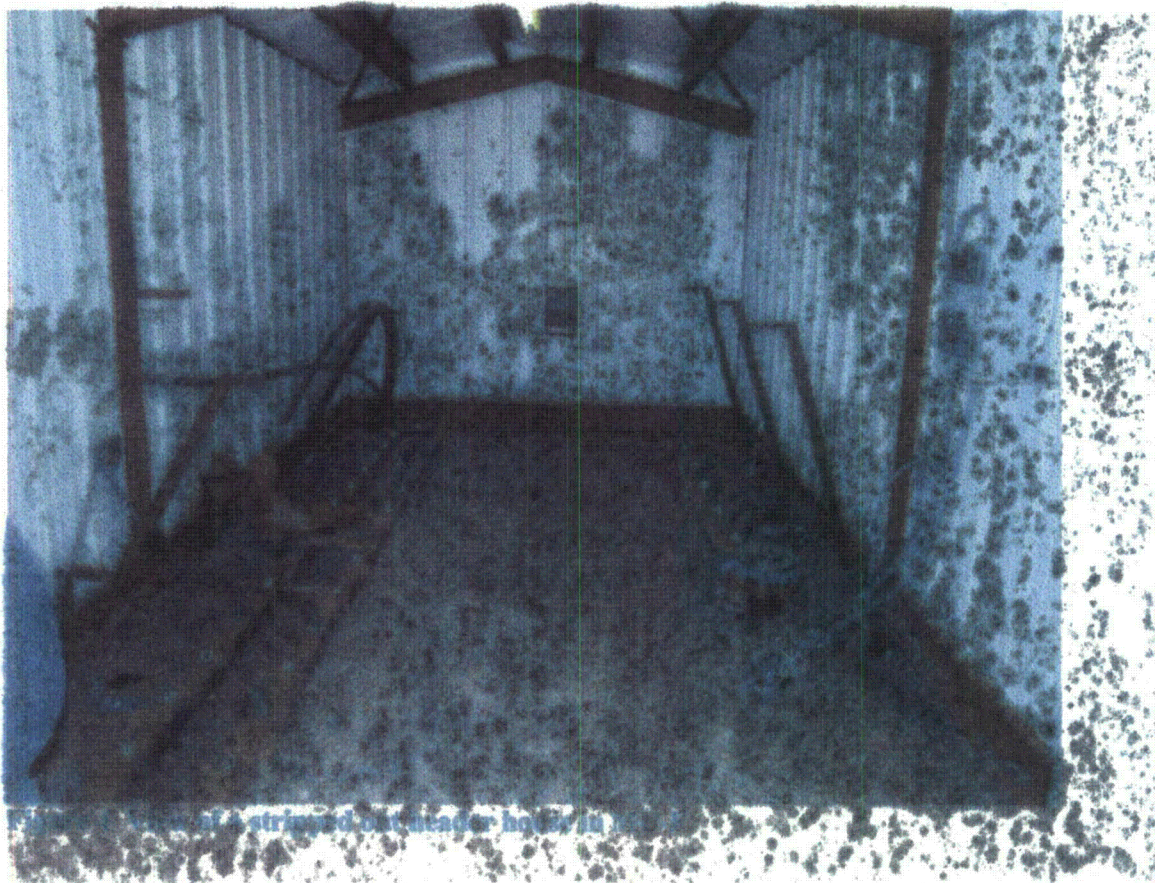
Figure 1: View of a stripped out header house in 1998

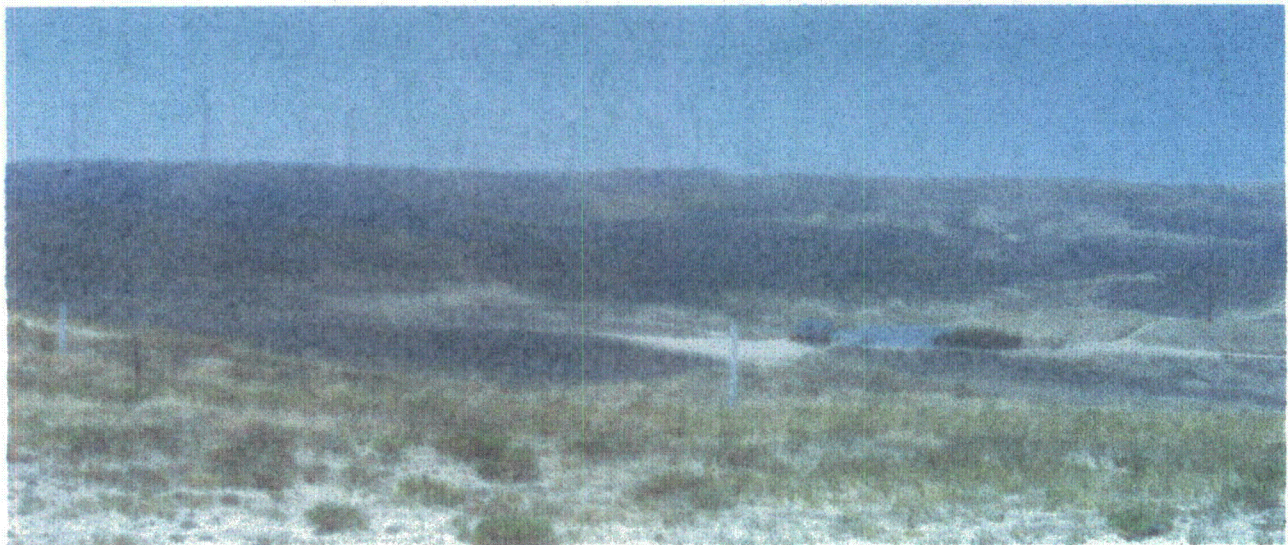
During observation of the water supply pond (Figure 7) it was discovered that there were additional wells installed to supply the pond. Those wells were approved by the State Engineer's Office and are permitted by the landowner (Figure 8).

- 4 A Notice of Violation, Docket No. 4988-12 was issued for disturbance outside the permit boundary and for unpermitted (LQD) use of water in the mining operations (water supply pond and wells). The violation was identified during the May 2012 inspection. Further inspection of the area was conducted to determine whether any of the wellfield unit injection or production wells were located outside the permit boundary. CR agreed to submit a professional survey of the boundary and wells near the boundary on a map. LQD also discovered additional wells were installed to supply the water supply pond. The map was provided to LQD on June 26, 2012. Cameco's practice has been to rely on the landowner for the appropriate permits for the water supplies used in the operation. The source, quality and quantity requirements of the Wyoming Environmental Quality Act have not been addressed in the permit. The additional wells found during the inspection, although not identified in the Notice of Violation will be addressed in the Settlement Agreement.

Figure 6 View of the water track at the supply pond outside the permit boundary

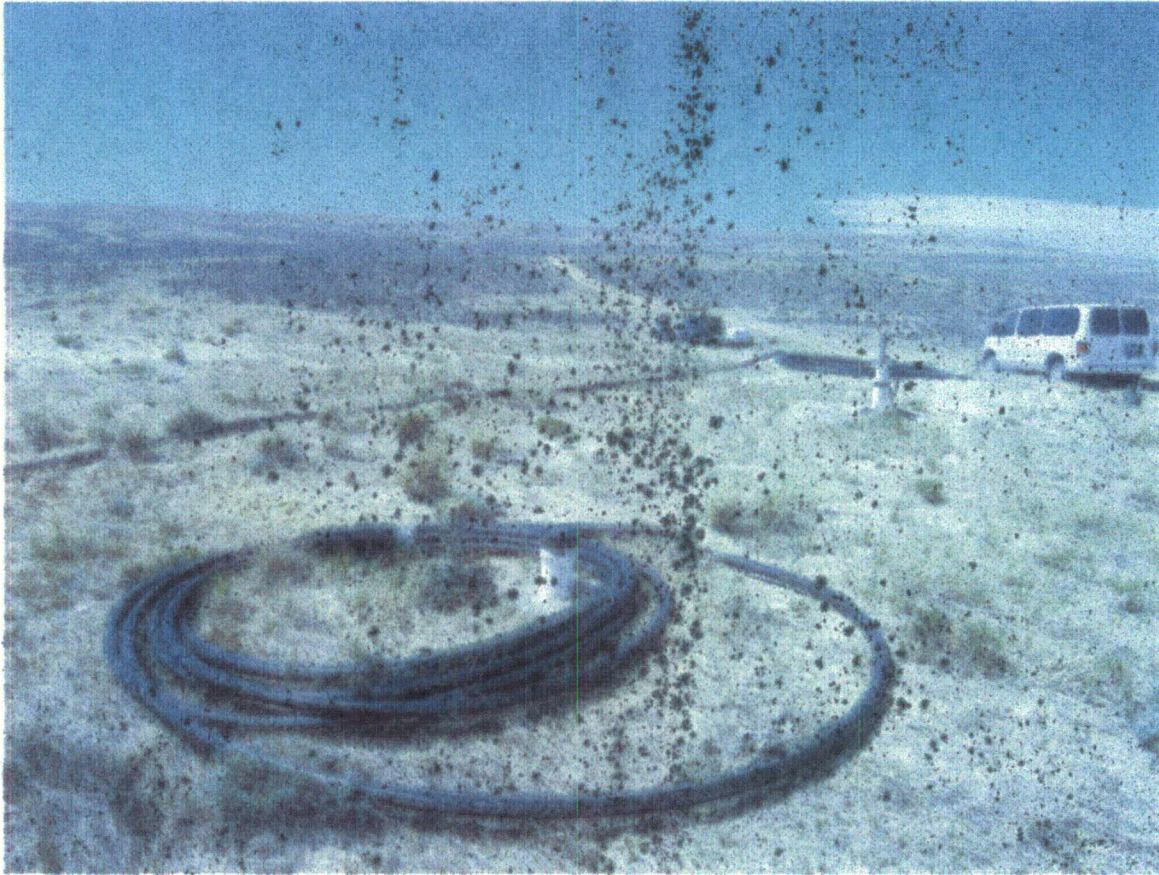
Figure 7 View of water supply wells and hose near the water supply pond
