**UNITED STATES OF AMERICA
NUCLEAR REGULATORY COMMISSION**

**INTERVENORS' FIFTH MOTION TO AMEND AND/OR SUPPLEMENT PROPOSED
CONTENTION NO. 5 (SHIELD BUILDING CRACKING)**

CONTAINMENT DELAMINATION: DAVIS-BESSE & CRYSTAL RIVER

SHIELD BUILDING / CONTAINMENT DELAMINATION: DAVIS-BESSE & CRYSTAL RIVER

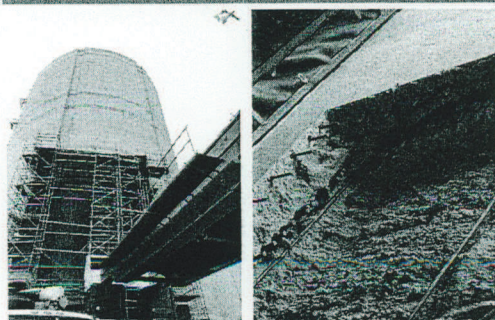
Construction Opening

- Laminar crack identified in architectural flute shoulder area during hydro-demolition for replacement of reactor vessel closure head (October 10th)
- Crack found on the vertical side of the opening (left side, looking from the outside), generally along main reinforcing steel, and extends ~6' across the top and ~4' across the bottom

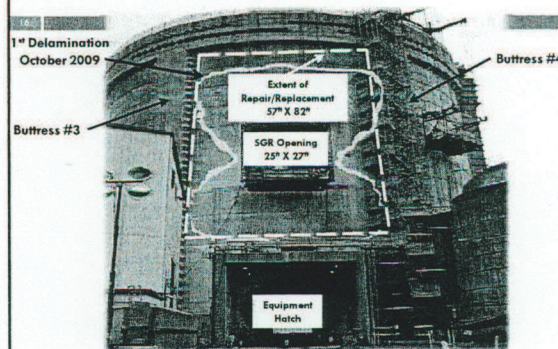
CR-3 Update: Original Delamination

- ❑ **Dec. 2008:** License Renewal Application (LRA) submitted.
- ❑ **Oct. 2009:** Delamination of containment concrete in Bay 3-4.
- ❑ **Nov. 2009:** Applicant starts repair of concrete in Bay 3-4.
- ❑ **Dec. 2010:** SER issued with open item for containment repair.
- ❑ **Jan. 2011:** ACRS Subcommittee meeting.
 - * Committee requested additional meeting after closeout of open item for containment repair.
- ❑ **Mar. 2011:** New delamination identified in containment Bay 5-6.
- ❑ **Jun. 2011:** NRC informs the applicant that a revised schedule for LRA review will be established after information on the containment repair plan is submitted.
- ❑ **Jul. 2011:** Spalling identified in Bay 1-2.
 - * Concrete sections (approx. 1.5" X 12' X 3' & 5') fell on Intermediate Building

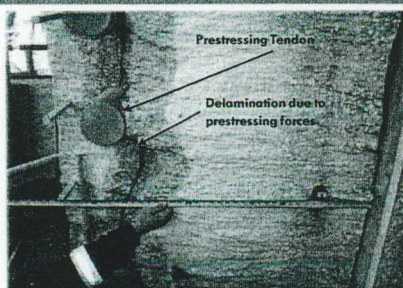
CR-3 Update: Original Delamination

Delamination between buttress 3 & 4
