**UNITED STATES OF AMERICA  
NUCLEAR REGULATORY COMMISSION**

**INTERVENORS' FIFTH MOTION TO AMEND AND/OR SUPPLEMENT PROPOSED  
CONTENTION NO. 5 (SHIELD BUILDING CRACKING)**

*APPENDIX VIII: NRC FOIA RESPONSES (B-49  
THROUGH B-50)*

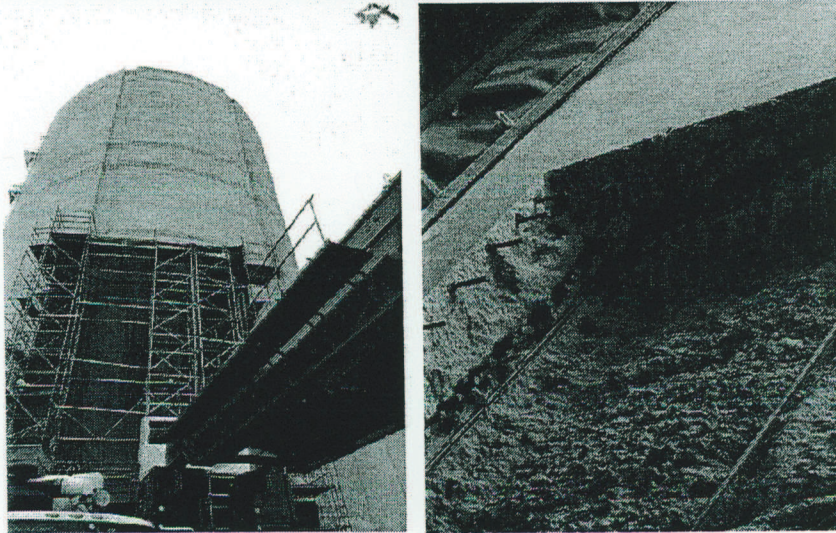
## Construction Opening

- "Chipping back" along cracked areas revealed crack extended beyond construction opening
- Impulse Response (IR) methodology employed to investigate extent of crack
- IR testing indicated crack extended ~38' above construction opening
- (4) core bores taken to validate IR results
  - ▣ Indicated crack existed near outer reinforcement mat

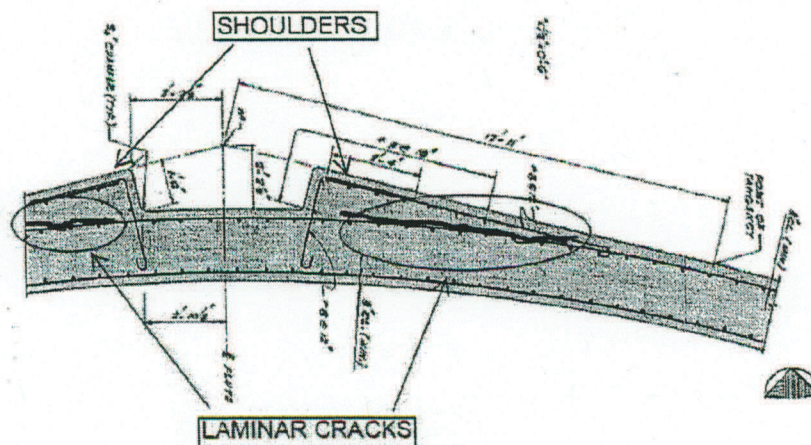
## Flute/Shoulder Geometry

- IR testing performed on 15 of 16 flute shoulders
  - ▣ Based on results, licensee assumed cracking throughout all shoulders
- Core bores taken on 12 shoulders to confirm crack boundaries
- Core bores inspected using boroscope to identify crack depths and widths
  - ▣ Very tight, less than 0.01"

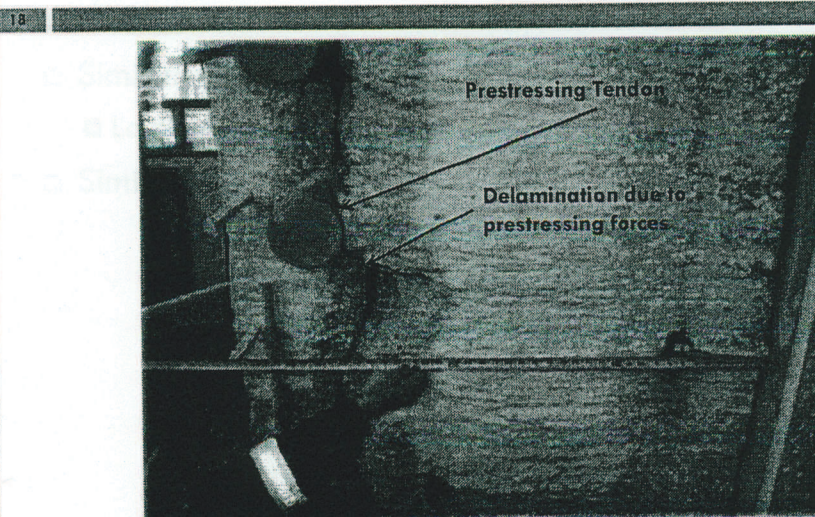
Delamination between buttress 3 & 4
