UNITED STATES  
NUCLEAR REGULATORY COMMISSION  
OFFICE OF NUCLEAR REACTOR REGULATION  
WASHINGTON, D.C. 20555

April 7, 2005

NRC INFORMATION NOTICE 2005-09:     INDICATIONS IN THERMALLY TREATED ALLOY  
600 STEAM GENERATOR TUBES AND TUBE-  
TO-TUBESHEET WELDS

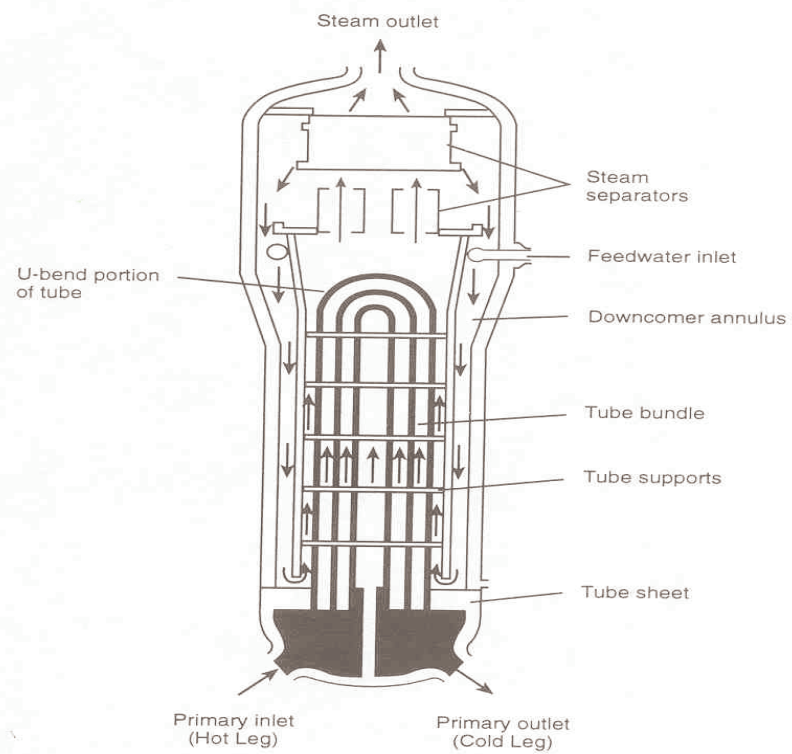
Figure 1

Catawba Nuclear Station, Unit 2, has four Westinghouse Model D5 recirculating steam generators. Each steam generator has approximately 4,600 tubes fabricated from thermally treated Alloy 600 (Figure 1). During fabrication of the steam generators, a portion of the U-shaped tubes are inserted into a thick plate called a tubesheet. The tubesheet is approximately 21 inches thick and has two holes for each tube (one hole on the hot-leg side of the steam generator and one hole on the cold-leg side). The lower end of the tubes were tack-expanded into the tubesheet for approximately 0.70 inch (Figure 2). This tack expansion is performed to facilitate welding of the tube to the primary side of the tubesheet. In the case of Catawba Unit 2, this region is frequently referred to as the tack roll region since the tack expansion was accomplished by mechanically rolling the tube into the tubesheet. The tack expansion forms a temporary expansion transition (i.e., a roll transition in the case of Catawba). Following welding, the tubes were hydraulically expanded for the full depth of the tubesheet. The transition from the expanded portion of tube within the tubesheet to the unexpanded portion of the tube at the top of the tubesheet is referred to as the expansion transition region of the tube.

PWR Recirculating Steam Generator

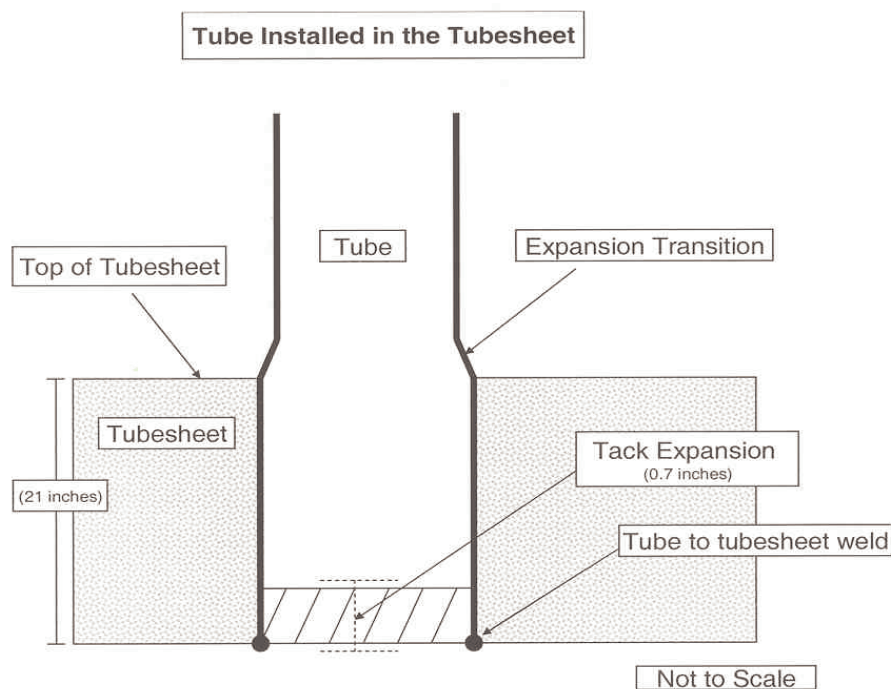
Figure 2

During these additional rotating probe examinations, no additional indications were found in the overexpanded (bulged) regions; however, several indications were found at the tube ends (tube-to-tubesheet weld) and one indication was found in the tack expansion region. At the tube ends, the licensee identified approximately 12 indications in steam generators A, B, and D. These indications were in the tube-to-tubesheet weld and were not visible during visual inspections of the weld. The indication in the tack expansion (the region of the tube expanded into the tubesheet to facilitate welding) was approximately 0.70 inch above the tube-to-tubesheet weld and was circumferentially oriented. It was estimated to be 330 degrees in circumferential extent and 100 percent through-wall.

In steam generator B, 9 tubes were found to have indications in the tack roll region. These indications were circumferentially oriented and consisted of either single or multiple cracks. No indications were found in the tack roll region in steam generators A, C, or D. In the tube-to-tubesheet weld region, 188 tubes in steam generator B, 1 tube in steam generator A, and 7 tubes in steam generator D contained indications in the tube-to-tubesheet weld. No indications were found in the tube-to-tubesheet weld region in steam generator C. Six tubes in steam generator B were identified with tube end (i.e., tube-to-tubesheet weld) indications that extended into the tube material. The indications in these tubes were axially and circumferentially oriented and consisted of either single or multiple cracks.

The licensee plugged the tube with the circumferential indications in the overexpanded region and the tubes with indications in the tack roll region. In addition, the licensee plugged the six tubes with indications in the weld region that extended into the tube material.
