Consolidated Edison Company of New York, Inc.
Indian Point 2 Station
Broadway & Bleakley Avenue
Buchanan, New York 10511

Re: Indian Point Unit No. 2
Docket No. 50-247

Subject : Root Cause Evaluation For Steam Generator Tube Rupture Event of February 15, 2000

Root Cause Evaluation For Steam Generator Tube Rupture Event of February 15, 2000

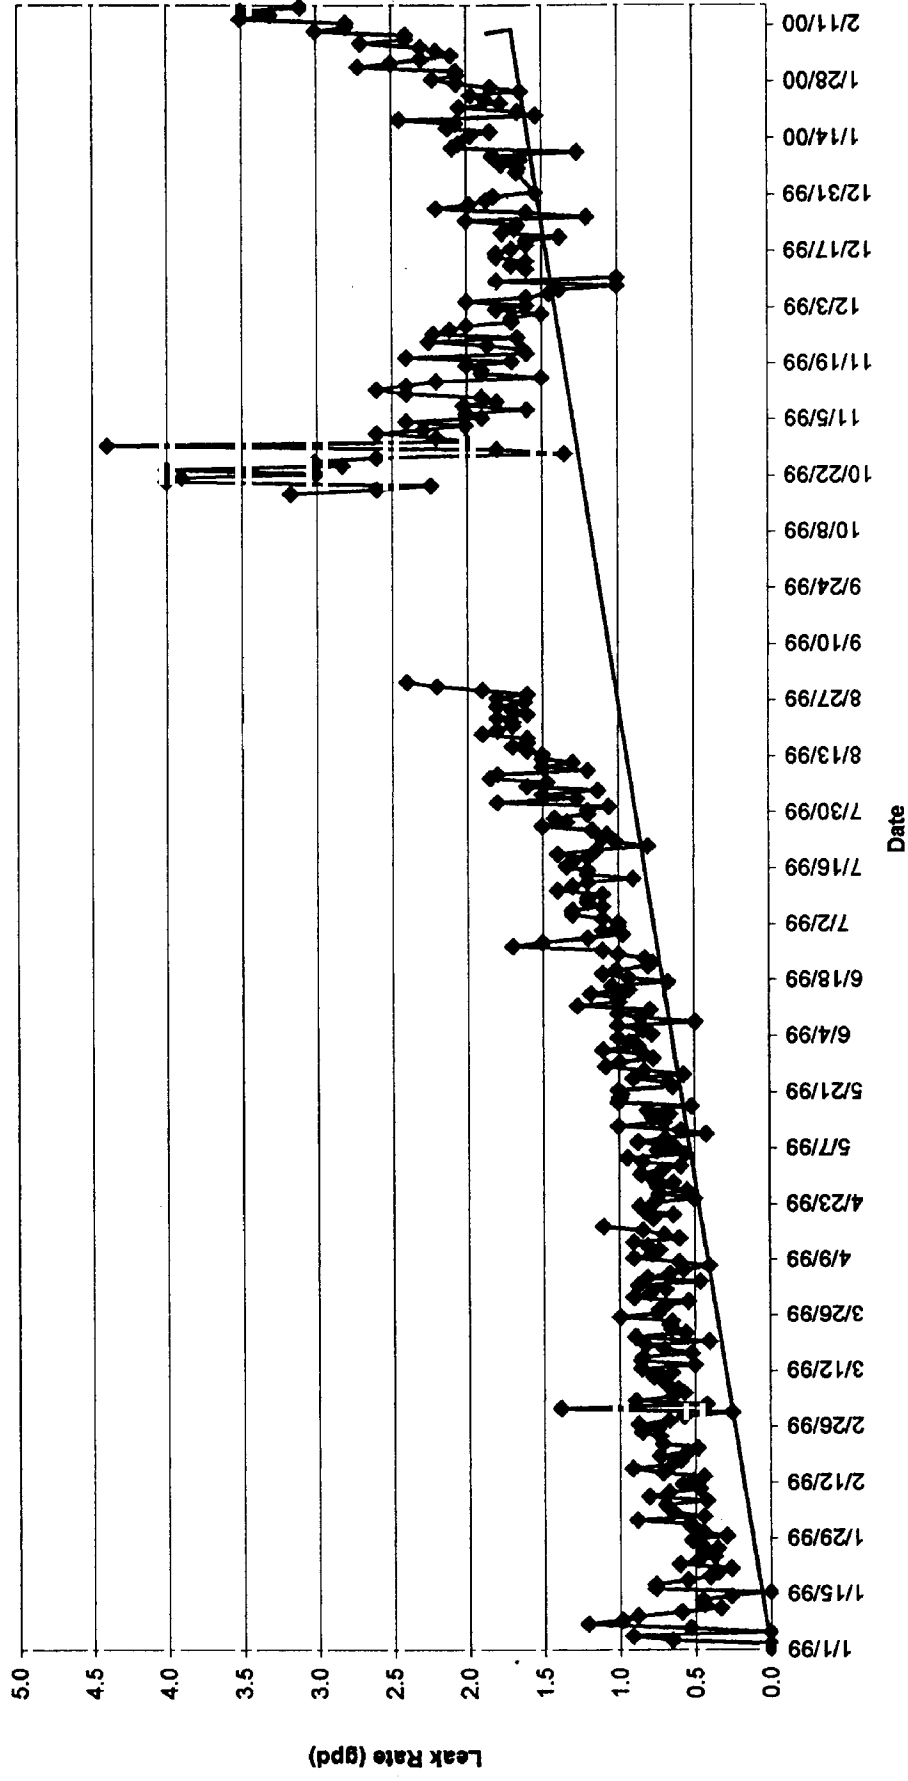
Figure 2 Indian Point 2 Leak Rate History

Although the N-16 monitor alarm signaled the leak, the recorder was out of operation at the time of the alarm. Consequently, the short-term leak rate data just prior to the shutdown are not available. However, the longer-term leak rate over a period of a year (1999) is available and shown in Figure 2. The trend of the long-term leak rate, although not conclusively verifying the postulated mechanism of coalescence of cracks, is consistent with that hypothesis. The low leakage indicated on Figure 2 may have been due to R2C5 or may have resulted from other sources in the SG, such as tube plugs.

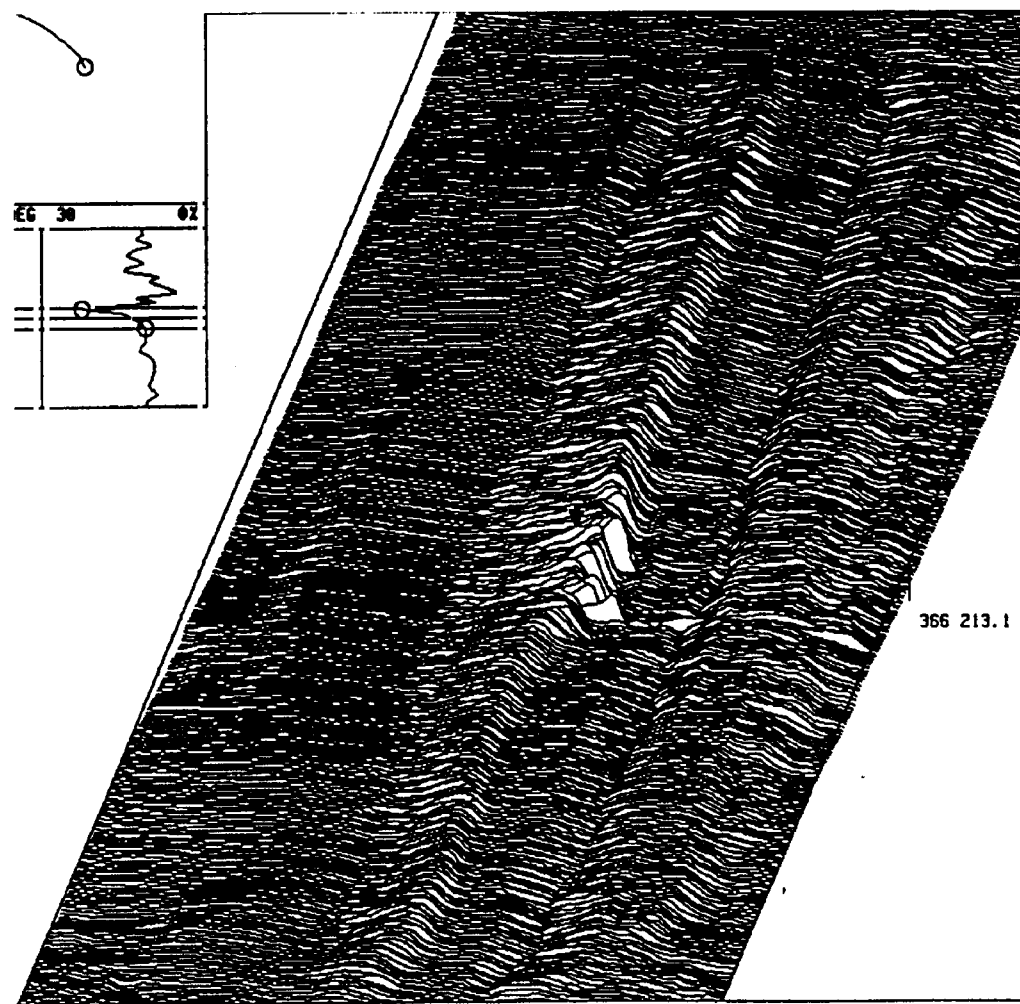
Figure 3
C-Scan of R2C5; 1997 Data

of the signal, proved to be an indication of a flaw that developed into the leak. However, background noise was apparent on the Plus Point C-scan plot due to tube geometry and the presence of deposits (Figure 3). The irregularities (offsets) in the ridges shown on Figure 3 can occur as a result of the probe rattling in the tube. The noise levels seen in Figure 3 would not typically permit the signal to be identified as an indication. This conclusion was consistent with that reached in the 1997 interpretation of the data.

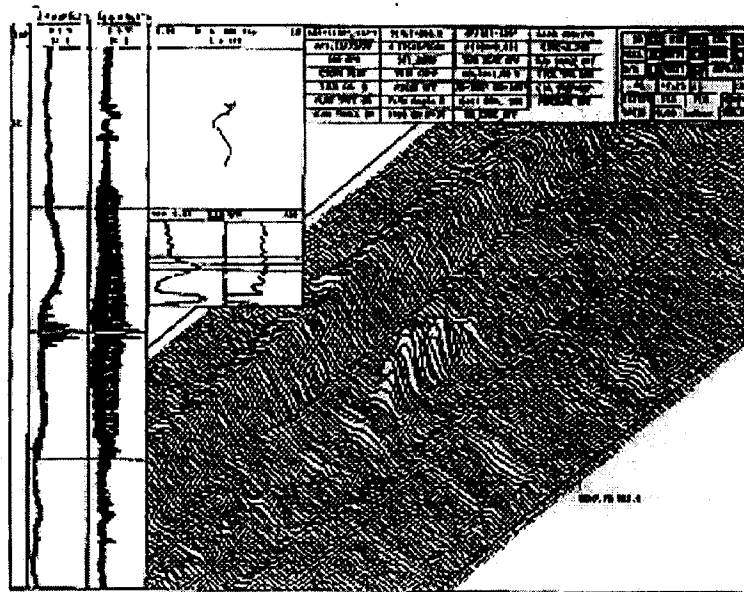
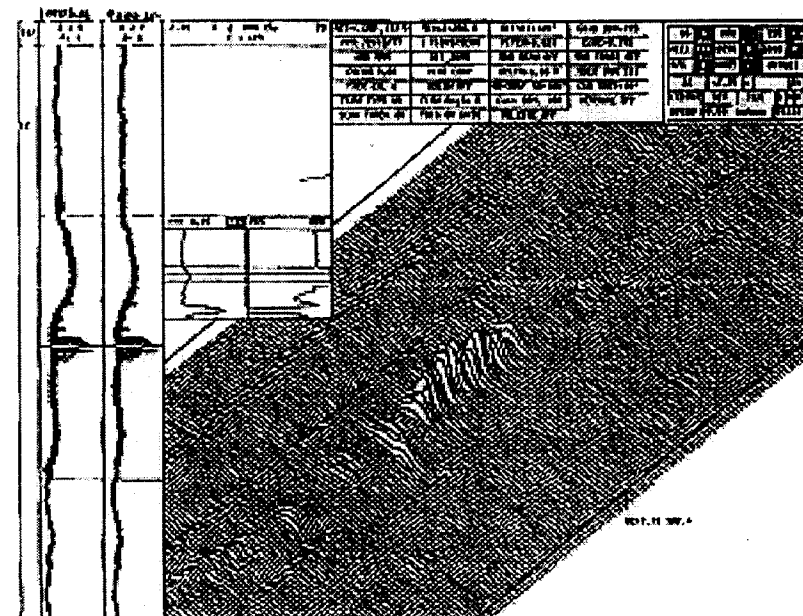
Figure 4
Comparison of Signal and Noise for Mid-Range and High Frequency Plus Point Probe

Mid-Range +Point
R2C69
2000 Data

High Frequency +Point
R2C69
2000 Data

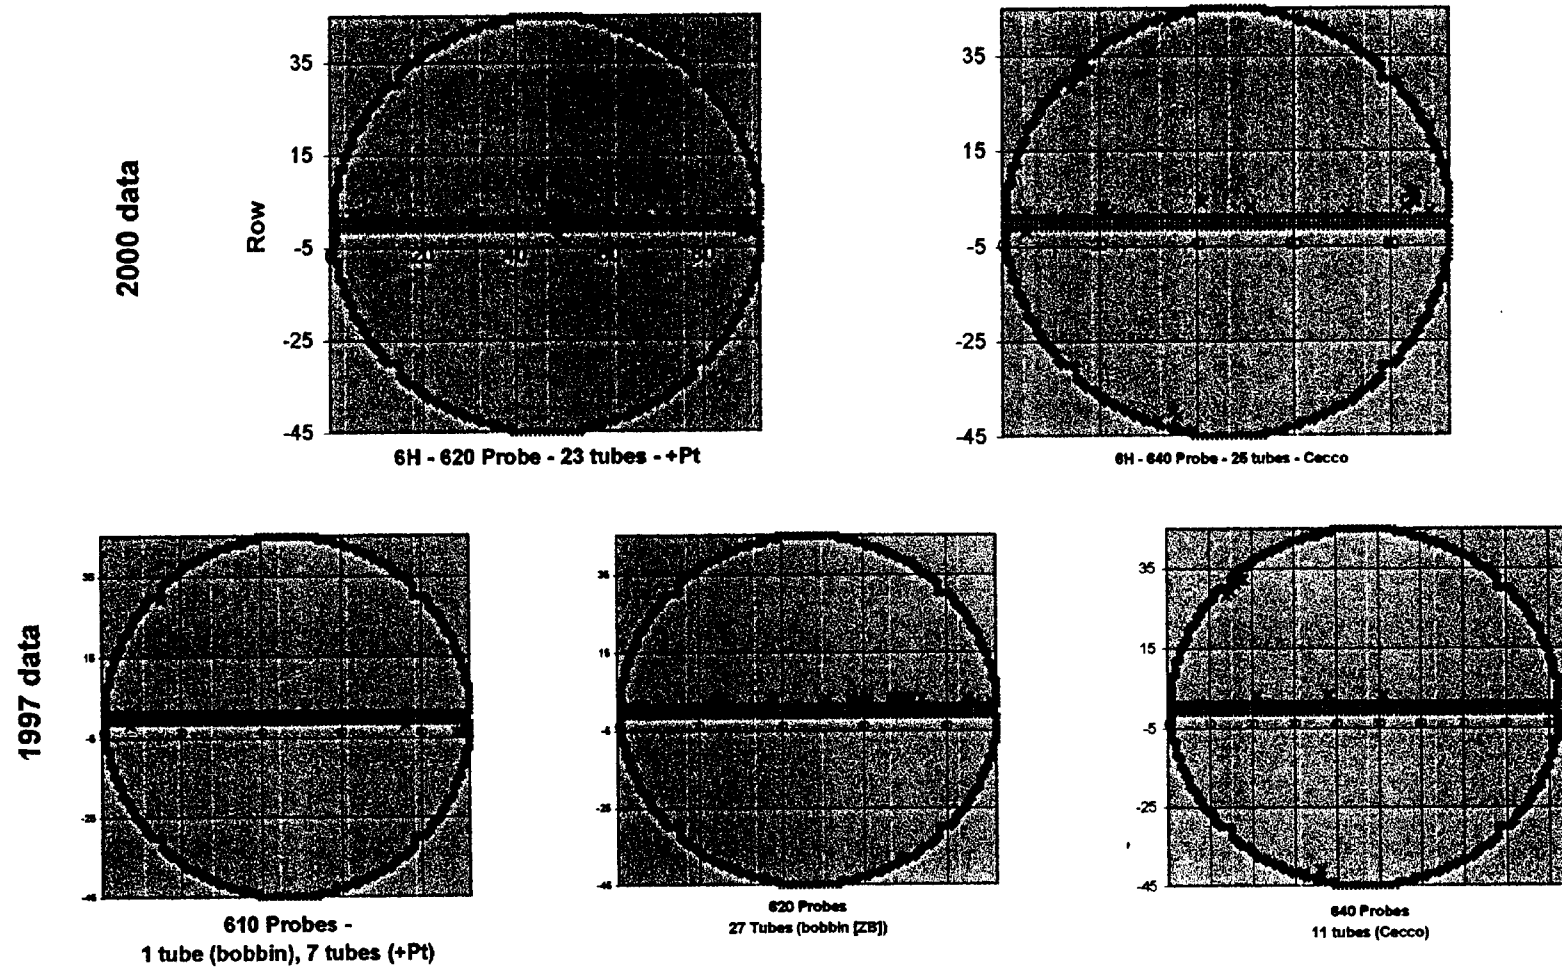
Figure 5
SG 24, TSP6 Probe Restrictions; 1997 Data Compared to 2000 Data

These observations are consistent with a general conclusion that the denting process is continuing at a slow rate. The rate of denting progression cannot be quantified from the increased number of restrictions since there is no available correlation between restrictions and denting. Also, variations between inspections on probe restrictions can occur due to differences in probe types, probe pushers and tolerances on probe length and diameter. However, the restriction study leads to the qualitative conclusion that, if additional restrictions are observed for the same probe type, it is reasonable to conclude that denting is continuing.

Indian Point 2 S/G 24 Composite Restriction Map

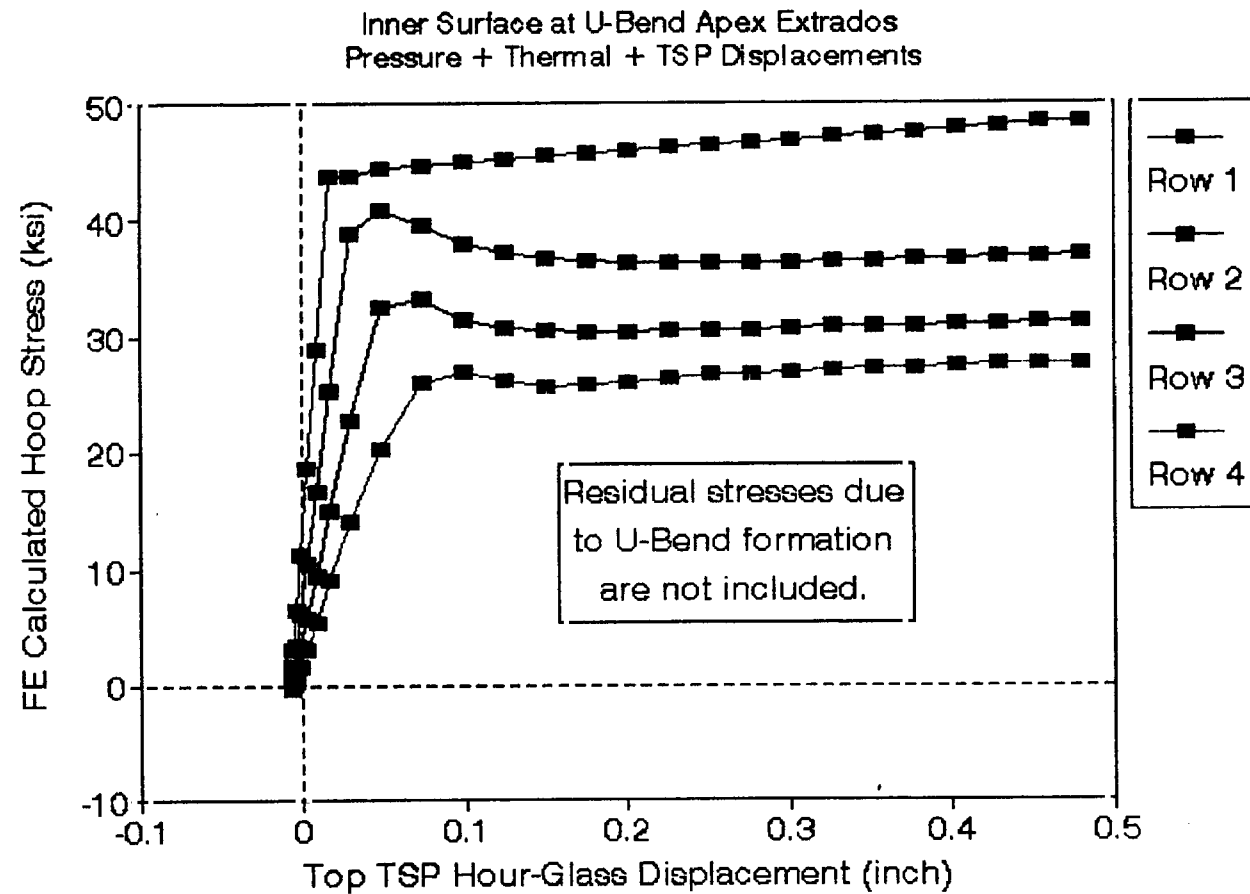
Figure 6

Stress analysis of the low row u-bends, R2, R3 and R4, was initiated with the objective to evaluate the sensitivity of the tube stresses to pinching of the straight legs resulting from hourglassing of the TSP flowslots. An analysis was performed, as described below, that assumed no residual stresses resulting from the bending process. A second analysis, to be included as part of the Condition Monitoring and Operational Assessment Report, seeks to establish the residual stress condition due to bending and ovalization on the tubes prior to imposing various leg spacing boundary conditions. The objective of the analyses is to evaluate if the predicted stresses are consistent with the observed cracking, i.e., PWSCC, and its location at the apex of the U-bend. Further, it is the objective of these analyses to estimate the comparative stresses and, therefore, sensitivity to cracking of the row 2, row 3 and row 4 tubes for the condition monitoring and operational assessments.

The results of this analysis support the observation that the leak is due to PWSCC at the apex of the tube, since the point of maximum predicted stress is at the inside surface of the tube wall at the extrados of the tube at the apex of the tube. The preliminary stress results also indicate that the row 3 tubes are expected to be less susceptible to PWSCC due to the larger TSP displacement required to reach the maximum stress condition and due to the lower stress in the row 3 tubes compared to the row 2 tubes.

**Finite Element Model Calculated Hoop Stresses
vs Reduction in Straight Leg Spacing from Nominal Dimension**

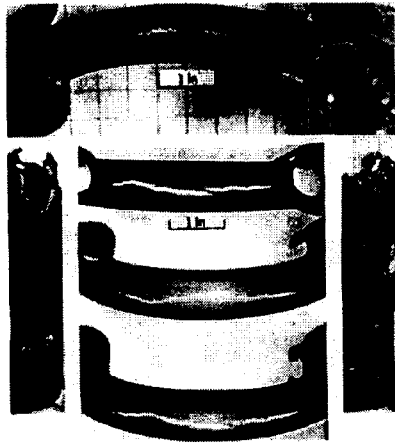
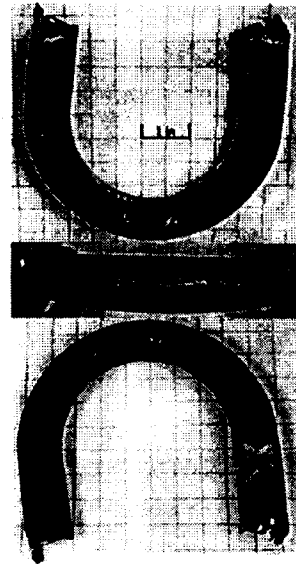
Figure 7. Apex crack location, on row 1 U-bend, which leaked in September 1976.

The rapid leakage event is characterized by the Surry 2, row 1 U-Bend tube rupture event of September 15, 1976, (Figure 7), which is described in NUREG/CR-6365⁷. The NRC estimate of leakage for this event was 330 gpm, in contrast to the 80 gpm reported by the plant operator. The source of the leak was attributed to high stresses from dent related hourglassing of the top TSP flow slots and the resultant strain placed on the U-bend. Stress corrosion cracking had occurred from the primary side at both the top and bottom (extrados and intrados) of the U-bend (Figure 8). The leak occurred at the top (extrados). The sudden, high leak rate occurred because an approximately four-inch long crack network had formed over the entire top of the U-bend. The leakage from this network was low because the individual through-wall sections of the crack were each relatively short, and, although several through-wall sections may have been leaking, the combined leak rate was still very small. The essentially parallel cracks however, overlapped each other and were separated by ligaments of sound metal that continued to decrease in cross section as the cracks grew in length and branched into a three-dimensional network. This resulted in the burst resistance of the network decreasing without a substantial increase in the leak rate. At the time that the network could no longer contain the normal pressure differential, the crack network opened over about a four-inch length, resulting in the large increase in leak rate.

Radiography Reveals Both Intrados and Extrados Cracking in Surry 2 U-Bend

Fig. 14. Surry 2, ARI-C7, as-received. Intrados view (top), cold-work view (extrados left), hot-work view (extrados right), and three full-arc radiographs (center).

Fig. 15. Surry 2, ARI-C7, as-received. Center picture is of extrados of U-bend.

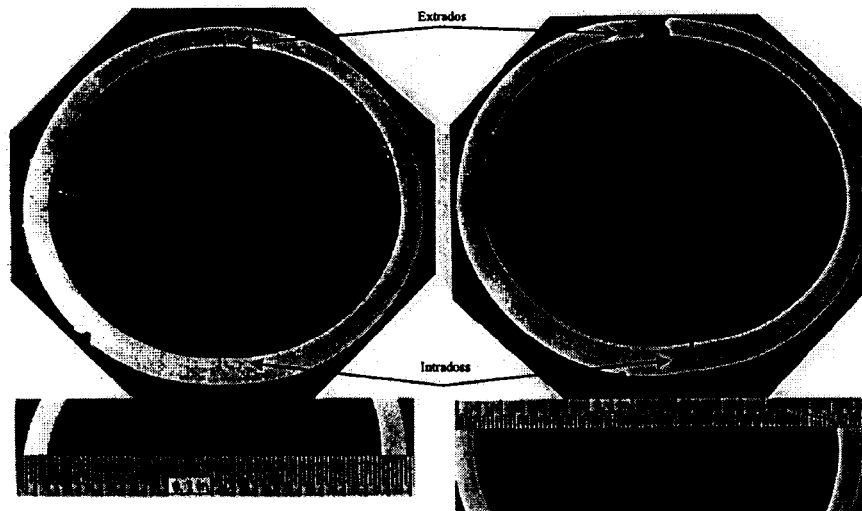
Figure 8. Cross section of row 1 U-bends for columns 6 and 7 illustrates the PWSCC crack networks on the extrados and intrados.

Metallographic Examination Confirms PWSCC For Both U-Bend Cracking Locations

Fig. 25. Surry 2, ARI-C7, midbend ring sample 2 for ovality and wall thickness measurements. Extrados is at top. (Notch is for identification.)

Fig. 26. Surry 2, ARI-C7, midbend ring for ovality and wall thickness measurements. Extrados (with operation) is at top (main crack area).

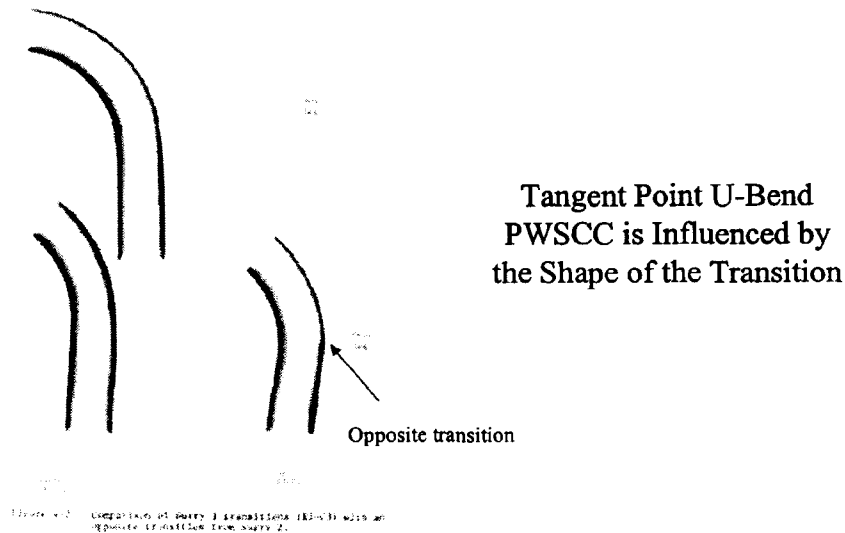
As part of this tube examination effort, additional examination was made of some U-bend samples previously removed from Surry 1 and 2 and Turkey Point 4. These comparisons showed that the Surry 1 and Turkey Point 4 U-bends had only smooth transitions on both sides and no cracking was observed at the tangent locations. Surry 2 U-bends displayed both the smooth and opposite tangent point transitions and one of the locations evaluated displayed a PWSCC crack (Figure 11). This was on R1C7, the same tube with the apex location leak.

Figure 11. The radiographs to the left show the smooth tangent point transitions of a row 1 U-bend from Surry 1. The hot leg is shown above the cold leg. To the right is a radiograph of the irregular tangent point transition from a row 1 U-bend of Surry 2
