North Anna 8/23/11 Seismic Event

NUHOMS® HD and ISFSI Pad 2 Overview

July 2012

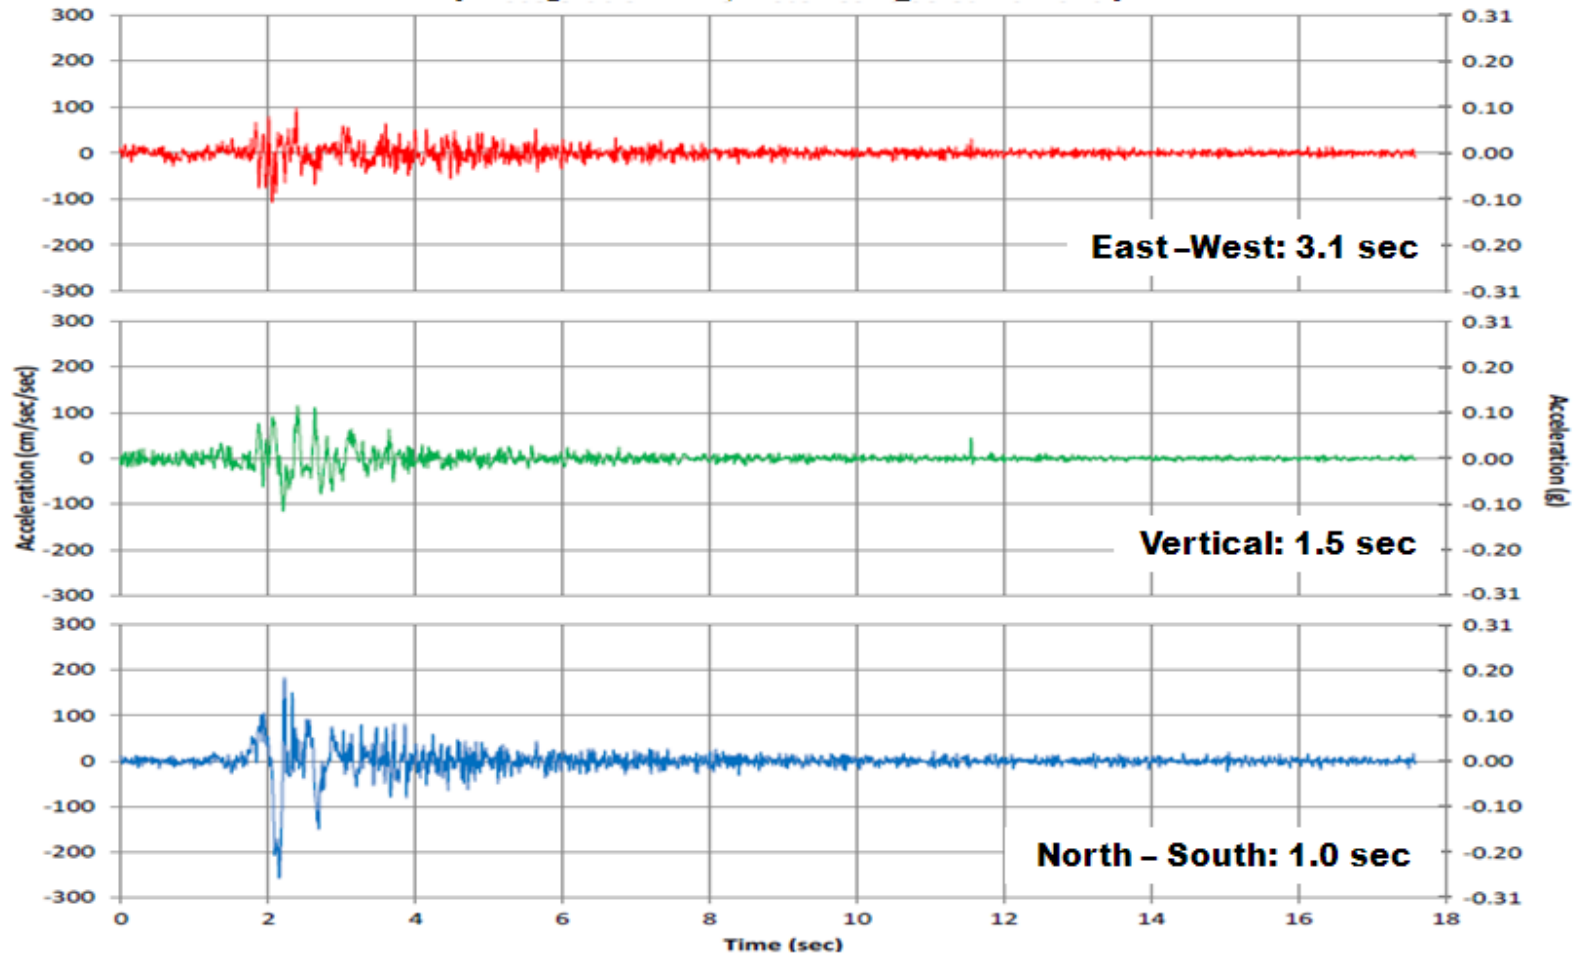
Acceleration Time Histories

- **5.8 magnitude earthquake**
- **Peak Ground Acceleration**
 - measured at Unit 1 basemat
 - 0.26 g north-south
 - 0.11 g east-west
 - 0.12 g vertical
- **Strong motion duration 3.1 seconds**

(very short, strong motion)

Containment Basemat (elevation 216')

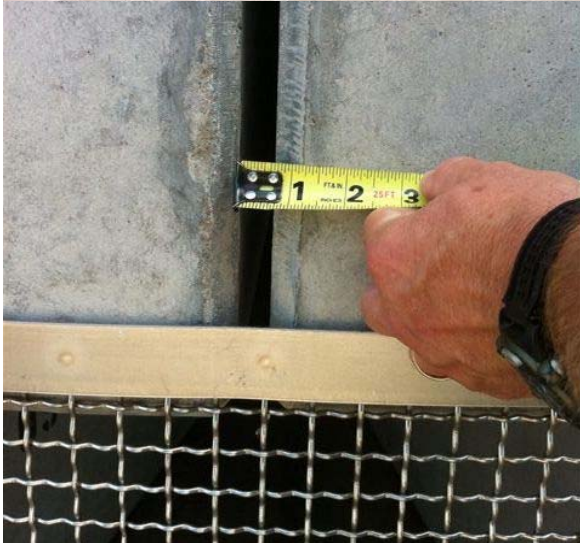
Initial Inspection Observations

- **Gaps between some base or roof components**
- **Cosmetic concrete damage**
 - on inlet vent between loaded HSM-H 1 and 3
 - on several empty HSM-H outlet vents, including associated displacement of screen
- **Some HSM-H fasteners no longer “snug-tight”**
 - could be turned by hand (ex: roof vent cover bolts)
- **Minor surface cracks in Pad 2 (pre-existing)**

- **All Concrete Repairs Completed**
- **All Fasteners Checked & Retightened**
- **All Module Alignments Re-established**
- **Delta Temperature Surveillances Normal (No Blockage)**
- **Dose Surveys Consistent with Pre-Event Measurement**
- **Recertification of HSM-H array in progress with TN**

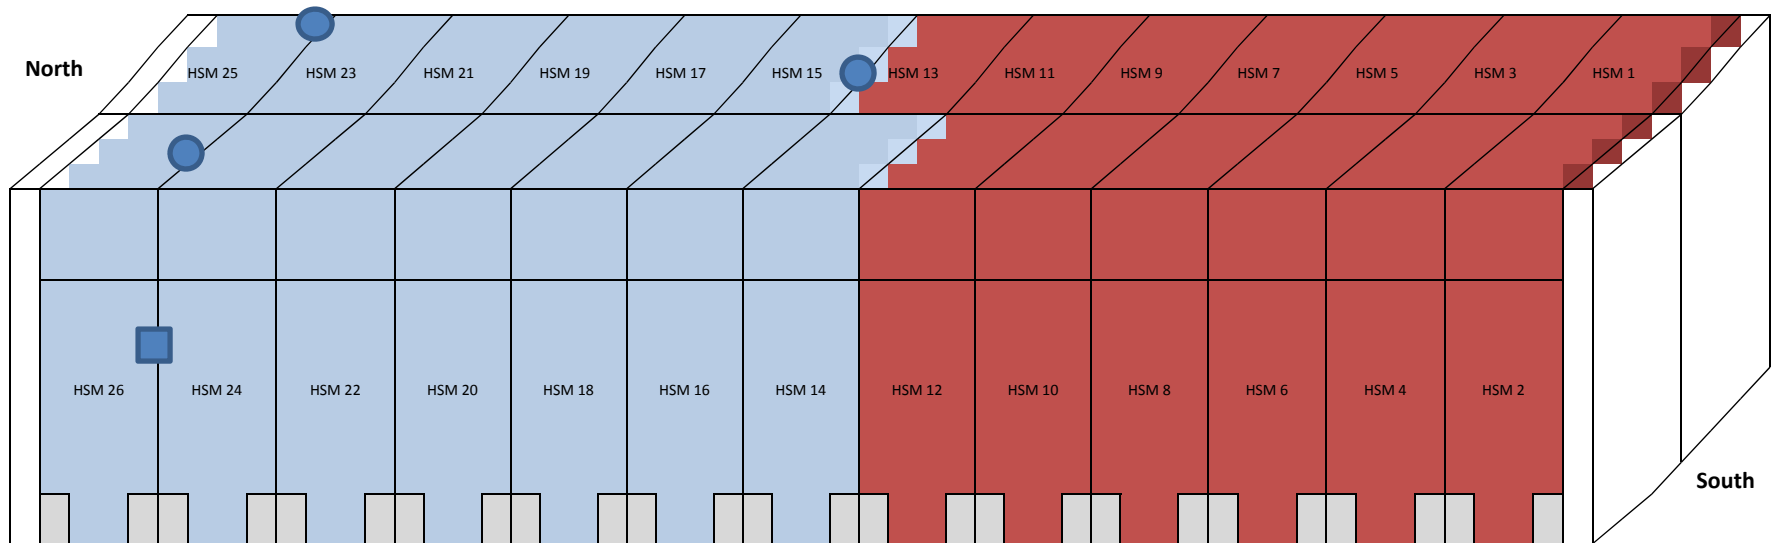
NUHOMS® HSM-H Gap Inspections Measured Gap Results

- One base-to-base gap of 1.0 inch with no contact (between empty HSM-H 24 & 26)
- Other base-to-base gaps 0.75 inch or less (typically < 0.5 inch and appear to contact)
- Three roof-to-roof gaps > 0.75 inch (maximum 1.25 inch gap between empty HSM-H 24 & 26)

HSM-H base-to-base gap > 0.75 inches
(maximum gap = 1.0 inch)

HSM-H roof-to-roof gap > 0.75 inches
(maximum gap = 1.25 inches)
