SUBJECT: DURANGO DISPOSAL SITE
OBSERVATIONAL SITE VISIT

Report: WM-00048/12-001

Facility: Durango Disposal Site

NRC Trip Report

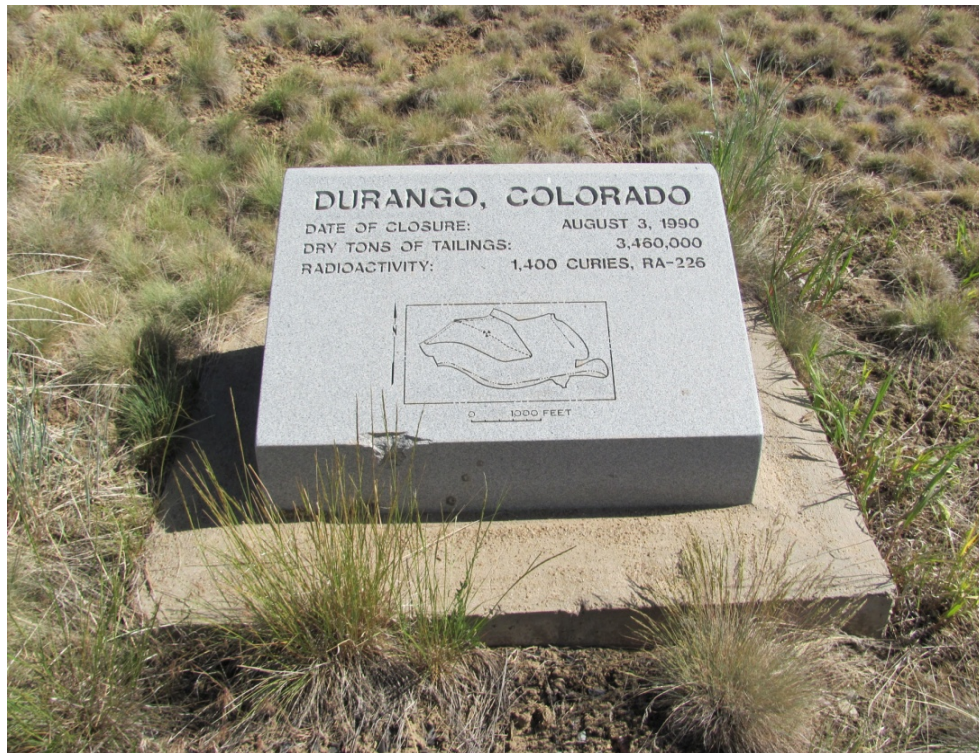
Figure 1: Granite Site Monument

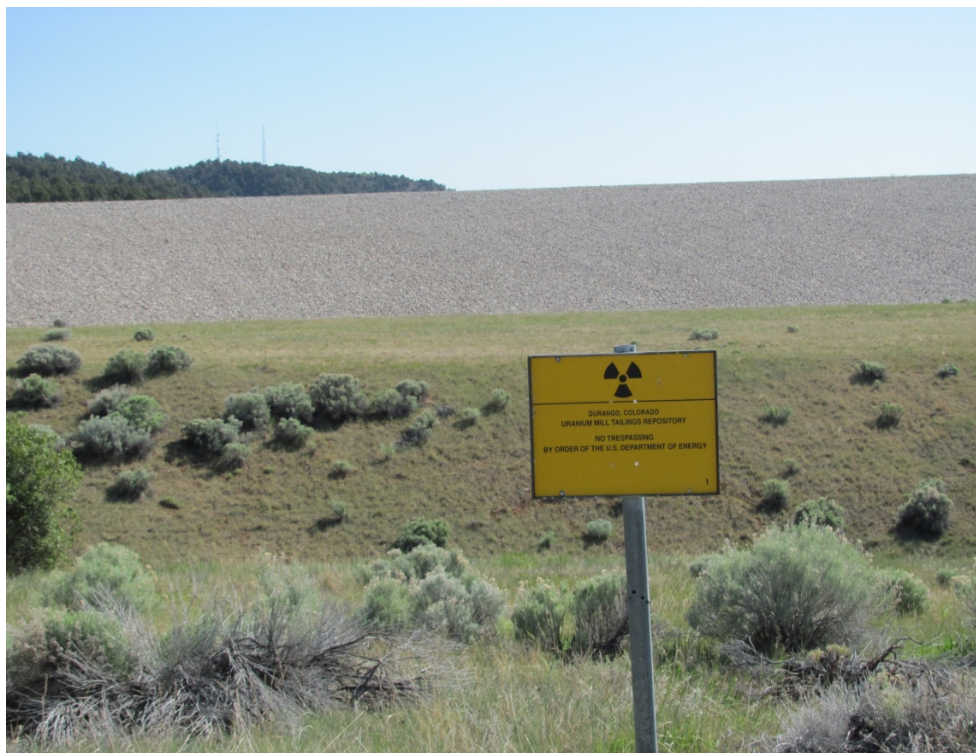
Figure 2: Riprap on Side Slope with Warning Sign

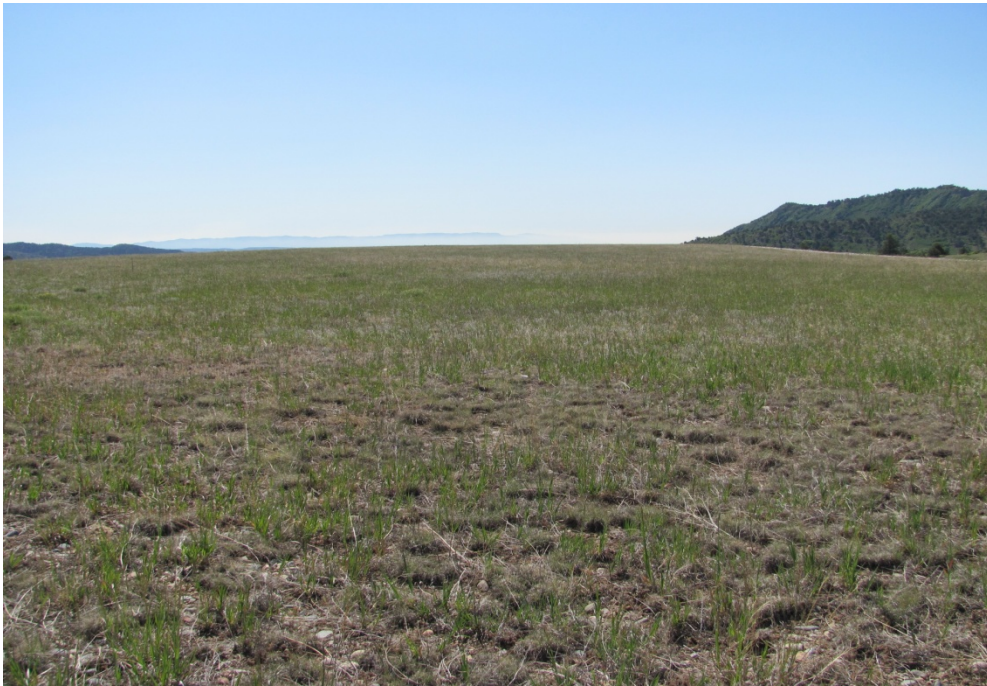
Figure 3: Vegetated Top of Cell

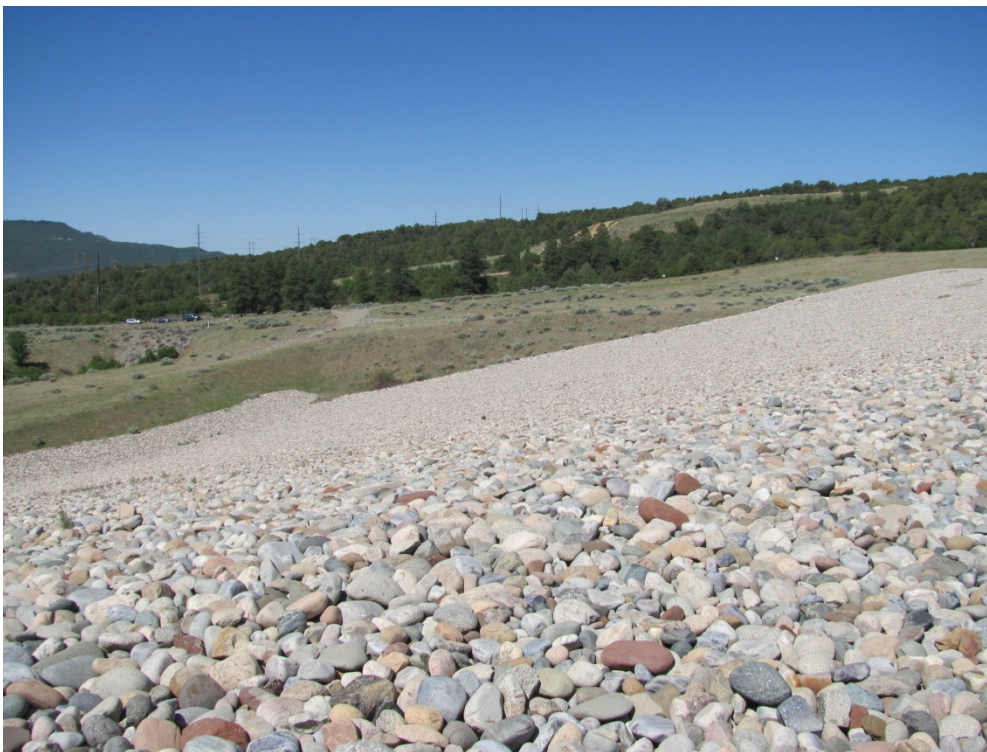
Figure 4: Rip Rap on Side Slope
