ATTACHMENT 9.6

SEISMIC WALKDOWN CHECKLIST FORM

Status: Y ☒ N ☐ U ☐Seismic Walkdown Checklist (SWC) SWEL2-008Equipment ID No. 19P-1A Equip. Class 5. Horizontal pumpsEquipment Description: Fuel pool cooling recirc pump ALocation: Bldg. RB Floor El. 326 Room, Area Col 3 line T

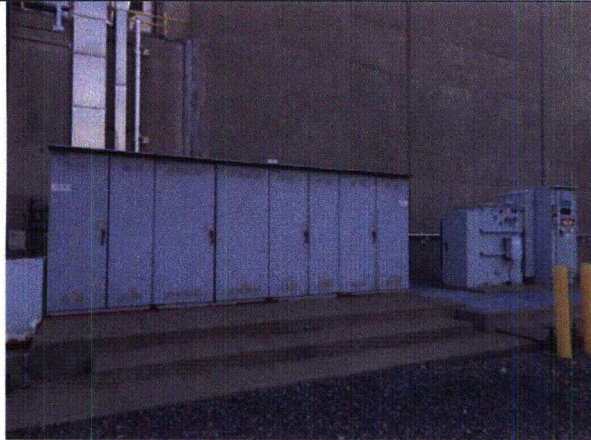
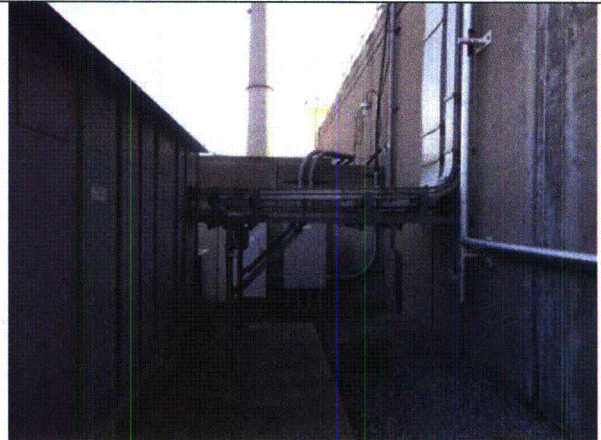
Some rust present along baseboard of MCC cabinet. Will not affect structural integrity of equipment.

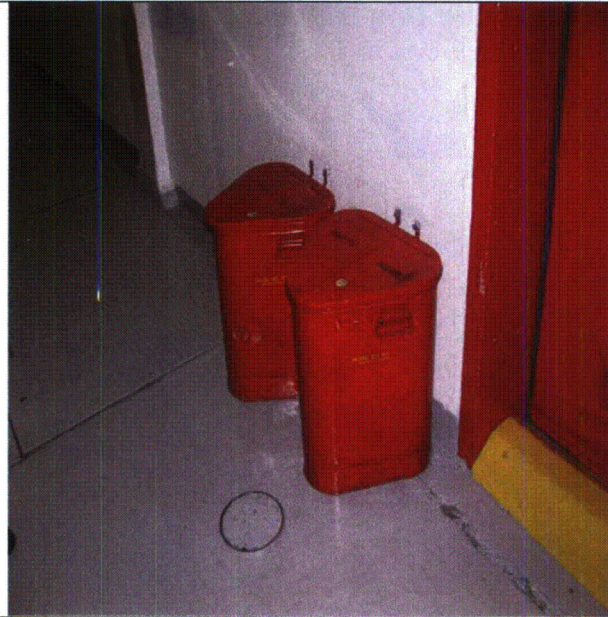
**Note:** *Picture of the clean/dirty rag bins.*

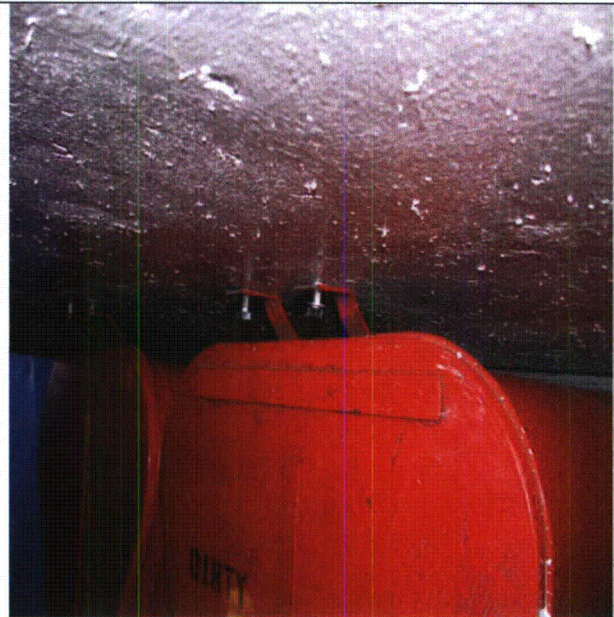
**Note:** *Picture of the non-tightened/loose anchorage of the clean/dirty rag bins.*

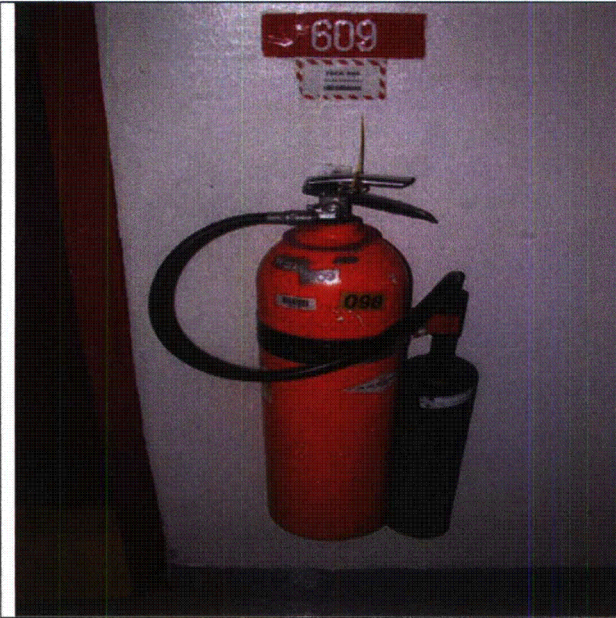
Note: PICTURE of the 76CX-609 hand held fire extinguisher.

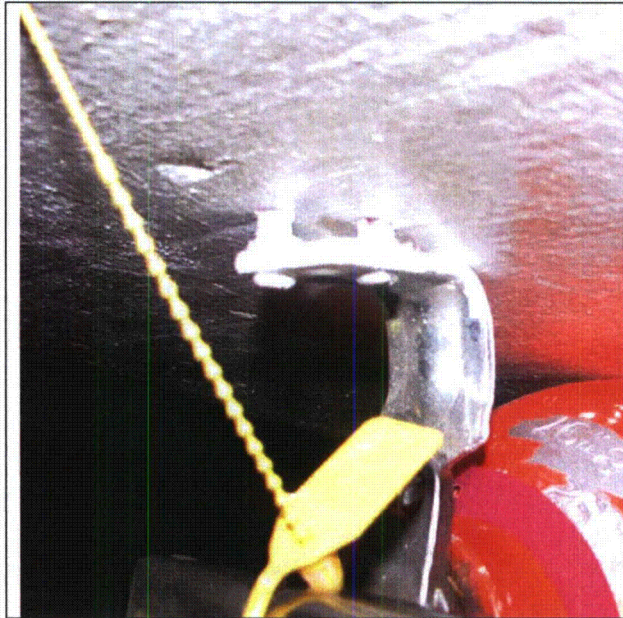
Note: PICTURE of the non-tightened/loose anchorage of the 76CX-609 hand held fire extinguisher.

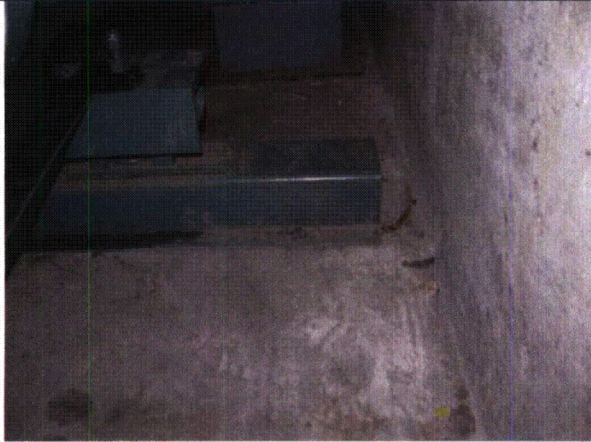
Note: Picture of a loose anchor for equipment 72FN-46D is loose.

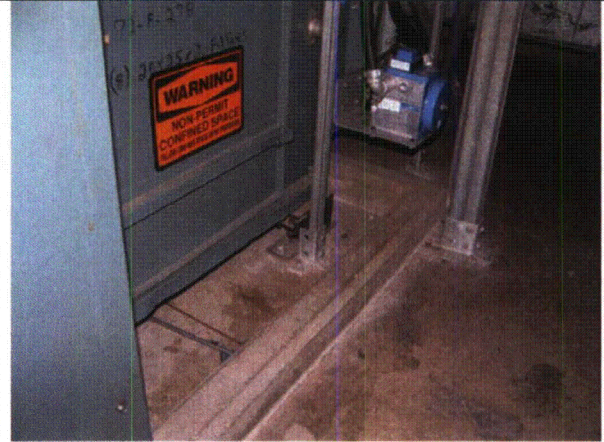
Note: Picture of a loose anchor in the UNISTRUT post base for equipment 72MOD-101B.

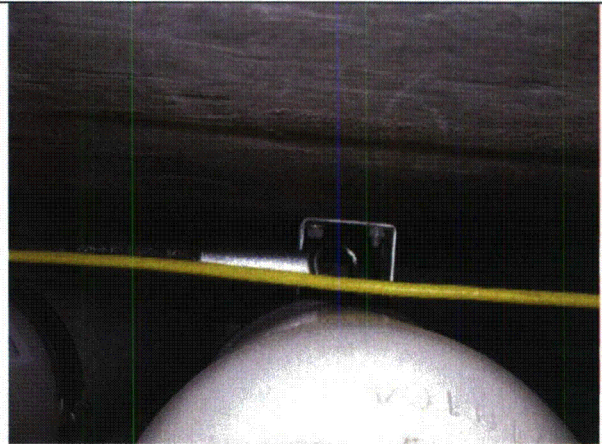
Note: Picture showing the loose bolts attaching the compressed gas cylinder tanks to a concrete wall and improperly stored tools.

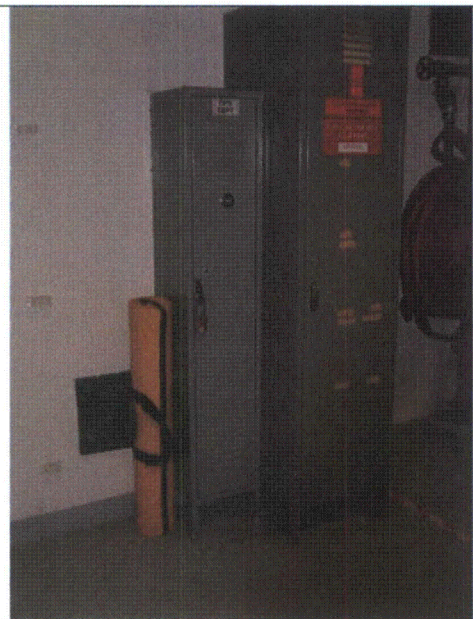
**Note:** *Unanchored Cabinets*

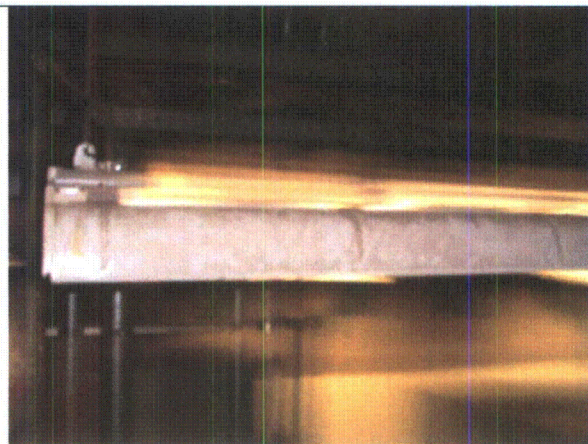
**Note:** *Improper light hooks.*

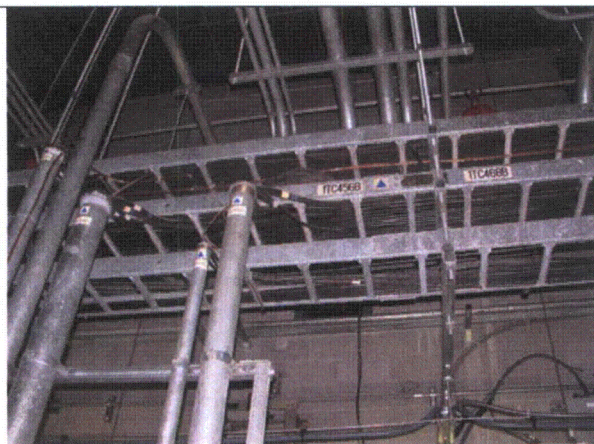
**Note:** *Overhanging cables.***Note:**

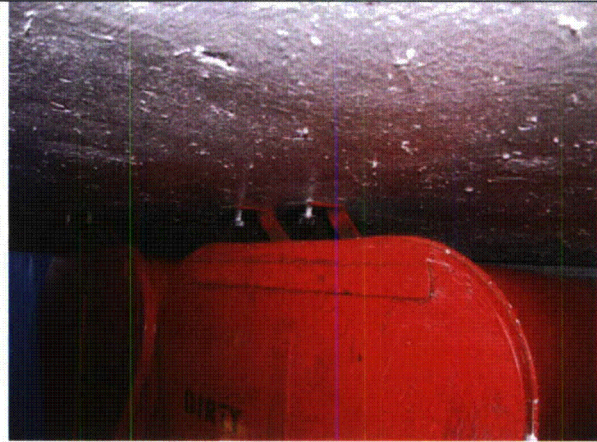
**Note:** *Picture of the non-tightened anchorage of the clean/dirty rags.*

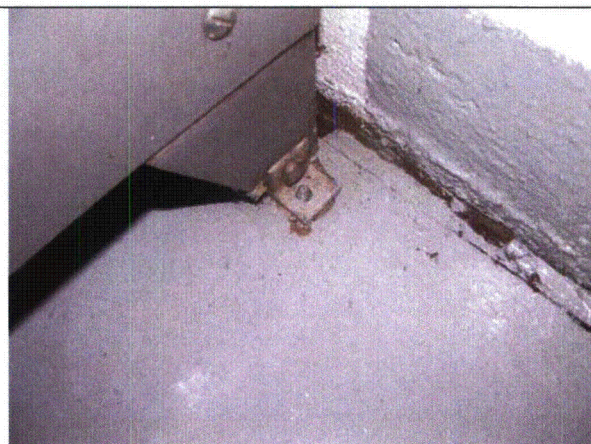
**Note:** *Picture of the missing anchorage of the work bench.*

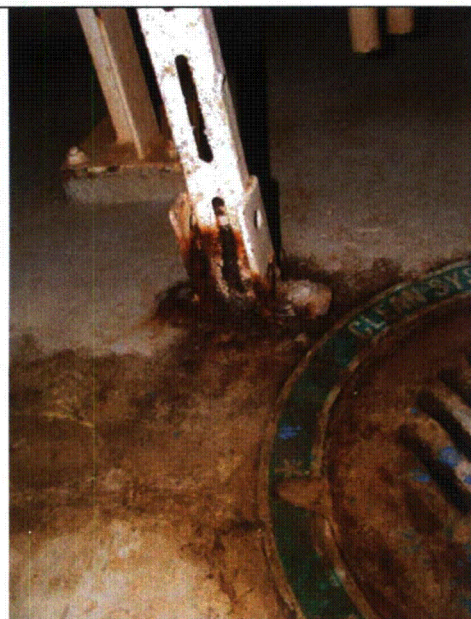
Note: Picture of the degraded anchorage of the UNISTRUT support.

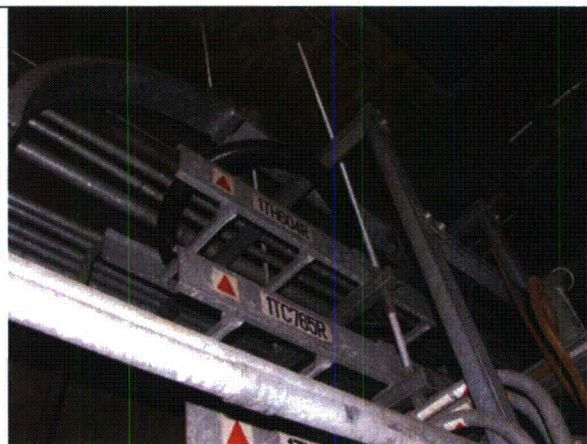
Note: Picture of the conduit hanging over the side of cable tray 1TH604R1.

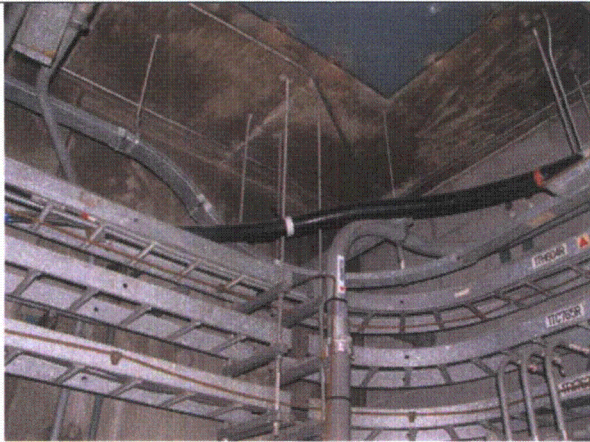
Note: Picture of the conduit tied to a rod hanger support the on cable tray 1TH604R1.

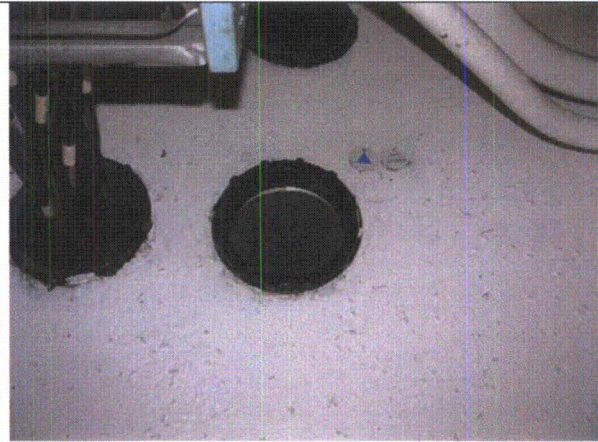
Note: Picture of uncovered penetration in Pump Rom B, West wall.

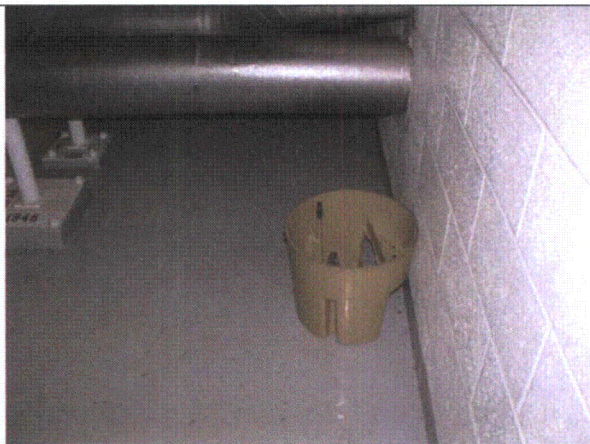
Note: Picture of a step ladder not in designated location in Pump Rom B.

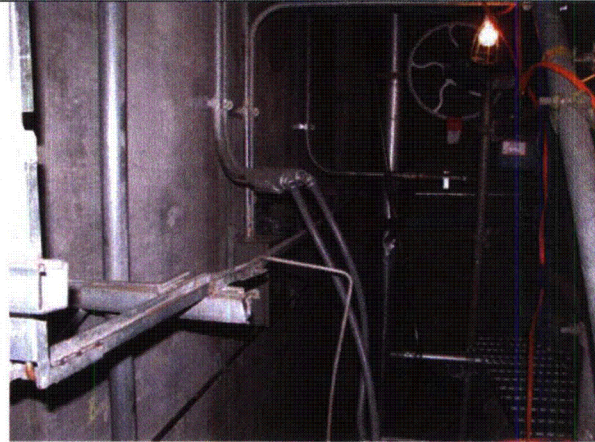
Note: *Picture showing the deflected shape of the instrumentation line resting on a strut support and the un-braced length.*

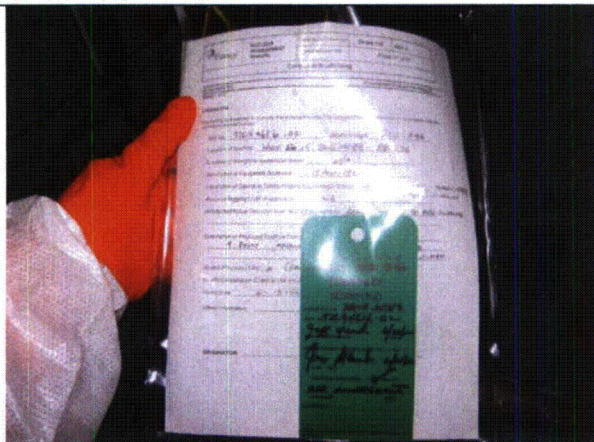
**Note:** *Picture showing the out of date scaffold tag.***Note:**

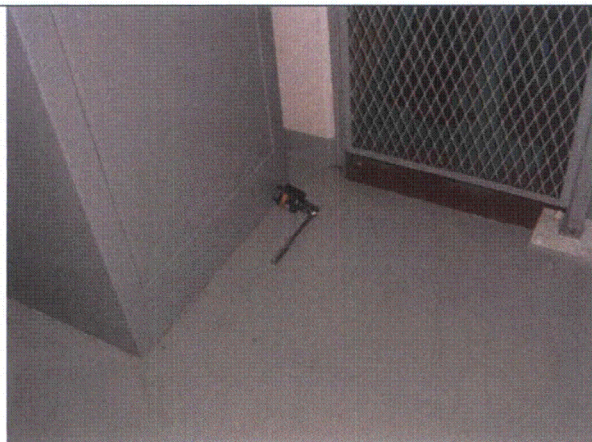
Note: Picture showing the location of the improperly stored tool.

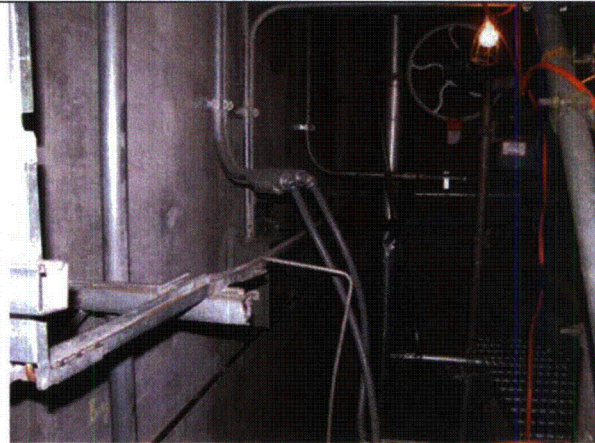
Note: *Picture showing the deflected shape of the instrumentation line and the unbraced length.*

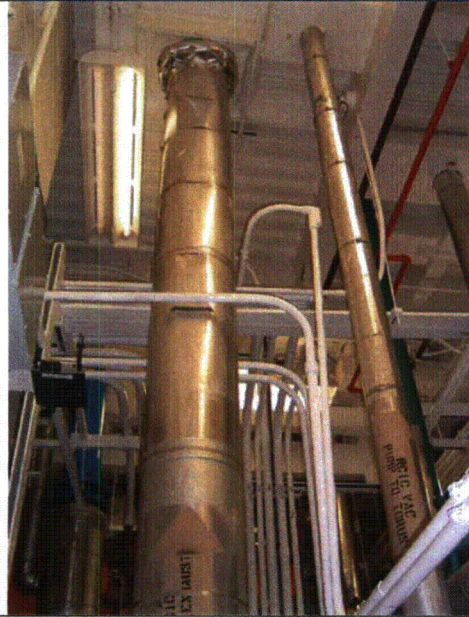
Note: *Unsupported vertical pipes and pipe/conduit interaction point.*

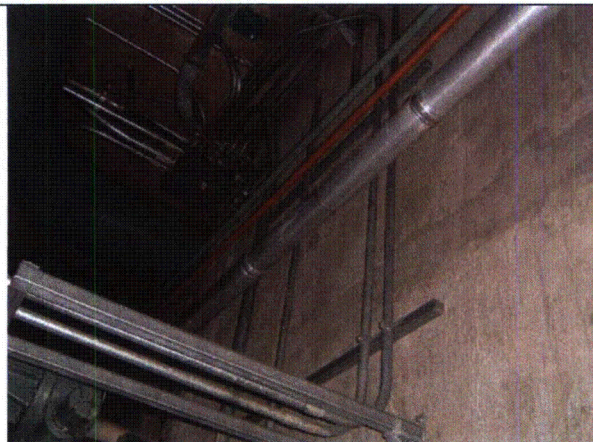
**Note:** *Unsupported Pipe Spans***Note:**

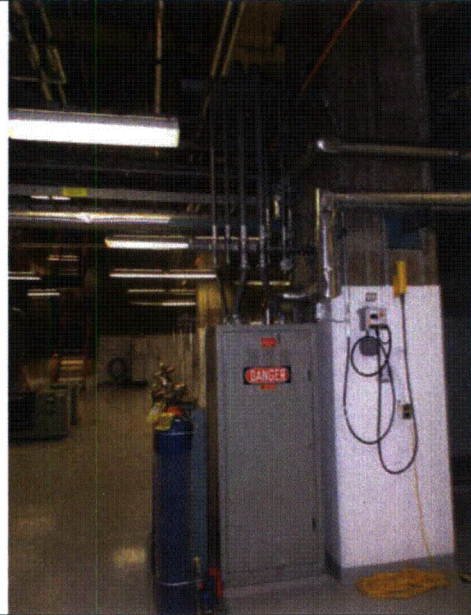
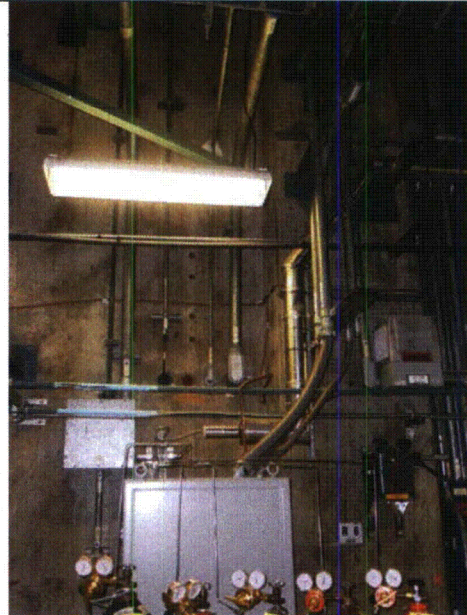
Note: Light fixture above 1/4" tubing from the gas tanks

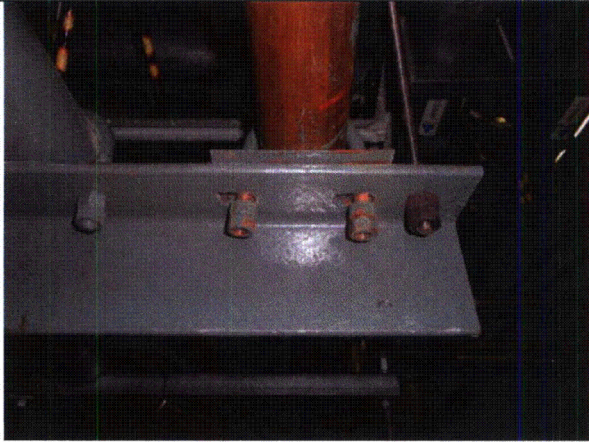
**Note:** *Loose nuts on the U-bolt connection.***Note:**

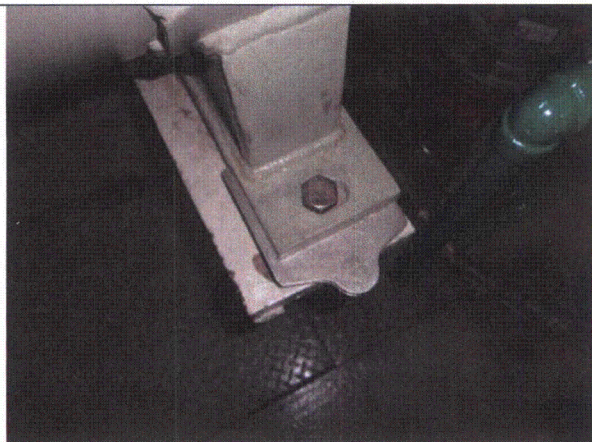
**Note:** Bolt missing washer on 93 WE-1A

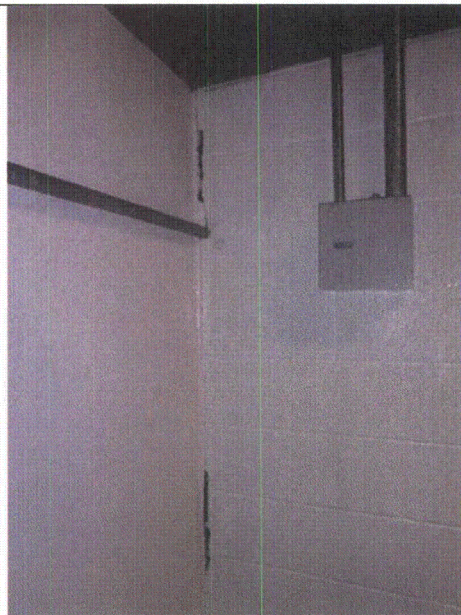
**Note:** Masonry wall joint with approx. 1/2" cracks.

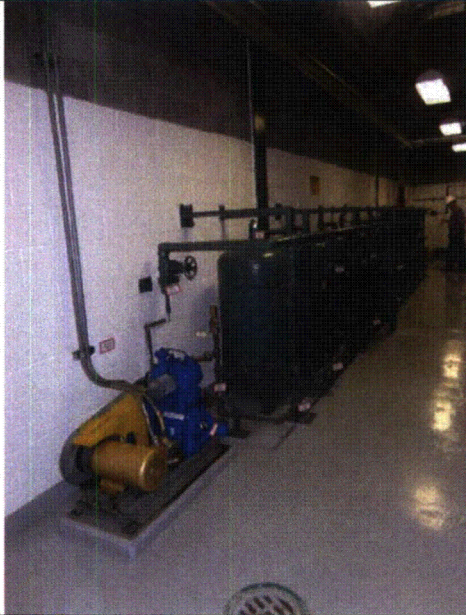
Note: 1/4" tubing along wall in tube track that is missing an anchor bolt

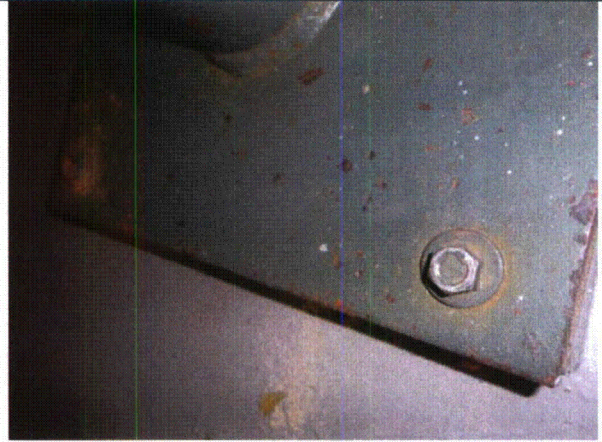
Note: 46FIS-102C anchorage. Less than full engagement by approx. 1 thread

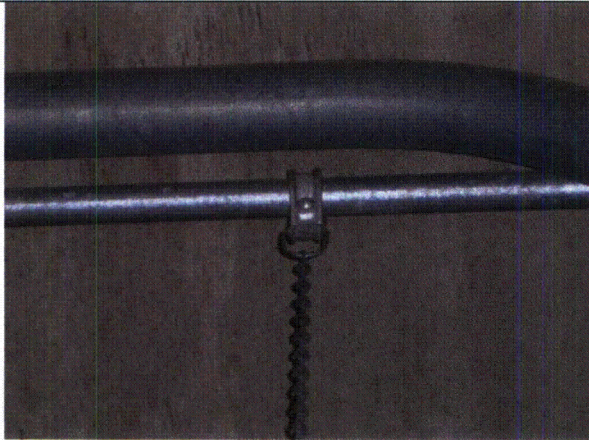
**Note:** :Light fixture chain supported from conduit.

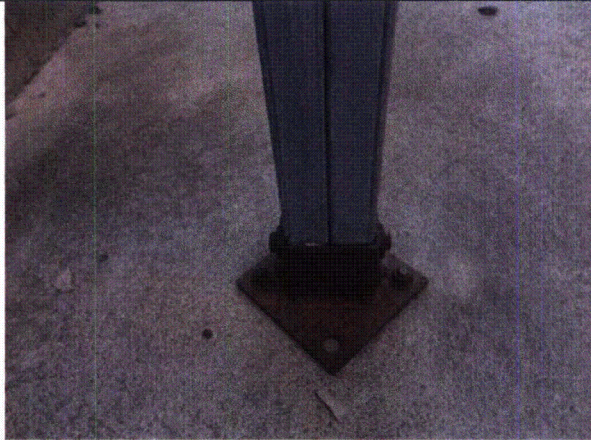
Note: Surface rust on baseplate for raceway support (back, i.e., west side, of 71MCC-120-OE1).

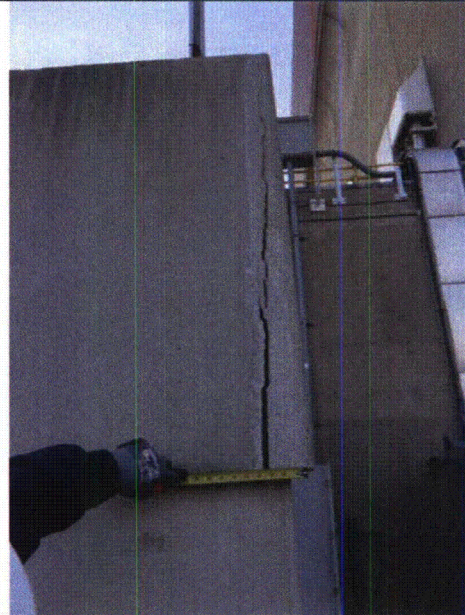
Note: Cracks in grout panel at enclosure that is adjacent to (south of) 71MCC-120-OE1.

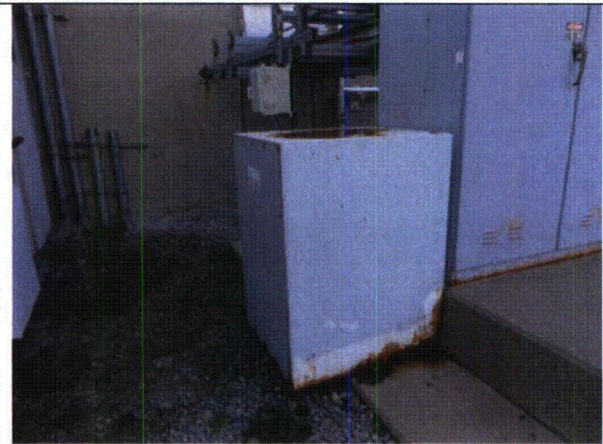
**Note:** Corrosion at base of JB Generator (box-like component in center of photo)
