VSC-24 Lead Cask Inspection Report
VSC-24 CoC Renewal Project

February 10, 2013

VSC-24 Lead Cask Inspection-Palisades May 21-24, 2012

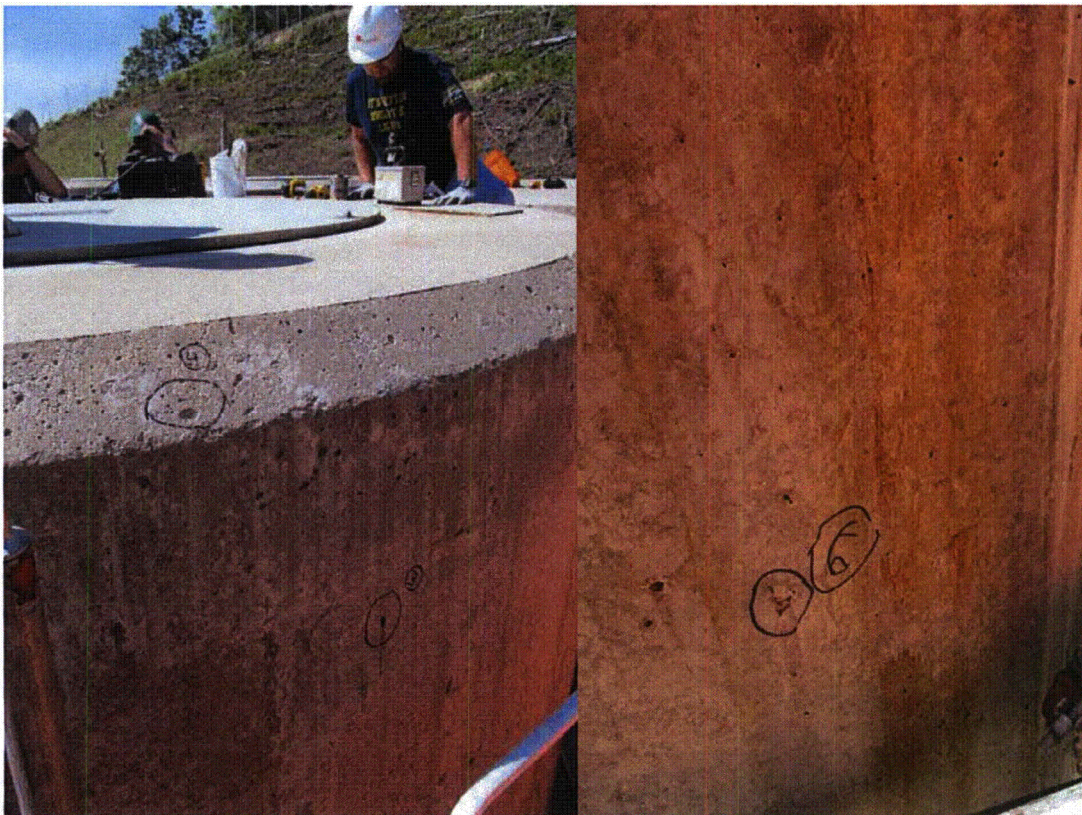
Inspection results revealed six "bug holes" which exceeded the established acceptance criteria and required grout repair. See Attachment 2 for location and size of the noted indications.

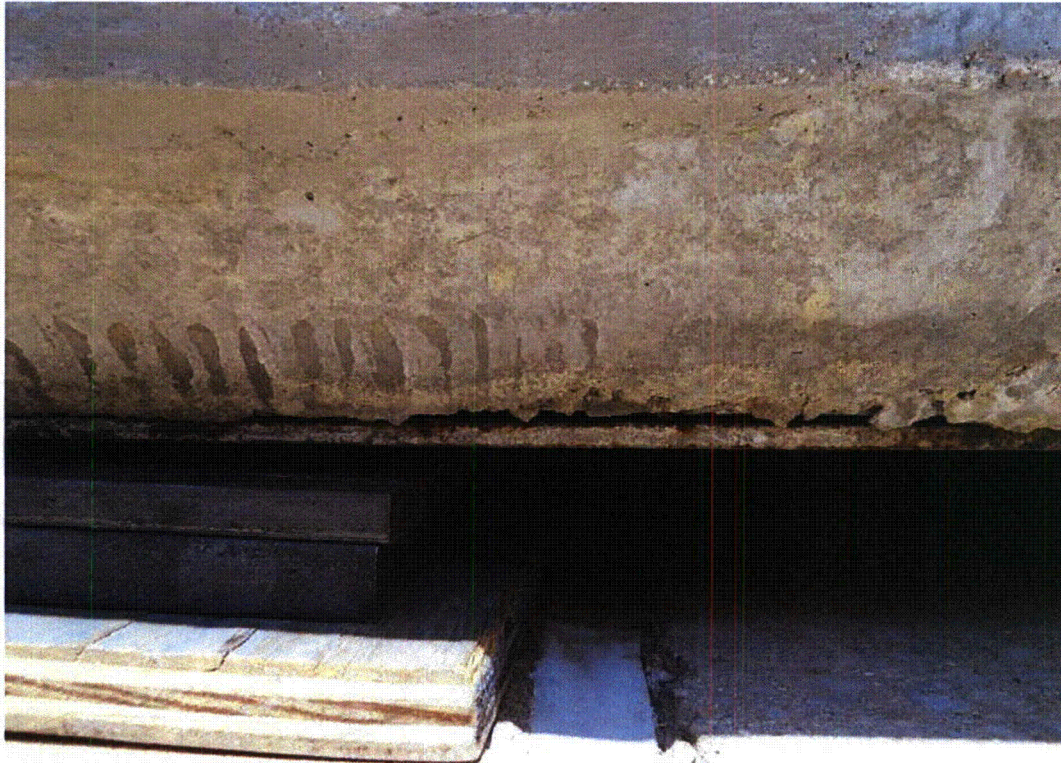
In addition, a small area (approximately 3ft long by 3/8 inch wide by 3/8 inch deep) or void in the concrete was identified at the interface between the VCC bottom plate and the vertical VCC concrete wall. This area was observed during re-setting of the VCC on the pad and no flexing or change in the small gap was noted. This condition does not affect the function of the VCC or VSC-24 system and is cosmetic only and is limited to the area of the concrete and bottom plate outer edge interface only. No other degradation mechanisms were identified as the overall condition of the VCC concrete exterior was found to be in good condition.

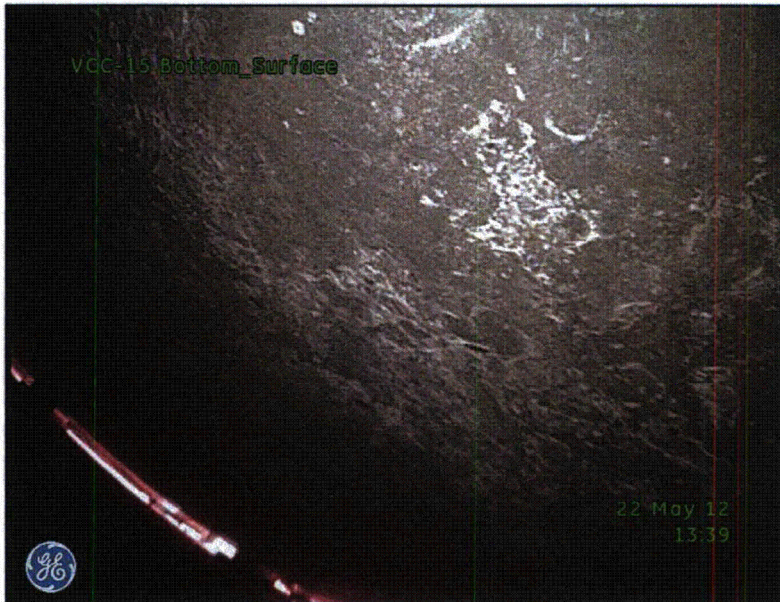
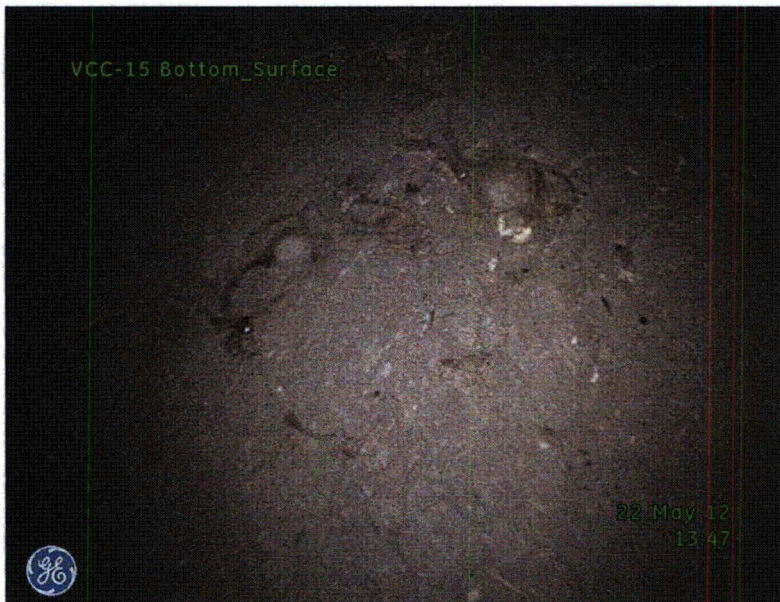
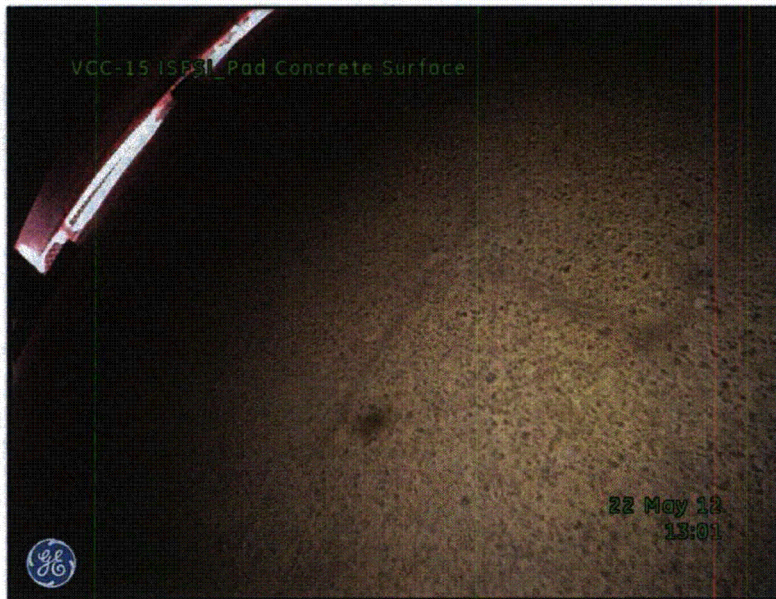
Visual inspection of the bottom surface of the VCC and the surface underneath the VCC (Concrete pad) was performed for evidence of coating degradation, corrosion and concrete degradation. In all cases, the inspections of the surfaces demonstrated the coatings and concrete to be in very good condition with no degradation mechanisms identified. Only minor dust, bugs etc were noted during the inspection. All acceptance criteria were satisfied.

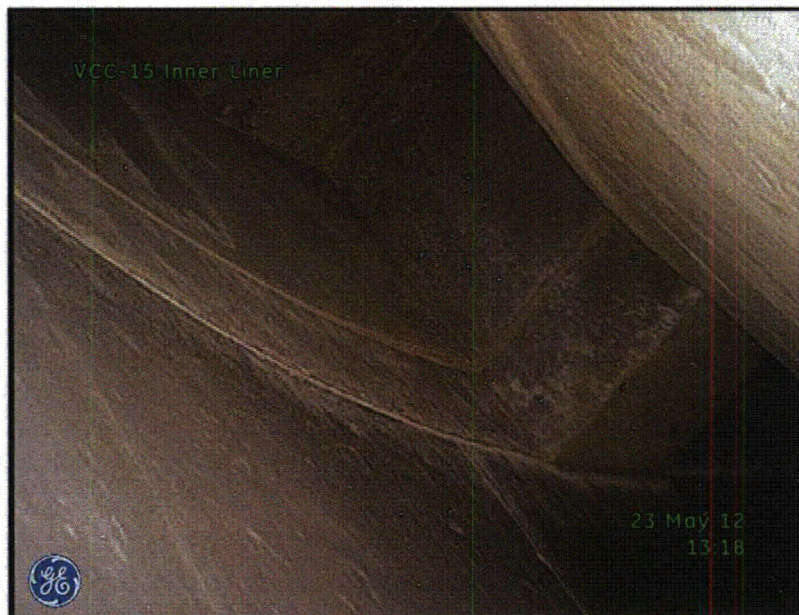
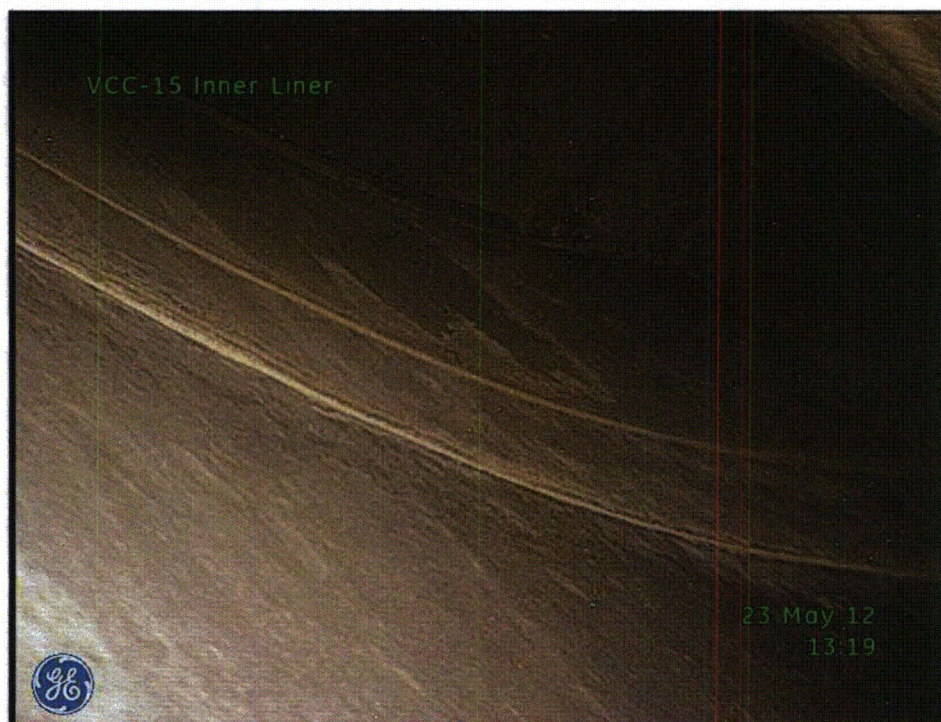
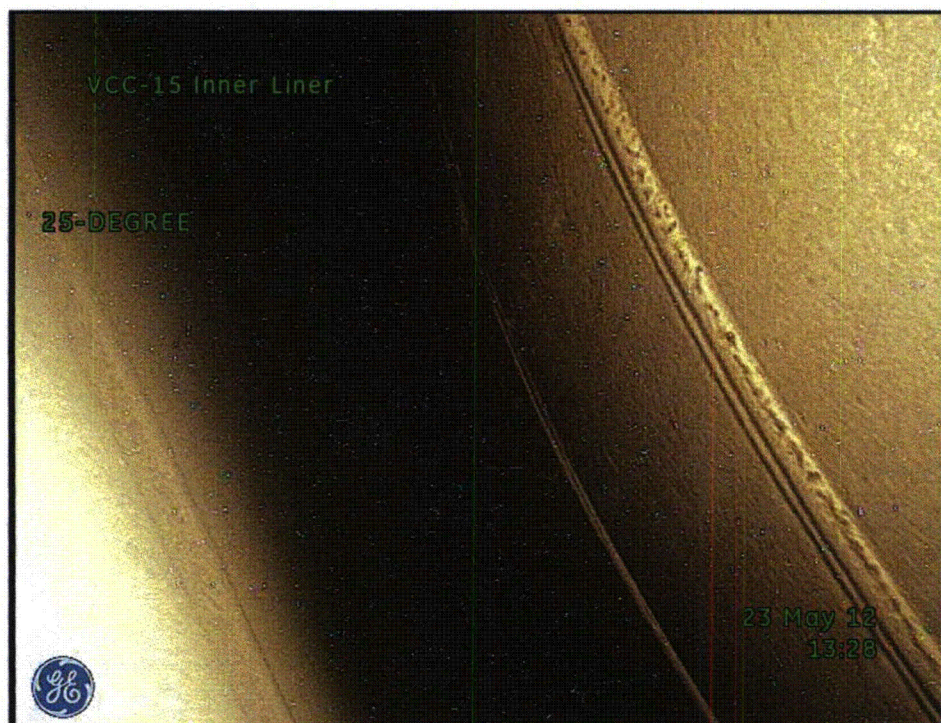
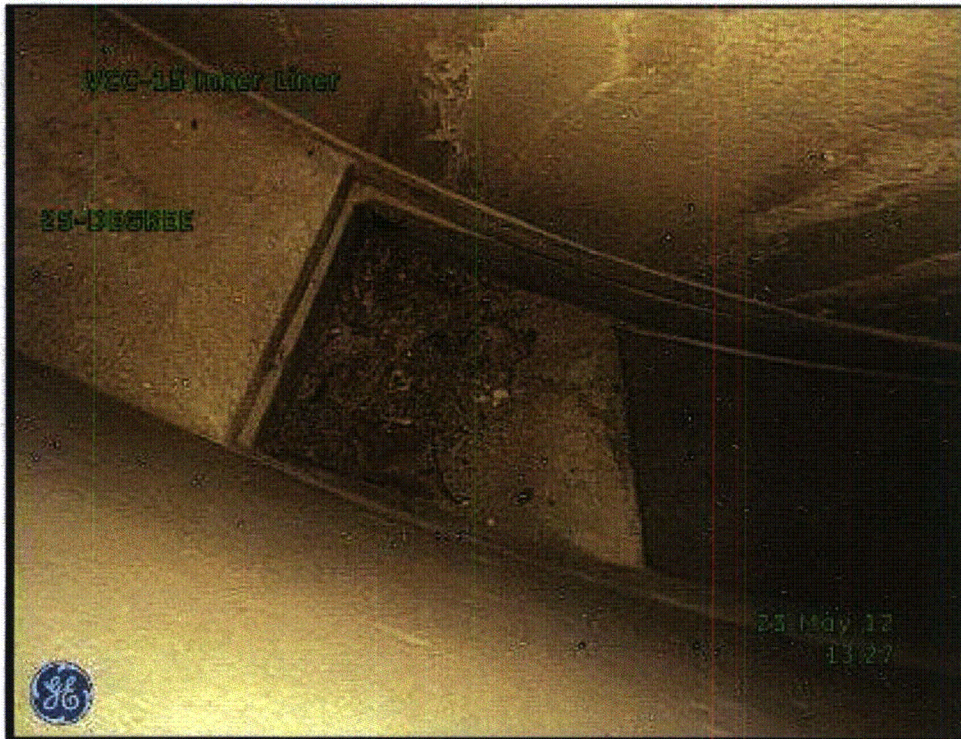
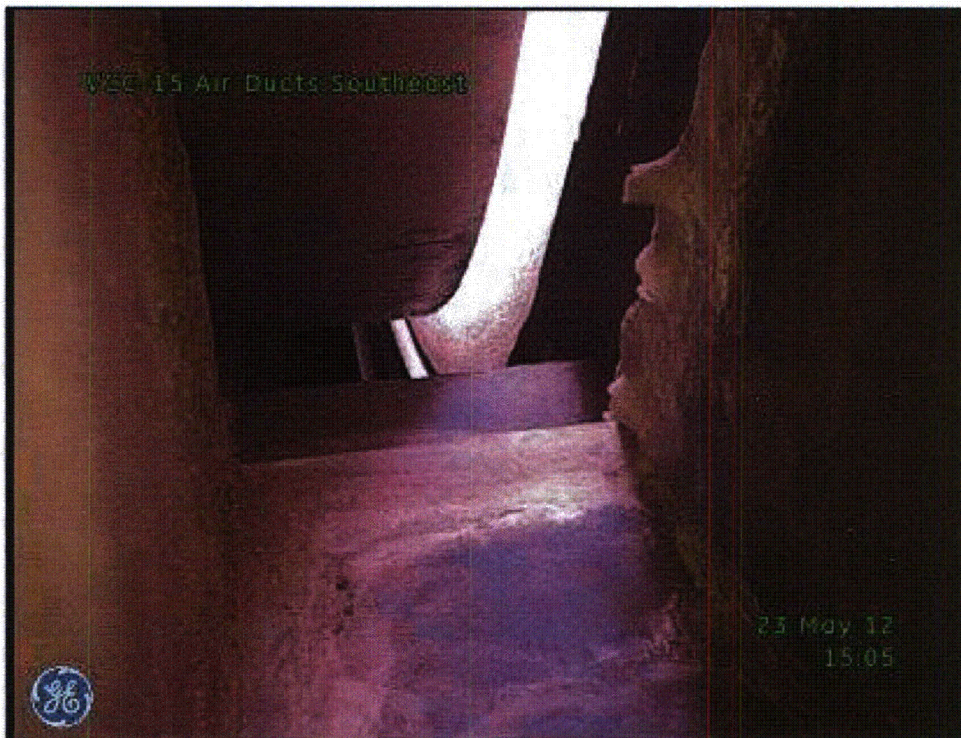
The readily accessible surfaces of the MSB Shell, VCC Liner (Interior) and VCC Air Ducts were visually inspected utilizing boroscopic equipment with video recording. Additional visual inspections were performed of the air ducts/channels from beneath the VCC using remote camera equipment. All acceptance criteria was satisfied with only minor debris (leave, bugs, mineral deposits) and dust/dirt noted. Coatings were noted to be in good condition with no corrosion noted. In all cases the air ducts were clear and capable of performing their intended functions with absolutely no challenge to the acceptance criteria of 10% blockage or less.

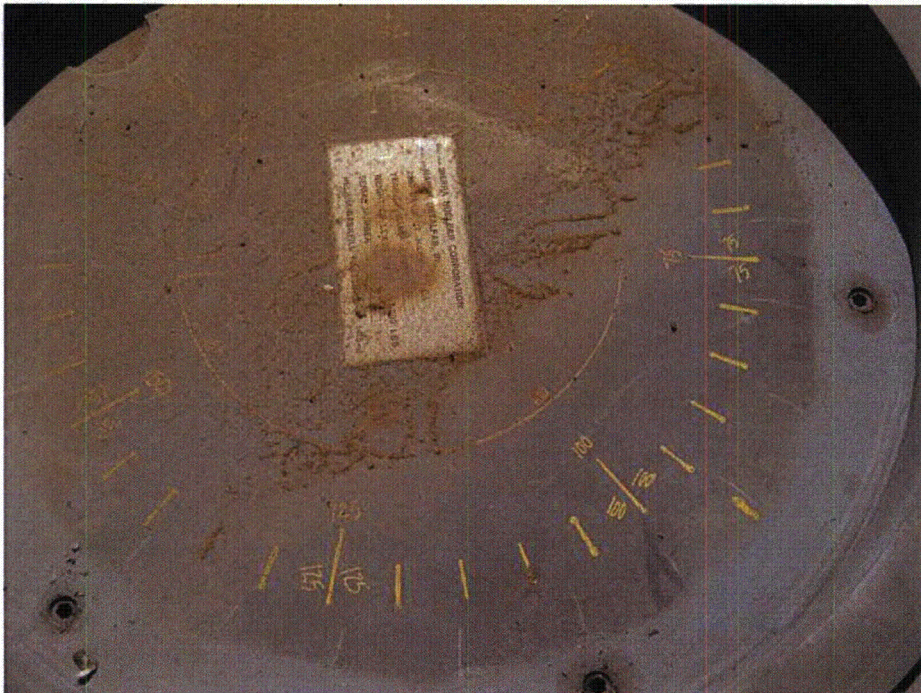
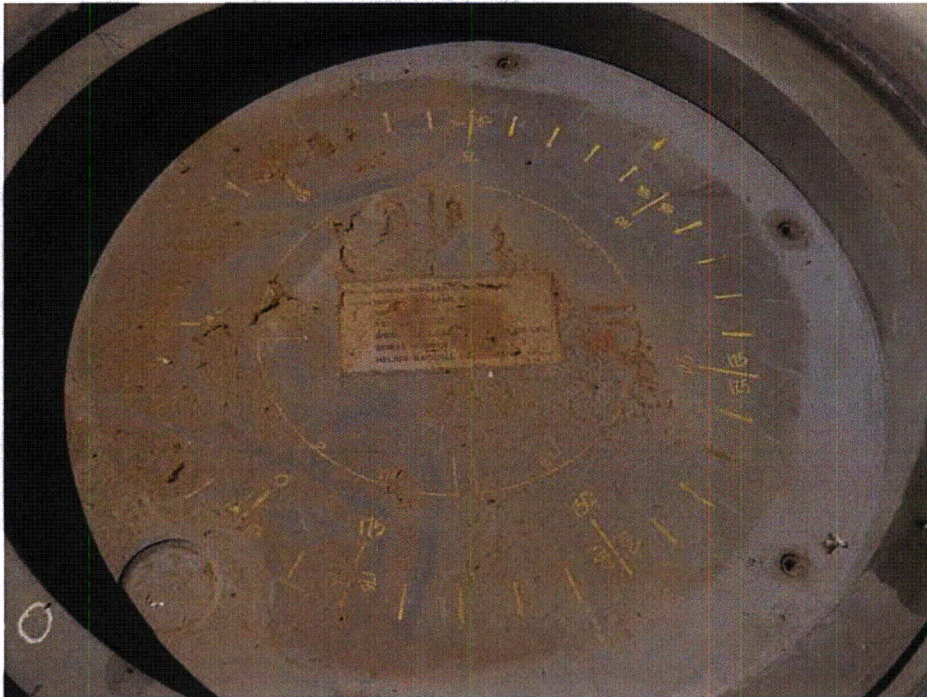
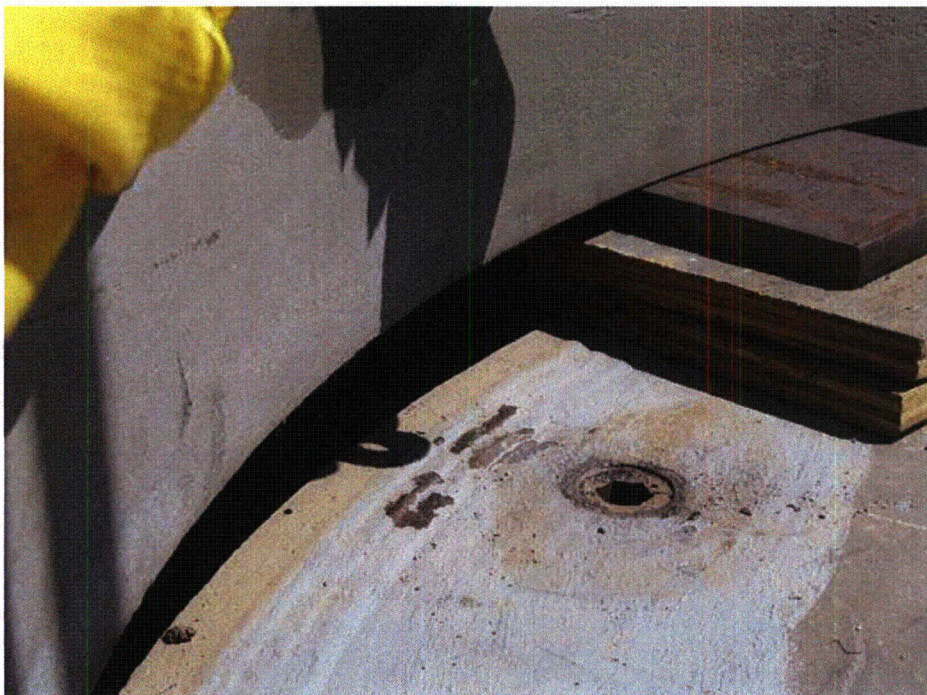
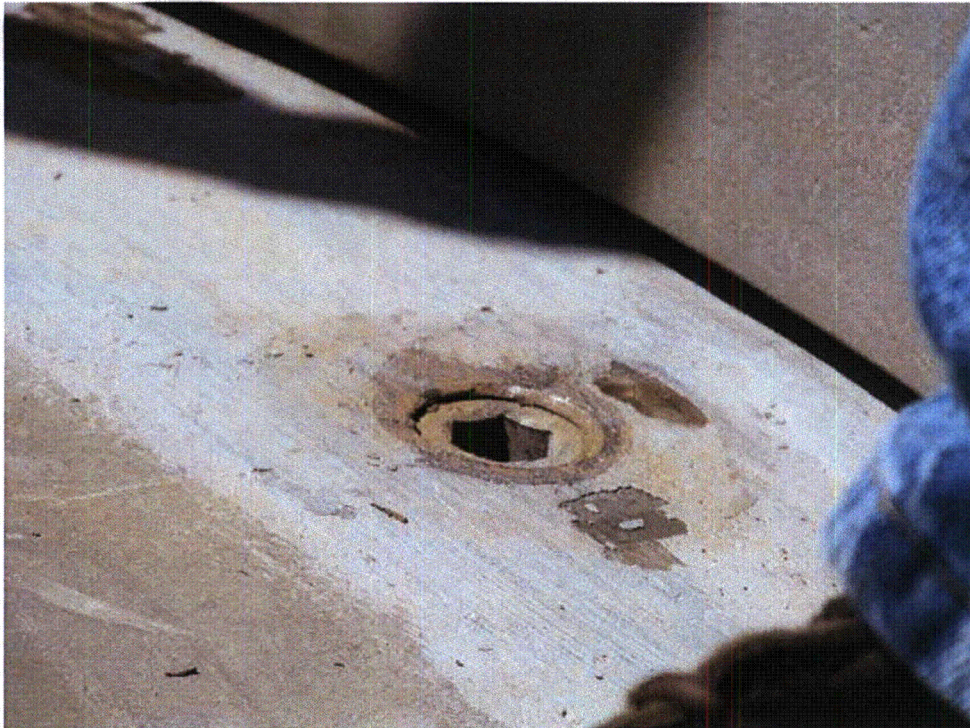
The VCC Lid was removed with the bolting noted as acceptable but corroded. In addition the gasket was noted to be in good condition as well. Minor dust/dirt was noted on the top of the MSB structural lid and the area was fully vacuumed and cleaned. With the shield ring lifted to reveal the MSB structural lid weld and provide access to the annulus between the MSB and the VCC interior liner, the weld itself was noted to be in good condition.. Direct visual inspection of all readily accessible surfaces was performed. In general, coatings were found to be in good condition with the exception of two areas where the coating was bubbled yet still intact. Consequently, when shielding utilized during the lifting of the shield ring was removed, some coating material was inadvertently scrapped off the area adjacent to the closure weld. Additionally, an area around one of the plugs threaded into the structural lid required cleaning and repair due to the bubbled coating. In both cases, the base material beneath the coating was found to be in very good or pristine condition. The subject areas were cleaned and recoated in accordance with manufacturer's recommendations. No corrosion was noted on the structural lid or the MSB itself.

- Structural lid was vacuumed to remove dust/dirt noted during visual inspection
- Areas noted in Section II.D were cleaned and recoated returning them to original condition.
- VCC Lid gasket was replaced with new gasket upon final closure. It should be noted that the original gasket was found to be in good condition with no evidence of leakage due to weather conditions.
- Corroded bolting removed from the VCC lid was replaced.
- Initiated CR-PLP-2012-04114 and CR-PLP-2012-04116 documenting conditions noted above.

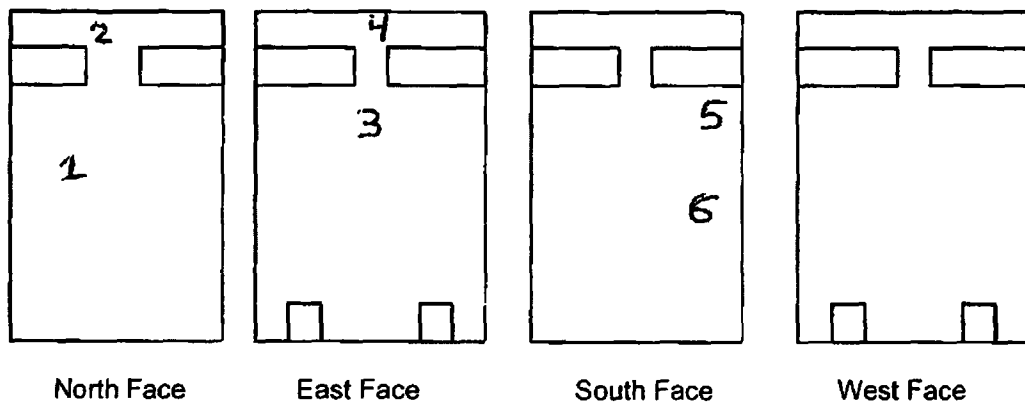
1. Bug Hole Approx 1.0" L x .25" D
2. Bug Hole Approx .6" L x .5" D
3. Bug Hole Approx .5 L x .4 D
4. Bug Hole Approx .75 L x .4 D
5. Bug Hole Approx 1.1" x .5 D
6. Bug Hole Approx 1.2" x .3" D
