# **San Onofre Nuclear Generating Station, Unit 2 & 3** **REPLACEMENT STEAM GENERATORS**

## **Root Cause Analysis Report for tube wear identified in the Unit 2 and Unit 3 Steam Generators of San Onofre Nuclear Generating Station**

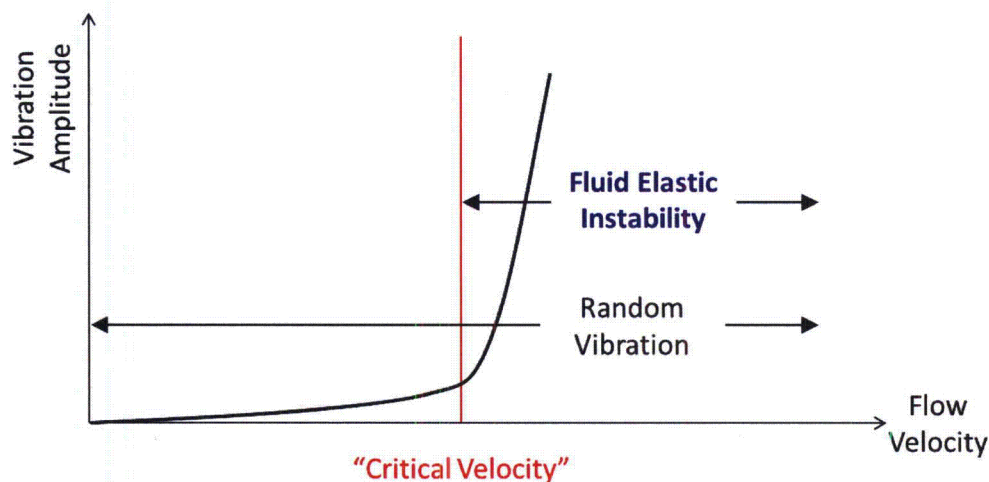
Figure 1

Fluid Elastic Instability (FEI) is a term used to describe a range of tube vibrations that starts at a point on a curve of vibration amplitude versus flow velocity. As depicted in Figure 1, one axis (Y) of that curve is vibration amplitude and the other (X) is flow velocity. The graph shows that as flow velocity increases vibration amplitude increases at a small linear rate until it reaches a point where the slope of the curve increases abruptly. The point in the curve where the slope changes is termed "critical velocity". The critical velocity is a function of several variables. These include tube natural frequency, which is dependent on the tube geometry and support conditions, damping,

which is a function of the steam-to-water ratio, flow velocity, which is dependent of the tube spacing.

As discussed below and in the technical reports referenced above (See Supplemental Technical Evaluation Report), MHI has determined that, due to ineffective support for the tubes in the in-plane direction resulting from the very small and uniform tube-to-AVB gaps, some of the tubes exceeded the fluid elastic critical velocity resulting in in-plane FEI, which in turn produced the large amplitude tube-to-tube wear. This mechanism is influenced by the local thermal hydraulic conditions around the tube. Regions of high void fraction have lower tube damping, which reduces the fluid elastic critical velocity threshold. High void fraction regions also have higher cross flow velocities. Therefore, tubes with low or no contact force in the region of highest void fraction are most susceptible to this mechanism.

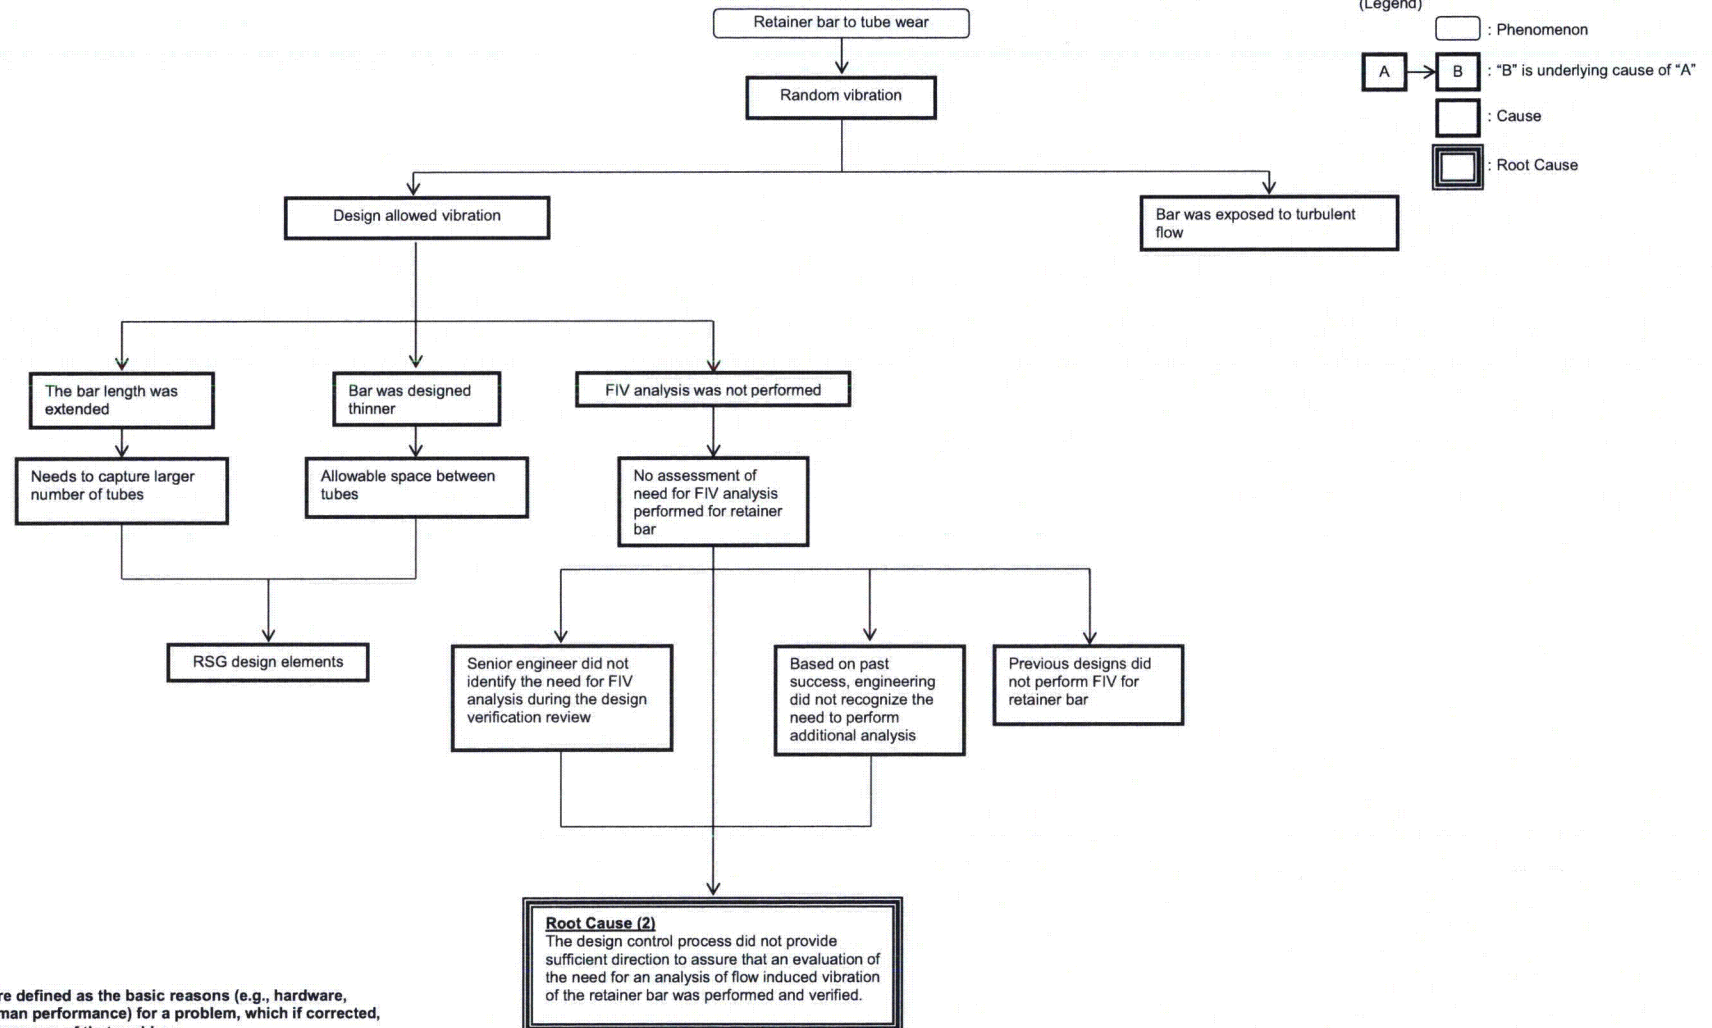
## Cause-effect analysis for the retainer bar to tube wear

The tubes exhibiting retainer bar wear have no indications of tube-to-tube or tube-to-AVB wear, which indicates that the wear is caused solely by retainer bar vibration. The SONGS RSGs have two types of retainer bars: [ ] diameter and [ ] diameter. Tube wear was only found on tubes adjacent to the smaller diameter retainer bars. The retainer bars with the smaller diameter have a relatively long span as compared with those for other SGs fabricated by MHI, which means that the natural frequency of these retainer bars is lower, making them more

likely to vibrate. This type of wear is caused by random flow-induced vibration of the retainer bars caused by the secondary fluid exiting the tube bundle.
