Re: **Summary of the thirteenth Weekly Inspection of Lost Creek ISR LLC's Permit 788**

Wyoming Department of Environmental Quality (WDEQ)- Land Quality Division (LQD)
Inspection Memorandum

File: Lost Creek ISR, LLC – Permit 788

Subject: Thirteenth Weekly Inspection

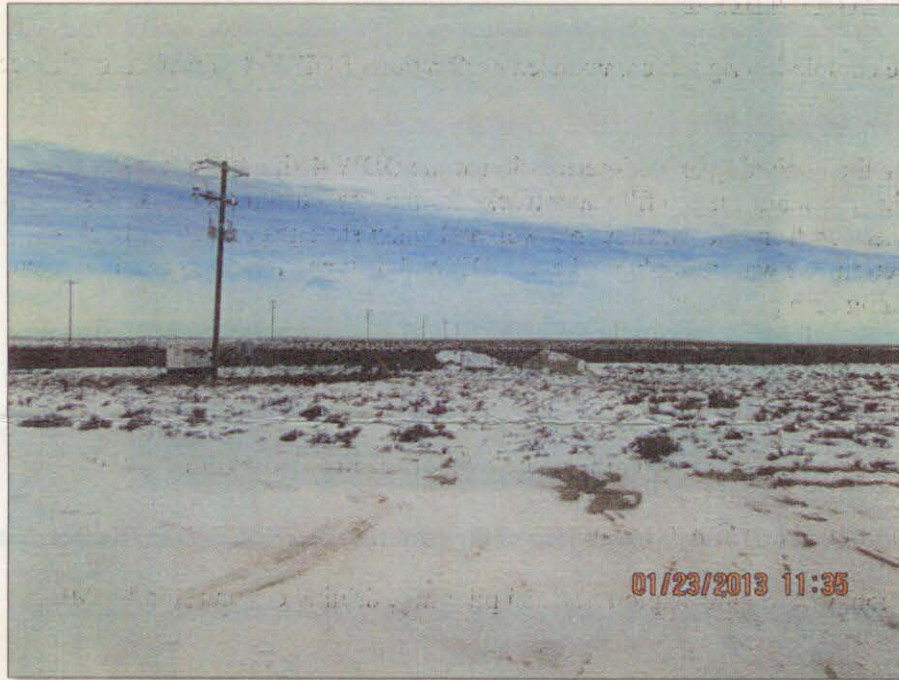
DDW-3: With the beginning of well-perforation at the DDW-4 site, the water storage tanks at the DDW-4 site are no longer being used to fill water trucks for the site's drilling efforts. Instead, drilling water is being solely derived from the water supply well and water storage pond at the DDW-3 drill pad. Since the last Inspection, the water supply well at the DDW-3 drill pad is now hooked up to electrical power. It had been running on a generator previously.

Photo Number 1: This depicts the water supply well immediately west of the DDW-3 drill pad. Note the power line next to the well. The well is now hooked up to electricity from the power line.

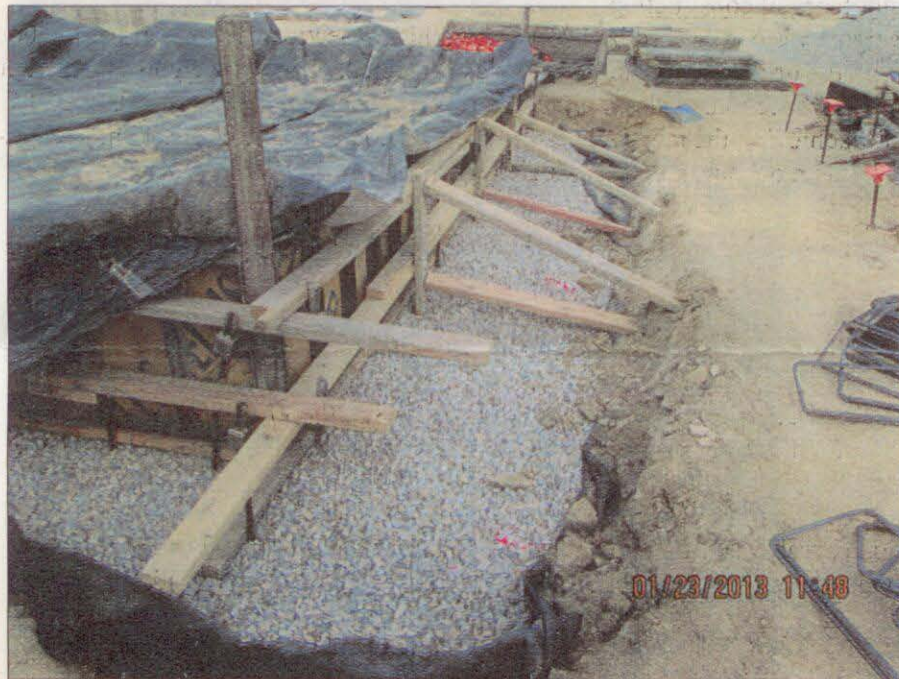
Photo Number 2: This depicts the "57 Rock" (an ASTM standard) underlain by geotextile. This combination will underlay all the concrete that is poured for the Plant Site floor (in addition to rebar).

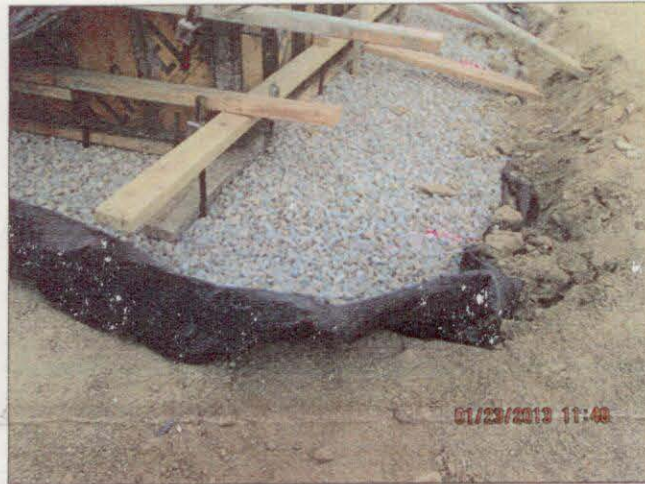
Photo Number 3: This is a closer view of the geotextile depicted in Photo Number 2 above.

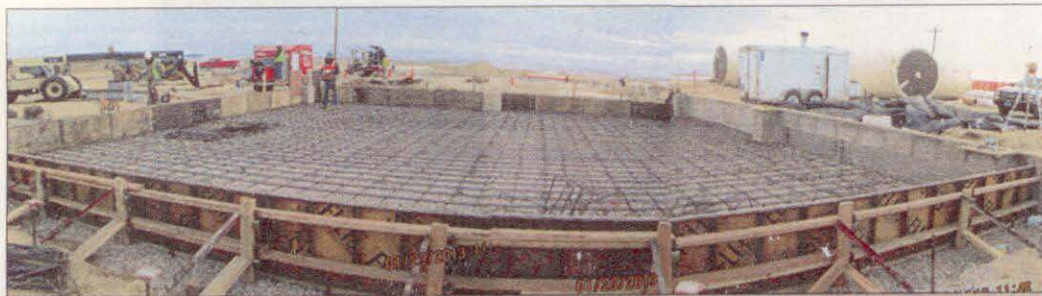
Photo Number 4: This depicts an area in the future floor of the Plant Site that has been secured with rebar and is underlain with 57 Rock and geotextile fabric.

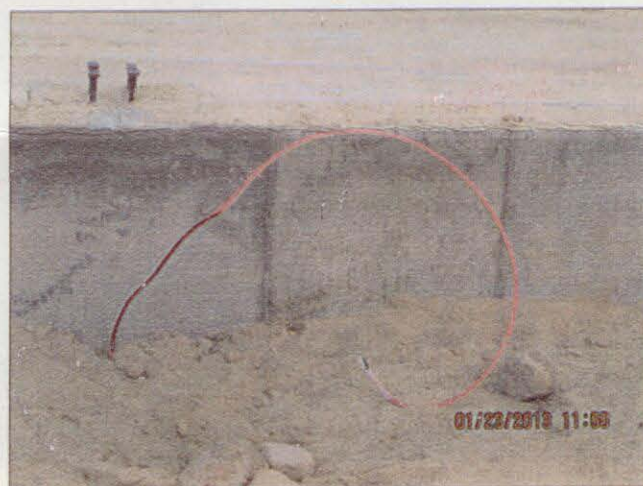
Photo Number 5: This depicts some copper grounding wire along the perimeter of the Plant Site.

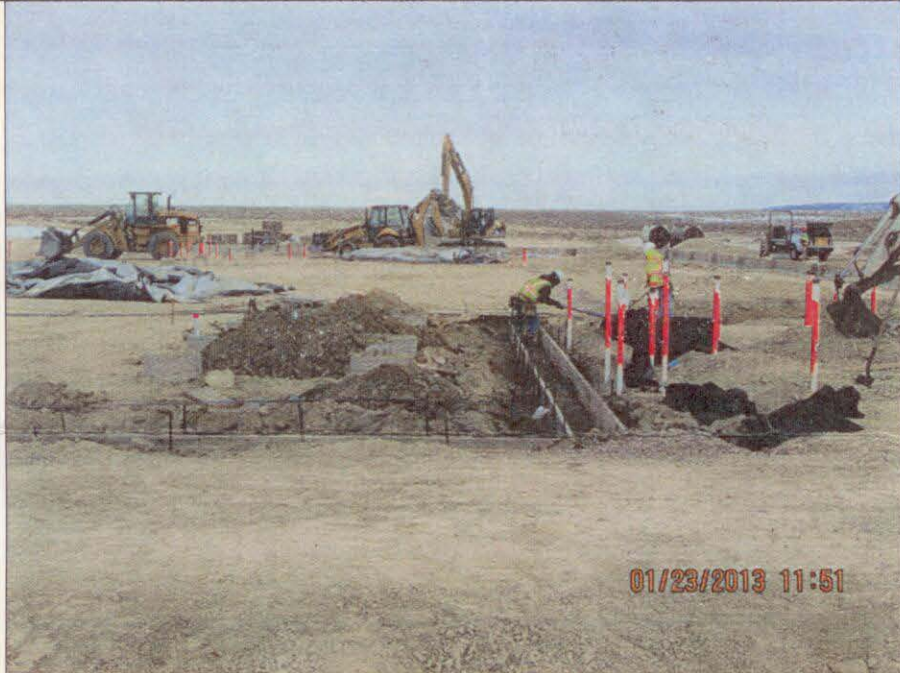
Photo Number 6: This depicts the future foundation for the "Radiation Protection Wall" for the Plant Site. This will become a grout-filled cinder-block wall separating the processing area (opposite and left sides of trenches depicted here) from the office area (the foreground of this picture).

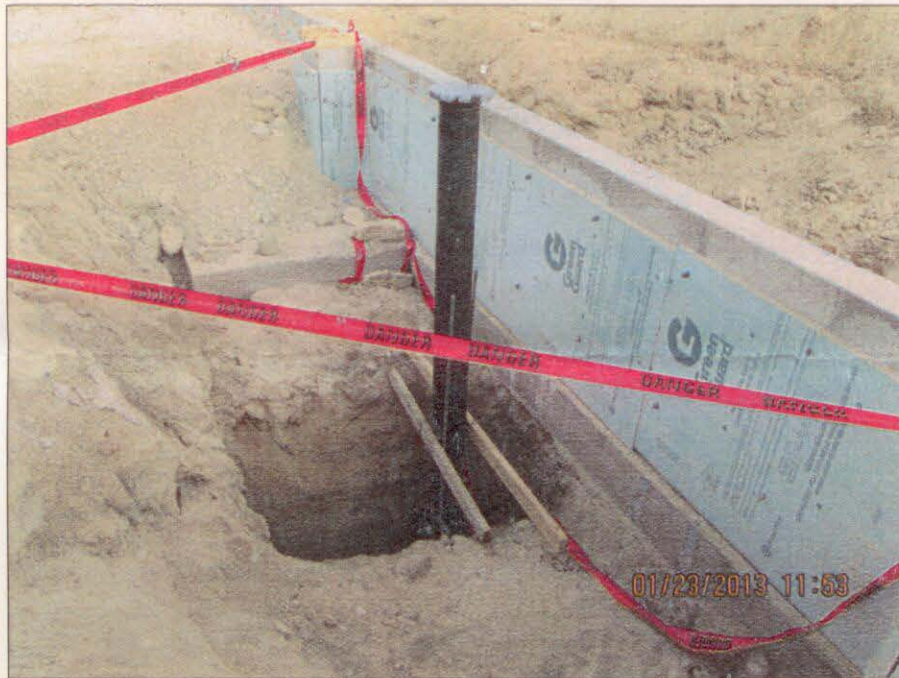
Photo Number 7: This depicts the Fire Protection Riser at the southeast corner of the Plant Site. This is the main water line for fire suppression at the Plant. Prior to pouring concrete in and around this pipe, it must be reinforced to endure sudden pressure changes from being turned on in the case of an emergency.
