Re: **Summary of the sixteenth Weekly Inspection of Lost Creek ISR LLC's Permit 788**

Wyoming Department of Environmental Quality (WDEQ)- Land Quality Division (LQD)
Inspection Memorandum

File: Lost Creek ISR, LLC – Permit 788

Subject: Sixteenth Weekly Inspection

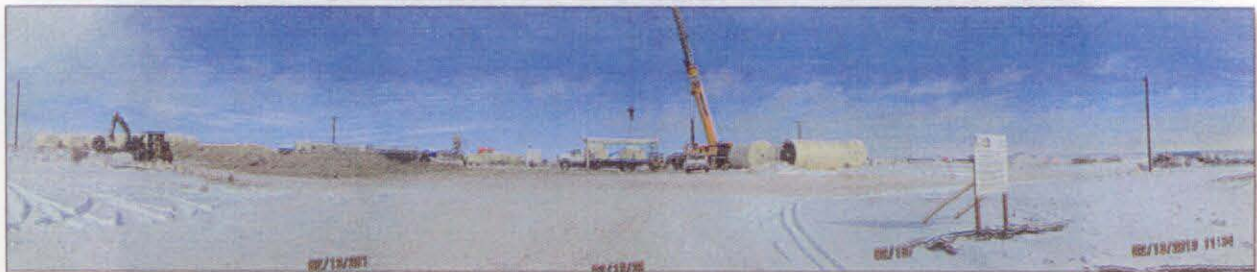
Photo Number 1: This is a panoramic view of the plant site. The crane will be used to install all of the processing tanks.

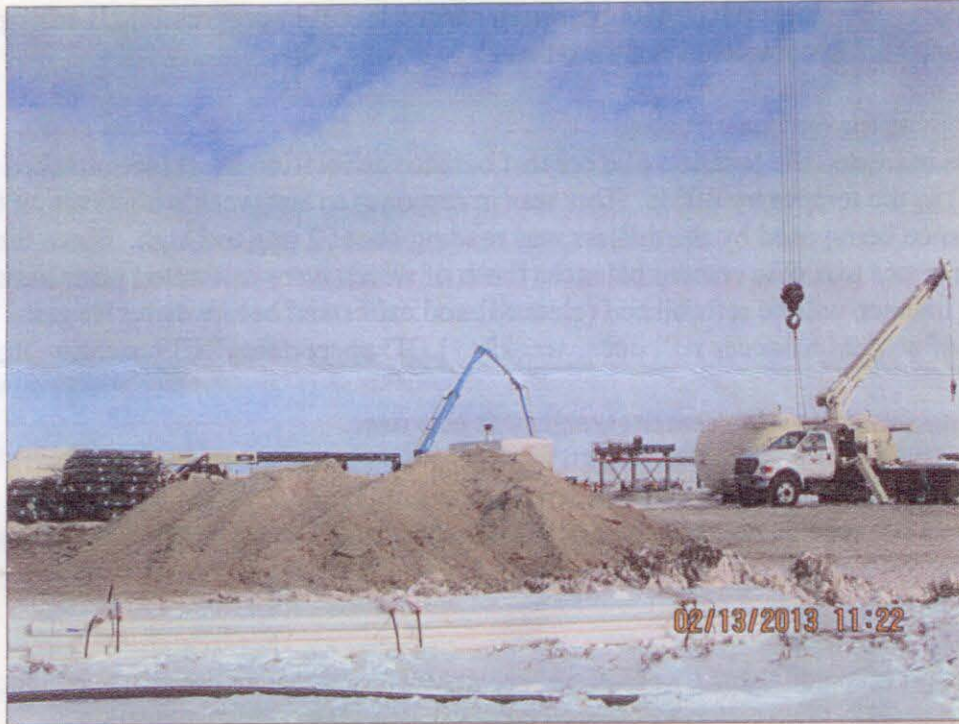
Photo Number 2: This depicts the concrete pumper (blue boom) being used at the plant site.

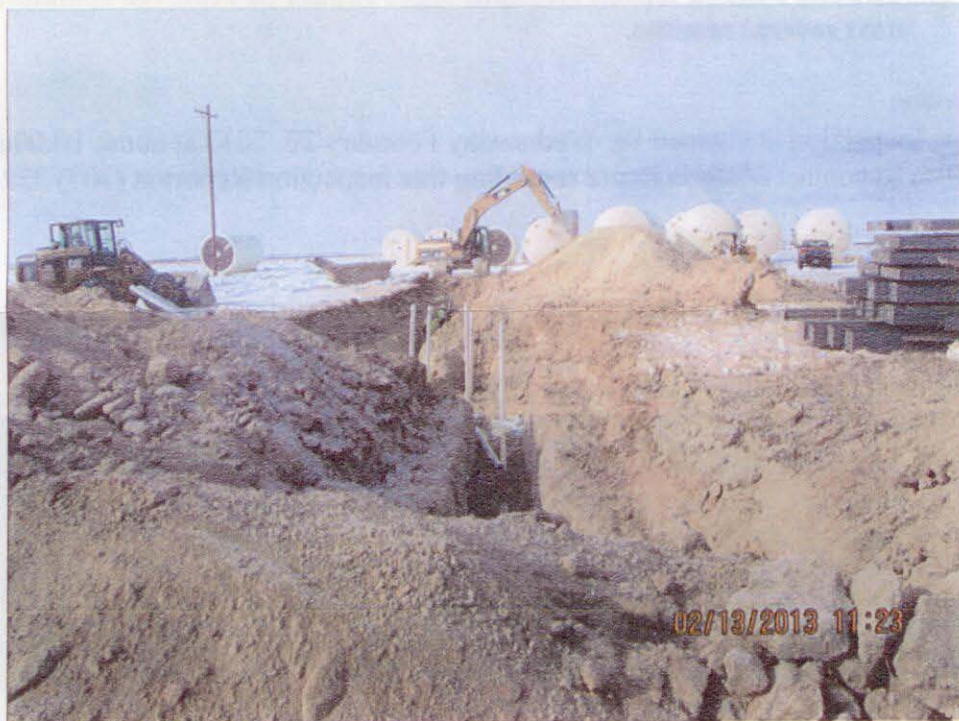
Photo Number 3: This depicts the septic field excavation. Workers were ensuring the correct slope exists in the bottom of the excavation using laser surveying equipment during this Inspection.

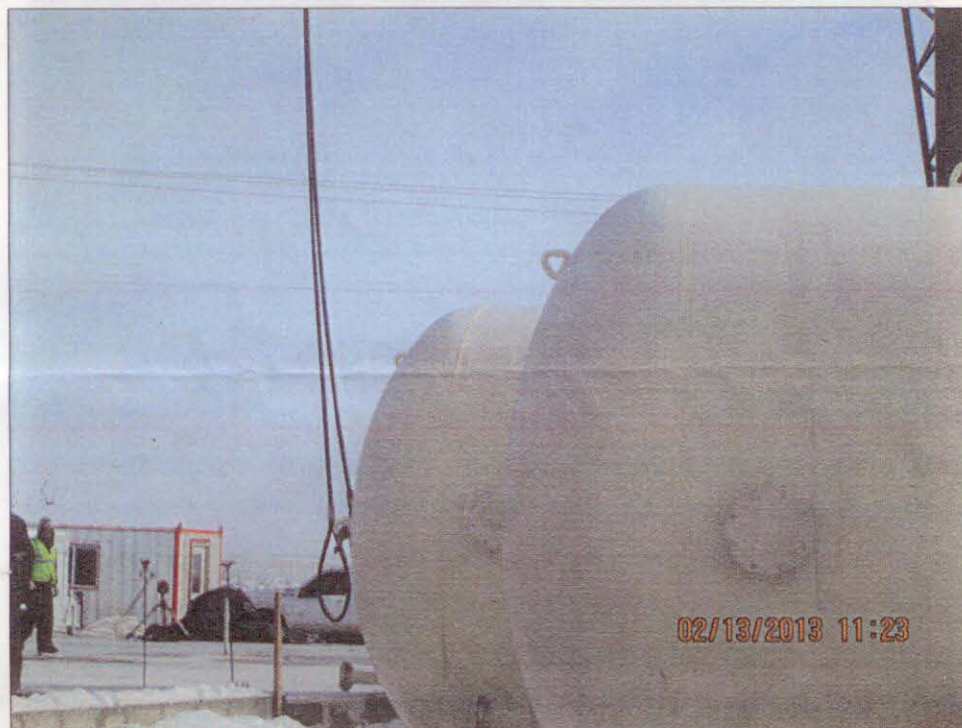
Photo Number 4: This is a close-up of the crane's cable attached to one of the processing tanks.

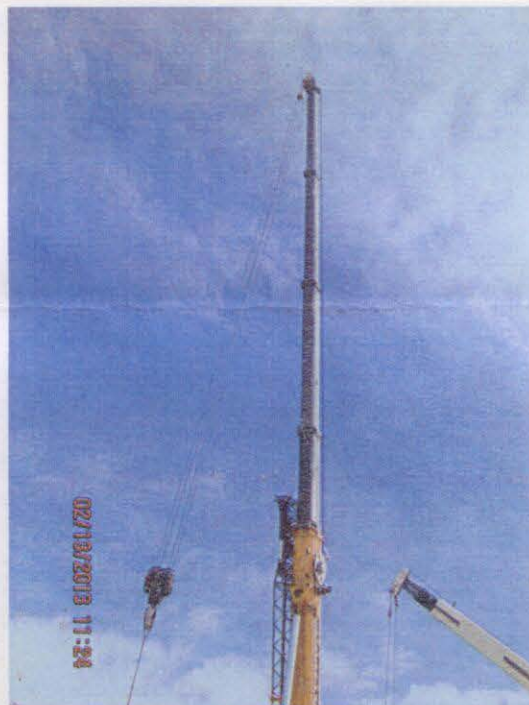
Photo Number 5: This is a view looking up at the boom of the crane.

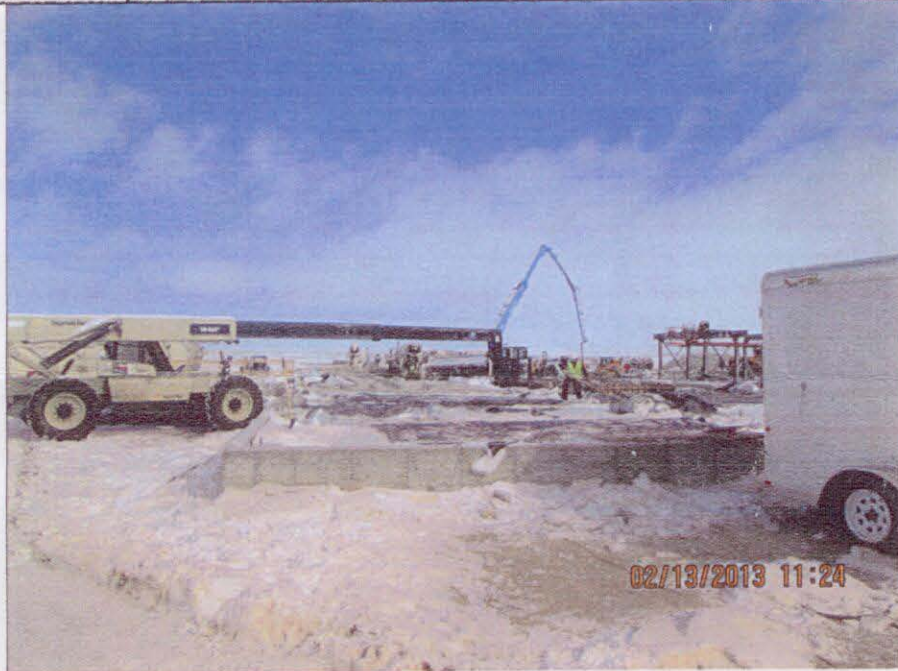
Photo Number 6: This is a ground level view of the activities occurring at the southwest corner of the plant site.

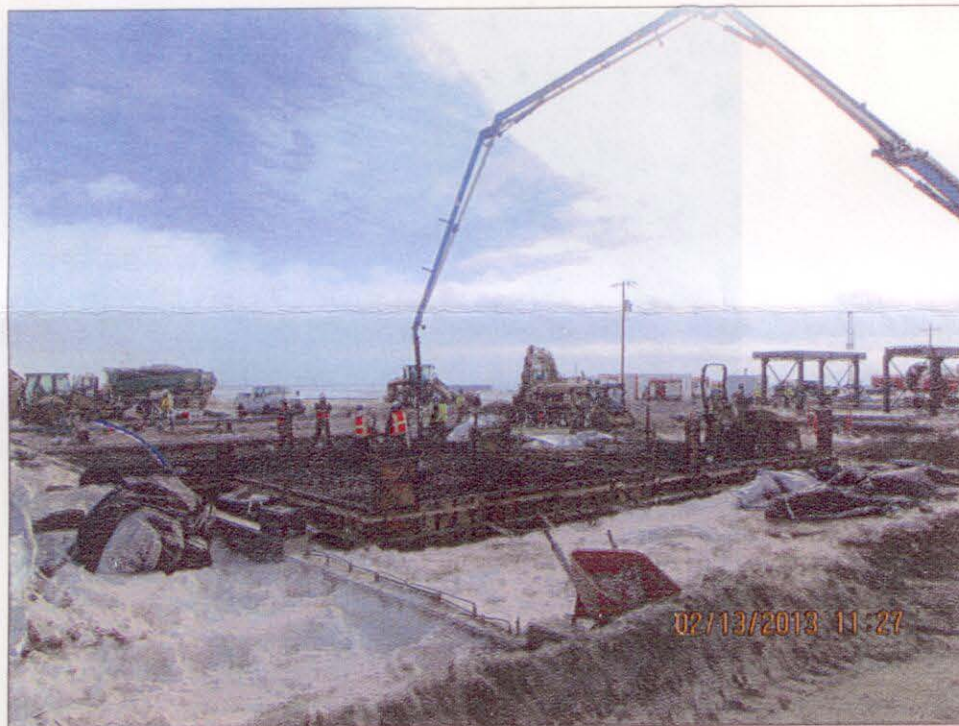
Photo Number 7: This is a closer view of the concrete pumper.

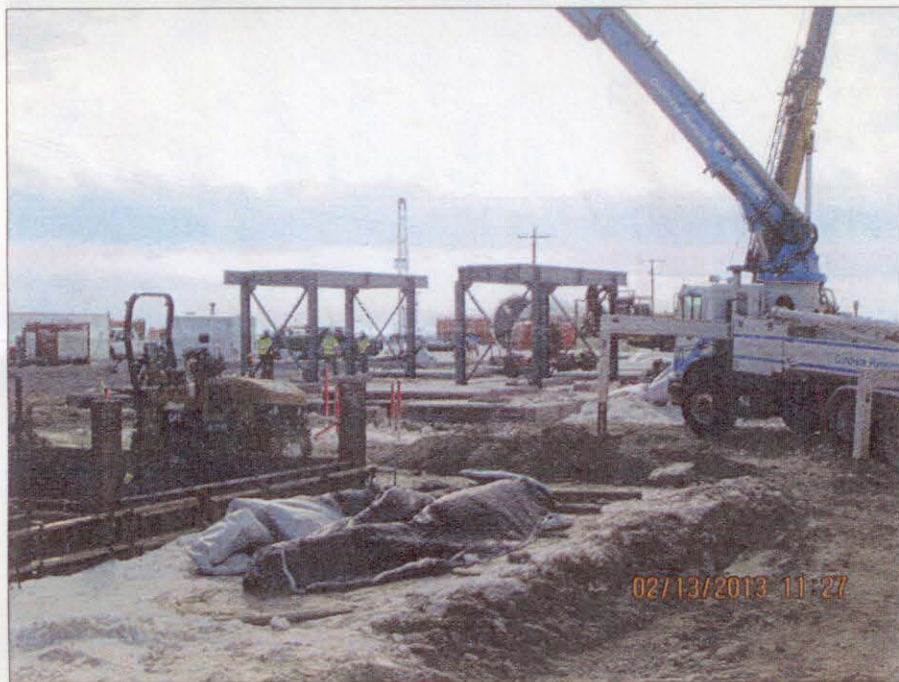
Photo Number 8: This depicts some metal framework that will eventually support a catwalk in the plant.

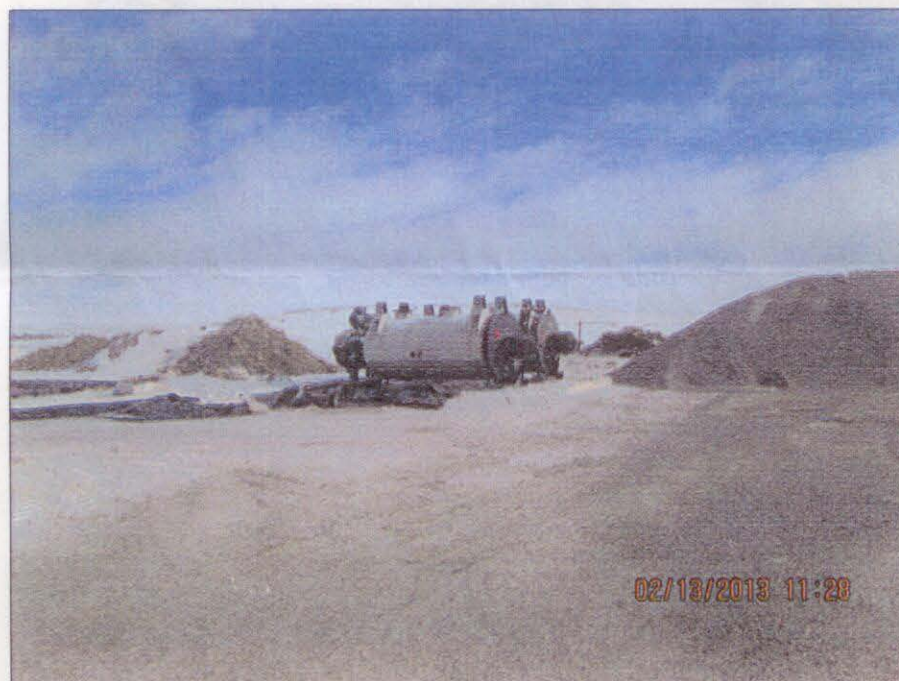
Photo Number 9: This depicts the two vacuum dryers that will be installed in the plant.

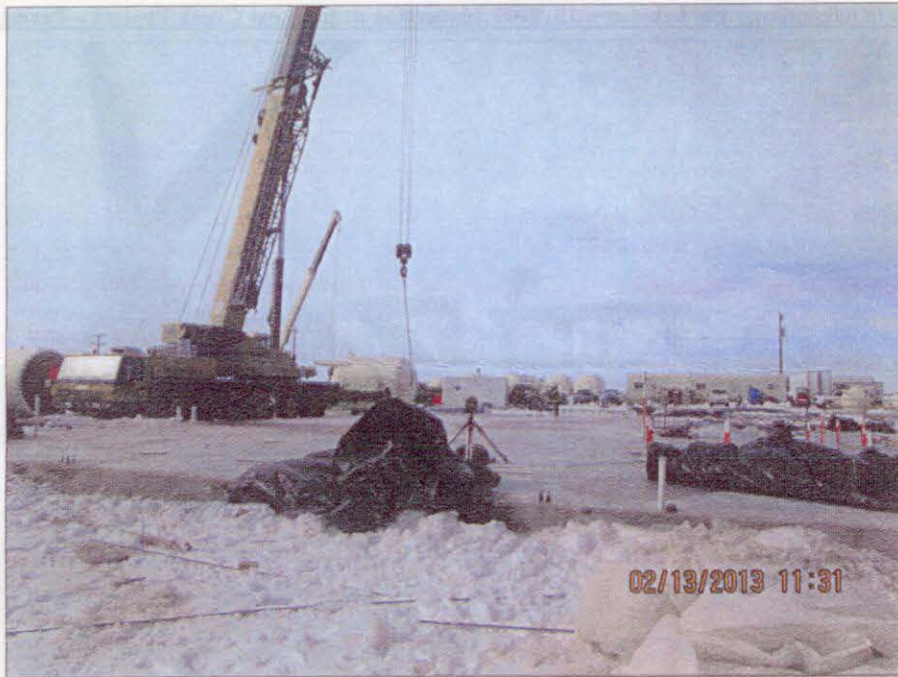
Photo Number 10: This is another view of the crane attached to one of the processing tanks.

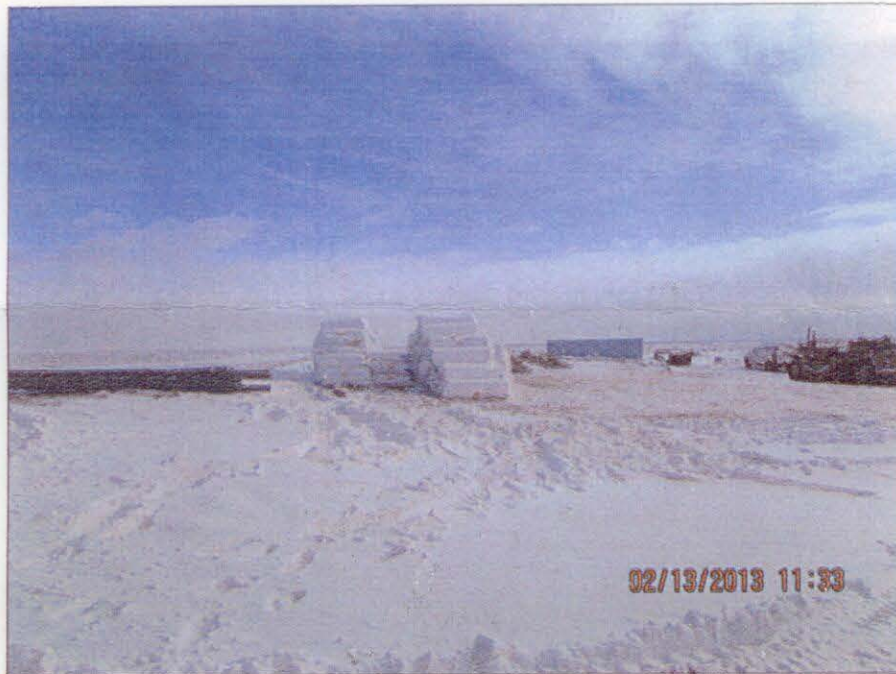
Photo Number 11: These white bags are insulation material that will be used in the walls of the plant building.

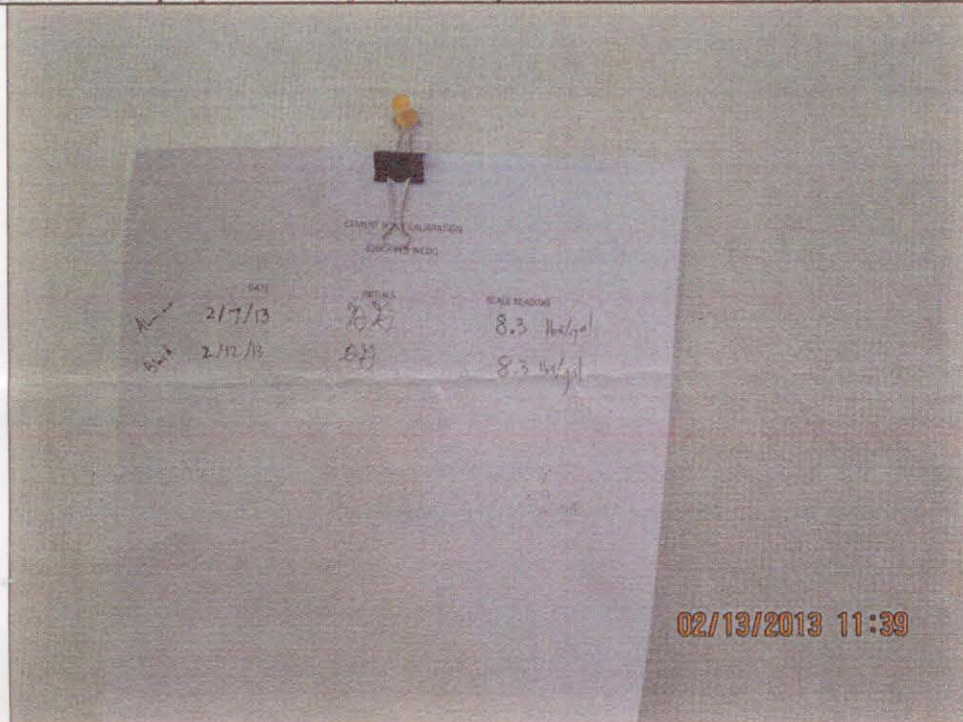
Mr. Lueders indicated the location of a cement balance calibration sheet (see attached Photo Addendum) in the temporary office. This was in response to last week's observation that the cement balance being used by the drillers was reading about 2 ppg too high. Since then, LCI have begun to use two new cement balances (both of which were calibrated prior to use). The old cement balance will be refurbished (cleaned) and calibrated before using it again. The calibration of cement balances will occur weekly. LQD appreciates LCI's attention to this topic.

Photo Number 12: This depicts the calibration check sheet (log) for the cement balances being used at the site. Two are currently being used: one aluminum balance and one black balance.

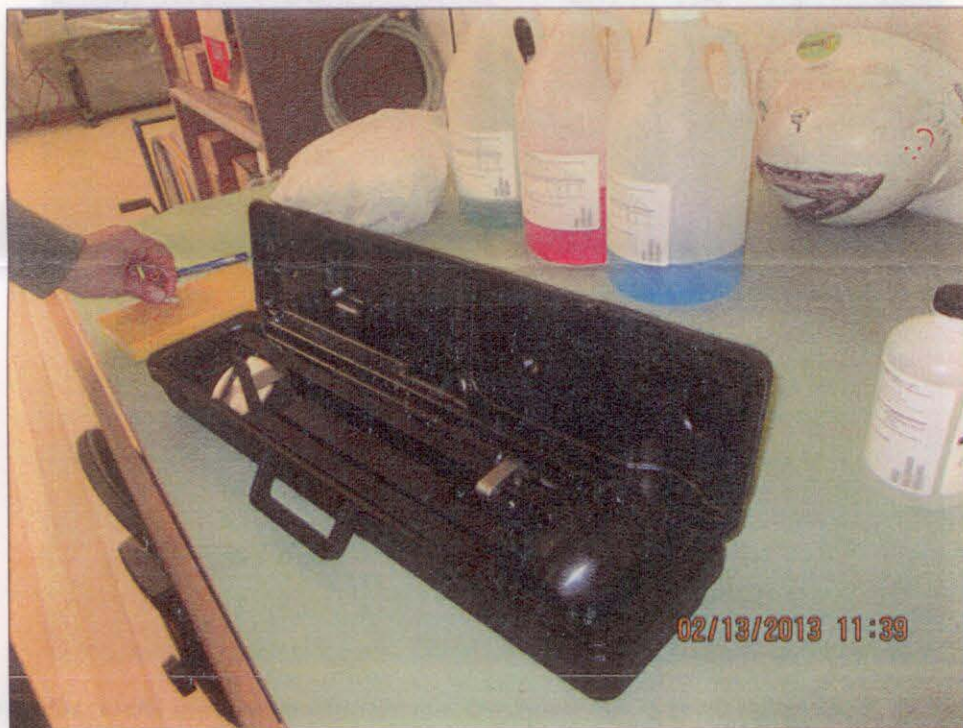
Photo Number 13: This depicts the black cement balance (newly purchased and calibrated).

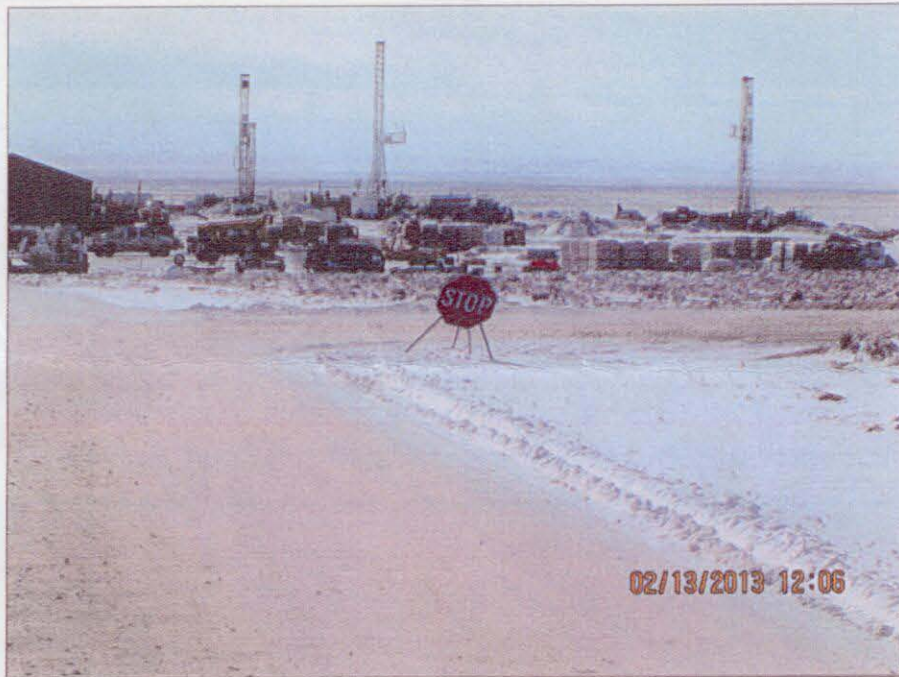
At the site's west entrance (where the haul road meets the Wamsutter-Jeffrey City Road), a speed limit sign and stop sign were noted. Additionally, four stop signs were noted at the intersection of the haul road with the "main" north-south road that connects the plant site with the laydown yard. These signs are welcome additions to the site.

Photo Number 14: This depicts one of the four stop signs at the intersection of the haul road and the road that connects the laydown yard with the plant site. The view is looking south. The drill rigs towered up in the background are in the MU1 Pattern Area. The laydown yard is just beyond this intersection.

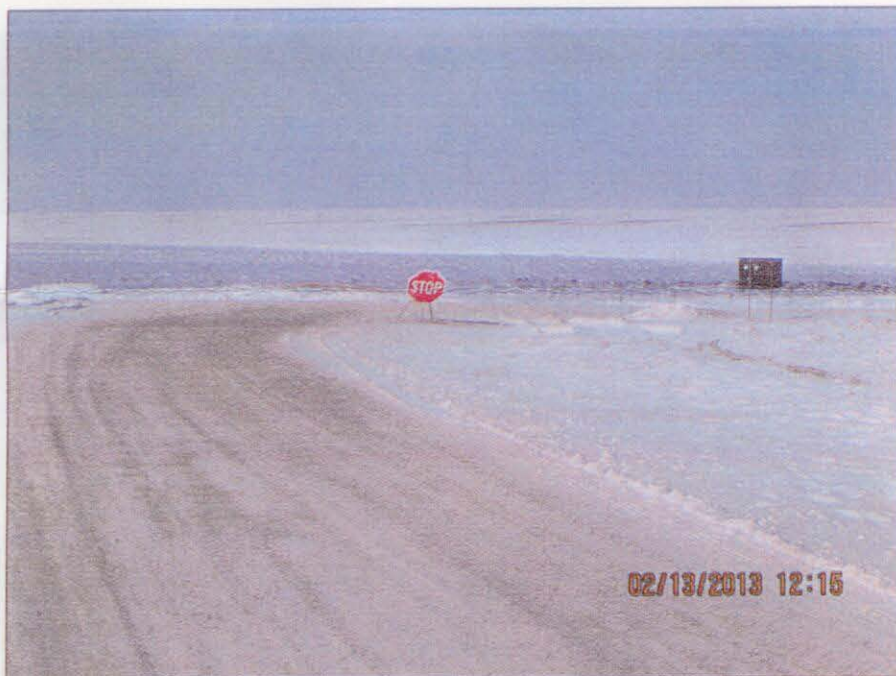
Photo Number 15: This depicts the stop sign facing westbound traffic on the west haul road where it meets the Wamsutter-Jeffrey City Road (County Route 4-23) at a "T"-intersection.

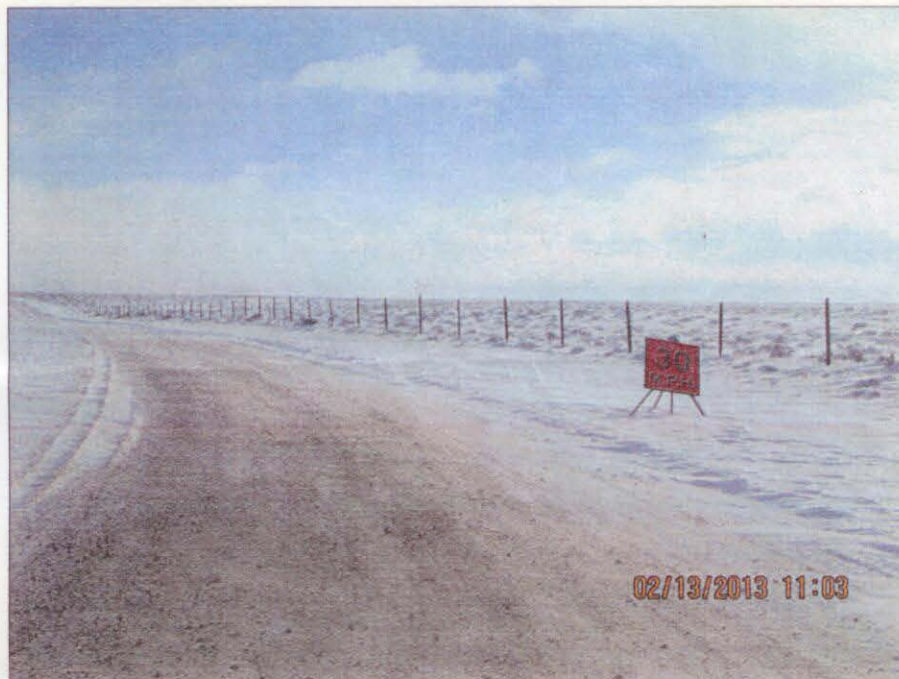
Photo Number 16: This depicts the speed limit sign that is located at the west entrance to the site, facing eastbound traffic; I.e. where the west haul road begins at its intersection with County Rte. 4-23.

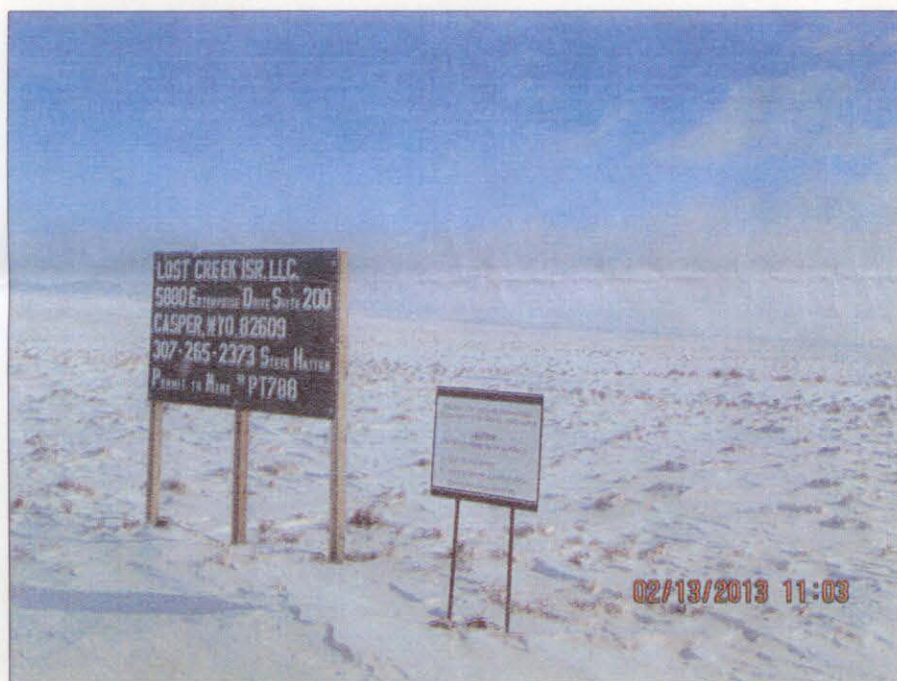
Photo Number 17: This depicts the signs posted at the beginning of the west haul road. It is at the northeast corner of the intersection of the west haul road where it meets County Rte. 4-23.
