From: Wideman Steve G
Sent: Tuesday, February 26, 2013 8:29 AM
To: 'Lyon, Fred'
Cc: Muilenburg William T; Peabody Charles A; 'Ron.Kopriva@nrc.gov'; Wagner Pat G; Herrman Paul J; Broschak John P; Westman Mike J; Fredrickson Kenneth L
Subject: RE: Steam Generator Inspections for Upcoming RFO

Fred - in accordance with the below email of February 1, 2013, this email is to make you aware of two items identified during the current refueling outage Steam Generator (SG) Inspections. If it is determined that a conference call is needed, please let Bill Muilenburg and myself know.

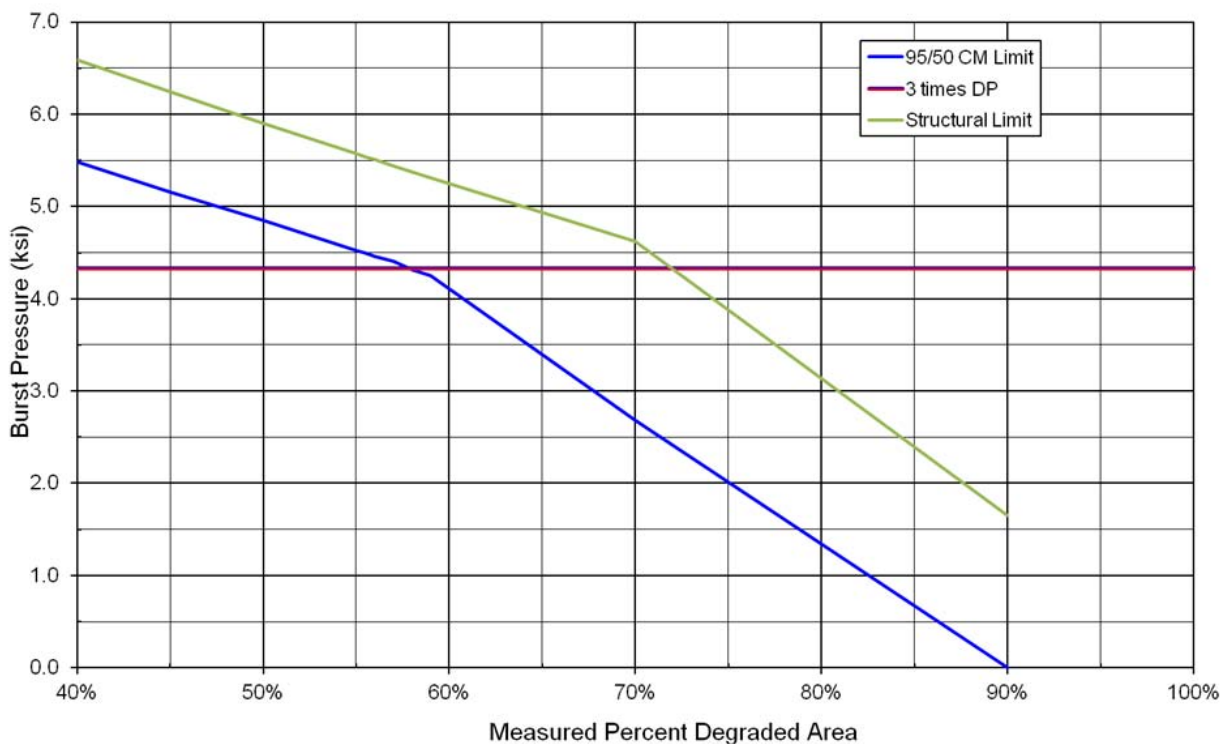
Related to Item 2, See the following graph related to the Condition Monitoring limit for the circ indication.

The steeper slope is tensile instability which relates to separation within the tubesheet. The shallower slope presumes that tube could bend at top of tubesheet and is conservative relative to locations within the tubesheet. In any case, the allowable percent degraded area (PDA) for 3 delta P considering all uncertainties is 58% and the measured PDA is 11%.

Burst Resistance vs. Percent Degraded Area Acceptance Limit
11/16" x 0.040" Alloy 600TT SG Tubes at 650°F ETSS 20510.1
Indication Measured PDA = 11% assuming through-wall

Item 2 - During the Top-of-Tubesheet eddy current inspection, a circumferential indication was confirmed in SG 'B' Hot Leg (17,89) ~TTS -6.46" which is located at a bulge indication. Due to this indication, 100% of the tubes containing BLG and/or OXP will be inspected in SG 'B' within the inspection region. Also, 20% of the tubes containing BLG and/or OXP within the inspection region for SGs 'A', 'C', and 'D' will need to be inspected. It should be noted that as part of the original inspection program that greater than 20% of the BLG and/or OXP within the tubesheet in SG 'A', 'C', and 'D' are already being inspected. Therefore, currently there is no additional testing required in SG 'A', 'C', and 'D'.
