WCAP-17369-NP
Revision 1

February 2013

ABWR Dryer Operating Experience for STP Units 3 and 4

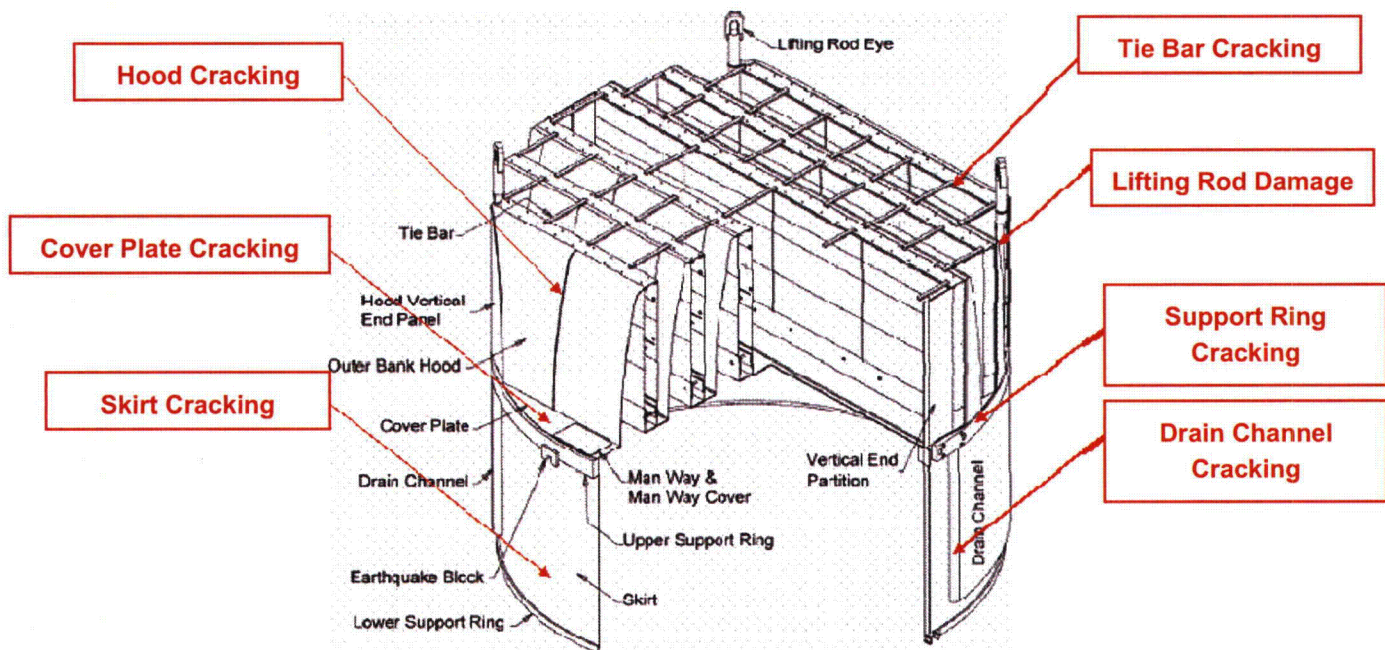
Figure 4-1 Field Cracking in BWR Steam Dryers

Figure 4-1 shows the different locations where cracking has occurred in BWR steam dryers. BWRVIP-139-A Figure 2-51 (Reference 2) shows the number of U.S. BWR plants with steam dryer cracking (by location). It is seen that the support ring and the drain channel welds are the most likely locations for cracking. The details of the cracking, cause and design fixes or repairs are discussed below:

Drain channel cracking has occurred in many U.S. BWR dryers and is attributed to high cycle fatigue and IGSCC. In Type 304 stainless steel dryers, welded regions are subject to weld sensitization and the weld heat affected zone (HAZ) can experience IGSCC. However, even when crack initiation is due to IGSCC, subsequent crack growth can occur due to fatigue. There have been many instances of fatigue cracking in the drain channel welds. The cracks were generally through the throat of vertical welds that attach the side of the drain channel to the exterior of the dryer skirt. The cracks are thought to have originated at the bottom of the drain channel where there is maximum stress in the welds. The high fatigue strength reduction factor at the fillet weld, weld residual stresses and flutter vibration of the relatively thin drain channel are believed to be the contributors to the cracking. The design fixes for the cracking include stop-hole drilling at the crack tip (short term) and increasing the weld size. The weld was also modified to wrap around the bottom of the attachment (where the drain channel is open at the end) to eliminate the sharp notch.

Support ring cracking has been found in many U.S. BWRs (at least 19 plants). The accepted cause of cracking has been IGSCC with potential contributors being weld sensitization and cold working during the fabrication process. Unlike fatigue crack growth, IGSCC crack growth rates decrease as the crack driving force from the residual stress attenuates. Most plants with support ring cracking have chosen to monitor the cracks and no repairs are planned.

Tie bar fatigue cracking has been reported in several U.S. BWR plants. The tie bars connect different dryer banks and increase the overall stiffness of the dryer. Fatigue cracking has been observed in plants with slender tie bars made of angle iron. The fact that plants with stiffer tie bars have not experienced fatigue cracking suggests that the potential for cracking is related to the size of the cross section of the tie bar itself.

Outer hood cracking has occurred in 11 U.S. BWR plants, more often so in square hood design dryers. These hood cracks were attributed to high cycle fatigue. The curved hood provides higher structural capability when compared to the square hood designs. The fix for the hood cracking has been to increase the weld size and in some cases, increase the thickness of the hood plate.

Skirt cracking has been associated with drain channel cracking (i.e., the location of skirt cracking is near the drain channel welds). The cracking is believed to be due to a combination of IGSCC and fatigue.

Lifting rod cracking has been due to a combination of weld HAZ IGSCC and fatigue cracking in tack welds and bracket attachments. They have been fixed by removing the cracks and performing weld repair.
