SUBJECT: MITSUBISHI HEAVY INDUSTRIES – REQUEST FOR WITHHOLDING ROOT
CAUSE ANALYSIS AND SUPPLEMENTAL TECHNICAL EVALUATION REPORT
INFORMATION FROM PUBLIC DISCLOSURE

REPLACEMENT STEAM GENERATORS

Root Cause Analysis Report for tube wear identified in the Unit 2 and Unit 3 Steam Generators of San Onofre Nuclear Generating Station

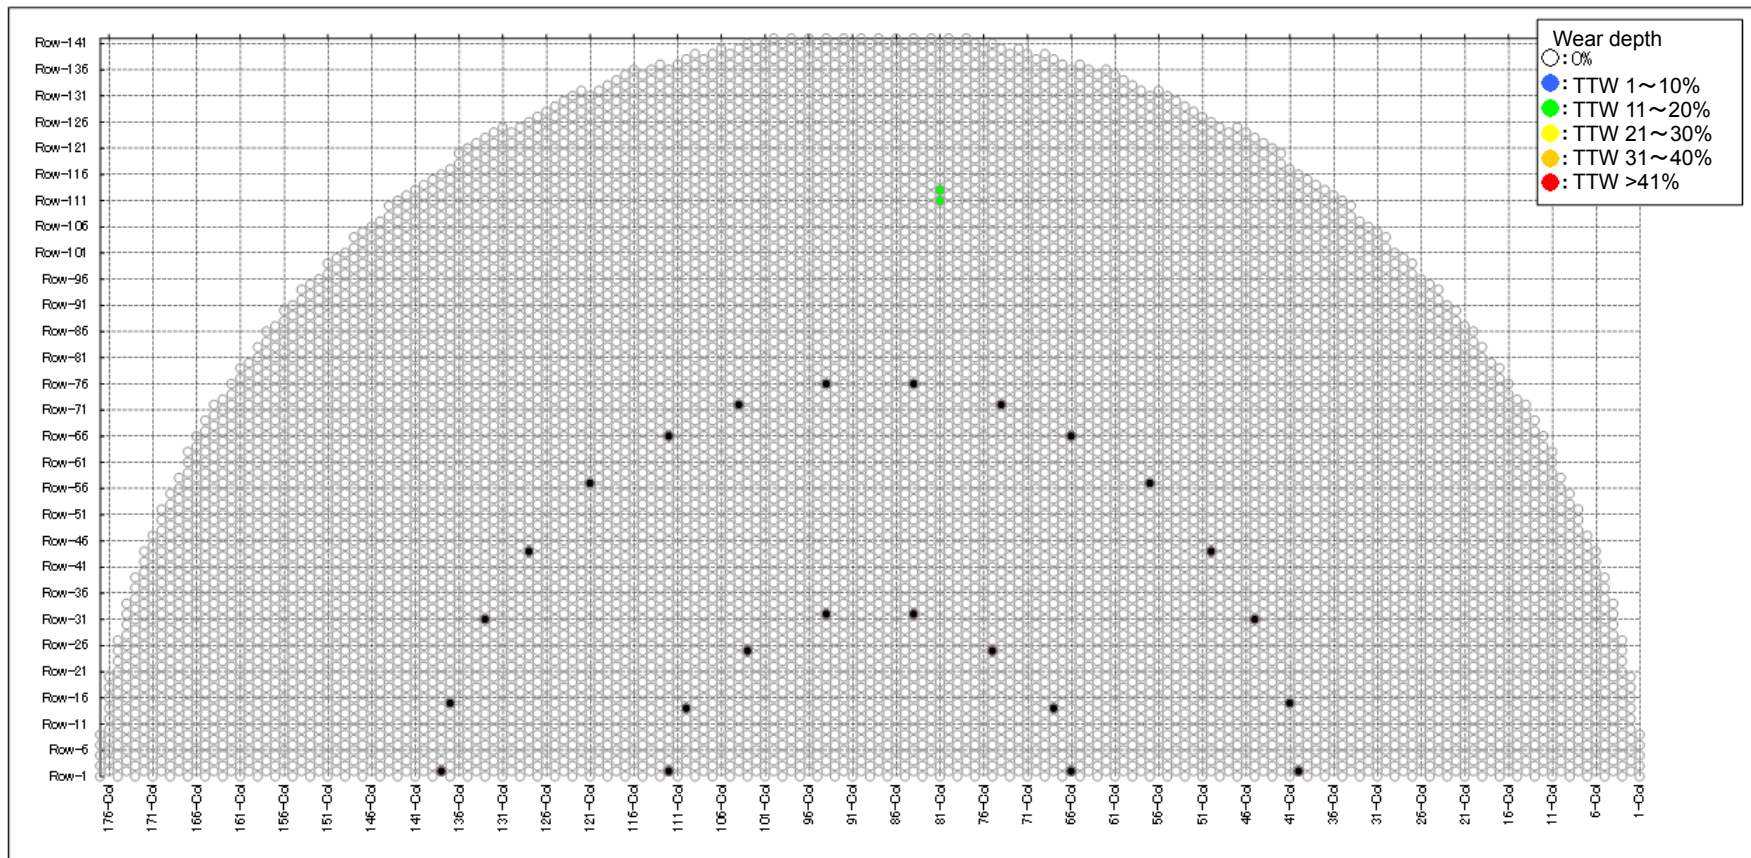
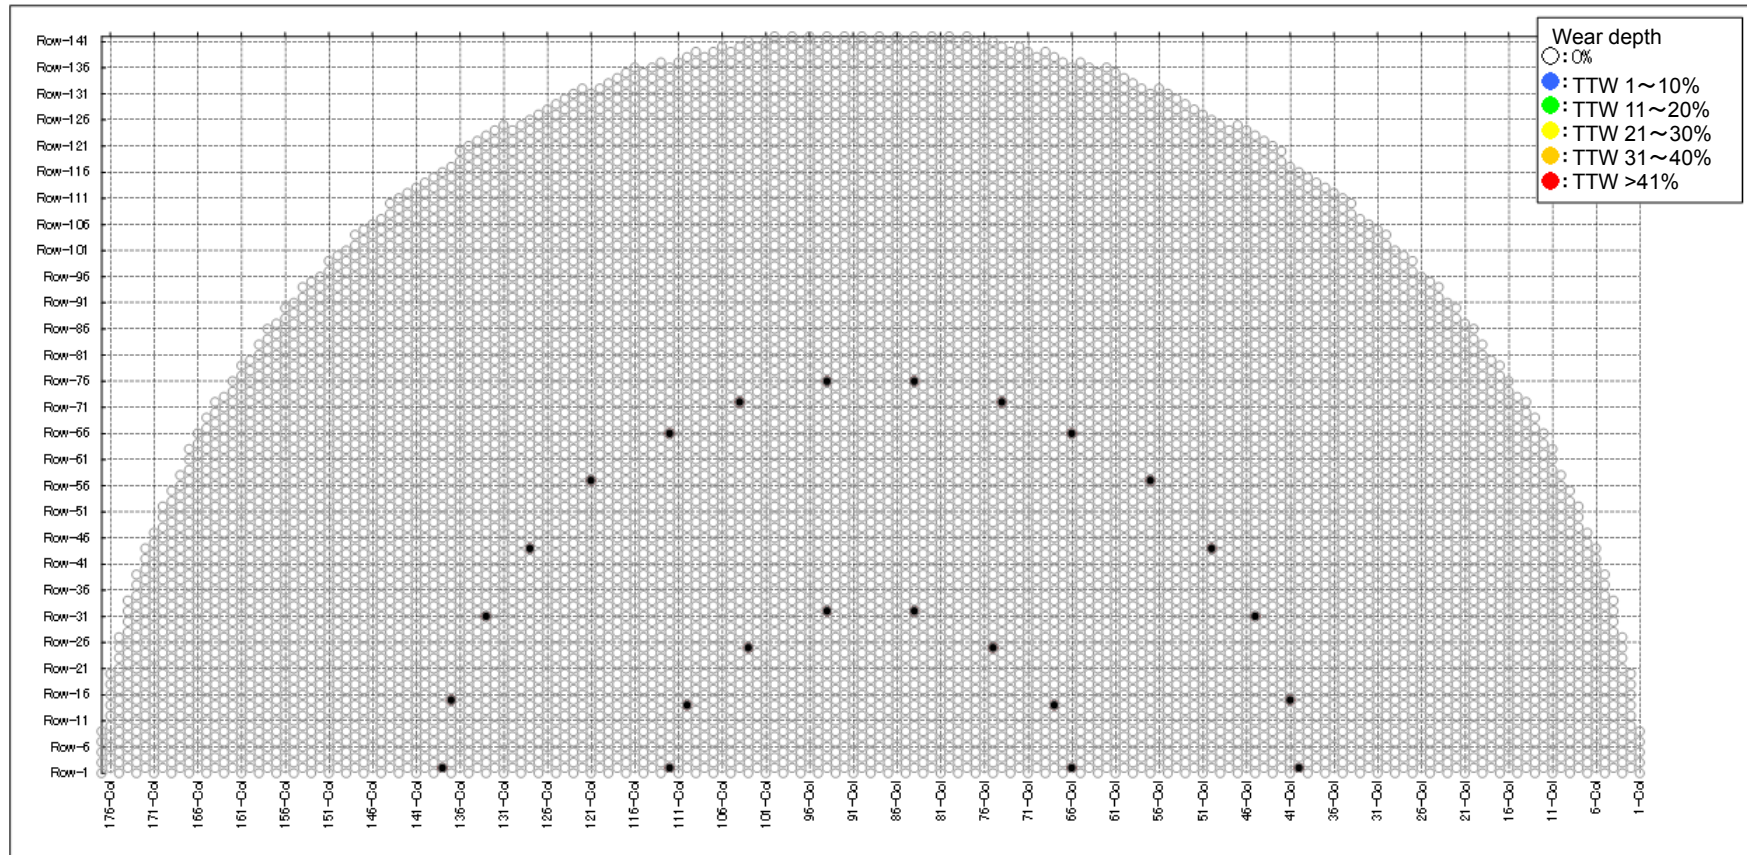
This pattern of wear reflects large amplitude displacement of the tubes in the in-plane direction. Those tubes with the large amplitude displacements also have significant wear at the top tube support plate (TSP 7) (See L5-04GA571 the latest revision (Ref. 3)), which is consistent with large displacement of tubes in the in-plane direction without in-plane AVB support.

Fig 2.1-1 (1/2) Unit 2 Tubes with TTW indications

Fig 2.1-1 (2/2) Unit 2 Tubes with TTW indications

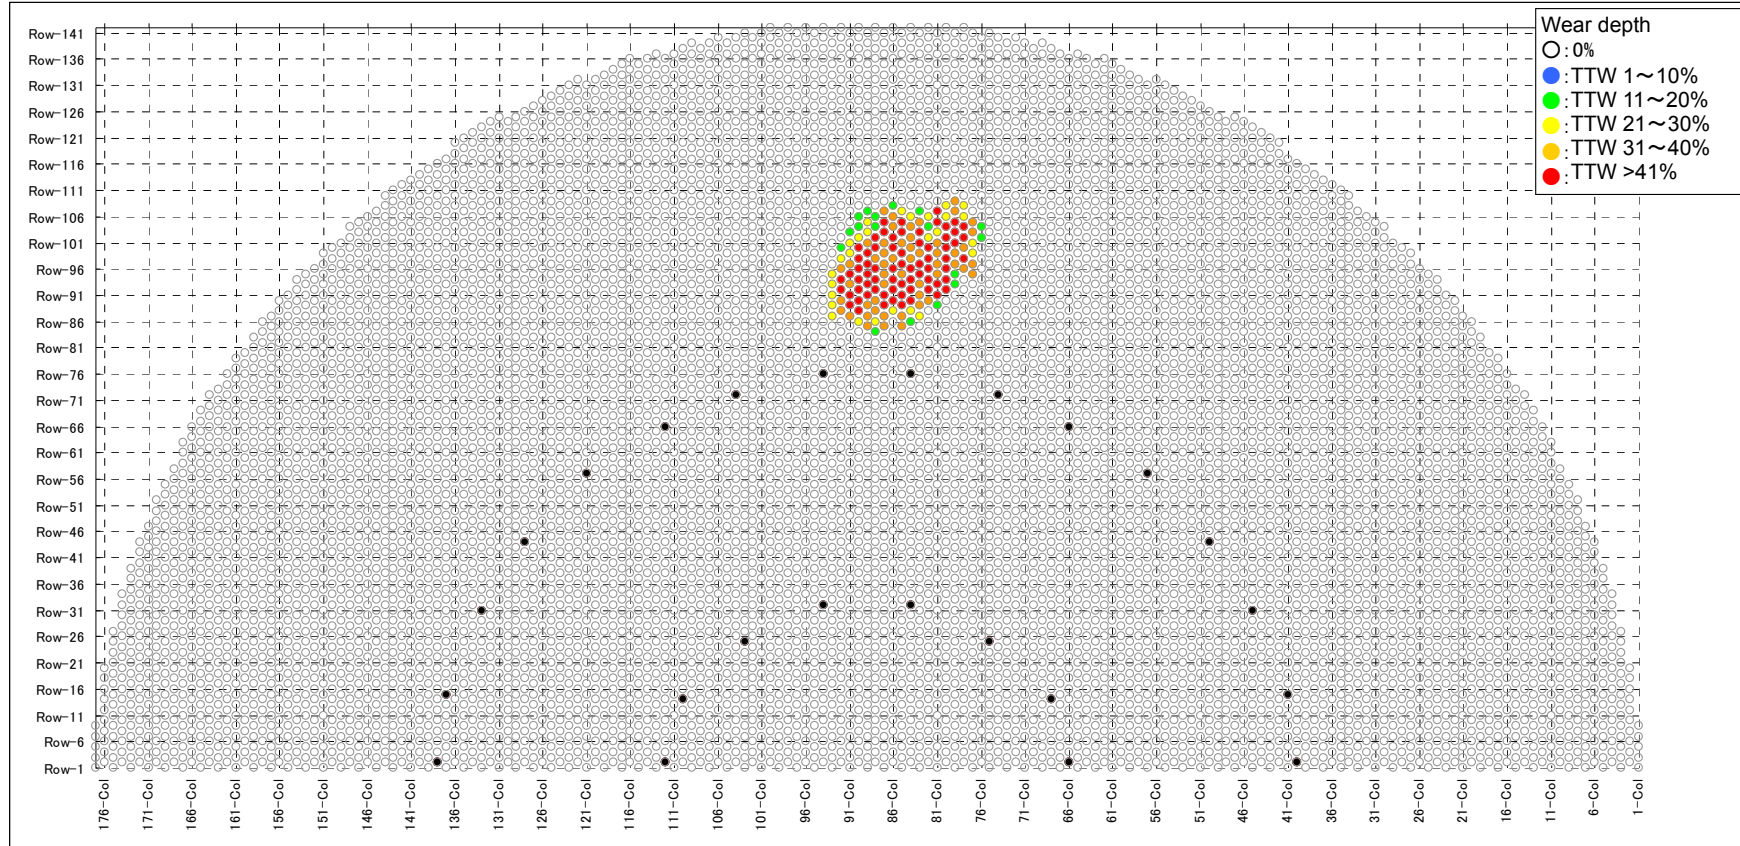
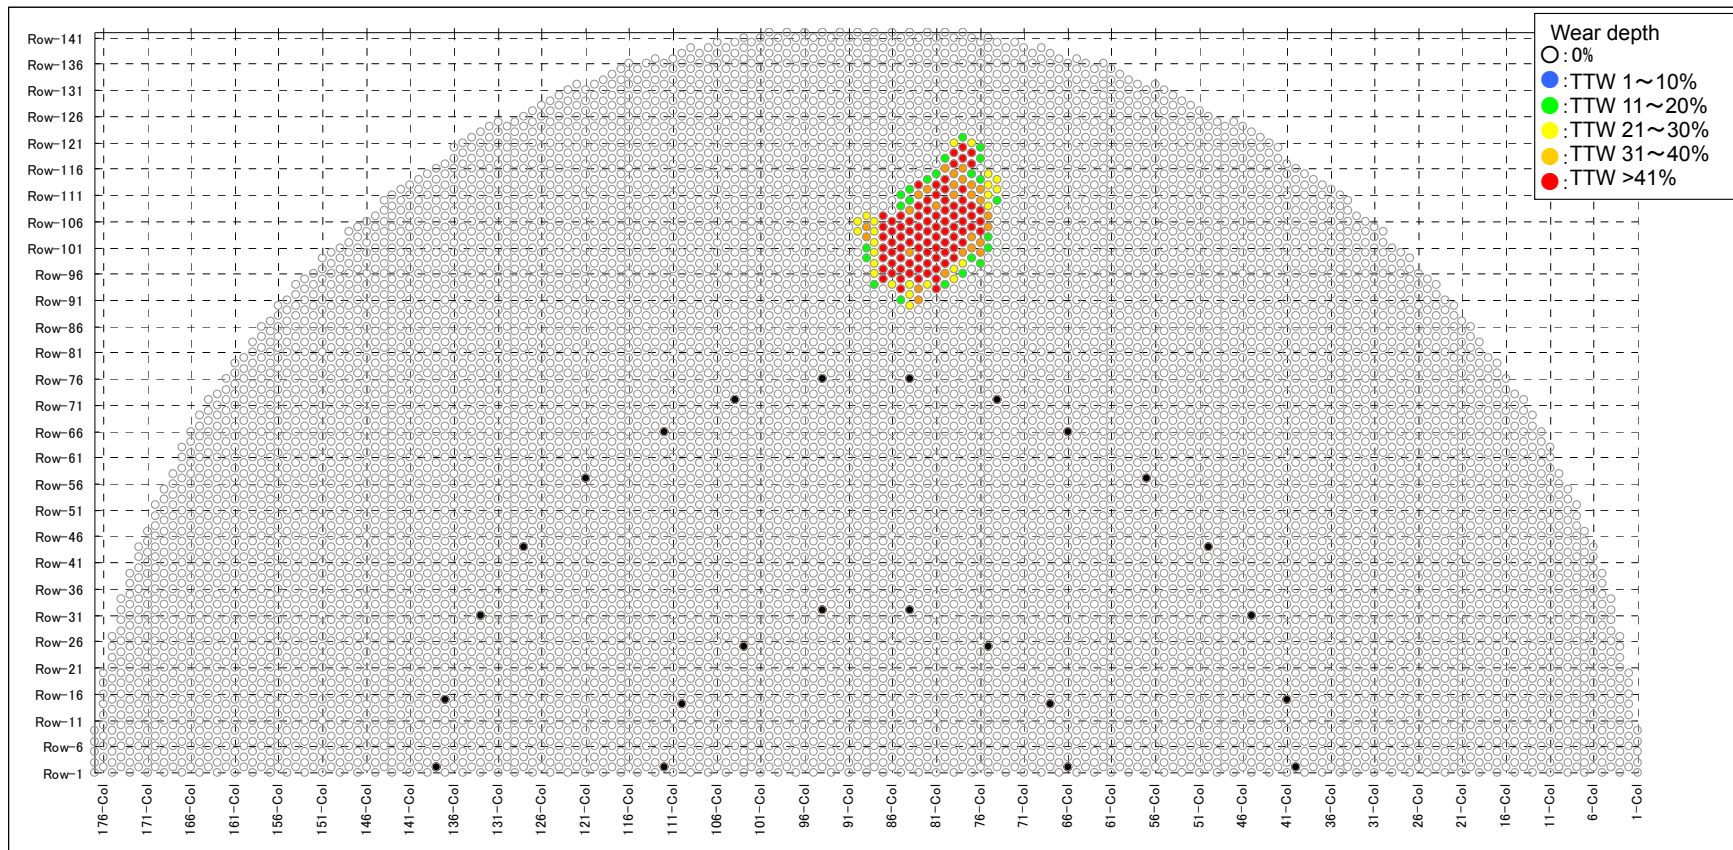
3A-SG (Unit 3 E089)

Fig 2.1-2 (1/2) Unit 3 Tubes with TTW indications

Fig 2.1-2 (2/2) Unit 3 Tubes with TTW indications

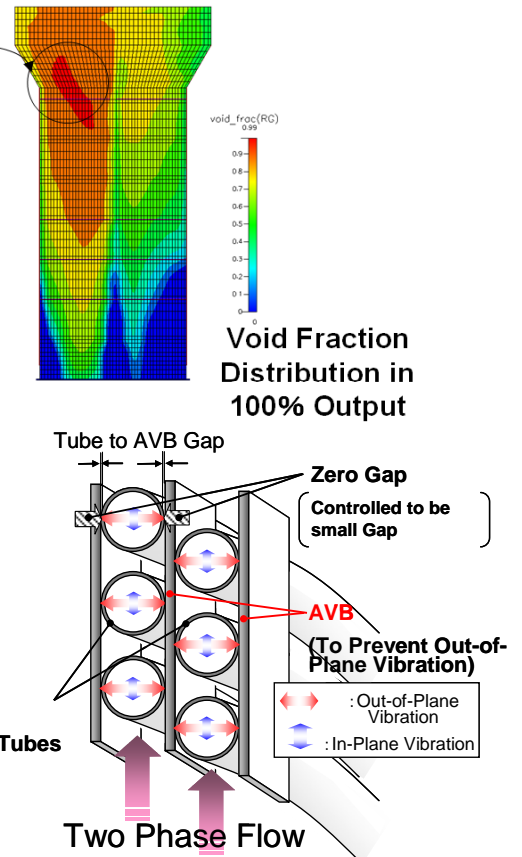
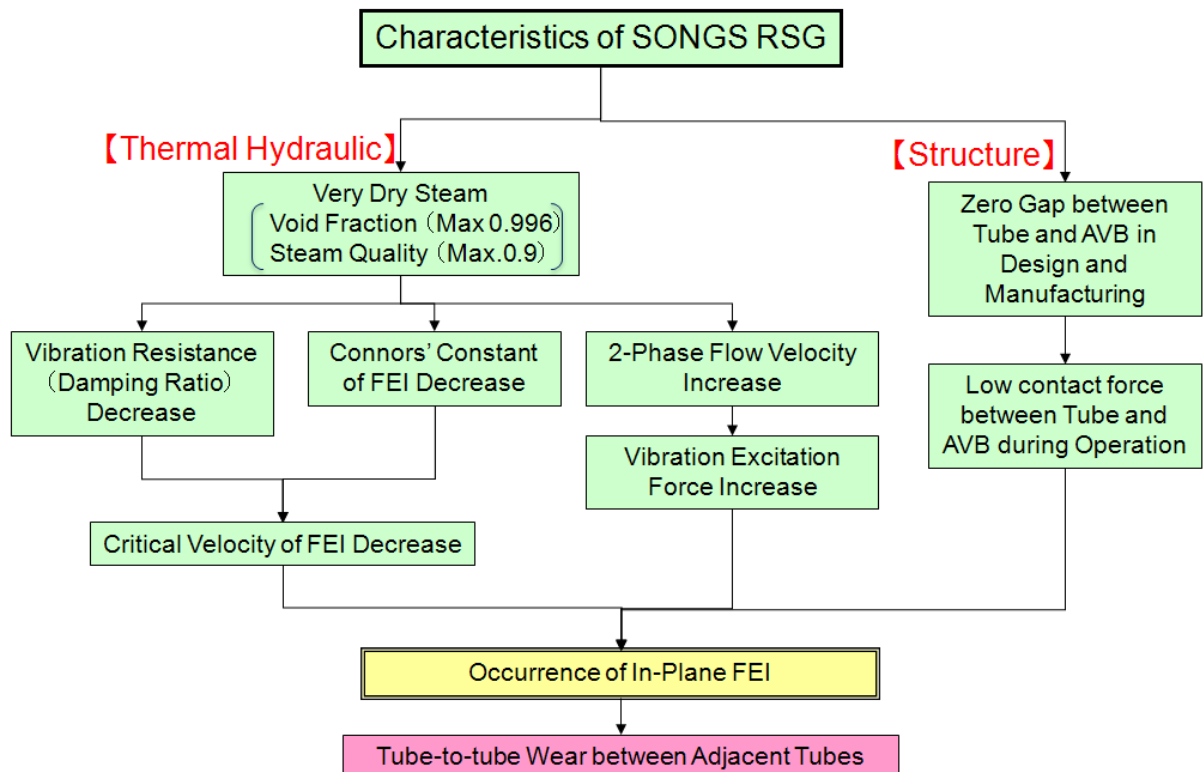
- ✓ Tube between 2 flat AVBs
 - AVB Design Assumes Out-of Plane Vibration
Since out-of-plane FEI is more likely to happen compared to in-plane FEI, AVBs are placed at the sides of tube to prevent out-of-plane vibration
- ✓ 6 V-Shaped AVBs (12 support points)
 - Number of AVB Support Points are confirmed to satisfy ASME FEI Requirements
- ✓ Designed and fabricated for effective "Zero" Gap between Tube and AVB in hot condition

Fig. 2.2-1 Type 1 Wear (TTW) In-Plane Mechanism

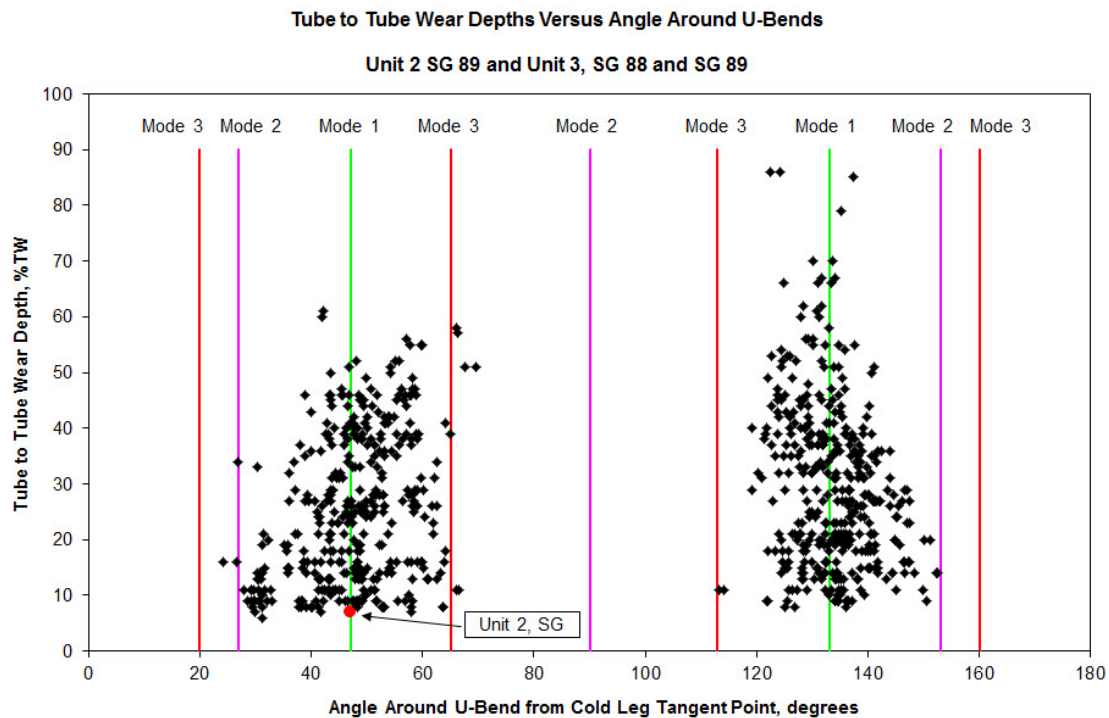
The locations of the Unit 3 and Unit 2 TTW wear indications along the U-tube arc length are depicted in Fig. 2.3.3-1 taken from AREVA's "SONGS U2C17 Steam Generator Operational Assessment for Tube-to-Tube Wear " No. 51-9187230-000 (Ref. 4).

Fig. 2.3.3-1 Location of deepest wear along the length of each TTW wear scar

From this figure it can be seen that the TTW indications are grouped at the 45/135 degree positions of the U-bend. This figure also identifies the theoretical tube-to-tube contact points associated with the first three natural frequency modes for in-plane tube vibration. The Mode-1 tube-to-tube contact points are also located at the 45/135 degree positions of the U-bend.

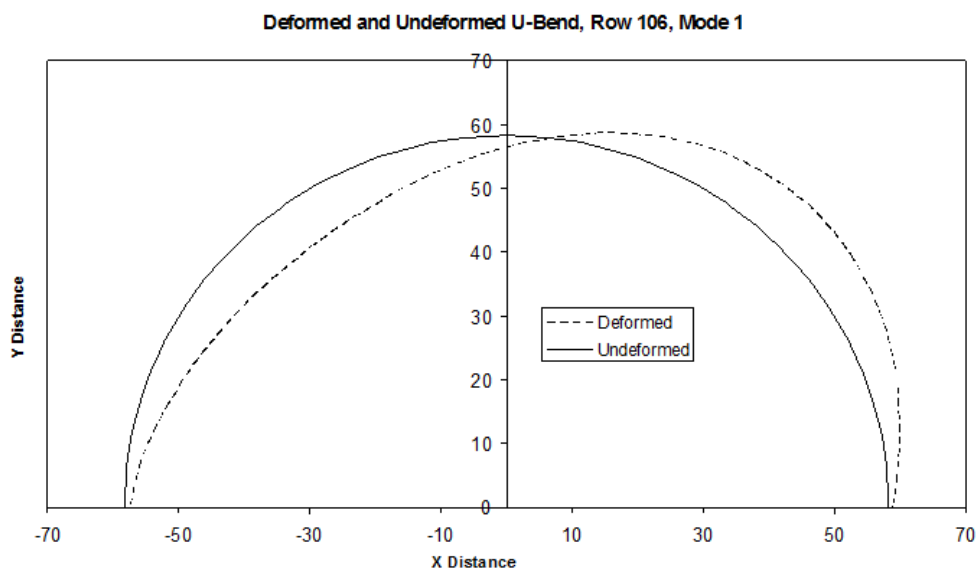
Fig. 2.3.3-2 is also taken from the AREVA Operational Assessment report (Ref. 4). This figure shows the large amplitude deformation of a U-bend tube in the first in-plane mode (i.e. Mode 1).

Fig.2.3.3-2 The large amplitude deformation of a U-tube in the first in-plane mode

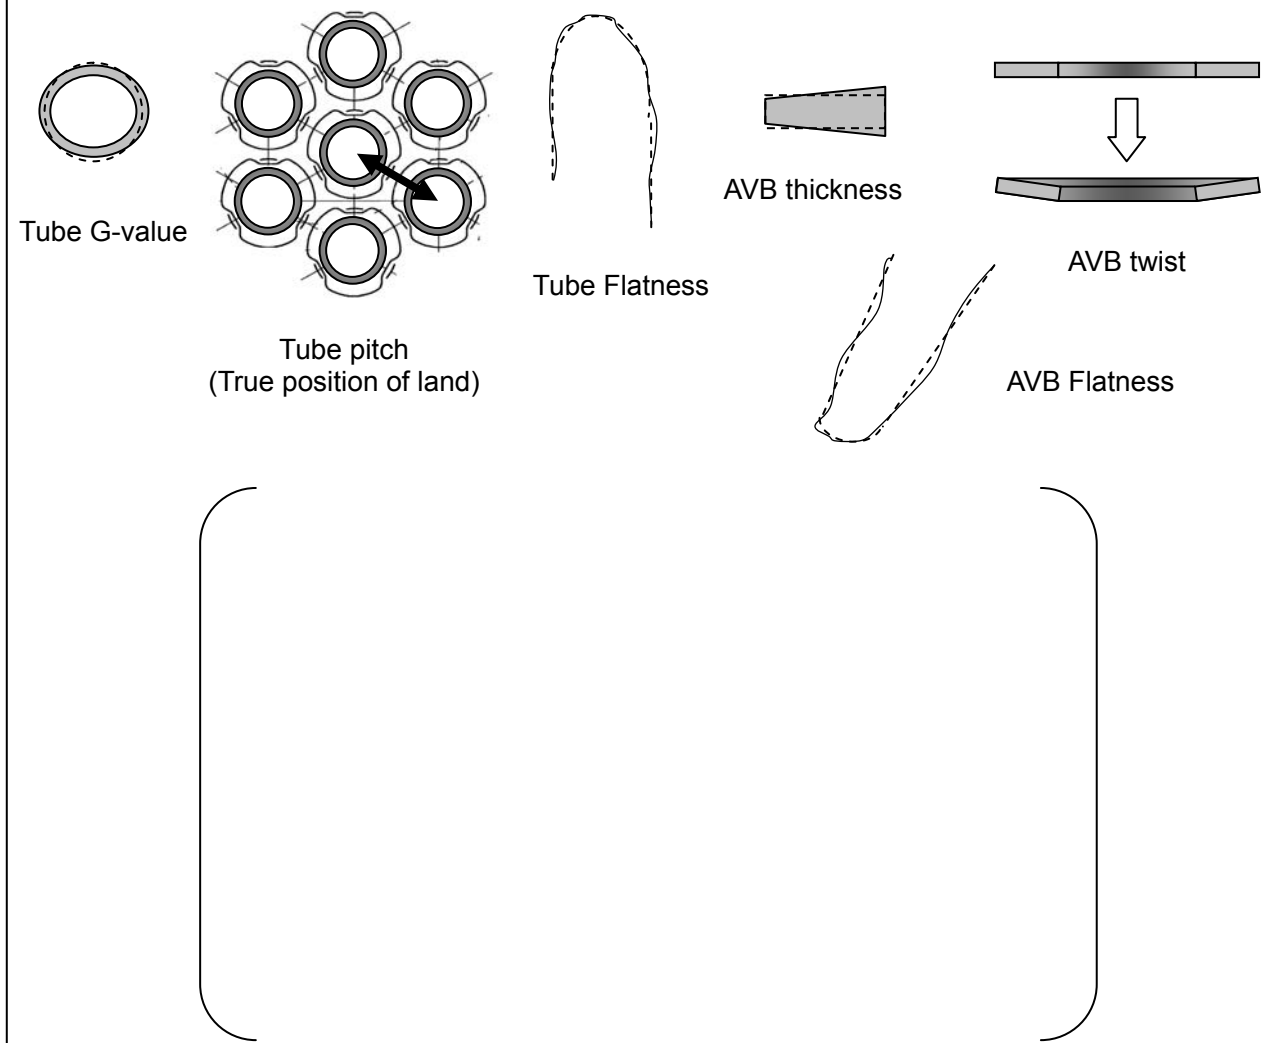
Fig.2.3.3-3 Contact Force Simulation with Manufacturing Tolerances

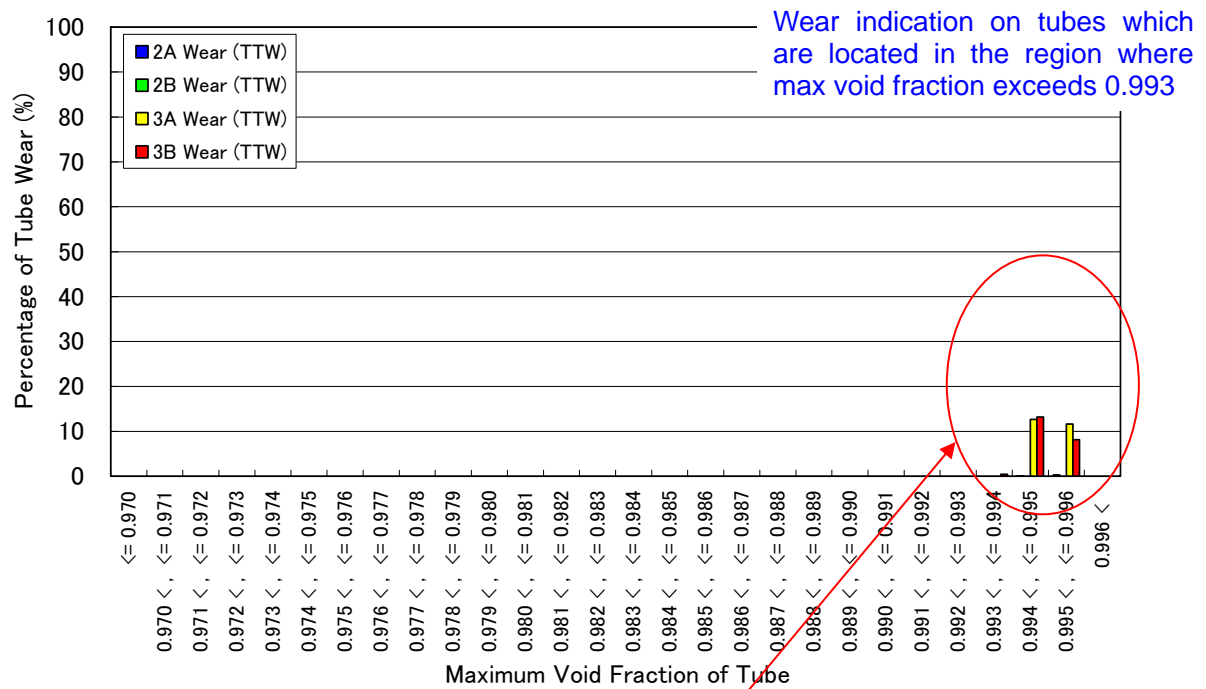
Fig. 2.3.4-4 shows the correlation between void fraction and steam quality with the percentage of tubes at different levels of void fraction and steam quality that have Type 1 wear. The 328 tubes that had Type 1 wear fall within the region of steam quality of | | to | | and void fraction of | | to 0.996. However, less than | | of the Unit 3 tubes in this region of high steam quality and high void fraction have Type 1 wear. Fig. 2.3.4-4 displays the same data as shown in Fig. 5.1-2 in the TER (Ref. 1). The TER (Ref. 1) also discusses the relationship between high velocity and Type 1 wear for which the correlation is not as strong.

Strong correlation between the number of tubes with wear and void fraction (steam quality)

Fig.2.3.4-4 Correlation between Type 1 Wear (TTW) and Void Fraction (Steam Quality)

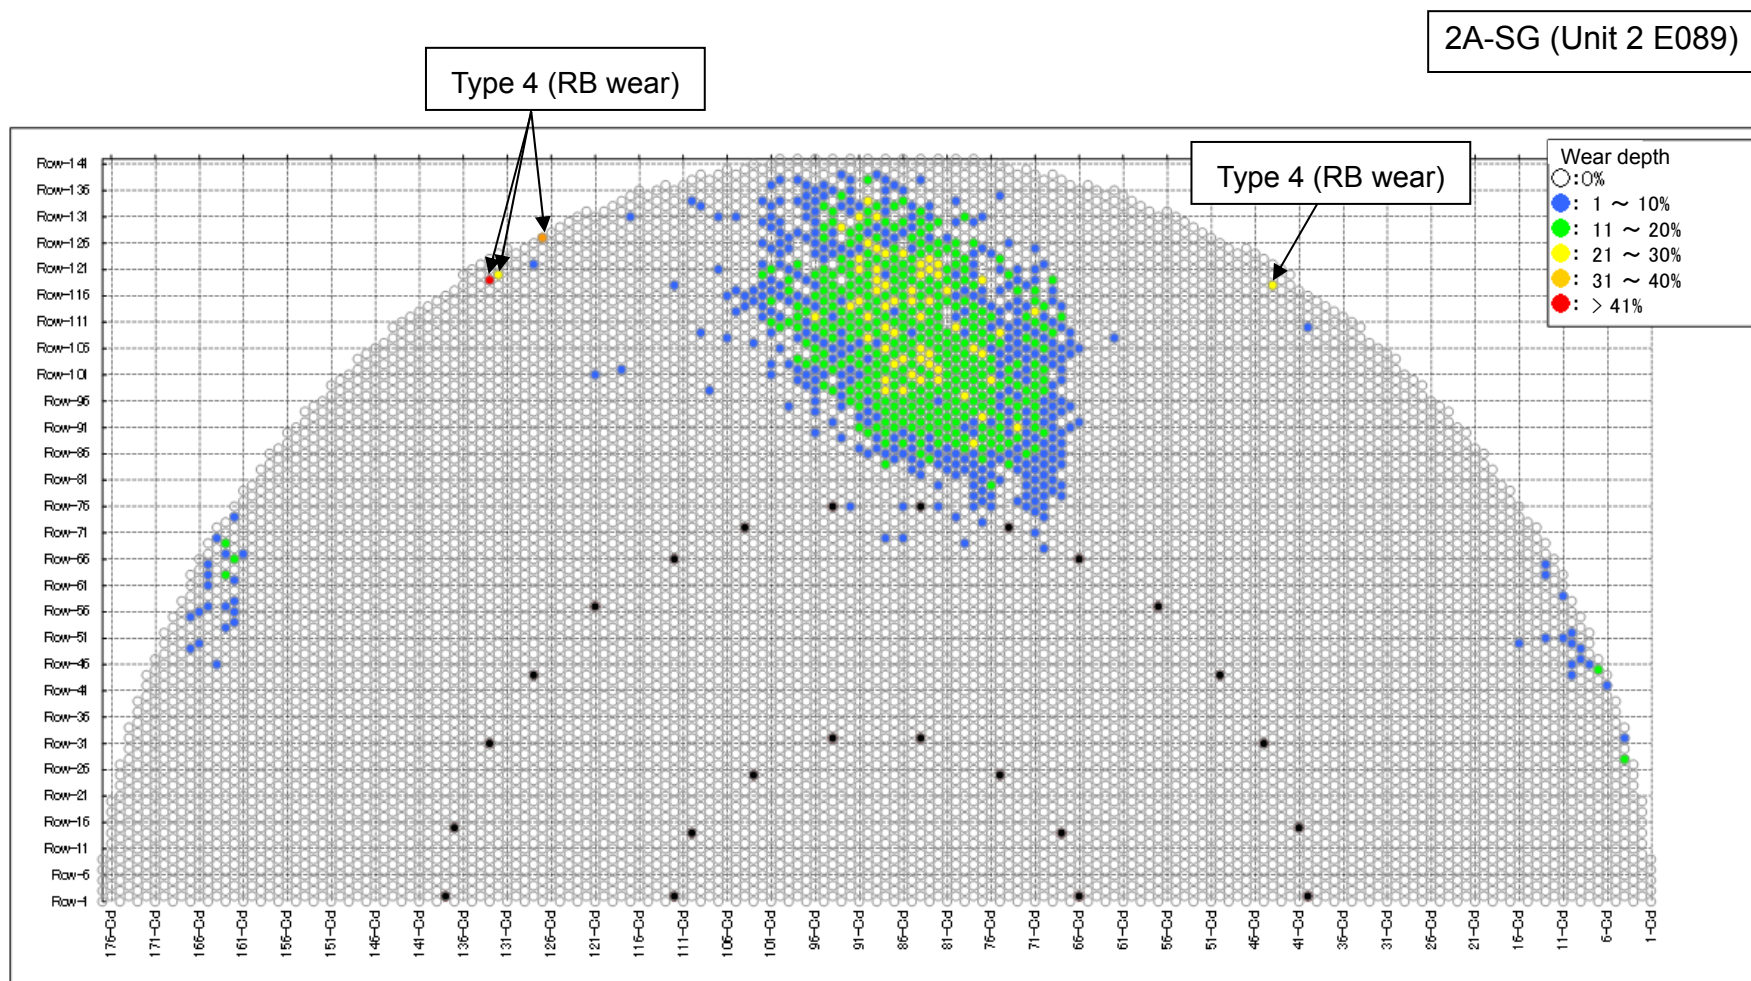
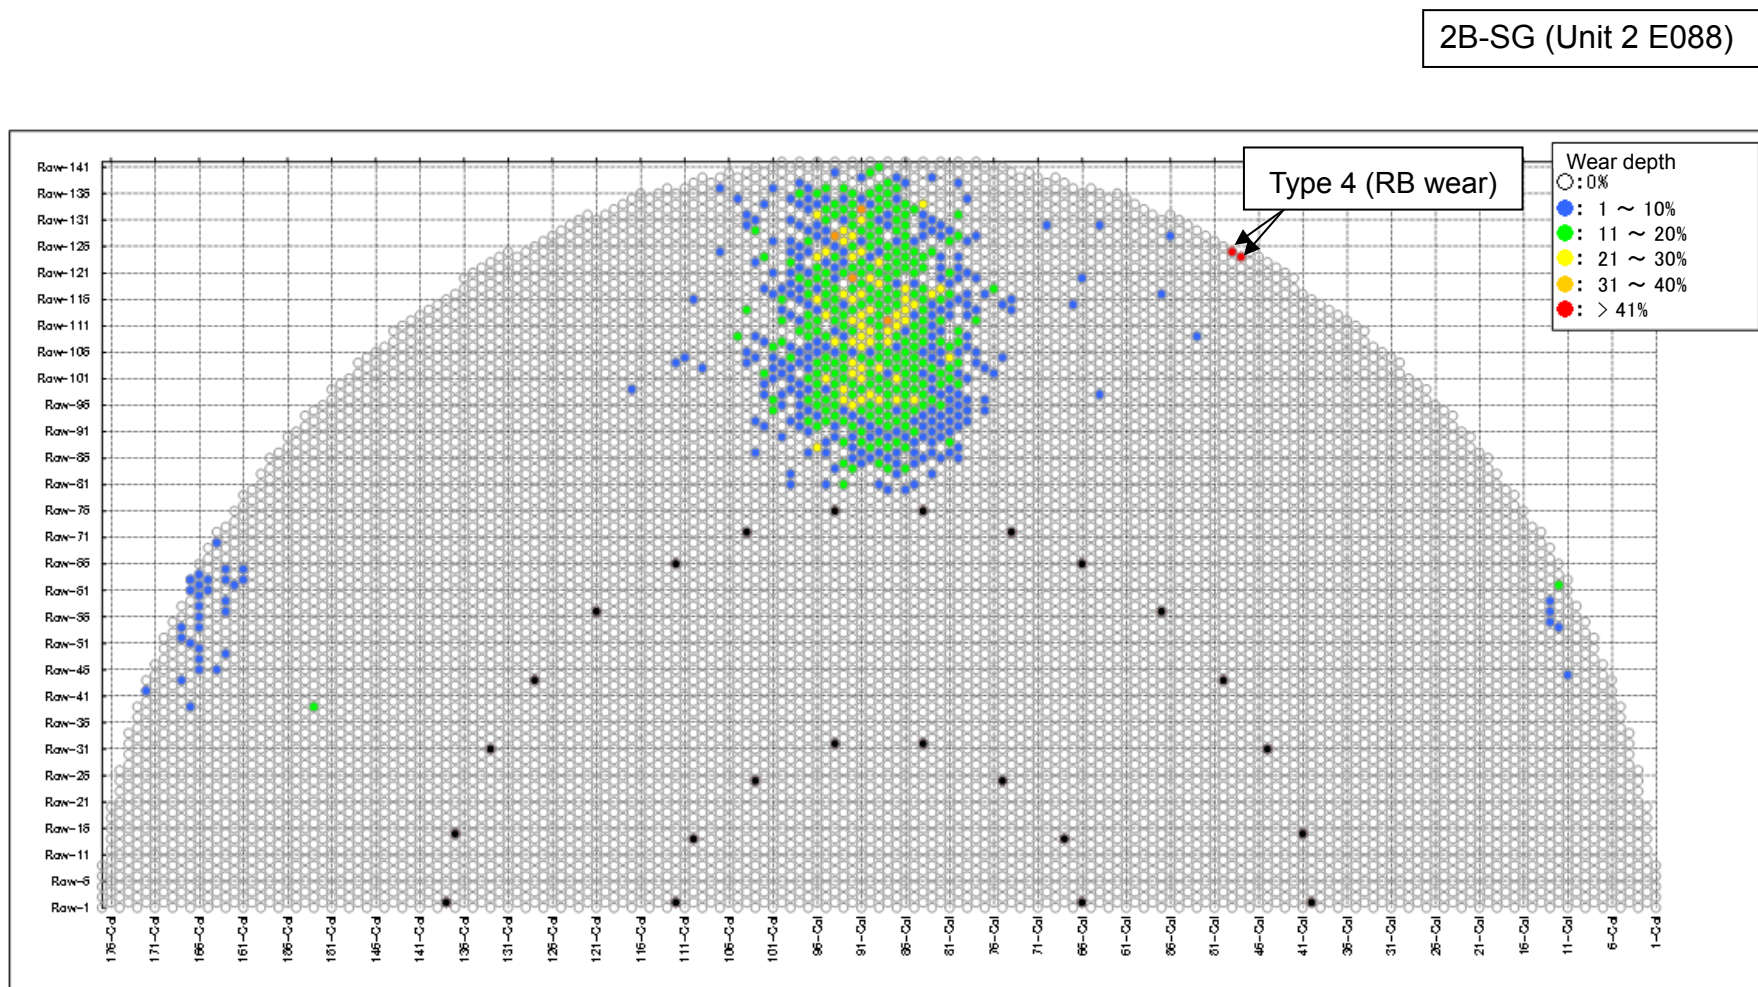
Tubes with Type 2 (AVB wear) indications are characterized by wear at the tube-to-AVB intersections with no free-span wear indications. They are produced primarily by U-bend tube vibration without any contribution from straight leg vibration although there are a few TSP wear indications on some of them. The locations of the tubes with wear indications at the tube-to-AVB intersections, including Type 2 wear, are shown in Fig. 3.1-1 (Unit 2) and Fig. 3.1-2 (Unit 3). The same data is shown on Fig 4.1.1-2 of the TER (Ref.1).

Fig 3.1-1 (1/2) All Unit 2 U-bend tube indications
 (Type 1 TTW, Type 2 Tube-to-AVB and Type 4 Retainer Bar to Tube)

Fig 3.1-1 (2/2) All Unit 2 U-bend tube indications
(Type 1 TTW, Type 2 Tube-to-AVB and Type 4 Retainer Bar to Tube)

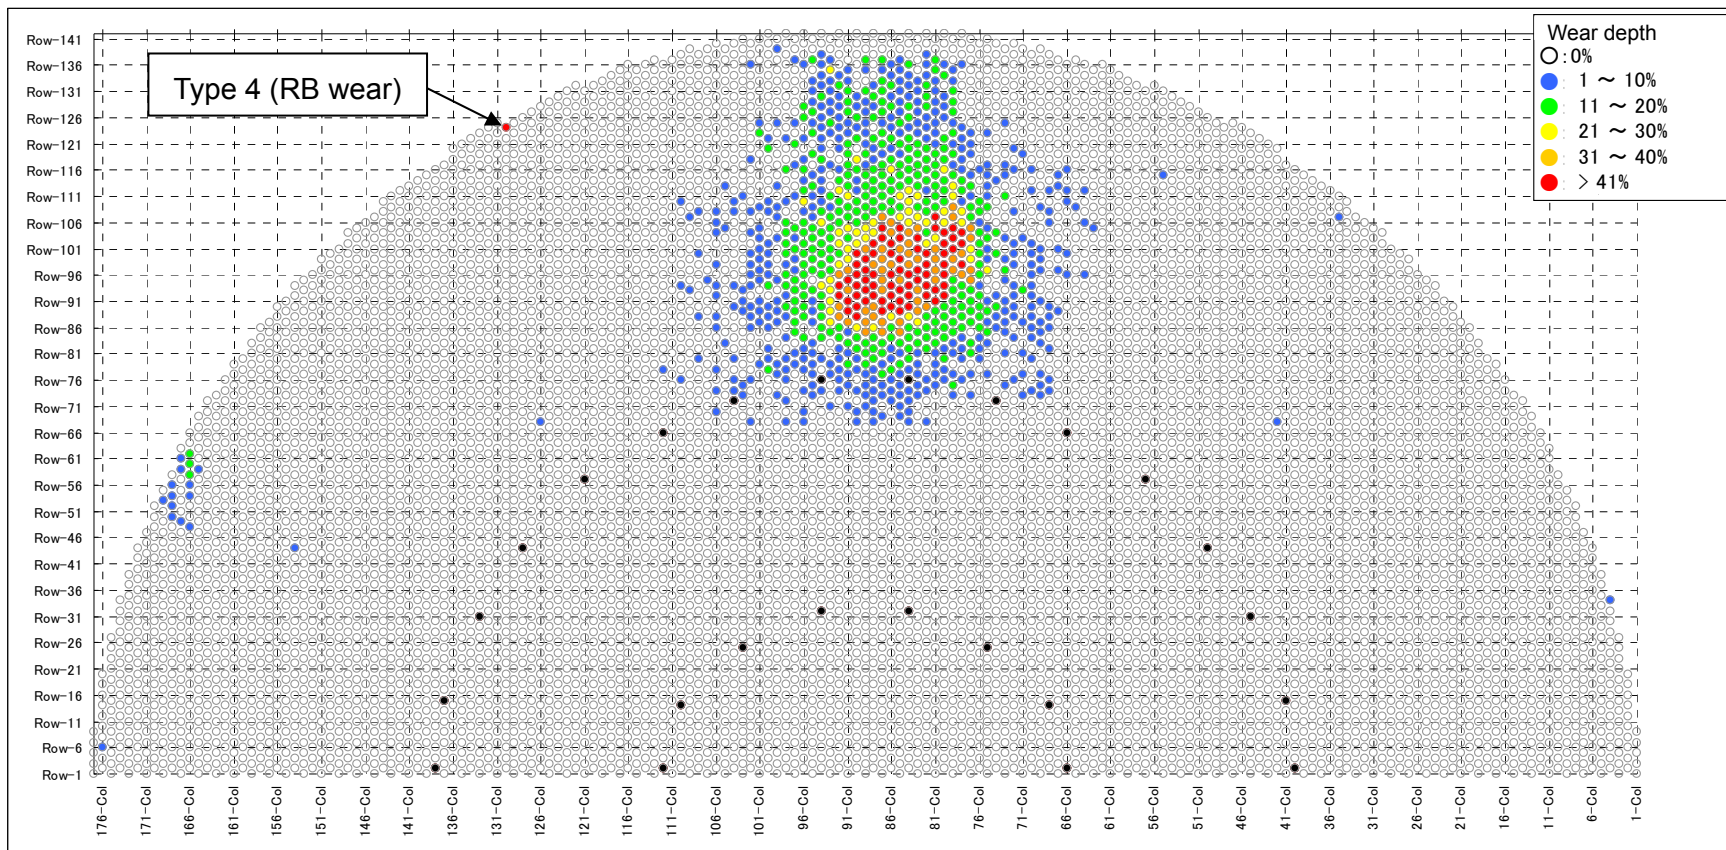
3A-SG (Unit 3 E089)

Fig 3.1-2 (1/2) All Unit 3 U-bend tube indications
(Type 1 TTW, Type 2 Tube-to-AVB and Type 4 Retainer Bar to Tube)

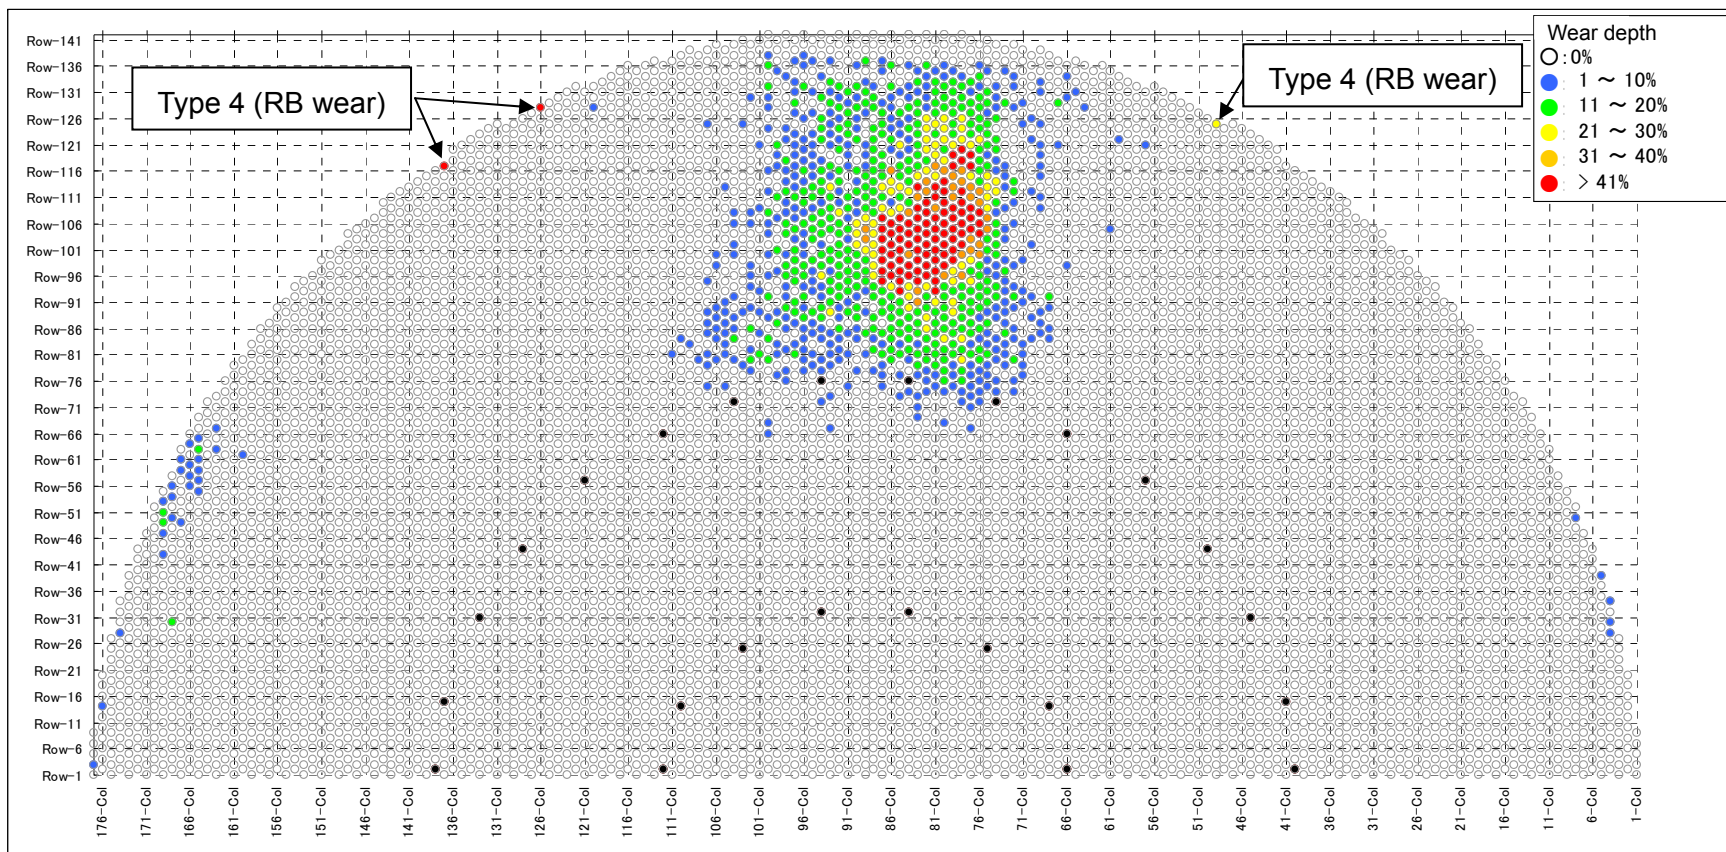
3B-SG (Unit 3 E088)

Fig 3.1-2 (2/2) All Unit 2 U-bend tube indications
 (Type 1 TTW, Type 2 Tube-to-AVB and Type 4 Retainer Bar to Tube)

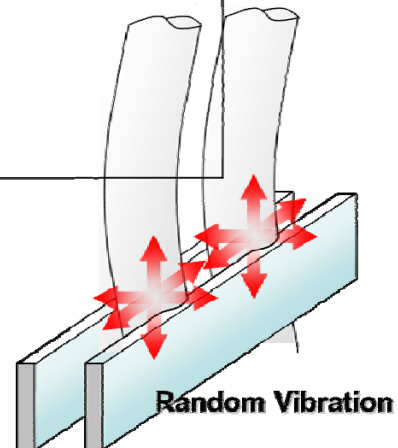
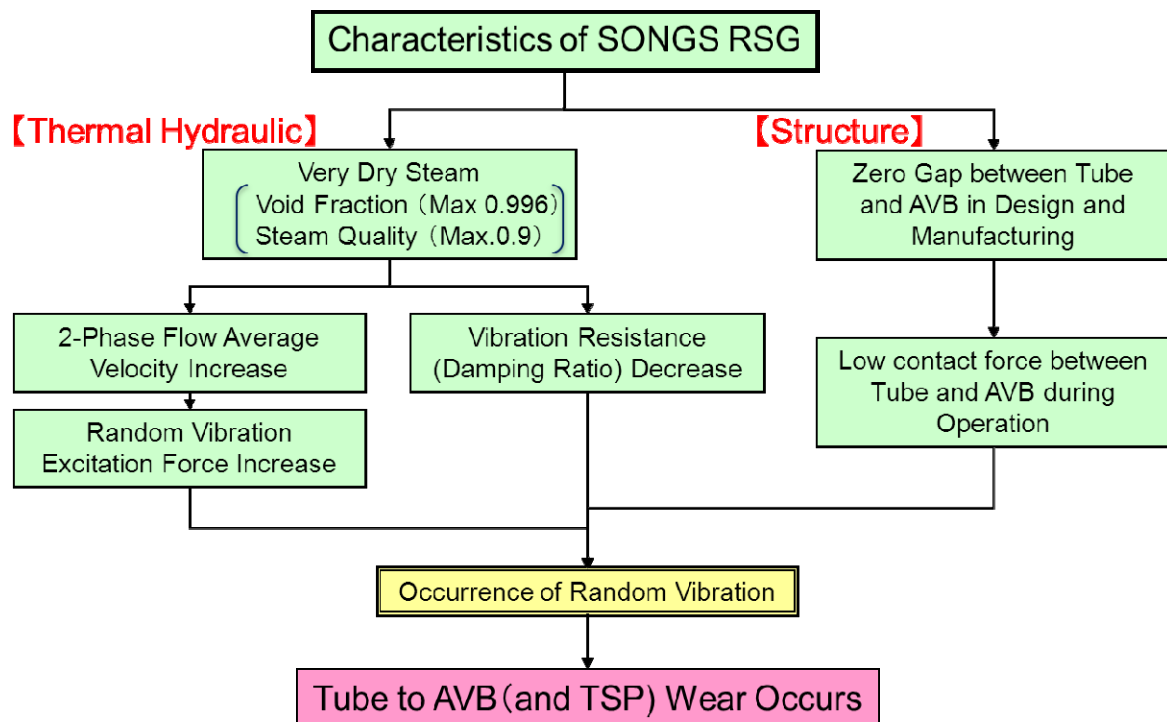
- Small gaps confirmed
- Low contact force

Fig.3.3-1 Type 2 Wear (AVB wear) Mechanism

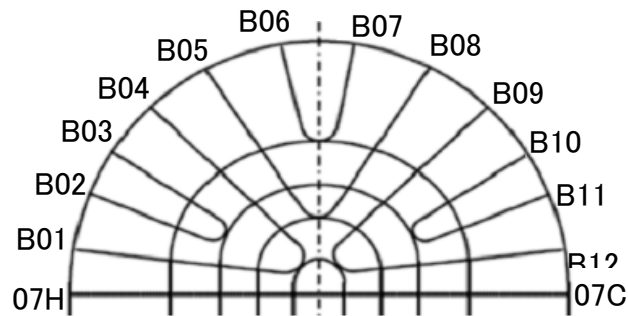
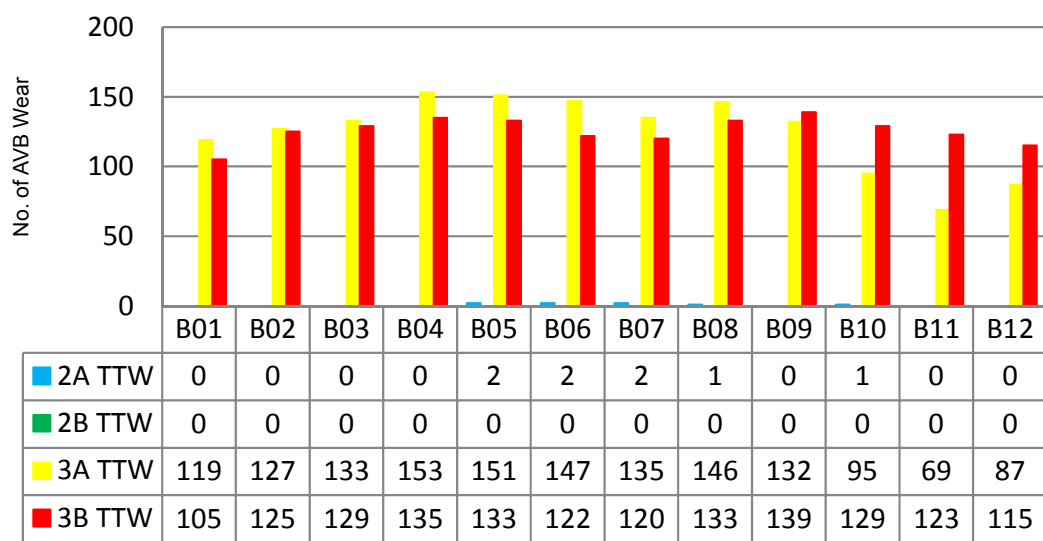
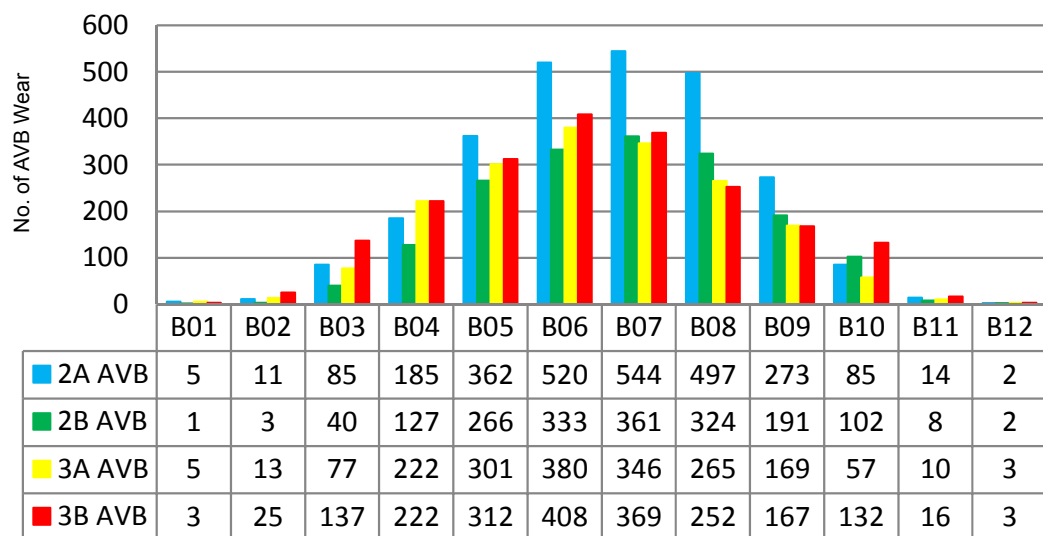
Number of TTW Tube with AVB wear

Number of Tube to AVB Wear Tubes (excluding TTW tubes)

Figure 3.5-1 AVB Tube Wear Number Comparison

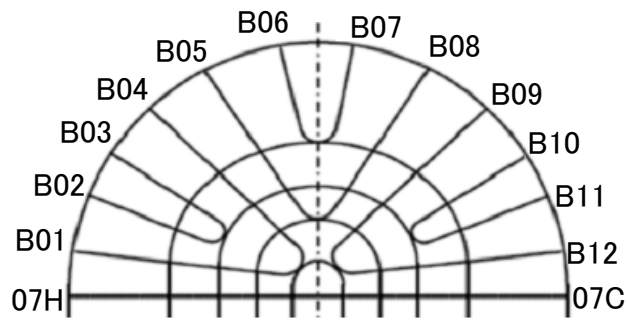
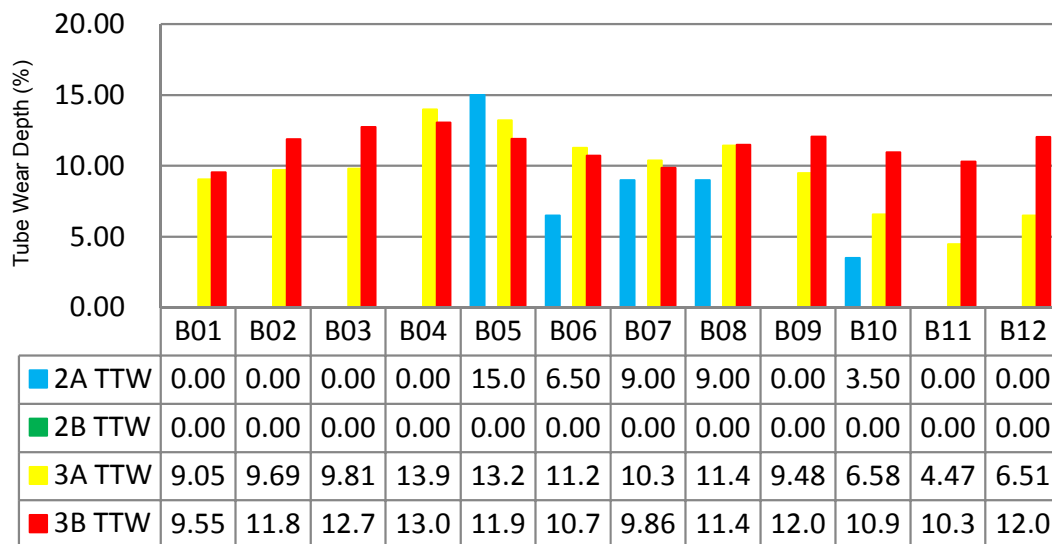
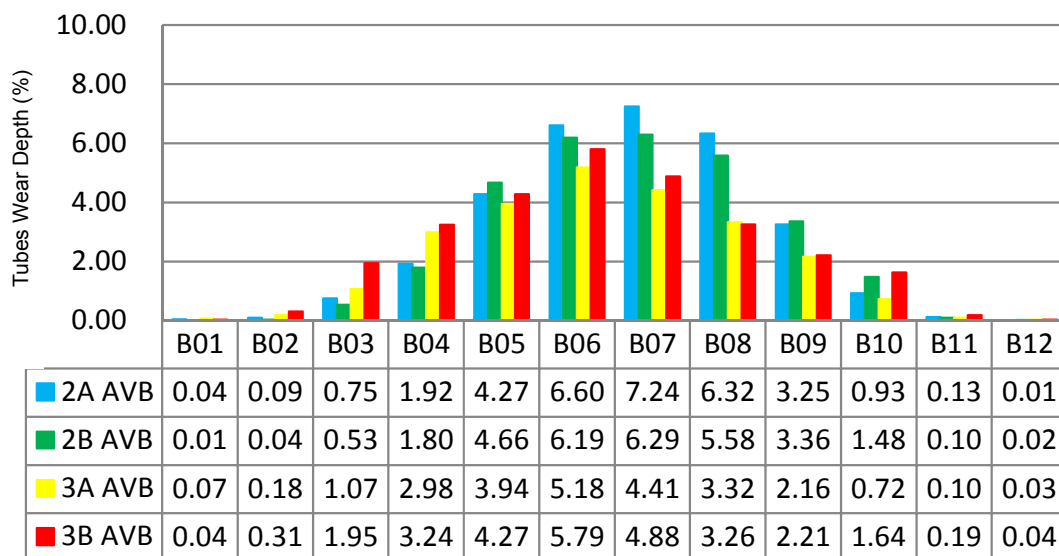
- 3) The average 10% of AVB wear depth in Unit 2 and Unit 3 excluding TTW tubes is almost the same. (See Fig. 3.5-2.) Therefore, if random vibration were a precursor to in-plane FEI one would expect to see a similar number of tubes with tube-to-tube wear in the two RSG units. However, Unit 2 only has 2 tubes with TTW.

Avg. Wear Depth % TTW at AVB Contact Points

Avg. AVB Wear Depth % (excluding TTW tubes)

Figure 3.5-2 Tube Wear Depth Comparison
