**9m drop test – HS-55x138-SS Insert Assembly  
DN3987 Assembly 'b'**

**TR 2013/02/02  
Issue A**  
Page 1 of 14

To conduct 9m drop tests on an Insert Assembly DN3987 as detailed in procedure CP 458 Issue B [Ref. 1].

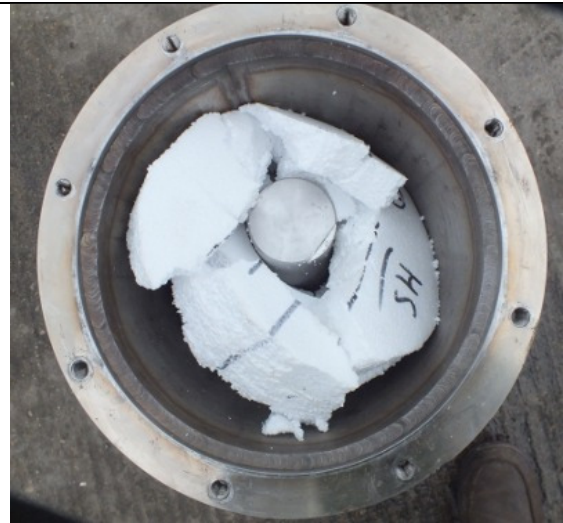
- Still photographs and movies taken during drop test.
- Figure 5 shows the test container with the cork packing and impact plate.
- Figure 6 shows the insert assembly within the test container supported by the polystyrene packing prior to the drop test.
- Figures 7 and 8 show the tape measure used for the 9m measurement.
- Figure 9 shows the typical setup employed, the test container at the drop height with the bottom of the tape measure off of the ground showing that the actual drop height is greater than 9m.
- Figure 10 shows the opened test container after the drop test, no indication of red dye leakage.

**Figure 10 - container opened post drop**

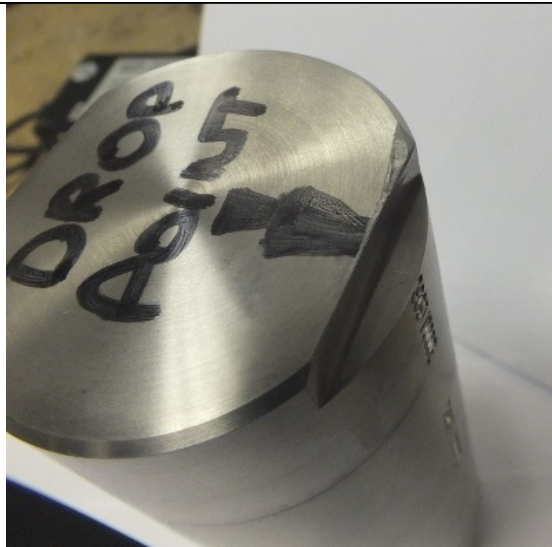
Figure 11 - showing damage at impact point

- Figure 12 (post drop) indicates no unscrewing of the lid when compared to Figure 3 (pre-drop).
- The leak test results indicate that there were no leaks.
- The liquid was contained within the Insert Assembly.
- Obvious damage to the insert lid, e.g. impact direction, was local flattening at the impact point and slight bowing of the lid.
- The only other obvious damage was local flattening at a point on, and slight bowing to, the bottom of the insert base.

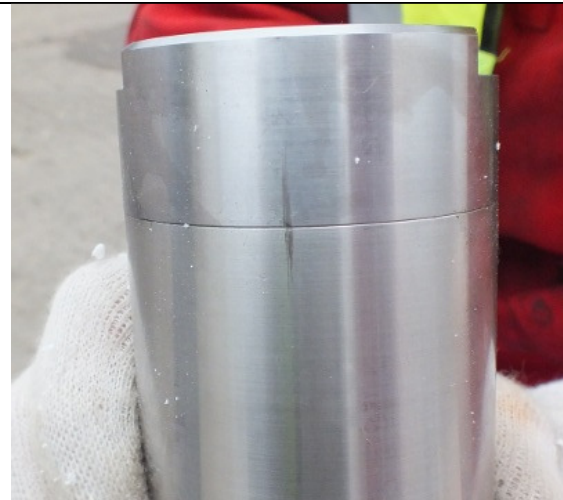
Figure 12 - showing match marks after drop

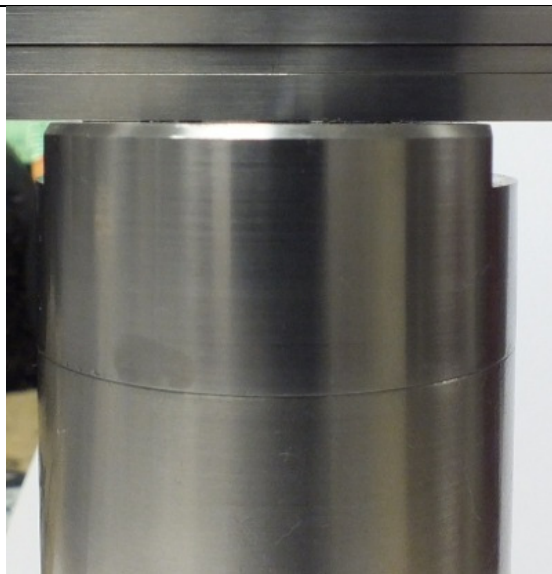
Figure 13 - showing slight distortion to insert lid

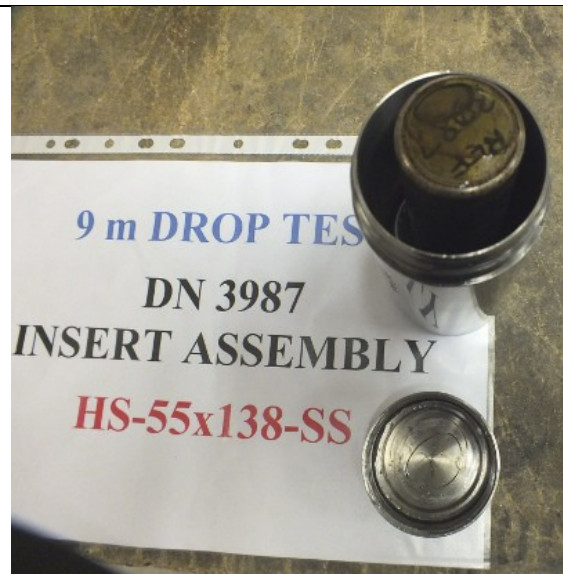
Figure 14 - showing opened insert with liquid still contained

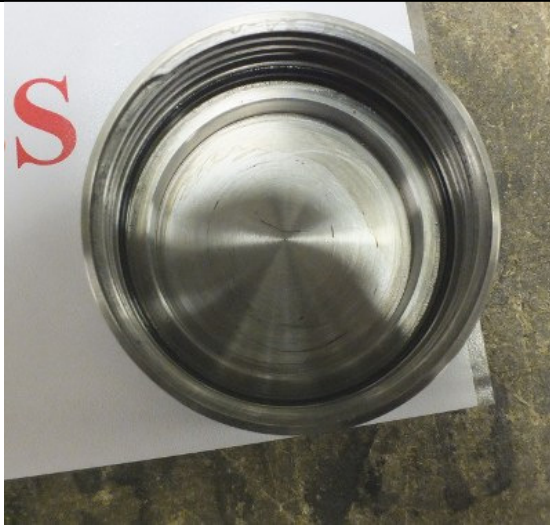
Figure 15 - showing inside of insert lid

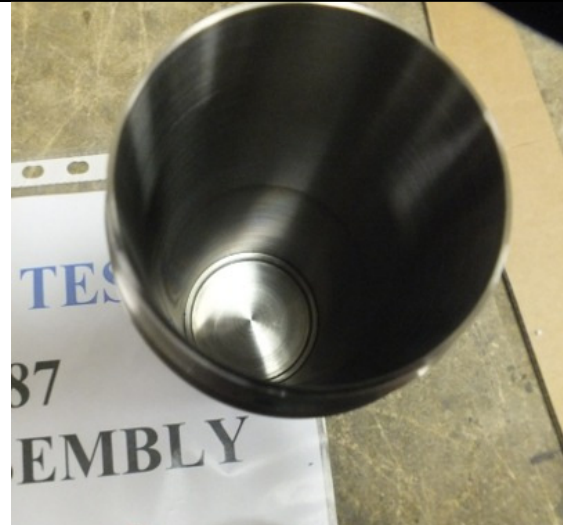
Figure 16 - showing inside of insert body

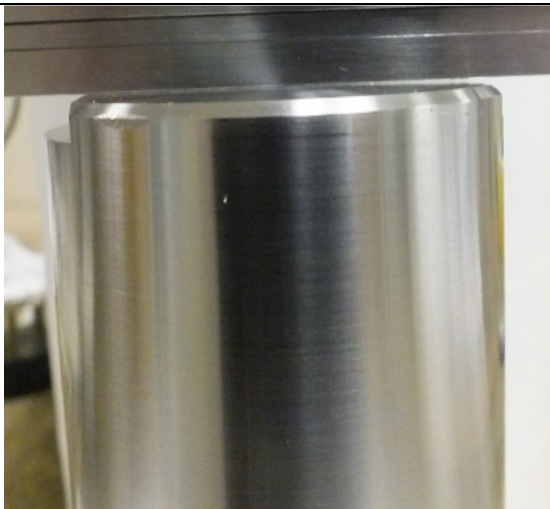
Figure 17 - showing slight distortion to bottom of insert assembly

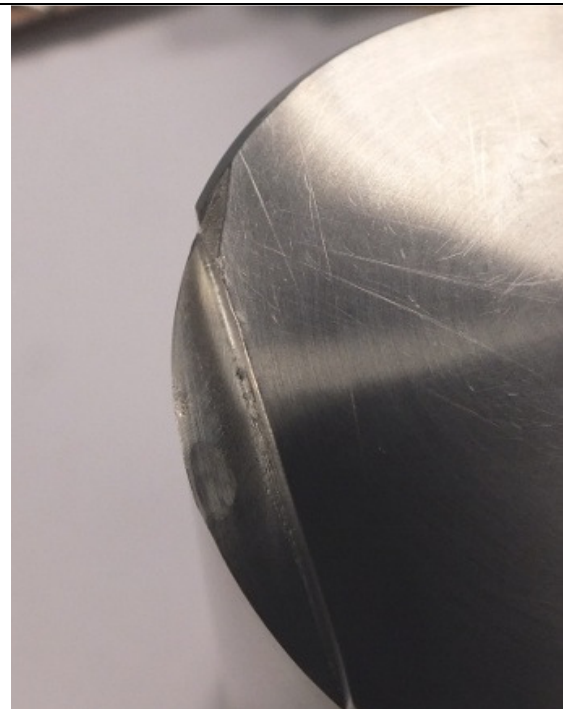
Figure 18 - showing damage to bottom of insert assembly
