# PART 21 REPORT - ESI REFURBISHED EMERGENCY DIESEL GENERATOR CYLINDER HEADS MAY HAVE VALVE KEEPER SEALS MISSING

Report No. 10CFR21-0108

COMPONENT: KSV Cylinder Head with Missing Keeper Seals  
Head Part Numbers 10-KSV-11-3-RR, 12-KSV-11-3-RR, and 13-KSV-11-6-RR

SYSTEM: Emergency Diesel Generator

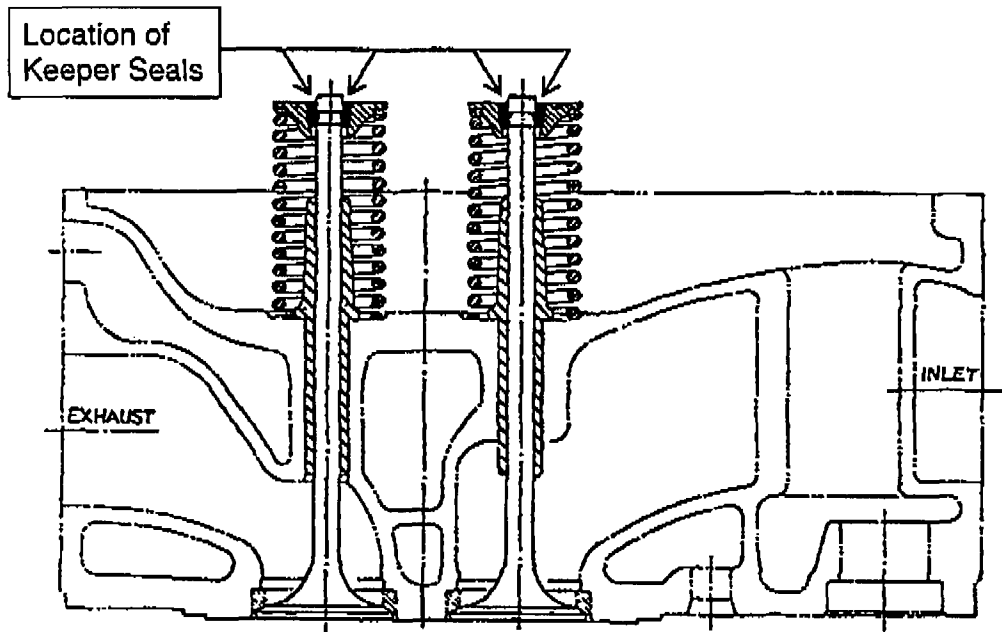
**Figure 1: Showing Location of Keeper Seals**

During the failure analysis investigation performed at the current Cameron facility in Casper, WY, it was noted that the intake and exhaust valve keeper seals, P/N W30C-1#1, were not installed. The purpose of the keeper seals is to deflect lube oil from draining into the cylinder head, and possibly the combustion chamber, during standby conditions. The source of this lube oil is the intake and exhaust rocker arms that are pressurized with heated lube oil during standby conditions to maintain the engine's fast start capability. The quantity of oil that travels through the rocker arms to the valve keeper area is dependent upon the component clearances within the rocker arm components. The absence of the valve keeper seals could allow a small amount of this lube oil to drain past the keepers, down the valve stem, through the valve guides and into the intake and exhaust ports of the cylinder head. In this particular case, the intake or exhaust valves were sufficiently open to allow oil to enter the cylinder (which is dependent upon the engine's position when it stops rotating following a shutdown). One or more cylinders on an engine will have open valves at any given position of the crankshaft, though not all cylinders are affected at the same time.

The seals are made of an elastomeric material in the form of a rectangular block and they are replaced during a rebuild as standard practice. Each cylinder head has eight seals (with two required for each valve and there are four valves per head). The seals are installed between the keeper halves on opposite sides of the valve stem. See figure and photo on the following page for a visual representation of the seal location.

Inspect the valve keepers for presence of the keeper seals. If seals are installed, no further action is required. If seals are not installed, it is recommended that a borescope inspection be performed to ensure no engine lube oil is in the combustion chamber. This inspection could be performed through the fuel injector bore or the Kiene valve passage (if equipment will allow).

If oil is present, then immediate action is required to remove the oil and rework or replace the cylinder head. Reworking the head can be performed on-engine as follows: With the Kiene valve open, the engine should be barred over until the piston is at top dead center. By doing this the oil will be pushed out of the Kiene valve. Lock the barring device to maintain the piston at TDC and connect a pressure test set to the Kiene valve. This pressure will be used to hold the valves against the fire deck of the cylinder head. An applied pressure of 50 psig should be used; however higher pressures may be utilized as required to maintain the valve against the fire deck. Remove the rocker arms to access the top of the valves. Using a valve spring compressor (such as P/N LS-44-AA#7), compress the spring retainer enough to loosen the keepers and insert the keeper seals. Replacement keeper seals are available from ESI as dedicated components. Relieve the spring compressor and ensure the keeper seals are fully inserted between keepers and flush with the top of the keepers. Repeat for the remaining valves.
