Attachment G

PEER Review Checklist for SWEL

Peer Review Checklist for SWEL

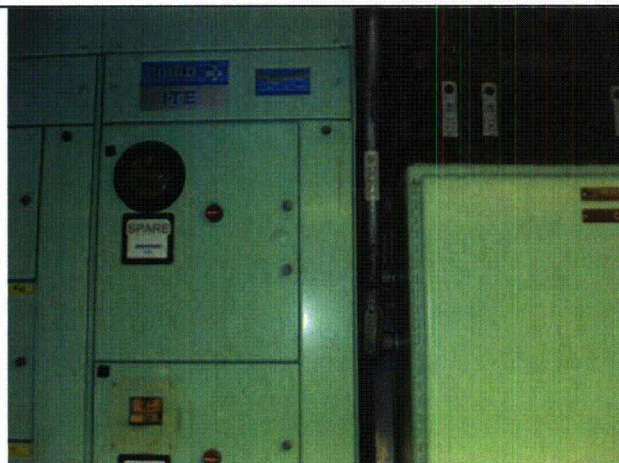
7. Are soft targets free from impact by nearby equipment or structures? Y ☒ N ☐ U ☐ N/A ☐
 - *Two conduits were found to be ~1/4" from the west end of the SSDEMCC311B. It was determined that the MCC will not move enough to strike the conduits so there is no interaction concern. See page 5 of 5 of this Seismic Walkdown Checklist for the determination of the movement for the MCC.*

Note: Conduits adjacent to west end of SSDEMCC311B.

Conduits 32563B5-NB and 32563B6-NB were found to be approximately 1/4 inch from SSDEMCC311B (see attached photo). According to EPRI Seismic walkdown guidance this is a seismic proximity interaction concern because of the potential impact on the panel due to relative motion during seismic excitation. The relays/contactors/starters located in the panel are prone to 'chatter,' and could potentially be impacted.

Therefore, there is no contact between the panel and conduits and this condition is satisfied.

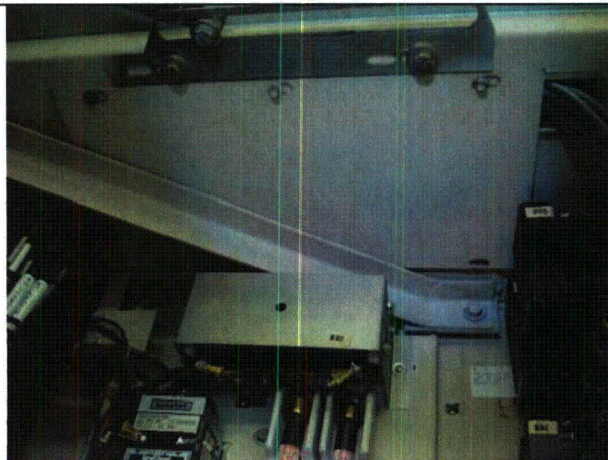
Note: Missing screw location inside
ACCEBKR3A 3 cubicle.

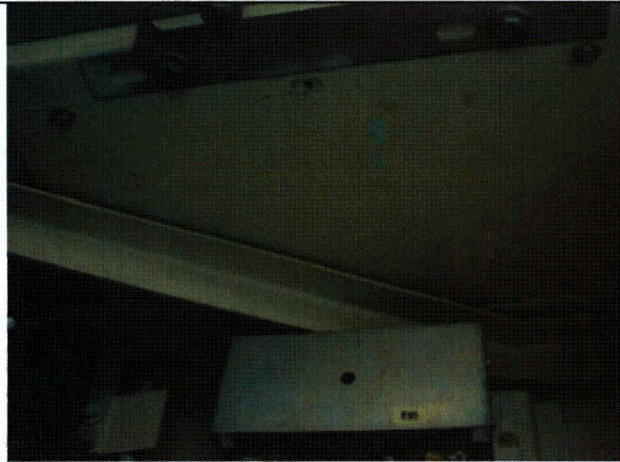
Note: Missing screw location inside HVREBKR3A 7 cubicle.

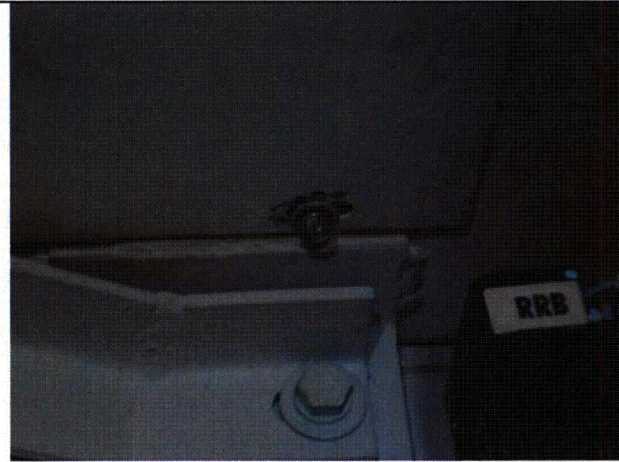
Note: Loose screw inside EG EBKR3A 14 cubicle.

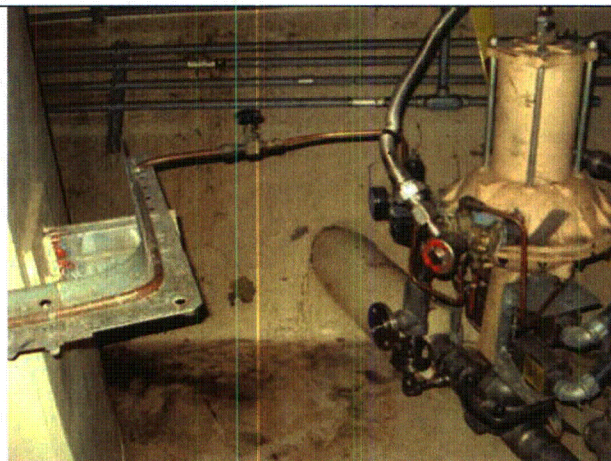
Note: View showing flexible connections on air lines to valve operator. Bends in air lines will provide movement for line. Valve location at lowest elevation of containment, plus line solidly embedded in concrete will assure very little movement of valve and valve operator.

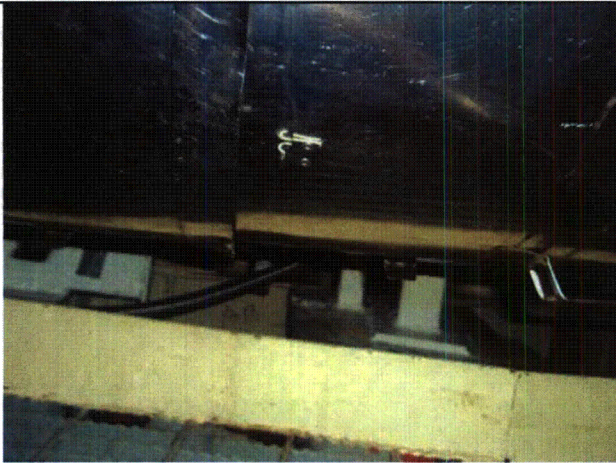
Note: View of underside of insulation on 1SI14-146B showing missing insulation buckles.

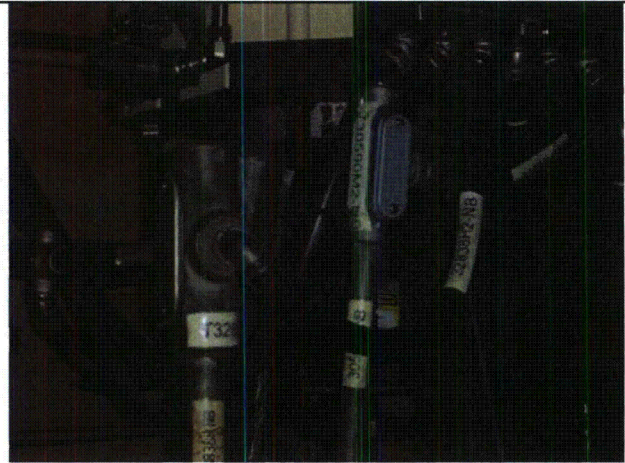
Note: View of tilted conduit 30590M-NB and tape on T30590M2-MB that is loose.

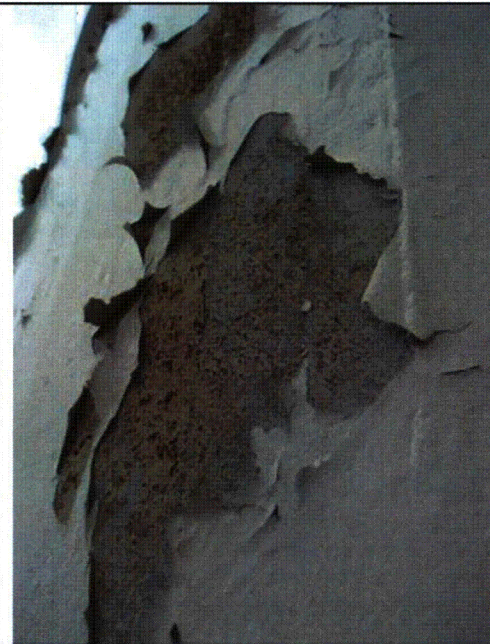
Note: View looking up on fan shroud showing peeling paint. Material underneath is galvanized.

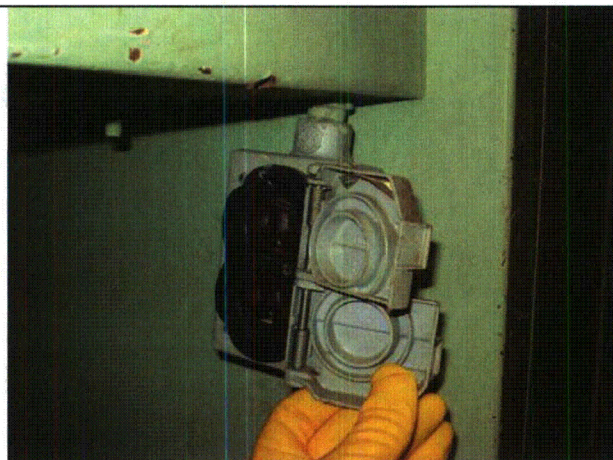
Note: Electrical plug underneath panel on left exterior of IC ICDC1-C. Plug connection to panel is loose.

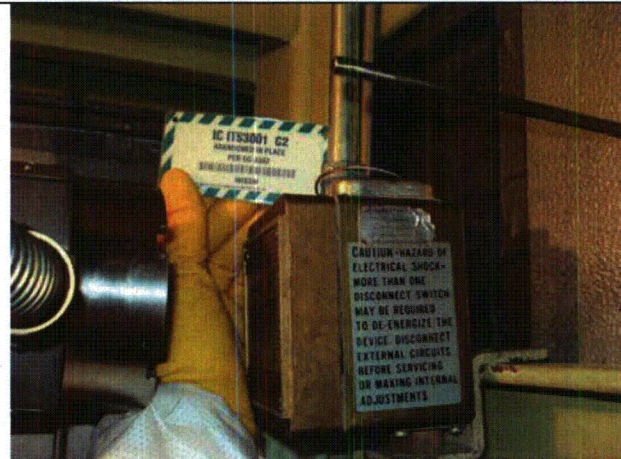
Note: IC ITS3001 C2 on upper right inside of panel. Note missing nut on holddown bracket for instrument.

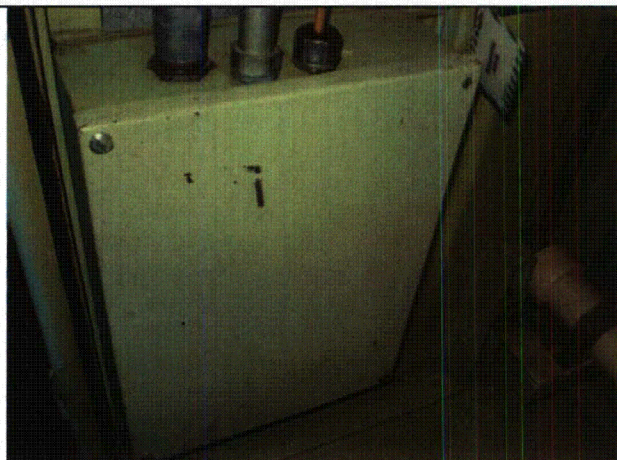
Note: Panel cover on lower right inside of panel with missing screw on upper right location on cover.

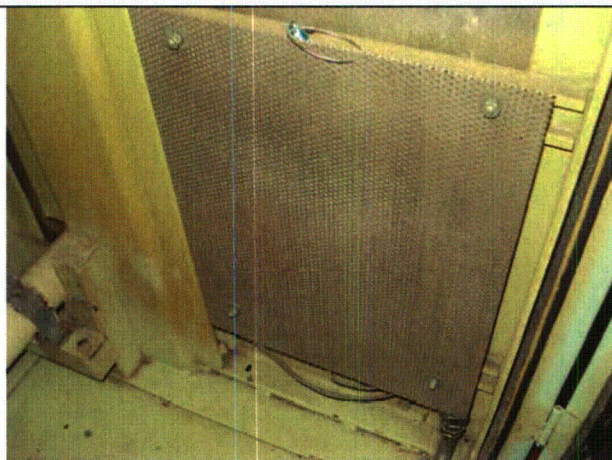
Note: Shield cover on lower right inside of panel with missing nut on lower right bolt.

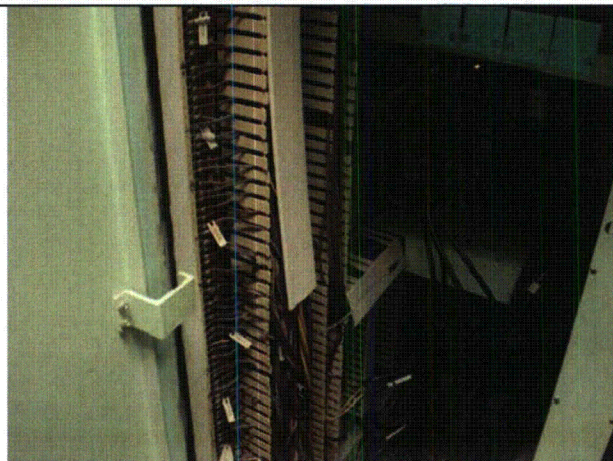
Note: Loose section of plastic wire tray cover.

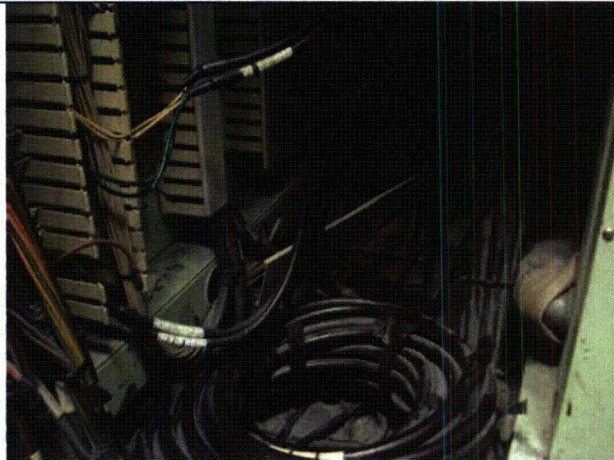
Note: Loose section of plastic wire tray cover.

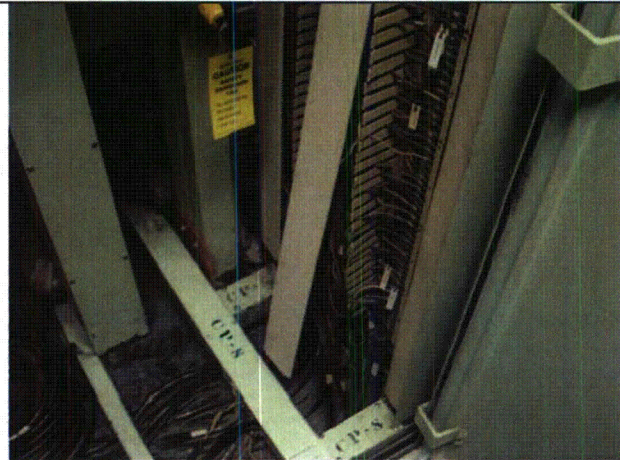
Note: Loose section of plastic wire tray cover.

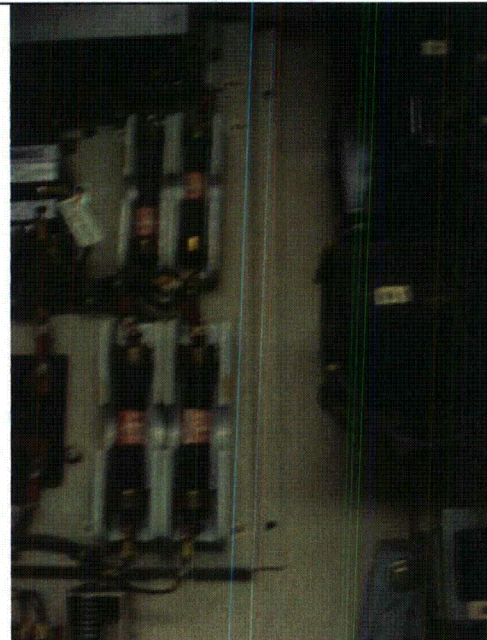
Note: Clips missing from edge of relay panel inside cubicle 14. CR-WF3-2012-06179 was written for this condition. Machine screw can be seen in center of relay panel, with missing machine screw hole towards top. CR-WF3-2012-06634 written for this missing machine screws.

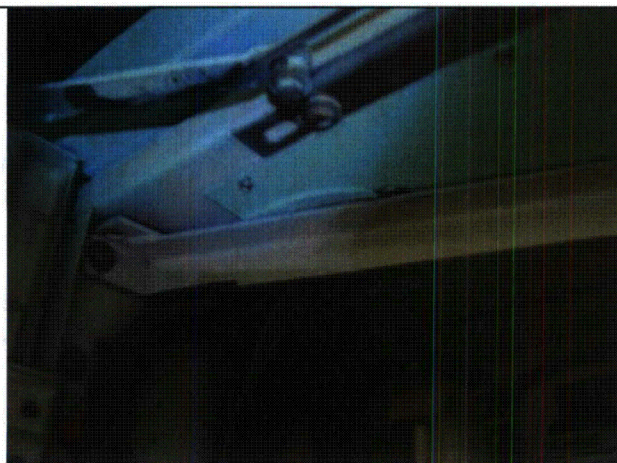
Note: Loose screw on sheet metal plate on top of Switchgear 3B cubicle.

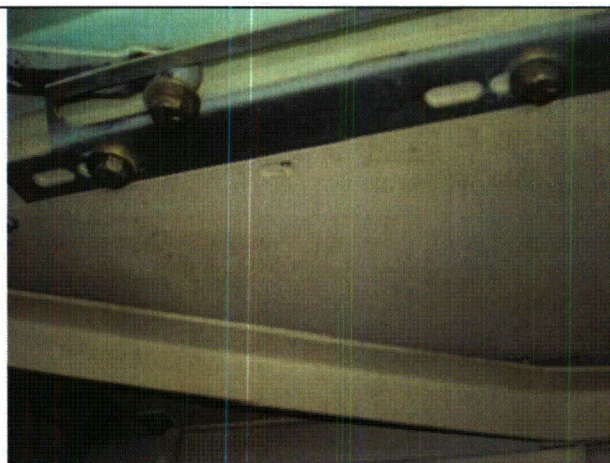
Note: Screw missing from sheet metal plate on top of Switchgear 3B cubicle.

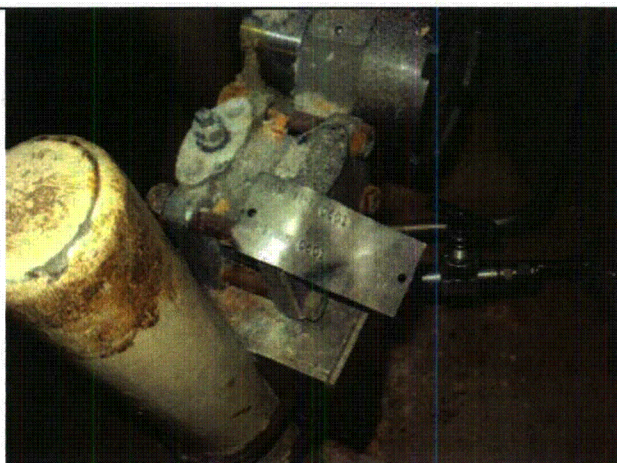
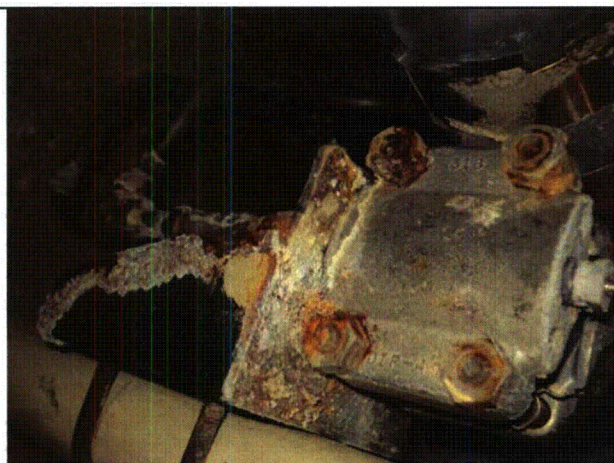
Note: Corrosion from boric acid on BM
IPT0601 IXMITR. See CR-WF3-2012-07125.

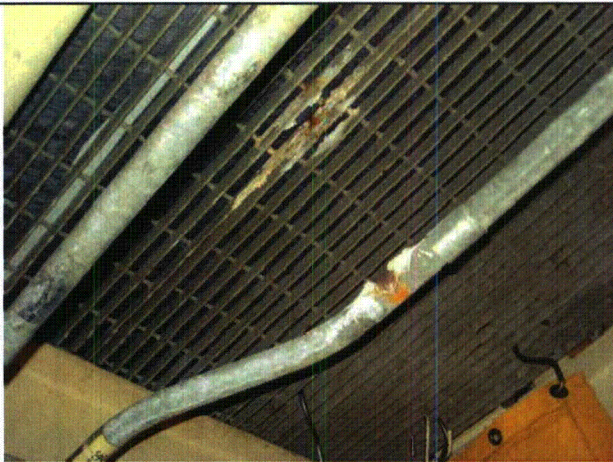
Note: Corrosion from boric acid on conduit and grating overhead. See CR-WF3-2012-07125.

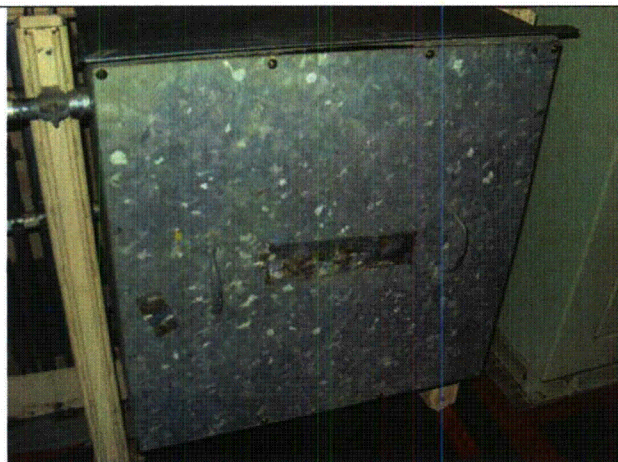
Note: *Unnumbered electrical box with conduit 32851B1-NB. Front cover is missing 6 of 12 bolts.*

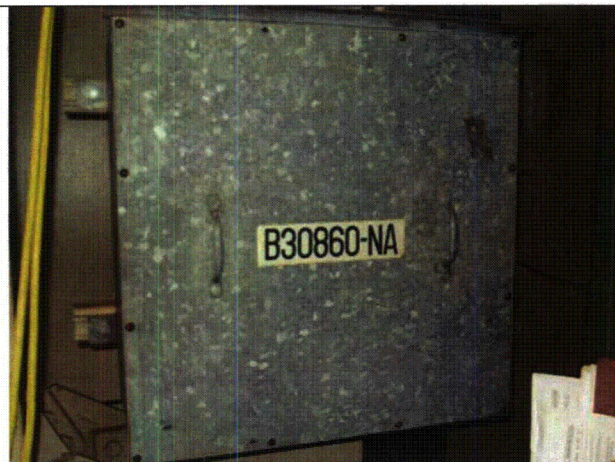
Note: *Electrical box B30860-NA is missing 1 of 12 bolts on front cover.*

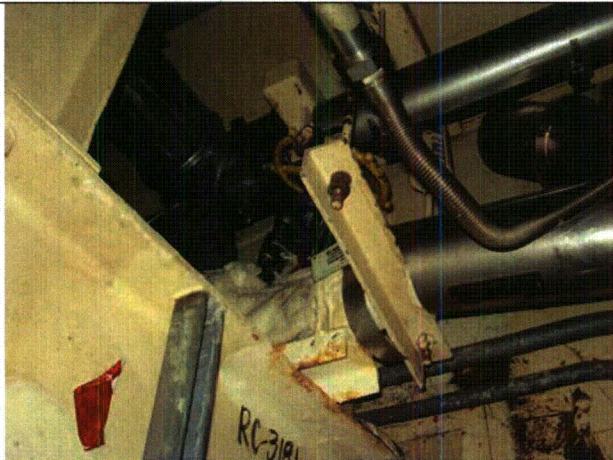
Note: View of evidence of boric acid leakage above RC ISV3184 and RC ISV1014.

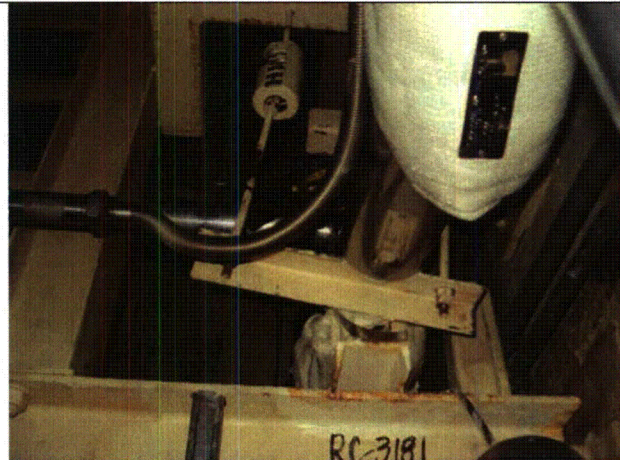
Note: View of RCSH-4162 off-center. CR-WF3-2012-07129 covers this condition.

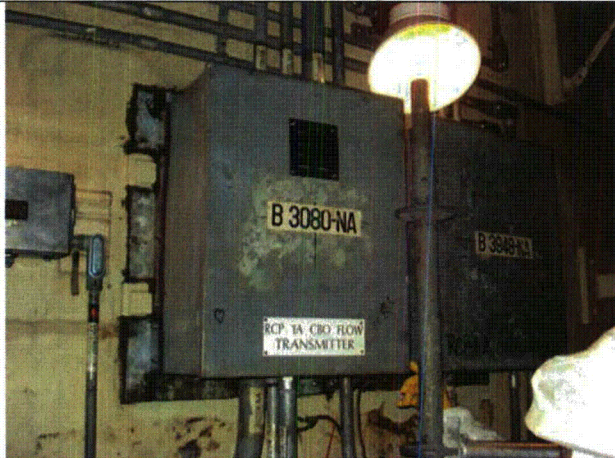
Note: Boxes B3080-NA and B3948-NA that are both missing screws on the right side of the front door. The left side has a hinge. CR-WF3-2012-07517 was initiated for this condition.

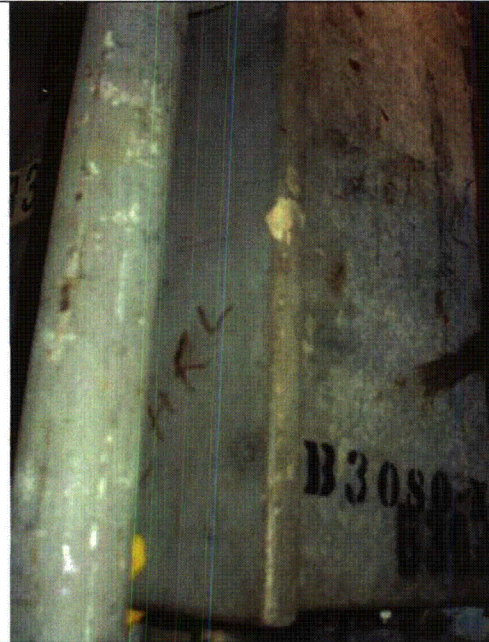
Note: Missing screw locations on box B3080-NA. The missing screws on box B3948-NA are in a similar location.

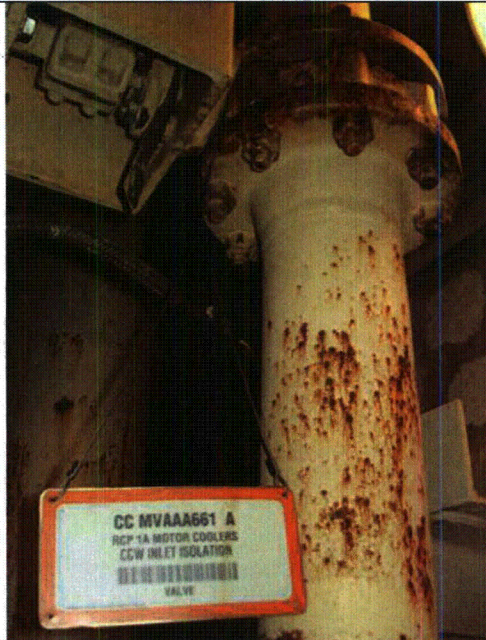
Note: Valve CC MVAAA661A that has corrosion.

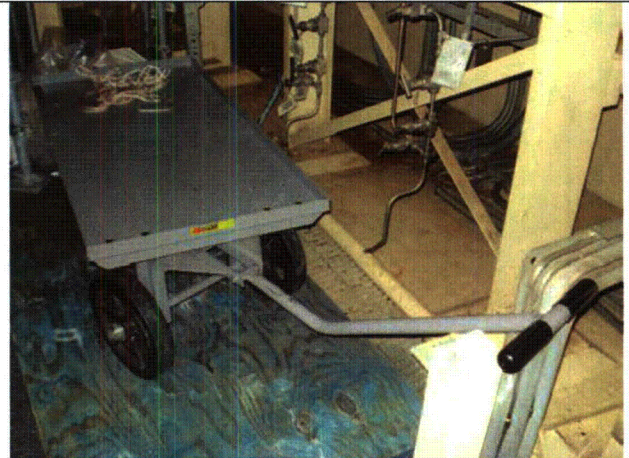
Note: Unchocked cart near SG ILT1115A. After notification, cart was removed and properly stored elsewhere.

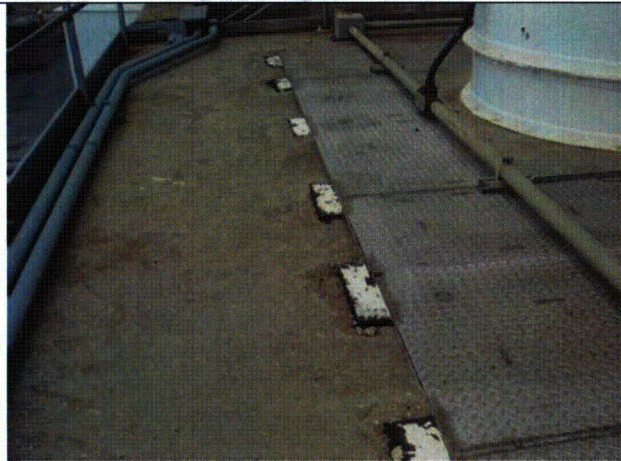
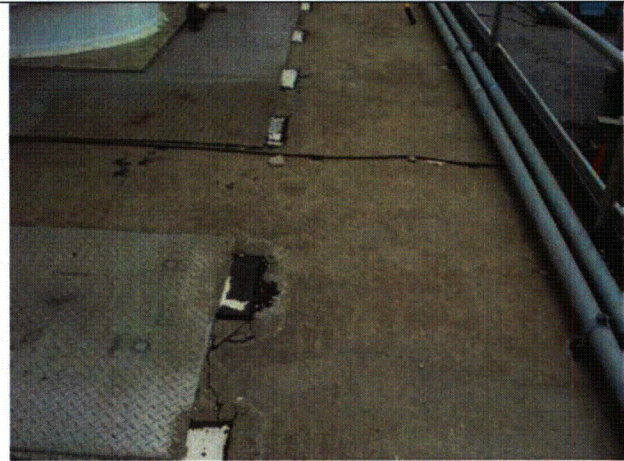
Note: *Spalled concrete around embedded support plates.*

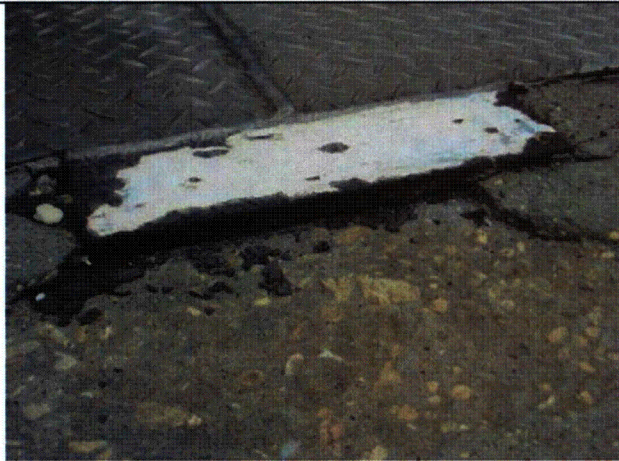
Note: *Spalled concrete around embedded plates.*

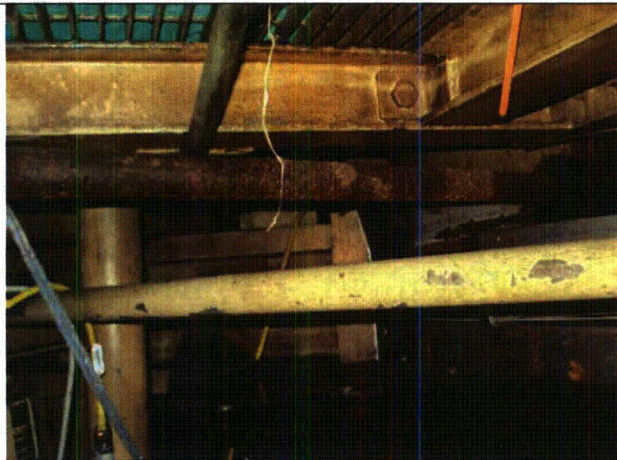
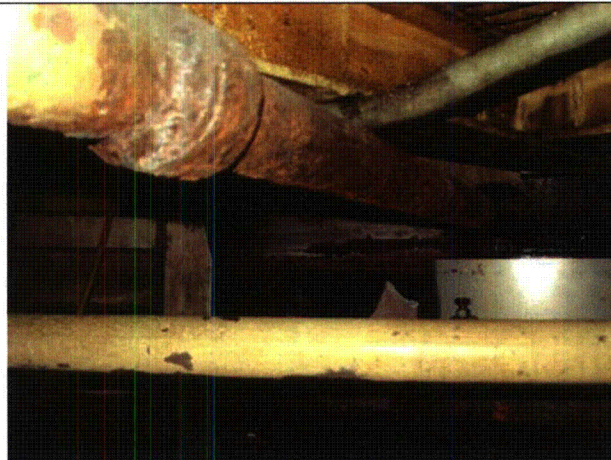
Note: Corroded line 3CC1 1/2-35-B2. CR-WF3-2012-07680 was written for this condition.

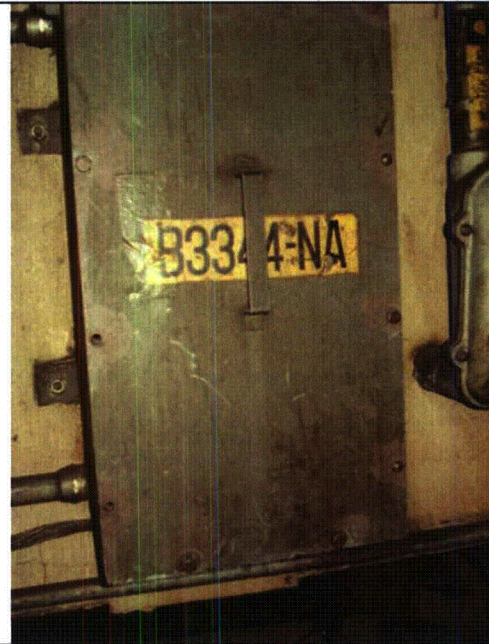
Note: Box B3344-NA with missing screw on front cover. CR-WF3-2012-07681 was written for this condition.

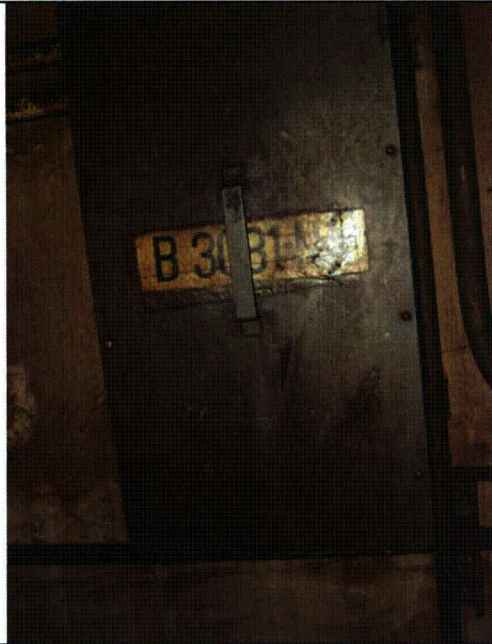
Note: Box B3081-NA with missing screw on front cover. CR-WF3-2012-07681 was written for this condition.
