**SUBJECT: AREVA NP, INC. (RICHLAND) – U.S. NUCLEAR REGULATORY COMMISSION
INTEGRATED INSPECTION REPORT NUMBER 70-1257/2013-002**

Report No: 70-1257/2013-002

Licensee: AREVA NP, Inc.

Facility: Richland, Washington

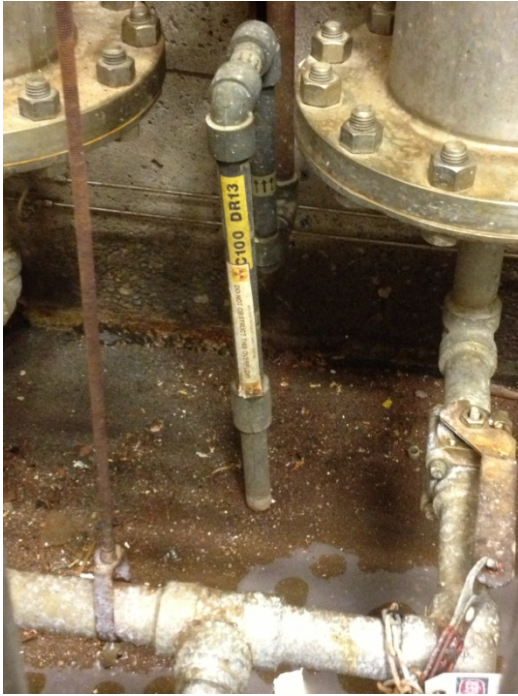
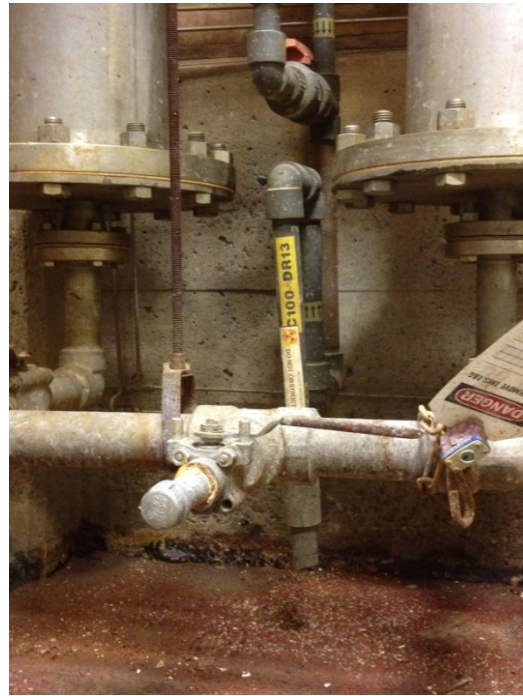
During a tour of the site, the inspectors noted that Criticality Drain C100DR13 in the South Tank Gallery of Room 102A in the UO2 Building was installed nearly flush with the floor. Maintenance work was ongoing in the area and the floor was wet and partially covered in debris when the drain was discovered. Following discovery, the floor was cleaned and approximately two inches was cut off the end of the drain to prevent backflow of UN solution into POG Scrubber S-184. The figures below show the drain before (on the left) and after corrective action was taken (on the right).

The inspectors reviewed evaluation E04-NCSA-186, "Supercritical Carbon Dioxide (CO₂) Extractor System," Version 6.0, to determine whether the as-found condition of the drain degraded its safety function. The inspectors determined that the drain, IROFS 6964, prevents overflow of process tanks into an unfavorable geometry POG scrubber S-184. The inspectors examined accident sequences relying on IROFS 6964 and determined that, in all cases, there were sufficient redundant criticality drains to ensure the performance requirements were met. The safety function of drain C100DR13 requires it to be capable of handling a flowrate of 10.5 gallons per minute (gpm). Based on the diameter and static fluid head in the pipe above the drain, the drain was calculated as having a drainage capacity of 27 gpm. The inspector determined that if the air gap between the drain and the floor was conservatively estimated as 1/8 inch, the flowrate could be reduced by approximately 50%. Due to the safety margin designed into the system, the drain would still be able to handle the required flowrate.
