1CAN041305

April 30, 2013

Subject: Response to Request for Additional Information  
Related to Fall 2011 Steam Generator Tube Inservice Inspections  
Arkansas Nuclear One - Unit 1  
Docket No. 50-313  
License No. DPR-51

**Response to Request for Additional Information  
Regarding the Steam Generator Tube Inservice Inspection  
Fall 2011 Refueling Outage**

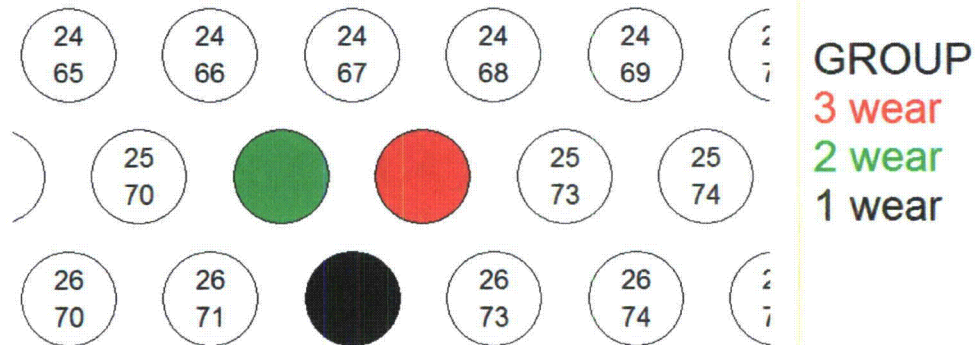
**SG B Location of Tube with 3 Wear Scars**

The initial planned 1R24 SG B eddy current inspections are complete. Inspections using qualified array techniques have identified one tube with TTW indications. The tube SG B R25 T72 has 3 wear scars and is shown below. The 1R24 inspections were performed for tie rod bowing phenomena. These inspections included tubes with previous TTW indications but not adjacent tubing. Adjacent tubing to R25 T72 could have TTW and currently would remain uninspected.

For the TTW Root Cause Analysis (RCA), the fact that a tube can be in contact with one or more tubes and experiencing wear is not an unlikely event. In this case, tube R25-T72 may not be active in the bowing, but rather affected by its neighbors bowing towards it. The additional inspection mentioned above will help in this determination.

Testing of adjacent tubing to R25 T72 will be performed with the Array Probe.
