**UNITED STATES
NUCLEAR REGULATORY COMMISSION
REGION I**
2100 RENAISSANCE BOULEVARD, SUITE 100
KING OF PRUSSIA, PENNSYLVANIA 19406-2713

May 1, 2013

SUBJECT: SEABROOK STATION, UNIT NO. 1 - NRC INTEGRATED INSPECTION
REPORT 05000443/2013002

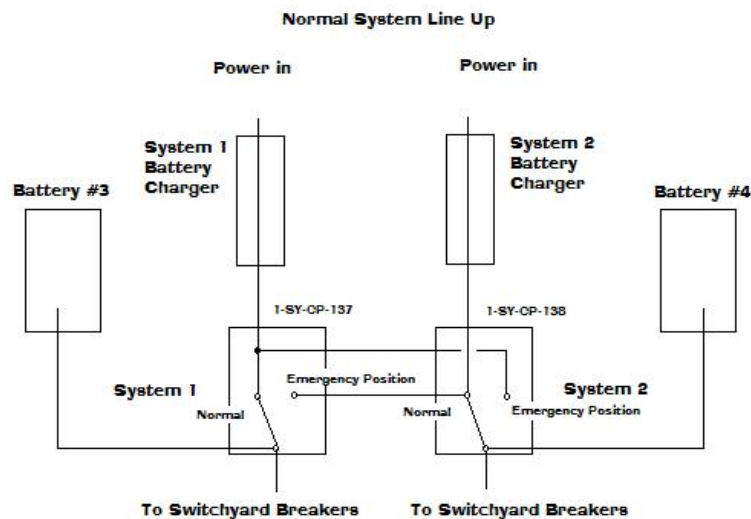
Description: The switchyards at Seabrook are two diverse and independent, but not completely redundant systems. Switchyard system 1 (SYS#1) provides breaker opening power and protective breaker trips for the switchyard system breakers and SYS#2 provides breaker closing power for all switchyard system breakers. Each switchyard system is supplied DC power via its battery and/or its battery charger (SYS#1 supported by SYB#3 and SYS#1 charger and SYS#2 supported by SYB#4 and SYS#2 charger). The normal power lineup for a switchyard system has its battery charger supplying power to its battery and loads. Each system charger is capable of simultaneously charging both switchyard system batteries and supplying both system's loads. This lineup is used during charger maintenance.

Each breaker in the Seabrook switchyard is designed with an automatic reclose device that will reclose a tripped breaker after the fault condition that tripped the breaker clears and the line conditions meet the system requirements for closing the breaker. The automatic reclose device is powered by SYS#2. A failure of this reclose feature affects the safe operation of the plant because it increases the probability that a loss of offsite power will occur. Specifically, if this feature fails, line faults that normally by design would result in a breaker trip and reclose (if the fault cleared), would result in a loss of offsite power. NextEra's PRA program for Seabrook credits the auto-closure feature of the switchyard breakers, and the loss of SYS#2, which provides the power for auto reclose, would cause an increase in the probability of core damage at Seabrook.

On January 24, 2013, during a planned maintenance discharge test of SYB#3, the control room received numerous 345 kV relay alarms for SYS#2. NextEra determined that the cause for the alarms was that SYB#4, the battery that supports SYS#2, was supplying DC power to SYS#2 for multiple days with its battery charger disconnected. Without the charger connected, SYB#4 fully discharged and DC power for SYS#2 was lost. NextEra secured the discharge test on SYB#3 and returned it and the battery charger for SYB#4 to service to supply loads to both switchyard systems. NextEra entered this issue into their CAP as CR 1841980 and conducted a root cause evaluation.

Analysis: The inspectors determined that the failure of NextEra operators to position the manual throw-over switch #2 associated with SYS#2 to the emergency position in accordance with ON1048.07 step 4.7.3, was a performance deficiency. The inspectors determined that the performance deficiency was more than minor because it was associated with the human performance attribute of the Initiating Events cornerstone, and it adversely affected the cornerstone objective to limit the likelihood of events that upset plant stability and challenge critical safety functions. Specifically, not properly performing NextEra procedure ON1048.07 resulted in the loss of the SYS#2 breaker automatic closure feature, thereby increasing the risk of an initiating event due to a loss of off-site power. The inspectors evaluated the finding in accordance with IMC 0609, Appendix A, "Determining the Significance of Reactor Inspection Findings for At-Power Situations" (IMC 0609A). The inspectors determined that the finding was of very low safety significance (Green) because the deficiency did not cause a reactor trip and the loss of mitigation equipment relied upon to transition the plant from the onset of the trip to a stable shutdown condition.
