## Plan for Future Seismic Walkdown of Inaccessible Equipment

**Peer Review Report**  
**for**  
**Near Term Task Force (NTTF) Recommendation 2.3**  
**Seismic Walkdown Inspection**  
**of**  
**Dresden Nuclear Station Unit 3**

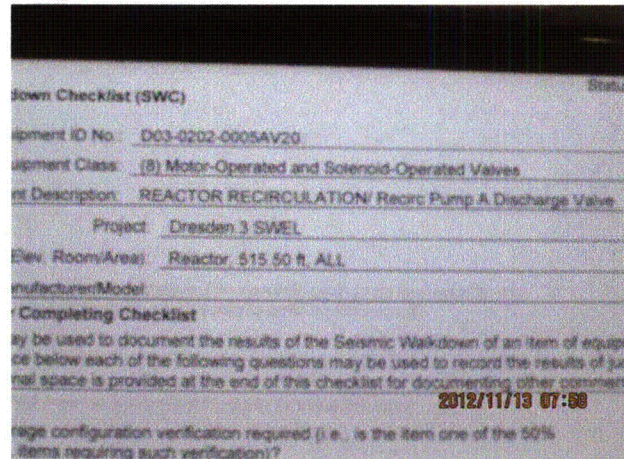
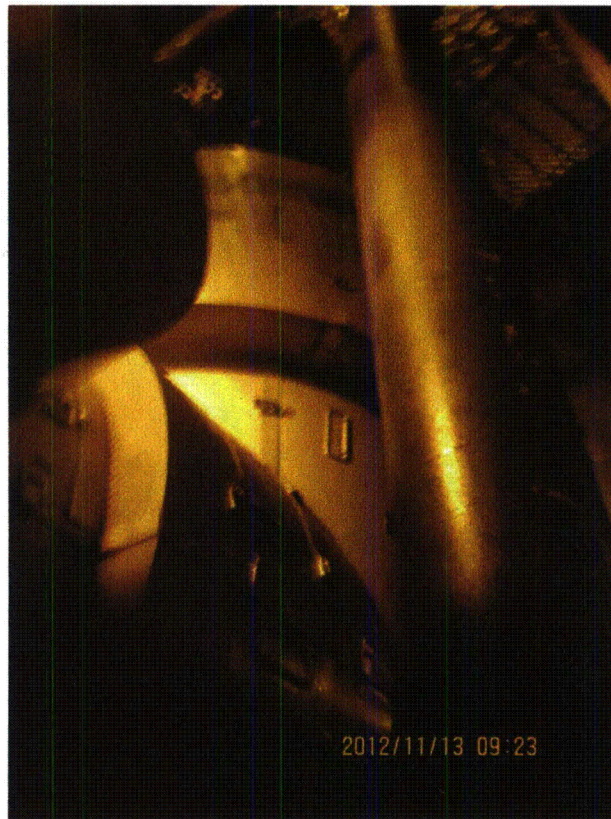
Equipment Description: REACTOR RECIRCULATION/ Recirc Pump A Discharge Valve

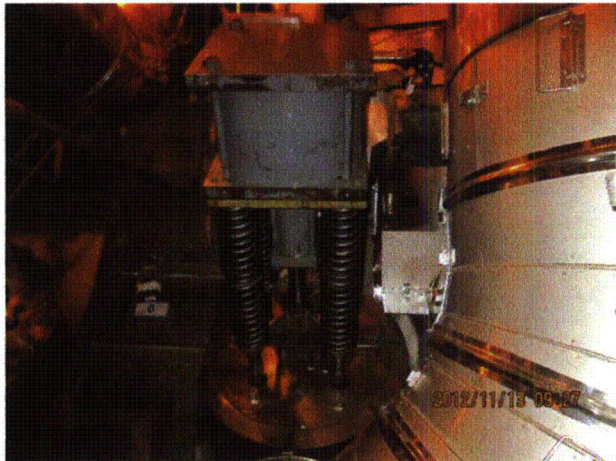
3-0203-1 2012-11-13

Equipment Description: MAIN STEAM/ Isolation Valve

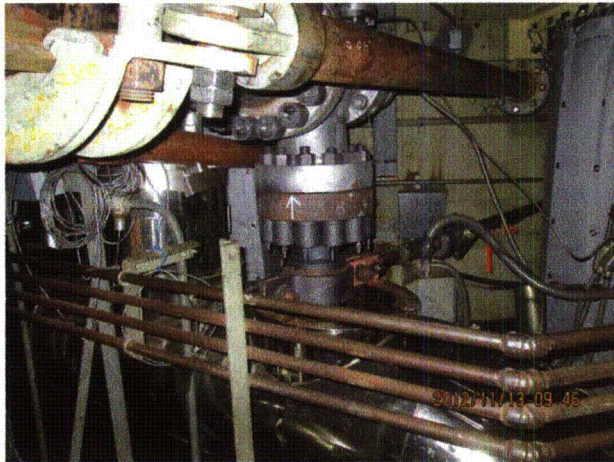
3-0203-3A 2012-11-13

Equipment Description: ADS/ Target Rock Valve

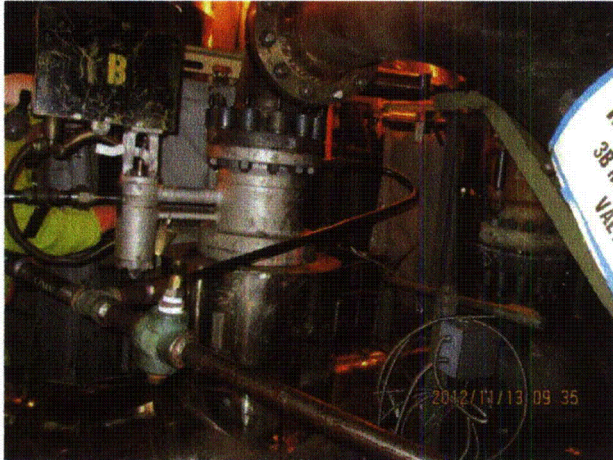
3-0203-3B 2012-11-13

Equipment Description: ADS/ Electromatic Relief Valve

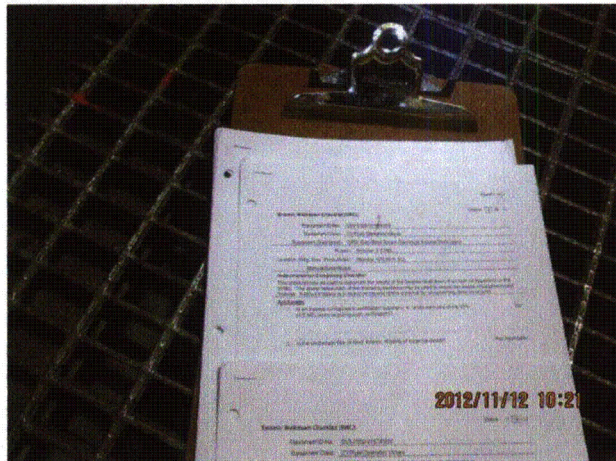
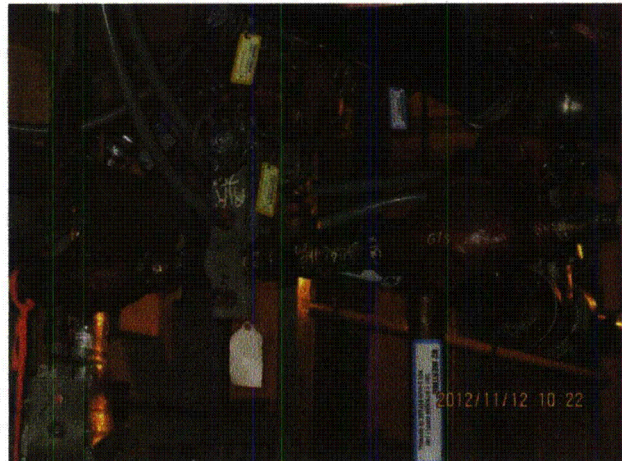
Equipment Description: CRD/ East Bank Scram Discharge Volume Drain Valve

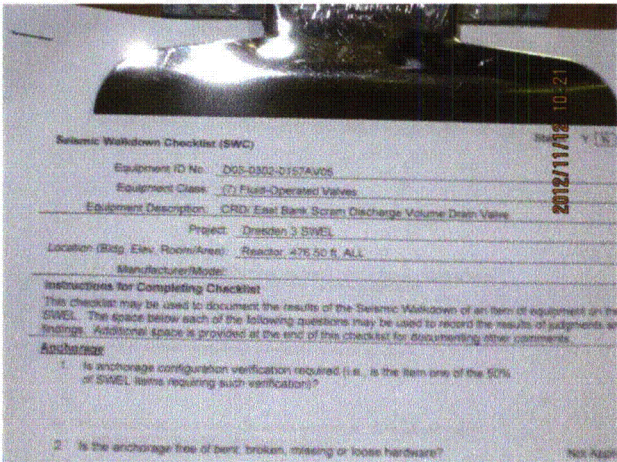
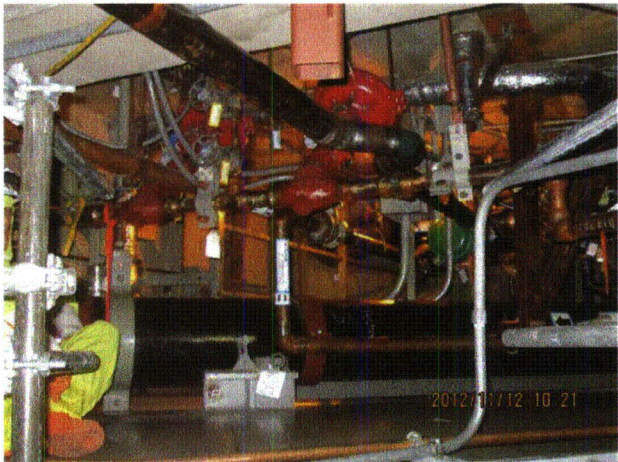
Equipment Description: CRD/ East Bank Scram Discharge Volume Drain Valve

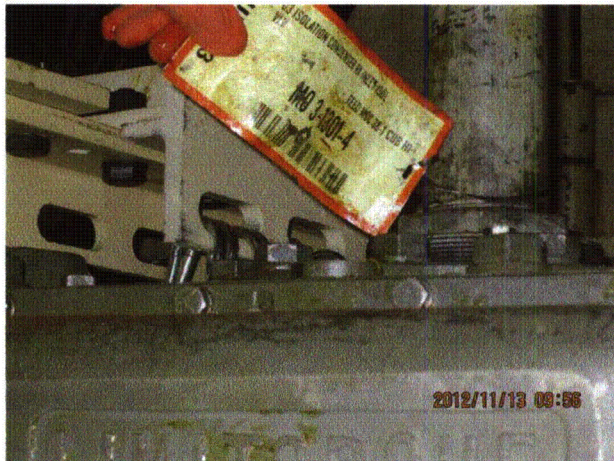
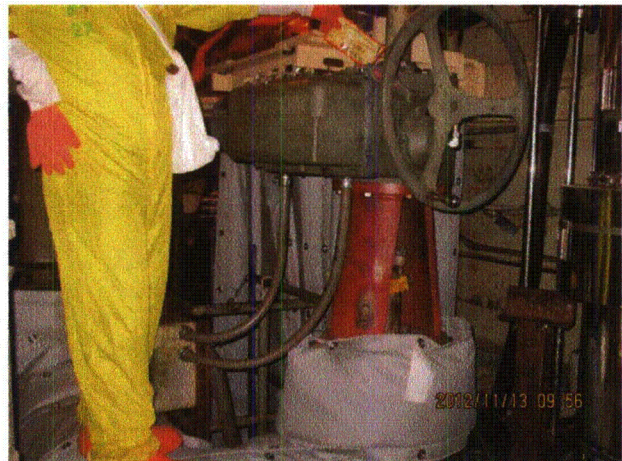
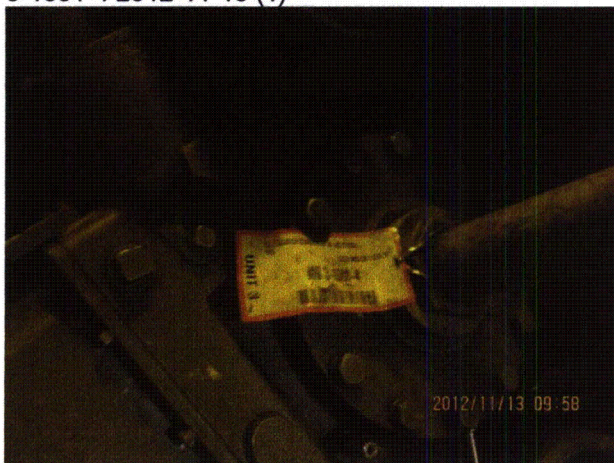
Equipment Description: ISOLATION CONDENSER/ Steam Return Line Isolation Valve

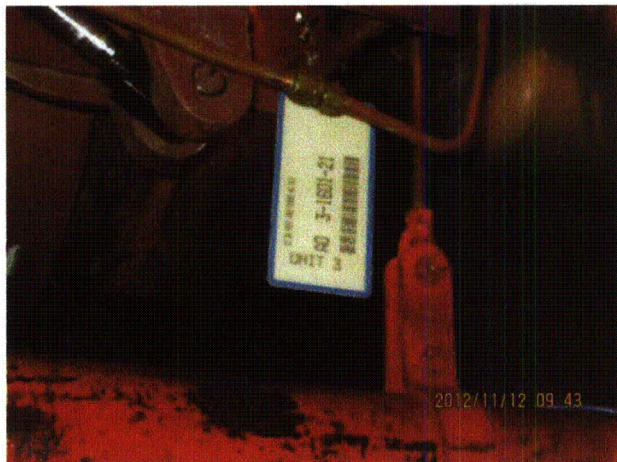
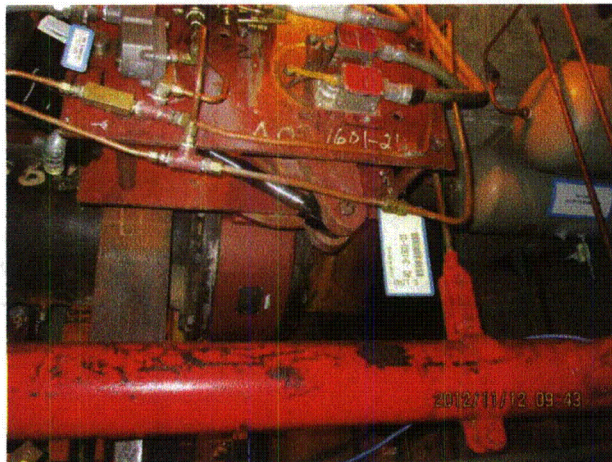
Equipment Description: PRESSURE SUPPRESSION/ Drywell Purge Line Valve

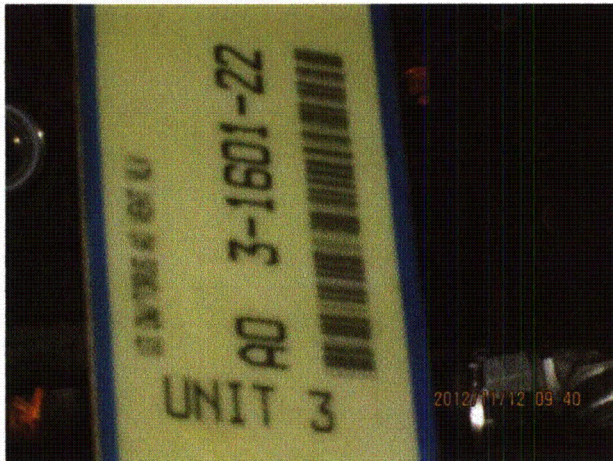
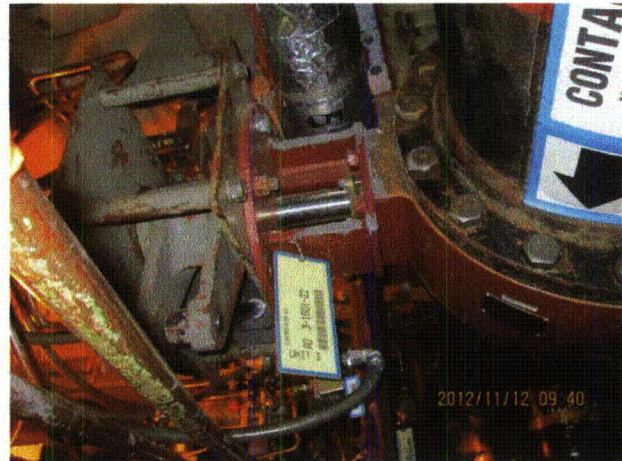
Equipment Description: PRESSURE SUPPRESSION/ Drywell/Torus Purge Line Valve

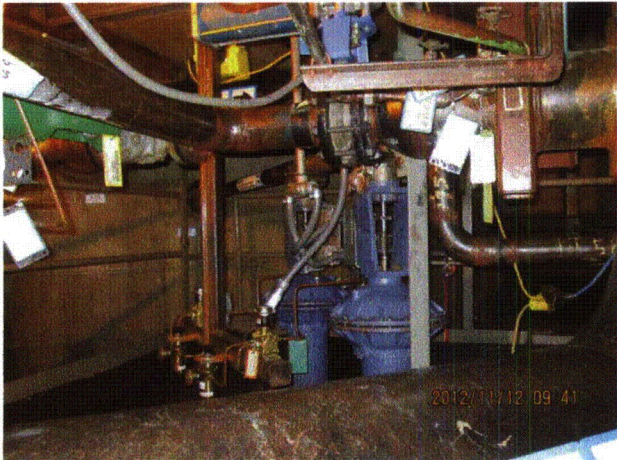
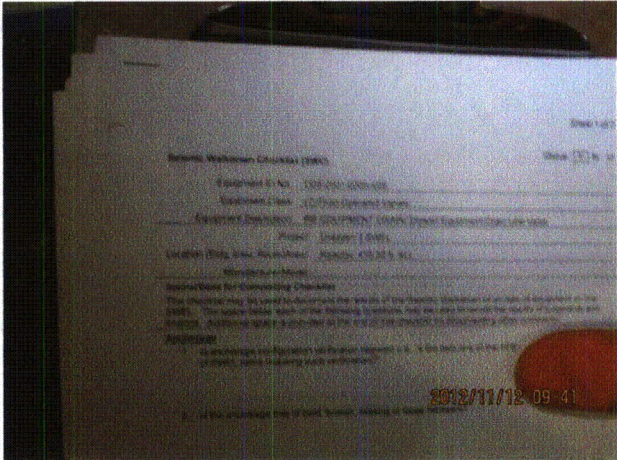
Equipment Description: RB EQUIPMENT DRAIN/ Drywell Equipment Drain Line Valve

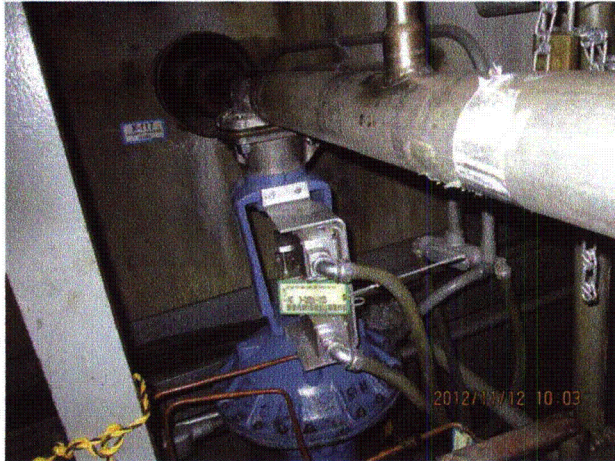
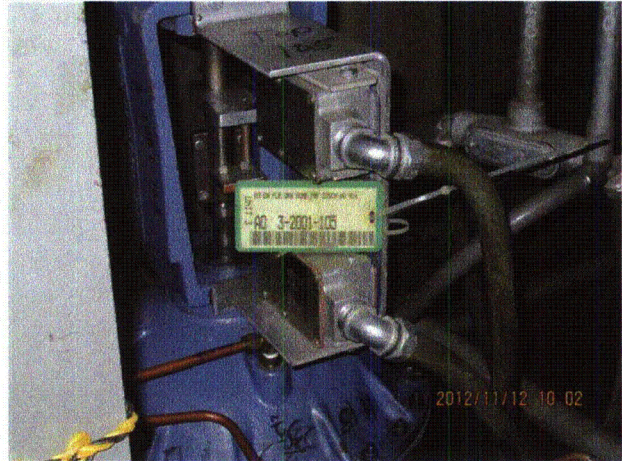
Equipment Description: RB EQUIPMENT DRAIN/ Drywell Floor Drain Line Valve

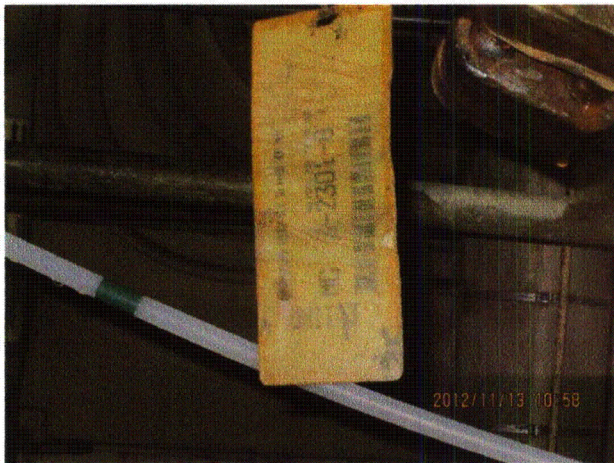
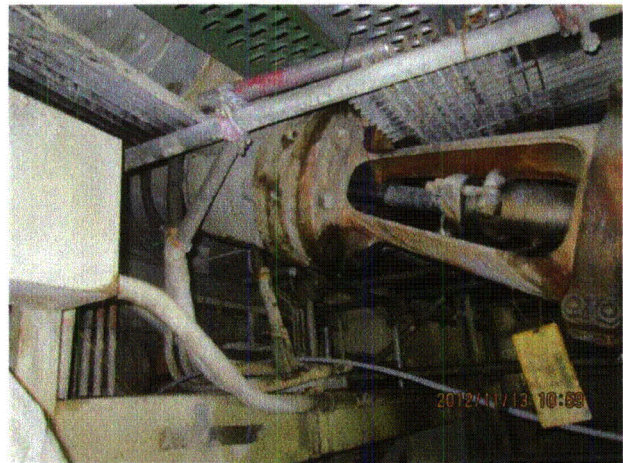
Equipment Description: HPCI/ HPCI Pump Injection Line Valve

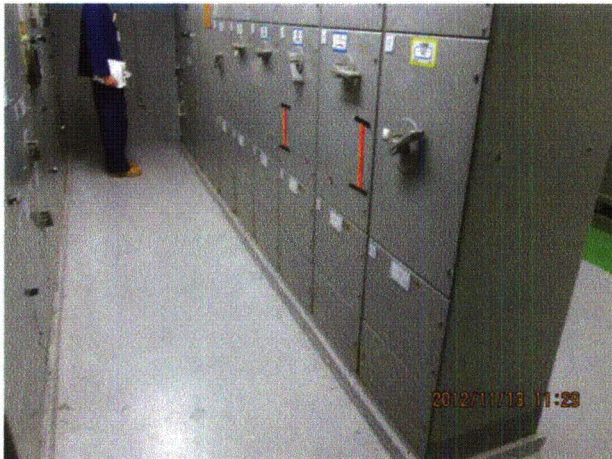
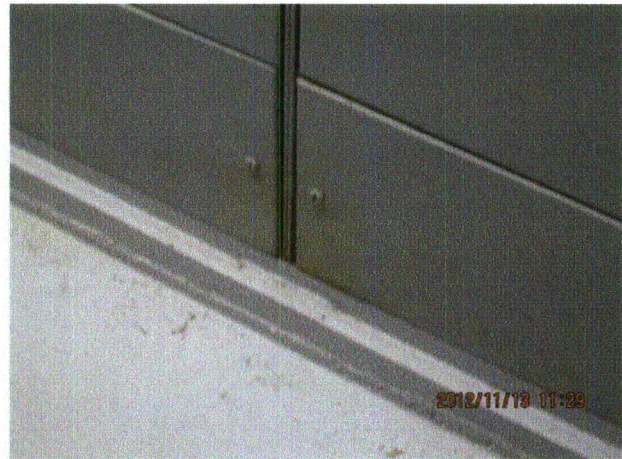
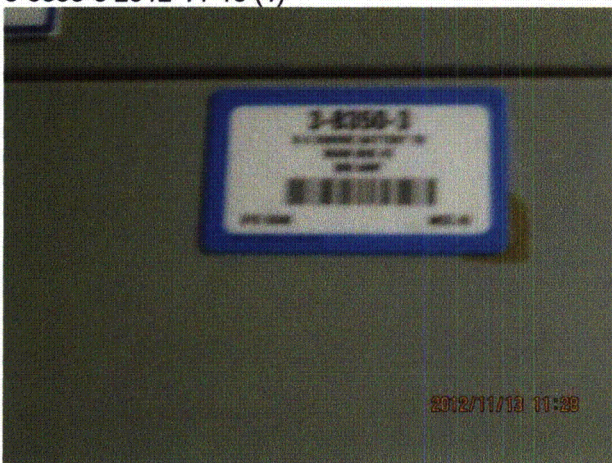
Equipment Description: 250V DC/ Breaker to TB MCC #3 (ROB-Battery #3)
