PART 21 REPORT - FUEL INJECTORS FAILED PRESSURE TEST

Report No. 10CFR21-0109

**10CFR21 REPORTING OF DEFECTS
AND NON-COMPLIANCE**

COMPONENT: EMD Fuel Injectors
P/N 40084720 & 40099335

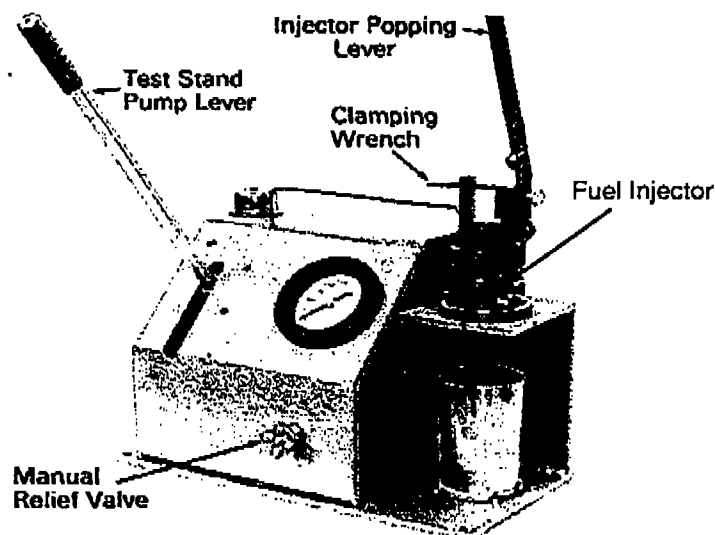
The standard holding pressure and leakage test specified for the EMD fuel injectors requires applying 2000 psi to the fuel injector and verifying the pressure does not fall below 1500 psi after 30 seconds. This test is performed on an Injector Tester designed specifically for this purpose. See Figure 1 below.

Figure 1: EMD Fuel Injector Tester
