**SUSQUEHANNA STEAM ELECTRIC STATION
PROPOSED RELIEF REQUEST NO. 3RR-20 TO
THE THIRD 10-YEAR INSERVICE INSPECTION
PROGRAM FOR SUSQUEHANNA SES UNIT 2
PLA-7014**

**PPL SUSQUEHANNA, LLC
SUSQUEHANNA SES, UNIT 2
THIRD 10-YEAR INTERVAL
REQUEST FOR RELIEF NO. 3RR20**

The Unit 2 'A' Reactor Recirculation Pump Flange

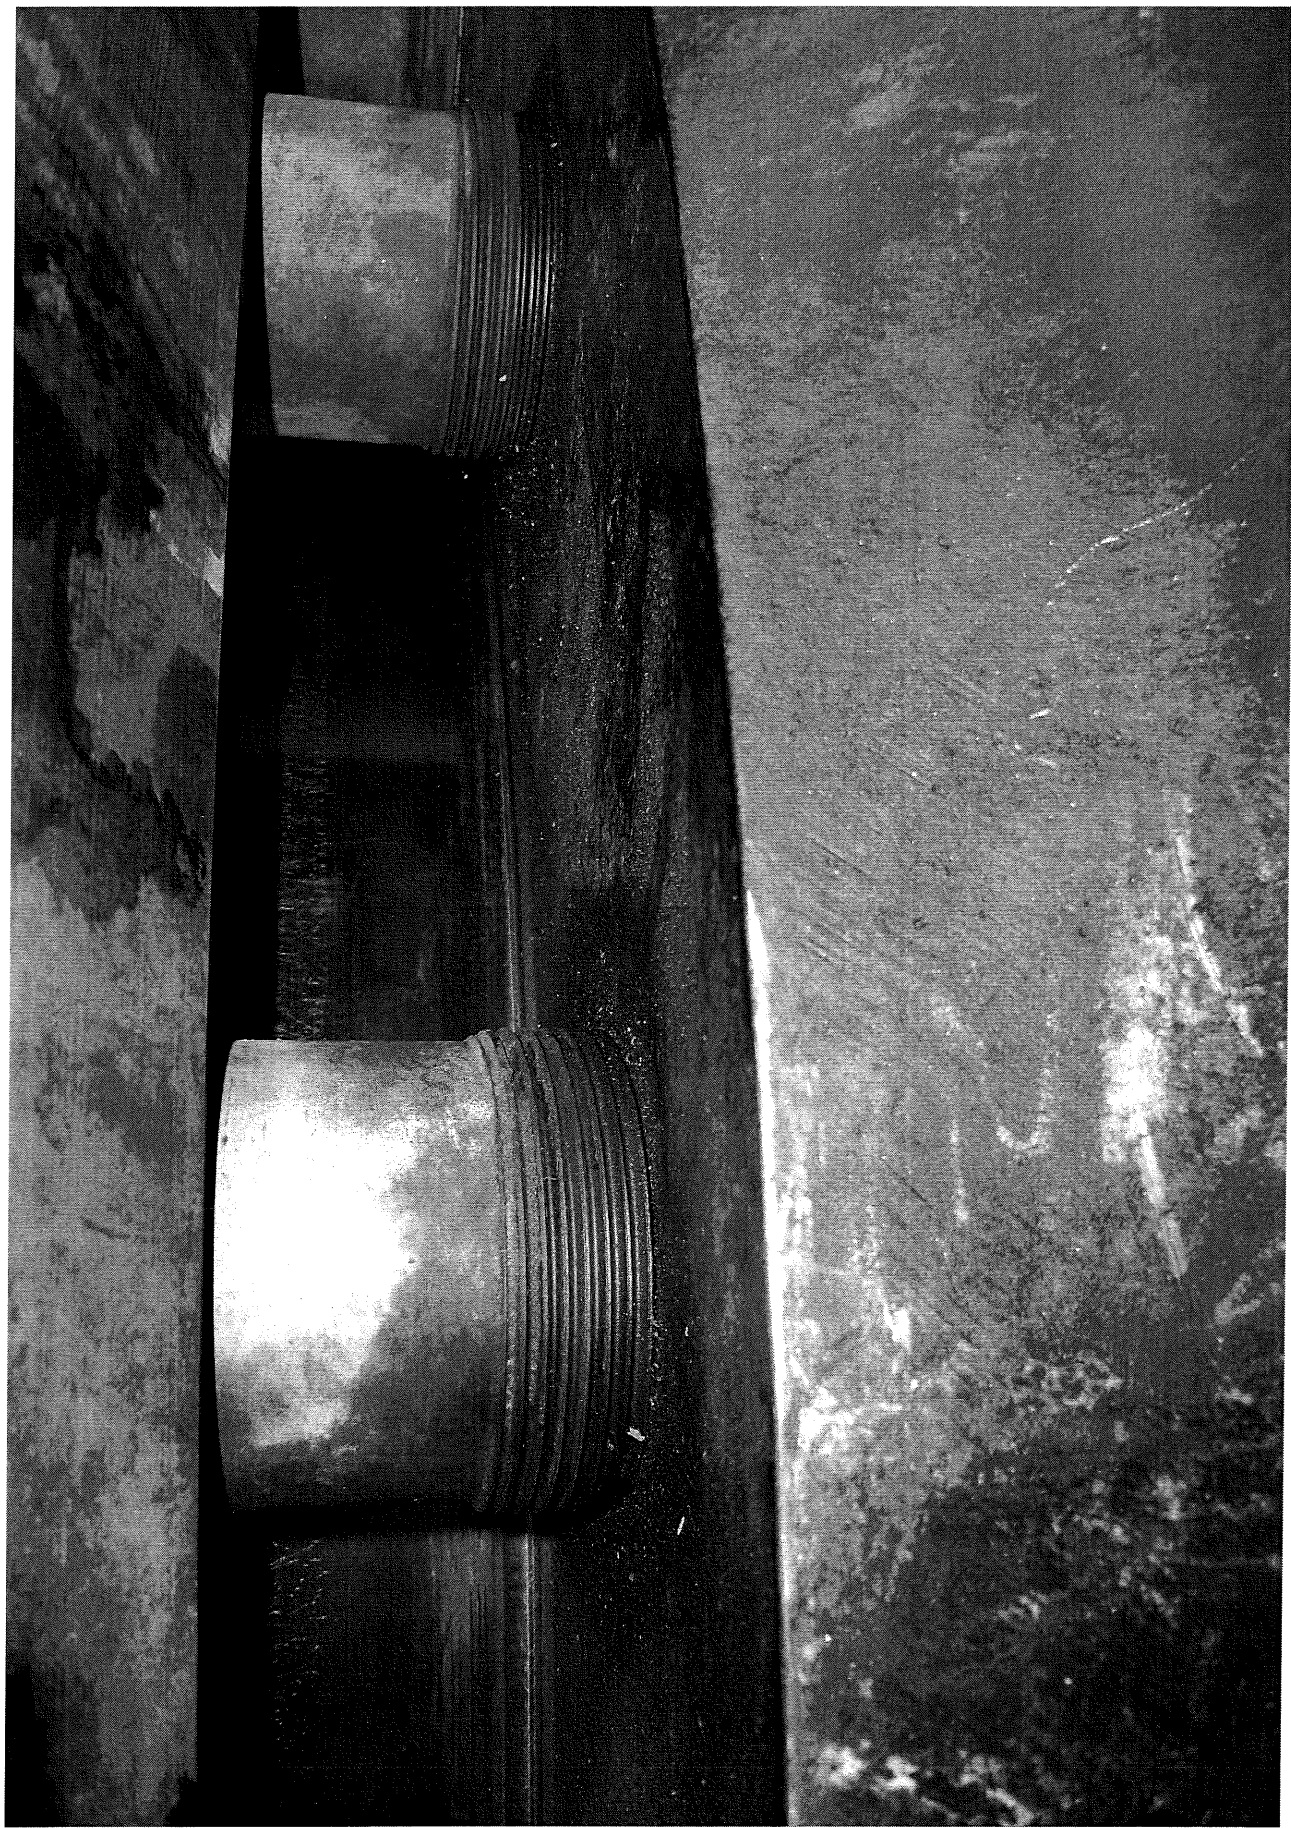
Unit 2 'A' Recirculation Pump Flange Stud Area

Table IWB-2500-1, Examination Category B-G-1, Item B6.190 requires a VT-1 visual examination of a one inch annular surface of the pump flange surface surrounding each stud when the pump is disassembled. The SSES Unit 2 'A' Reactor Recirculation pump was disassembled during the Unit 2 16th Refuel and Inspection Outage (U2-16RIO). During the time the pump was disassembled, a VT-3 of the pump bowl was performed. However, the required VT-1 examination (examination for discontinuities) of the flange surface was not performed. This omission was not recognized until the pump had been reassembled. Originally, PPL reported that access to this area of the pump was not available. After discussions with the SSES engineering staff, a qualified visual inspector was dispatched, and a VT-1 examination was performed on the pump flange surface. Since the pump was reassembled prior to this examination being performed, interferences from the pump internals limited the examination of the flange to approximately 98%.

surface inspection that was performed by the pump vendor and SSES Quality Control personnel prior to pump reassembly. No evidence of degradation was noted. Although the examinations were not VT-1 qualified, and not credited for ASME credit, it adds additional assurance that the flange surface (including the 2% of the flange surface that was not accessible) is acceptable for continued service. PPL will also perform at VT-2 examination on the pump prior to startup of Unit 2.
