## 5.4 Industry Standard Nondestructive Evaluations

## 6 Destructive Validation of Nozzle 63

## 7 Correlation of Ultrasonic and Destructive Results

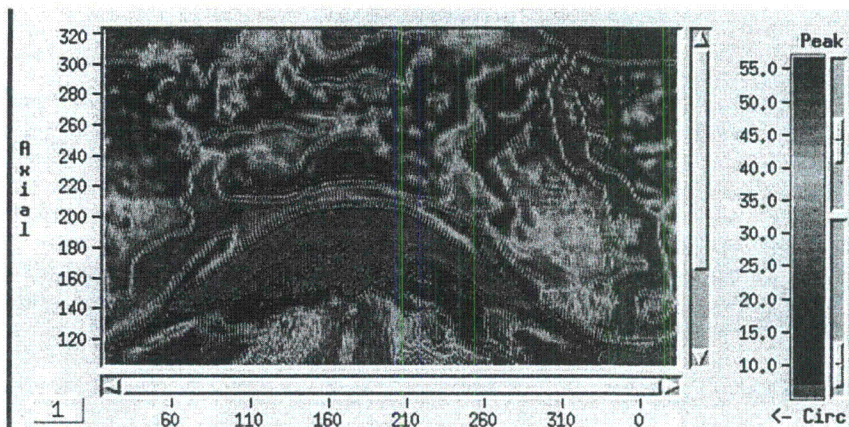
The Figure 5.17 image can be compared to the PNNL's results in Figure 5.15. Both data sets were acquired with probes having nominal center frequencies of 5 MHz and they show the main leak path as a high-amplitude signal. In the WesDyne data, this is represented by the magenta color. Both data images capture other partial leak paths and show similar areas of high and low reflectivity. The PNNL data however possess better data registration in the odd and even scan lines as well as improved resolution and focusing. These images demonstrate that PNNL was successful in achieving a better evaluation of the interference fit as compared to a qualified industry procedure.

Figure 5.17 Ultrasonic Data from Nozzle 63 as Obtained by WesDyne International. The image was acquired with a 5-MHz probe. The horizontal axis represents the nozzle circumference in units of degrees. The vertical axis represents the nozzle axis in units of millimeters.

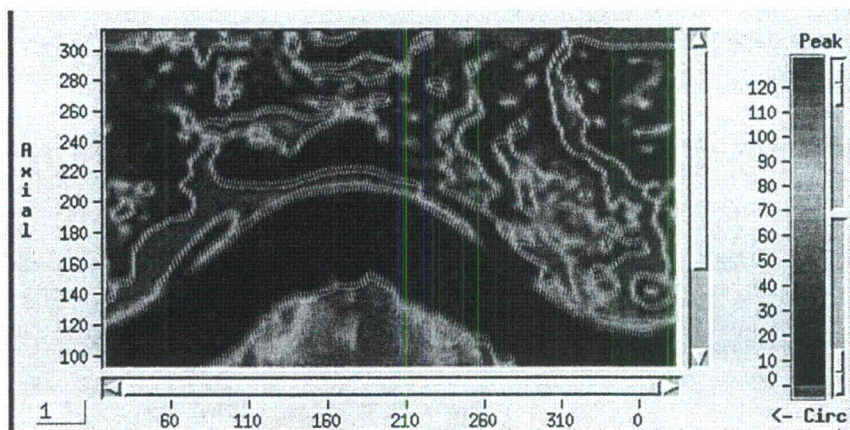
**Figure 5.18** Ultrasonic Data from Nozzle 63 as Obtained by WesDyne International. The image was acquired with a 2.25-MHz probe. The horizontal axis represents the nozzle circumference in units of degrees. The vertical axis represents the nozzle axis in units of millimeters.

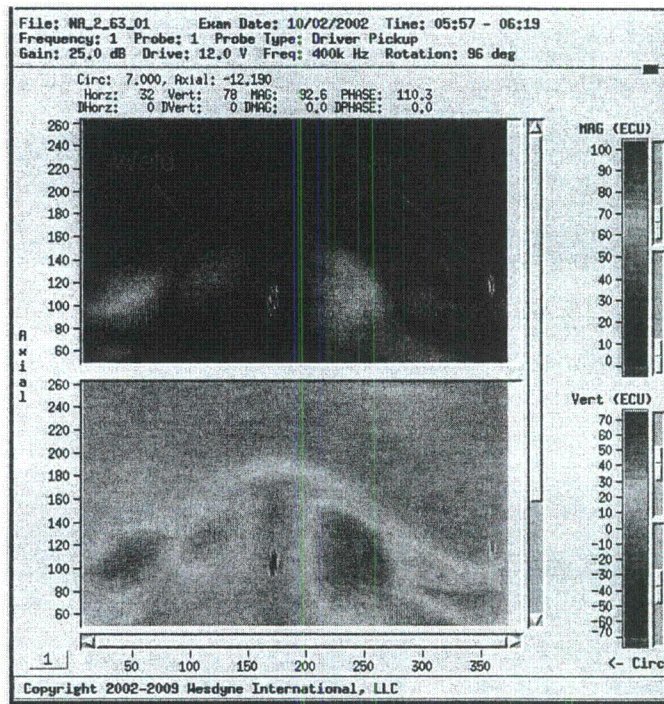
Additionally, an eddy current inspection conducted by WesDyne International detected two axial flaws. These were found at the locations shown in Figure 5.19 (data supplied by JP Lareau). The specific circumferential locations were noted at 172 and 360 degrees with 0 or 360 degrees representing the downhill position. The axial length for flaw 1, below the weld, was 25.4 mm (1.0 in.) and for flaw 2, above the weld and in the main leak path, was 19.3 mm (0.76 in.). These cracks were ID surface-connected and reported as shallow flaws.

While PNNL did not specifically perform an evaluation for axial cracking in the Alloy 600 tube, the two axial cracks noted by industry were detected. The zero-degree PNNL inspection was not optimized for crack detection as an axial crack presented only a knife-edge profile to the ultrasonic beam and did not reflect much energy. Nevertheless, the cracks were visible in the interference fit response and on further analysis also marginally detected in the water-to-Alloy 600 tube reflection (ID surface of the tube). Figure 5.20 shows the uphill images for the ID tube and interference fit responses. Similarly Figure 5.21 shows the responses for the downhill images. Both flaws appear to be ID surface-connected as they were detected in the data acquired at the ID surface of the Alloy 600 tube. These two flaws are also evident in the image in Figure 5.15. The ultrasonic data did not provide any depth-sizing information.

**Figure 5.19** Eddy Current Data (WesDyne International) Showing Two Axial Flaws. The horizontal axis represents the nozzle circumference in degrees. The vertical axis represents the nozzle axis in millimeters.

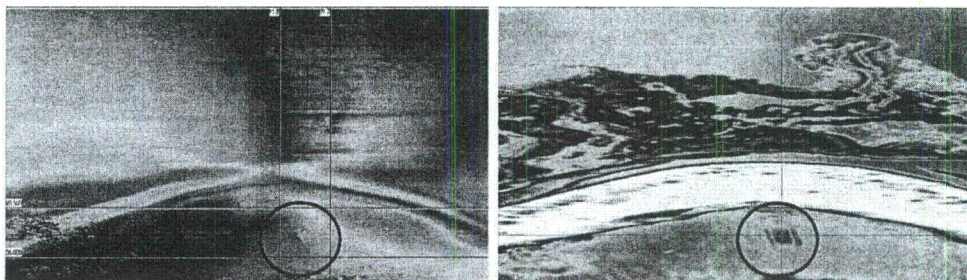
**Figure 5.20** Uphill Nozzle ID Response on the Left and Interference Fit Response on the Right with the Axial Flaw Indication Circled. The horizontal axes represent 189 degrees and the vertical axes represent 360 mm (14.2 in.).

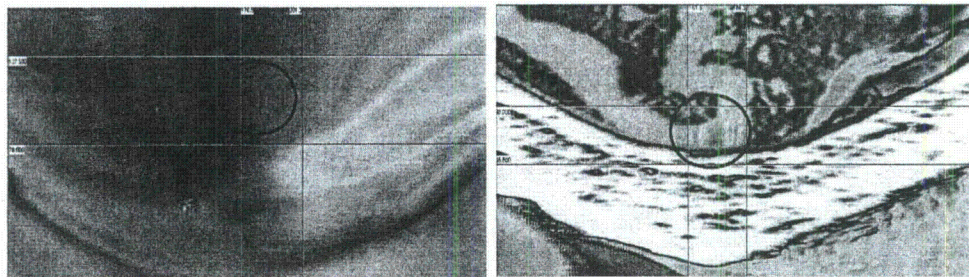
**Figure 5.21** Downhill Nozzle ID Response on the Left and Interference Fit Response on the Right with the Axial Flaw Indication Circled. The horizontal axes represent 188 degrees and the vertical axes represent 155 mm (6.1 in.).

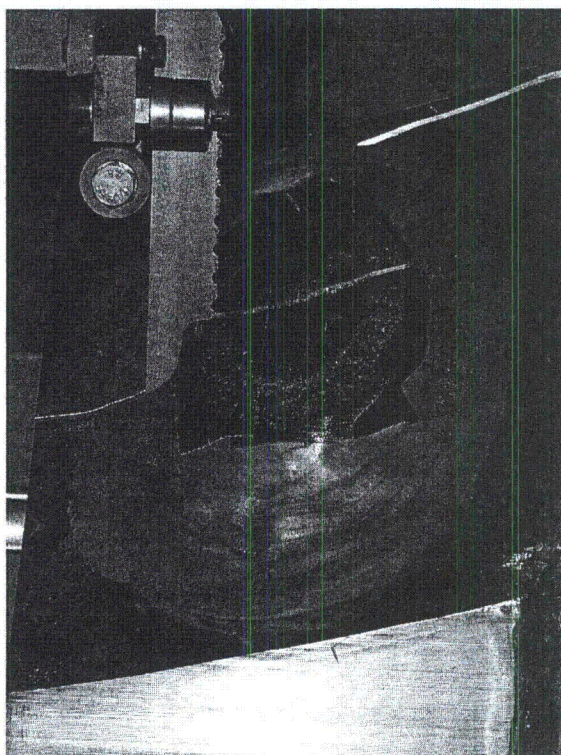
Dissection cutting began with the coarse-toothed blade. The cut progressed for approximately 20 minutes until an unidentified 'hard spot' was reached at the outer edge of the Alloy 600 nozzle region and stopped the cutting progression. A slower feed rate with a faster blade speed was attempted, but did not traverse the hard spot. The cause of the hard spot was not fully investigated, but a likely cause was from a cold-worked region of material within the heat-affected zone of the J groove weld adjacent to the nozzle outer diameter (OD). The coarse-cut blade was exchanged with a fine-toothed cutting blade and the cut was attempted again without success. Finally, the carbide blade was employed to abrasively grind through the hard spot. This blade required a greatly reduced feed rate, thus lengthened the cutting time. Further, the kerf of the carbide blade was thicker than the cutting blades, requiring the cut to be restarted at the initial cut path. The carbide grit abrasive blade is shown in Figure 6.4. The cut through this hard spot required approximately 2 hours to complete.

**Figure 6.4 Abrasive Carbide Blade Progressing Through the Hard Spot**

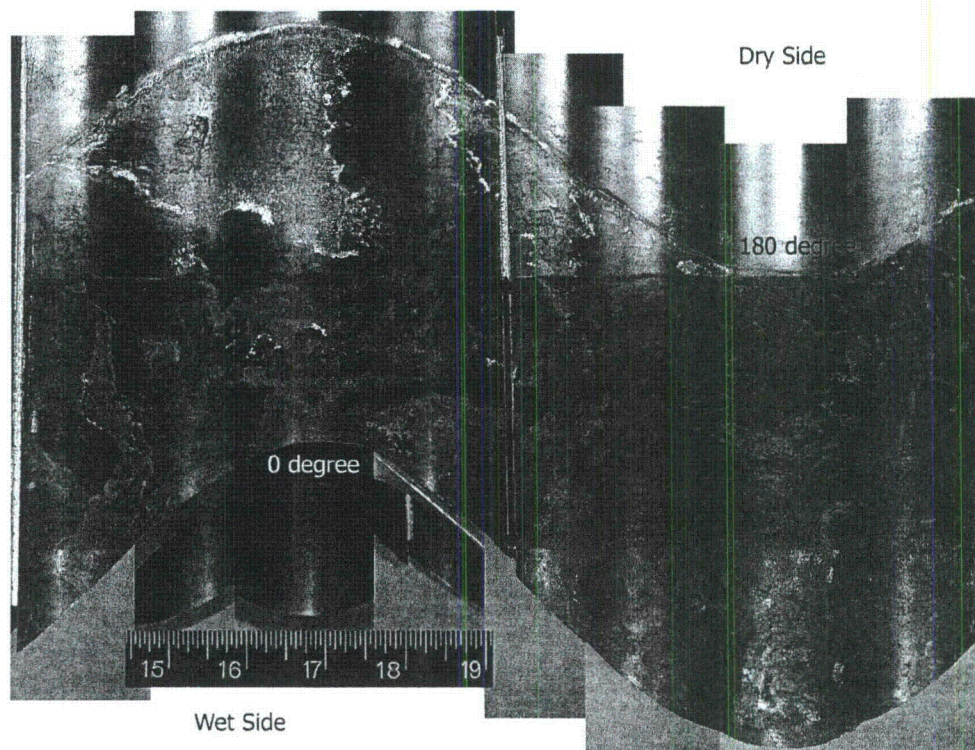
**Figure 7.1 Nozzle Surface.** The red line marks the interference fit region.

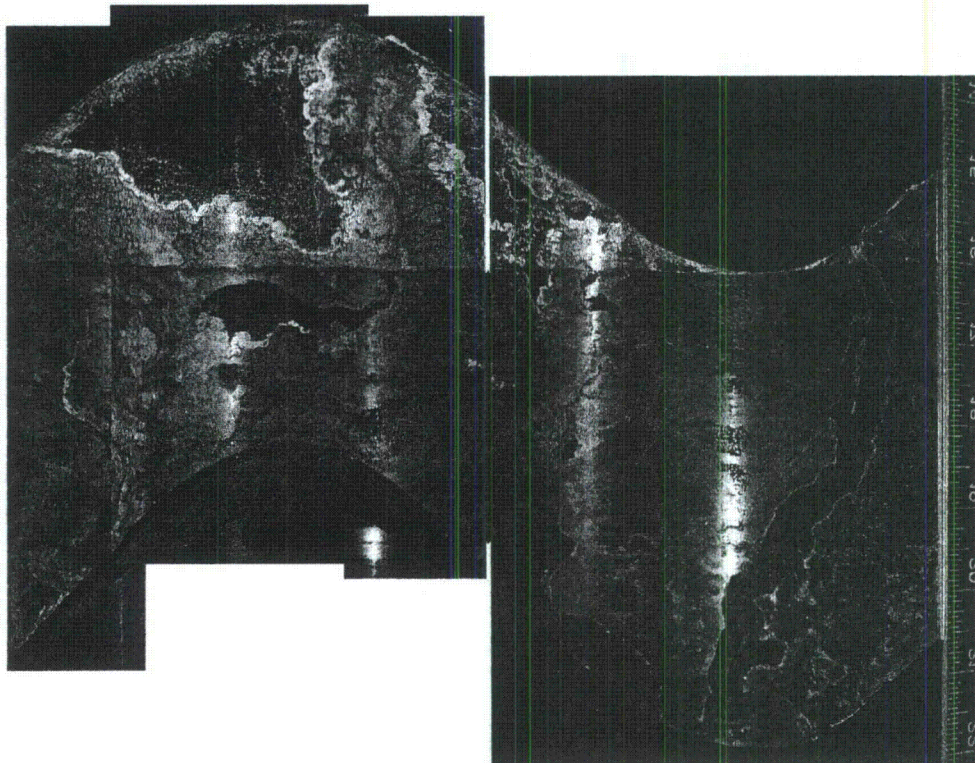
Similarly, the exposed reactor pressure vessel (RPV) head was photographed and the stitched image is displayed in Figure 7.2. The **main leak path** and other features seen in the ultrasonic images are clearly evident. Boric acid deposits are visible in white and corrosion products in the rust color. The interference fit region is evident in the photograph and is marked with the red line.

**Figure 7.2 RPV Head Surface. The red line marks the interference fit region.**

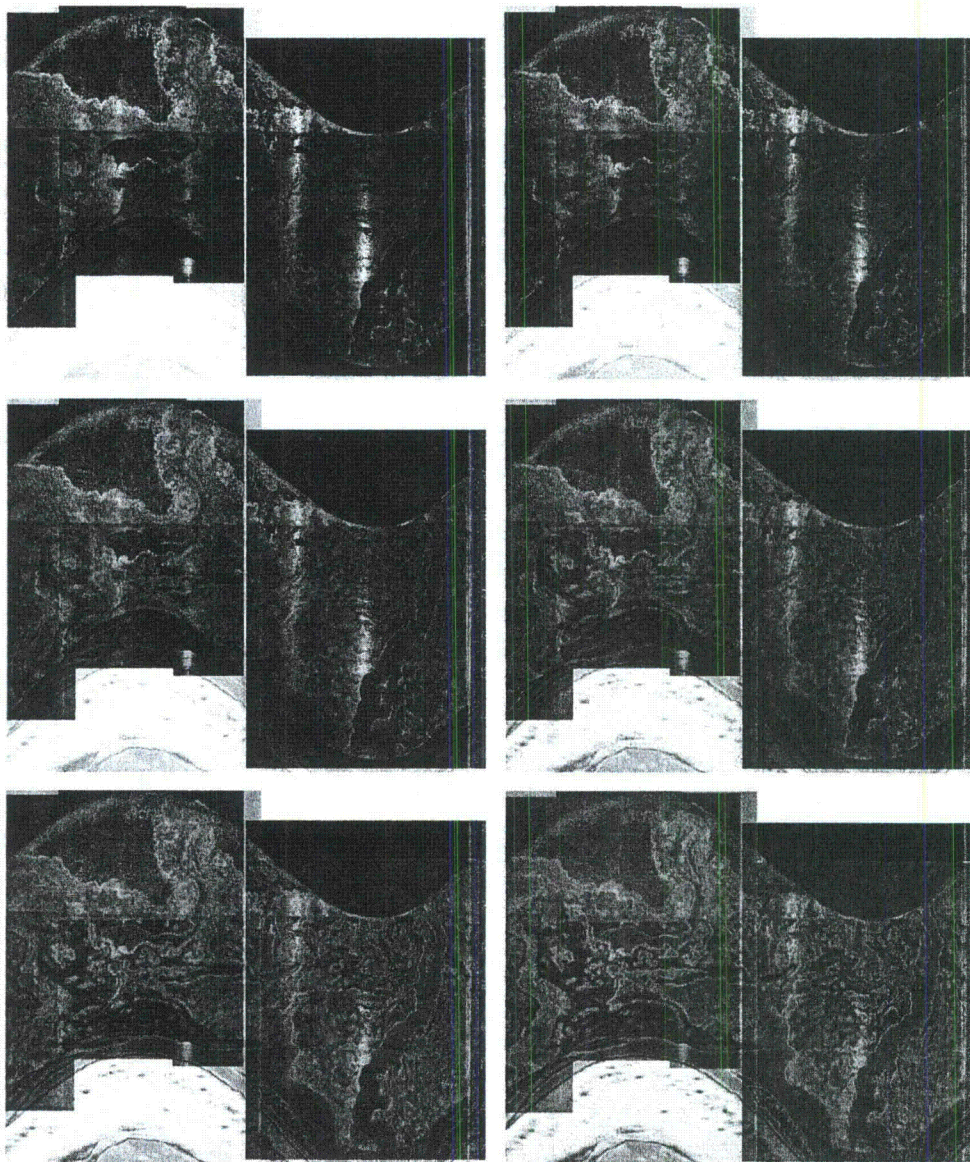
A comparison of the ultrasonic and visual images is next presented. The ultrasonic data is overlaid on the RPV head montage photograph in a series where the opacity of the ultrasonic data is varied from 10 to 60%, in increments of 10%. Figure 7.3 displays the results with increasing opacity from left to right, top to bottom. The ultrasonic image was stretched to best fit the visual data but the match is not perfect due to the curved surfaces. Nevertheless, the ultrasonic features well match the features seen visually on the RPV head annulus. Clearly, the main leak path was precisely imaged and other partial leak paths are evident as well.

Figure 7.3 Ultrasonic Data Overlaid on RPV Head Photograph with Opacity Varying from 10 to 60%, Top to Bottom

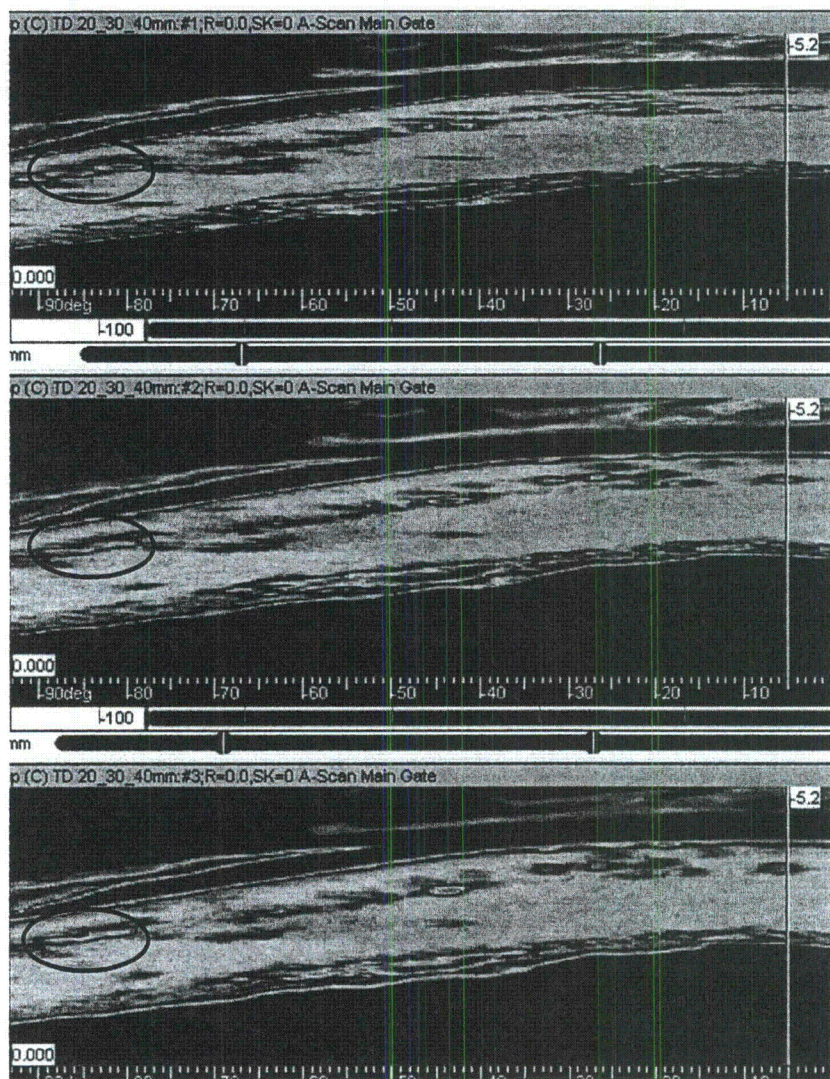
Figure 8.1 Weld Images with Focal Depths at 20, 30, and 40 mm (0.79, 1.18, and 1.56 in.) from Top to Bottom, Respectively. The horizontal axis represents approximately 90 degrees and the vertical axis represents approximately 150 mm (5.9 in.). A 20-mm (0.79-in.) focus provided the best resolution in this data.

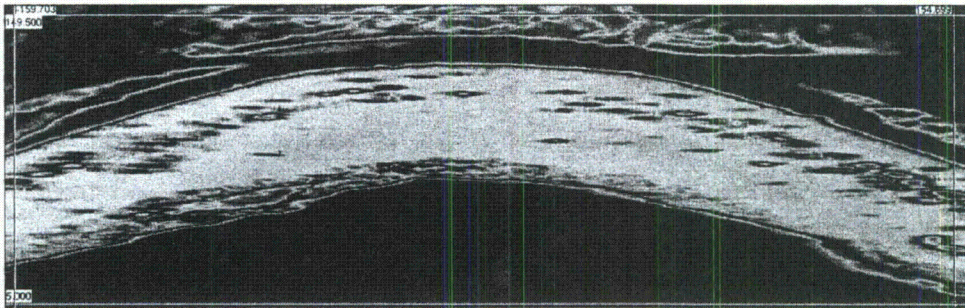
A composite view of the ultrasonic indications in the weld are presented in the C-scan top view or plan view images in Figures 8.2 and 8.3 for the uphill and downhill halves of the weld, respectively. Each figure represents approximately 150 mm (5.91 in.) in the vertical or axial direction and 180 degrees in the horizontal or circumferential direction. The indications were generally all located at the Alloy 600 tube-to-weld interface, or near surface, as will be discussed in more detail below. These indications appear to be volumetric in shape, indicative of fabrication flaws and assumed to be welding anomalies. The types of fabrication flaws expected would include incomplete or lack of fusion between individual weld beads, inclusions, voids, etc. Notice that the downhill image contains more indications. This is not unexpected due to the more difficult configuration at this position in the nozzle assembly. One would be welding upside down, in a deeper cavity, and with limited access at this location; and therefore more likely to introduce imperfections in the weld. A connected string of indications following the curvature of the weld are observed in Figure 8.3—likely a lack of fusion between weld bead passes. These indications are noted by the red arrow in the figure.

**Figure 8.2 Uphill Half of the Weld.** The horizontal axis represents approximately 180 degrees and the vertical axis represents approximately 150 mm (5.9 in.).

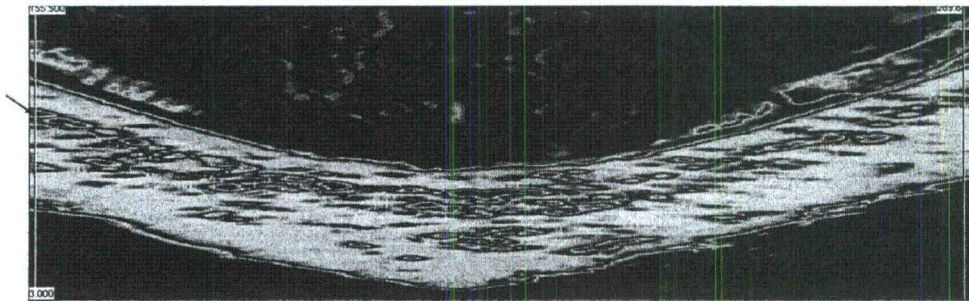
**Figure 8.3 Downhill Half of the Weld.** The horizontal axis represents approximately 180 degrees and the vertical axis represents approximately 150 mm (5.9 in.).

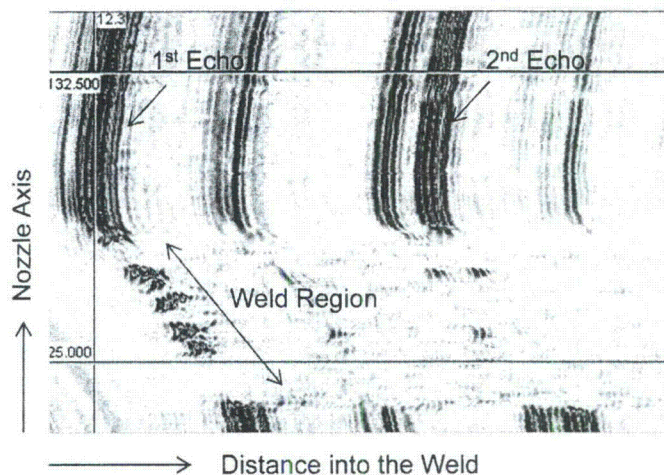
**Figure 8.5** B-scan Side View at the 174-Degree Circumferential Position. Near-surface indications are visible in the weld material. The horizontal axis represents approximately 40 mm (1.6 in.) in metal and the vertical axis 155 mm (6.1 in.).

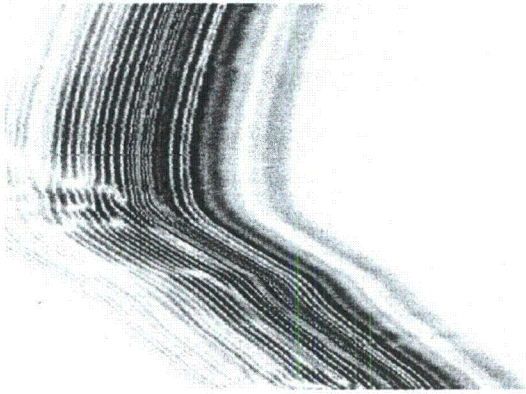
**Figure 8.6 B-scan Side View of the Front Surface Echo Showing Surface Profile Distortion Due to Welding and Cooling at the 174-Degree Circumferential Position. The horizontal axis represents approximately 20 mm (0.8 in.) in metal and the vertical axis 155 mm (6.1 in.).**

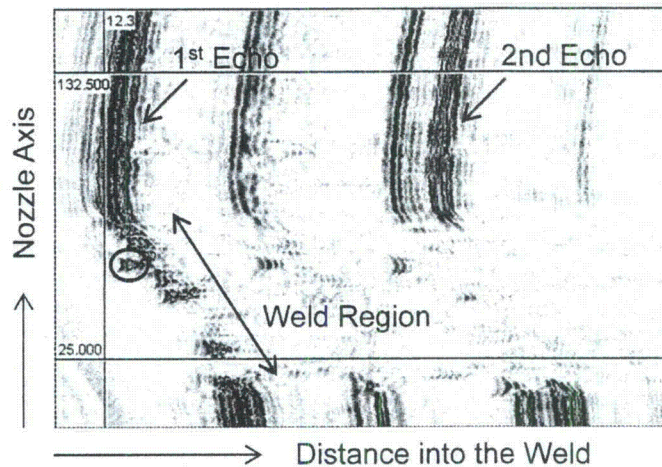
The weld region was evaluated for anomalies throughout the full 360-degree circumference. The indications fell along the Alloy 600 tube-to-weld interface at all but one circumferential position. At the 193-degrees position as noted in Figure 8.7, an indication appeared earlier in time than the other indications. The corresponding B-scan side view is shown in Figure 8.8 with the early indication circled. This earlier indication would plot into the tube material and could possibly be from a gouge in the tube and improper or no weld fill or repair. The indication displacement is shallow at approximately 1 mm (0.04 in.) in depth. No indications of circumferential cracking across or along weld beads were detected.

**Figure 8.8 B-scan Side View at the 193-Degree Circumferential Position. Near-surface indications and one indication, circled in red, occurring earlier in time are visible. The horizontal axis represents approximately 40 mm (1.6 in.) in metal and the vertical axis 155 mm (6.1 in.).**

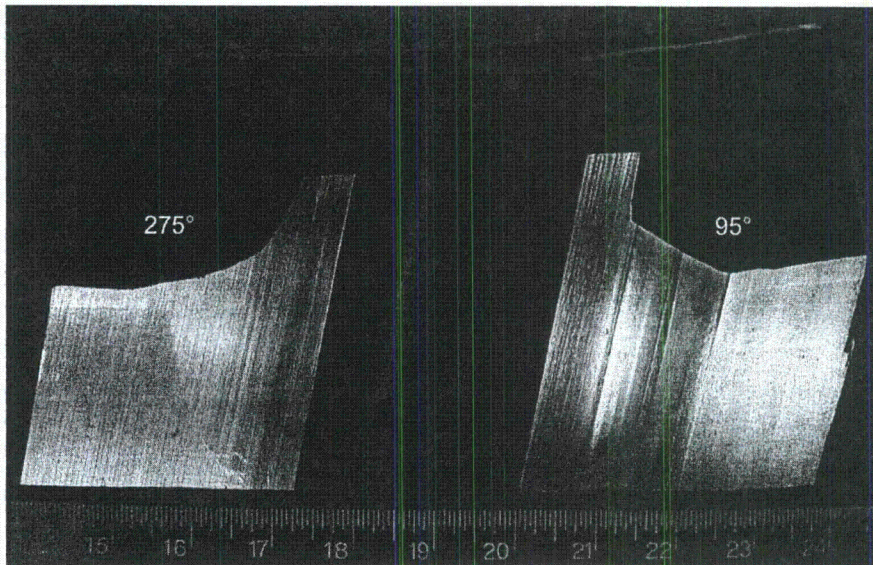
A comparison between the cut surface and ultrasonic data was made. It was observed that the 180-degree or low point on the weld was found to be located at 171 degrees in the ultrasonic image. Therefore, the ultrasonic data was shifted by 9 degrees to account for this offset. By this reasoning, the 95-degree cut surface corresponds to the 86-degree position in the ultrasonic data and the 275 cut surface corresponds to the 266-degree position ultrasonically. Again, note that these positions and the positions of the cut surfaces are estimated. The corresponding ultrasonic positions are noted in the ultrasonic C-scan top view image in Figure 8.11 with the left red vertical line at 87 degrees (on the left edge of the image) and the right blue vertical line at 266 degrees. The image did not extend to the 86-degree position so the 87-degree position is noted instead. The two indications marked by arrows at the 87-degree position in Figure 8.11 correlate to the two indications noted in Figure 8.10. An indication is also marked on the right side at the 266-degree position.

**Figure 8.9** Cut Surfaces of the Nozzle Assembly at 95 Degrees on the Right and 275 Degrees on the Left. The scale is in inches.

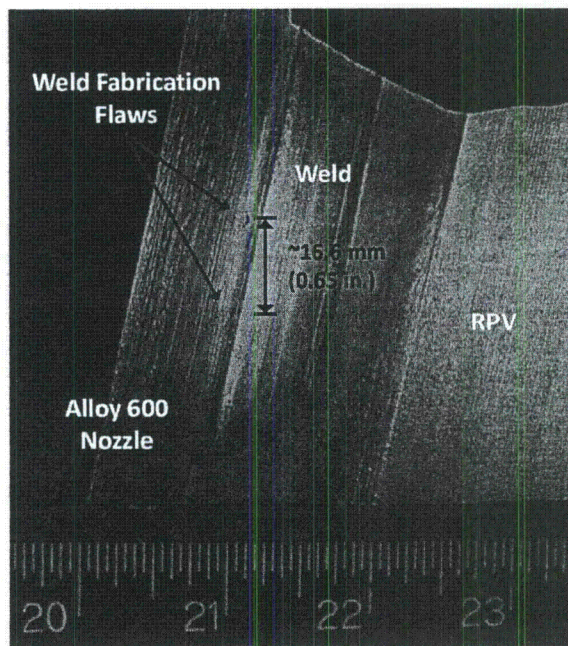
Figure 8.10 The 95-Degree Surface Shows Two Fabrication Flaws at the Alloy 600 Tube-to-Weld Interface

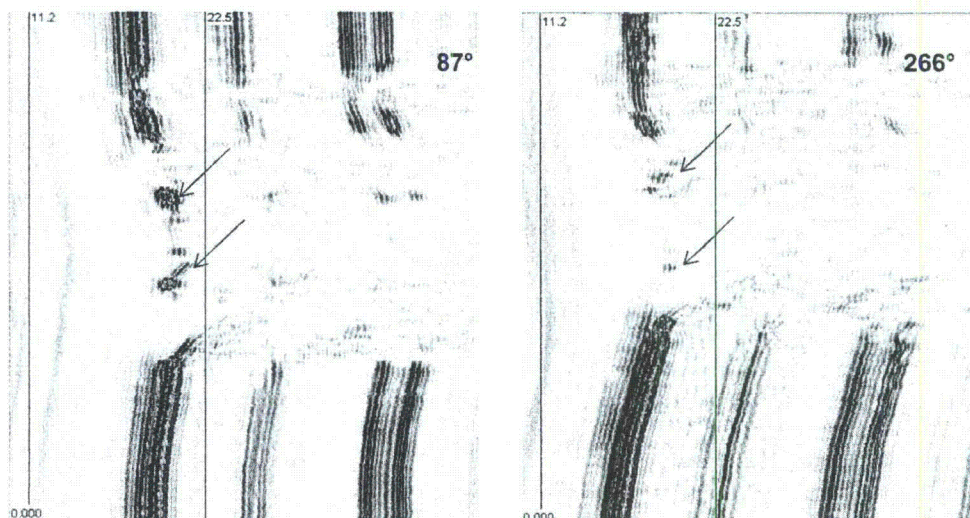
B-scan side view images are displayed in Figure 8.12 for the 87- and 266-degree positions from Figure 8.11. The left side view image in Figure 8.12 at the 87-degree circumferential position shows the two defects with anomalous signals in between. The right image at the 266-degree position shows two possible defects with much lower signal amplitude, indicating smaller flaws.

**Figure 8.12 B-scan Views of the Data at 87 Degrees on the Left and 266 Degrees on the Right, Corresponding to the Cut and Exposed Surfaces in Figure 8.9. The horizontal axis in each image represents 40 mm (1.6 in.) in metal and the vertical axis represents 155 mm (6.1 in.) approximately. Flaw indications in the Alloy 600 tube-to-weld interface are noted with arrows.**

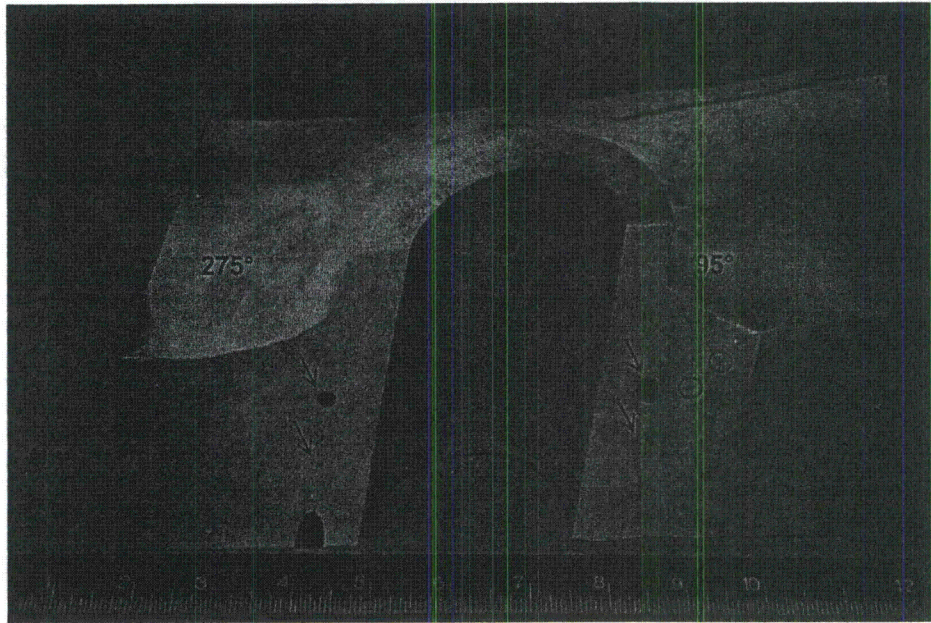
The presence of these flaws was further confirmed by the dye penetrant test results on the cut surfaces shown in Figure 8.13. The two flaws at the 95-degree and two at the 275-degree cut surfaces are marked with arrows. Furthermore, two additional flaws in the weld material are circled on the 95-degree surface. These weld flaws were not evident in the ultrasonic data for two likely reasons. First, the beam possibly did not focus well at those depths. Second, any flaws occurring earlier in time (depth) would return or reflect the ultrasonic energy causing a shadow region beyond or later in time (depth) that would not be insonified.

**Figure 8.13 Dye Penetrant Test Results on the Downhill Dissection Cut Surface. The scale is in inches.**

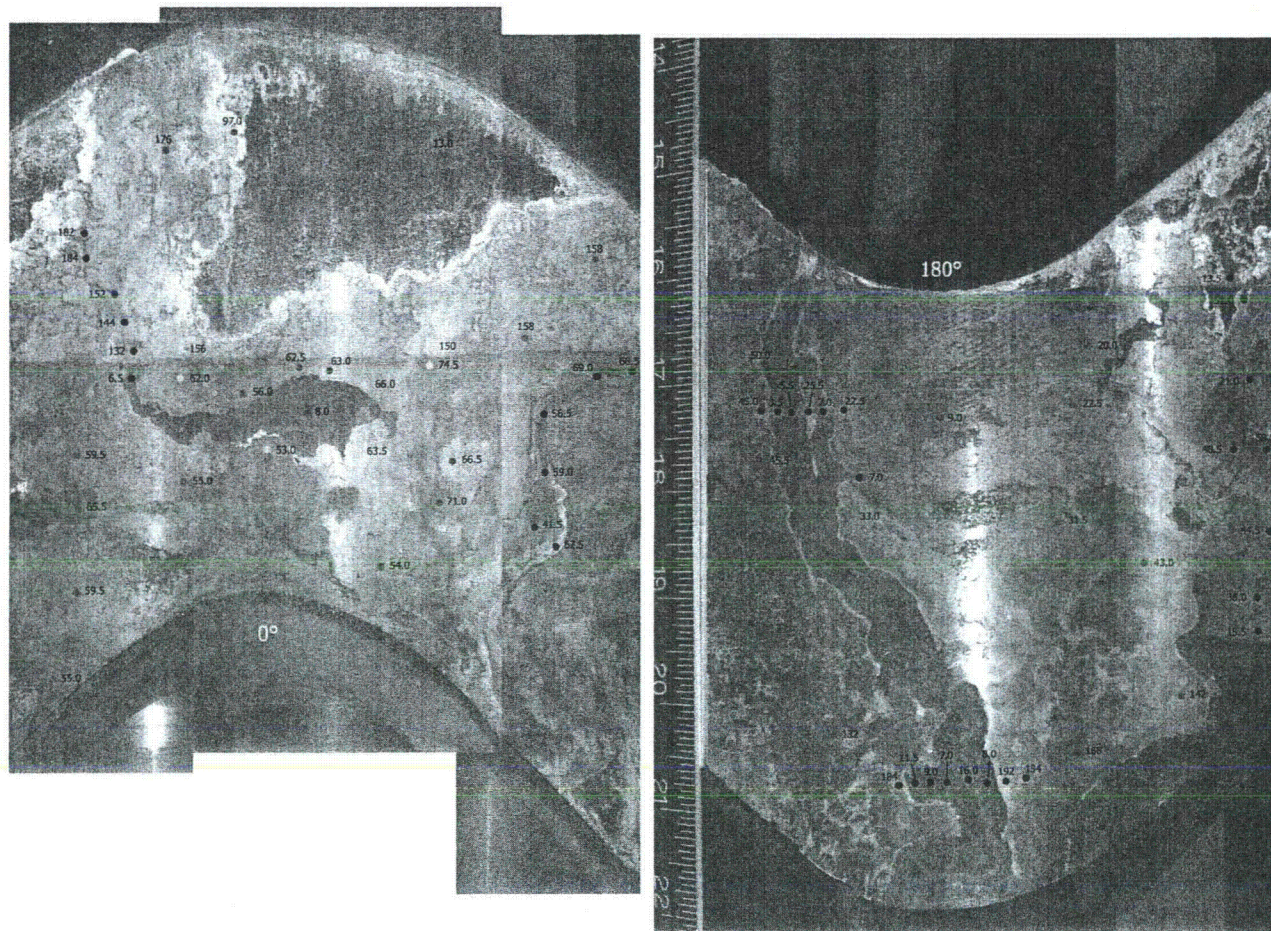
- 1) Boric acid values above and below the interference fit region outside of leak path and bare metal or nearly bare metal regions are nominally in the 130 to 200 micron (5.1 to 7.9 mils) range.
- 2) The two pairs of data (yellow dots) on either side of the interference fit on the uphill section show boric acid values of 156 and 150 microns (6.1 and 5.9 mils) above the fit region and 62 and 74.5 micron (2.4 and 2.9 mils) in the fit region.
- 3) Leak path and bare metal or nearly bare metal points have a thin surface corrosion layer, not visible boric acid deposits, with deposits at 16 microns (0.63 mils) or less.

Figure 9.3 Boric Acid Thickness Values in Microns

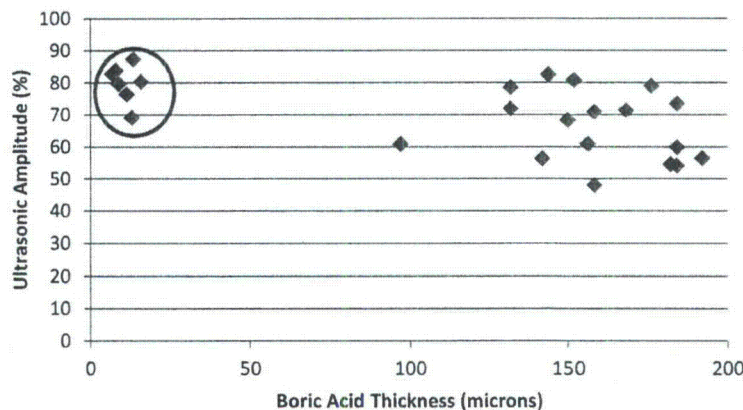
The data above and below the interference fit are displayed in Figure 9.5. The leak path or bare metal points are circled and have ultrasonic values between 69 and 87% and boric acid or corrosion thickness values of 16 microns (0.63 mils) or less. Outside of this circled cluster and the one isolated data point in the middle, the remaining data have boric acid thickness between 132 and 192 microns (5.2 and 7.6 mils) and ultrasonic amplitudes between 48 and 83%. The one outlier point is from the dry side on the uphill half and is towards the edge of a boric acid patch with a center-of-patch (0.7 in. or 17.8 mm to the center) thickness of 176 microns (6.9 mils).

**Figure 9.5** Ultrasonic Amplitude as a Function of Boric Acid Thickness from Points Above and Below the Interference Fit Region

If this outlier or transitional point from Figure 9.5 is excluded, all of the boric acid measurements can be segmented into three categories. The leak path or bare metal regions have approximately less than 16 microns (0.63 mils) of boric acid/corrosion products. The interference fit points contain between 16 and 75 microns (0.63 to 3.0 mils) of boric acid, and the annulus region above and below the interference fit contain 132 to 192 microns (5.2 to 7.6 mils) of boric acid. These numbers are assumed to depend on the geometry of the particular control rod drive mechanism (CRDM) assembly and more specifically on the size of the interference fit and counter bore regions outside of the interference fit. It is reasonable to assume that with a leak, any interference fit or counter bore gap could fill with boric acid and corrosion products.

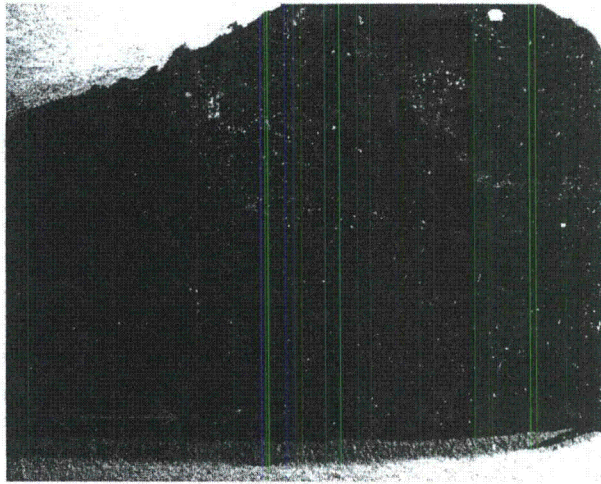
The only corrosion observed in the replicated surfaces was in the region above the interference fit in piece 9. The piece is shown in Figure 9.13 with the two areas of interest circled. The circled region on the left was in the main leak path and covered an area of approximately 6.4 mm (0.25 in.) in diameter with a depth of 0.25 mm (0.01 in.). The corroded area on the right was approximately 12.7 by 1.6 mm (0.5 by 0.06 in.) with a depth of 0.25 mm (0.01 in.).

**Figure 9.13 Corrosion Areas Observed Above the Interference Fit Region. The red line represents 2.0 mm (0.80 in.) in length.**
