SUBJECT: Review of Draft NUREG/CR – XXXX Entitled, "Ultrasonic Phased Array Assessment of the Interference Fit and Leak Path of the North Anna Unit 2 Control Rod Drive Mechanism Nozzle 63 with Destructive Validation"

**Ultrasonic Phased Array  
Assessment of the Interference  
Fit and Leak Path of the  
North Anna Unit 2 Control Rod  
Drive Mechanism Nozzle 63 with  
Destructive Validation**

NUREG/CR-XXXX  
PNNL-XXXXX

Manuscript Completed: February 2012

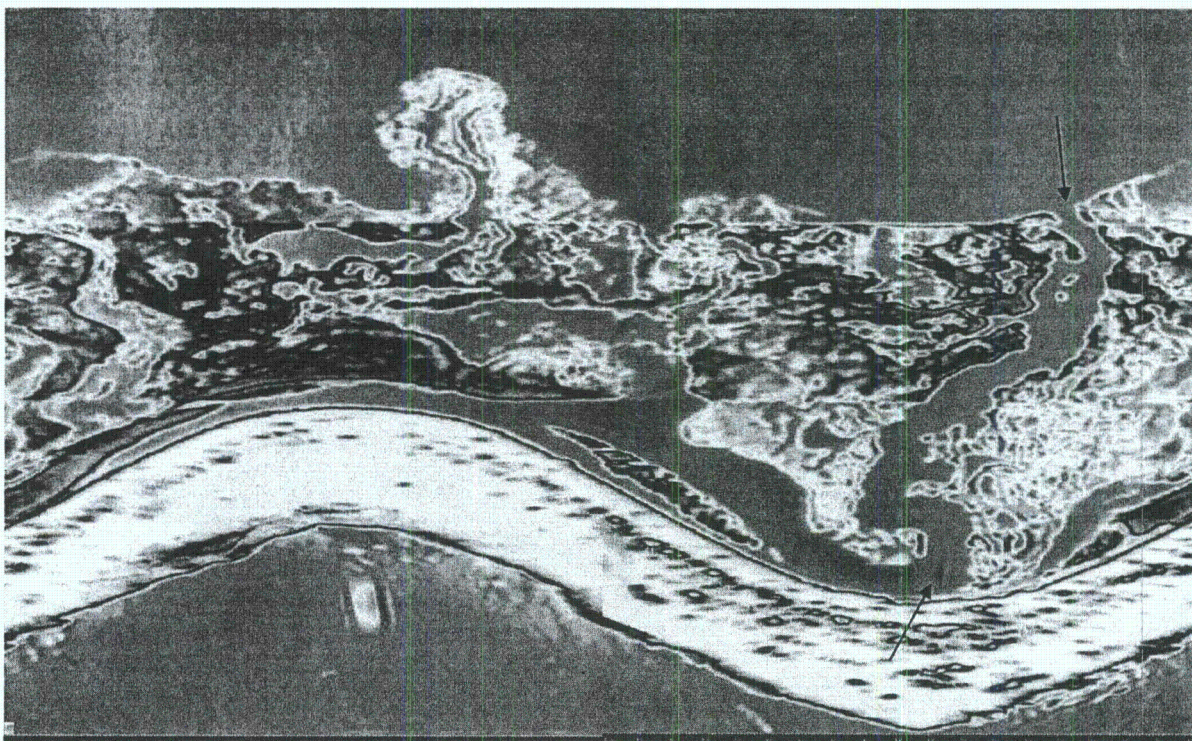
**Figure 5.3** PA Ultrasonic Data from the Interference Fit in Nozzle 63 Acquired After the Second Brushing of the Nozzle ID. The horizontal axis represents the full 360-degree area and the vertical axis represents 360 mm (14.17 in.). Black arrows indicate primary leak path. The left edge marks the -90 degree location and the right edge the 270 degree location.

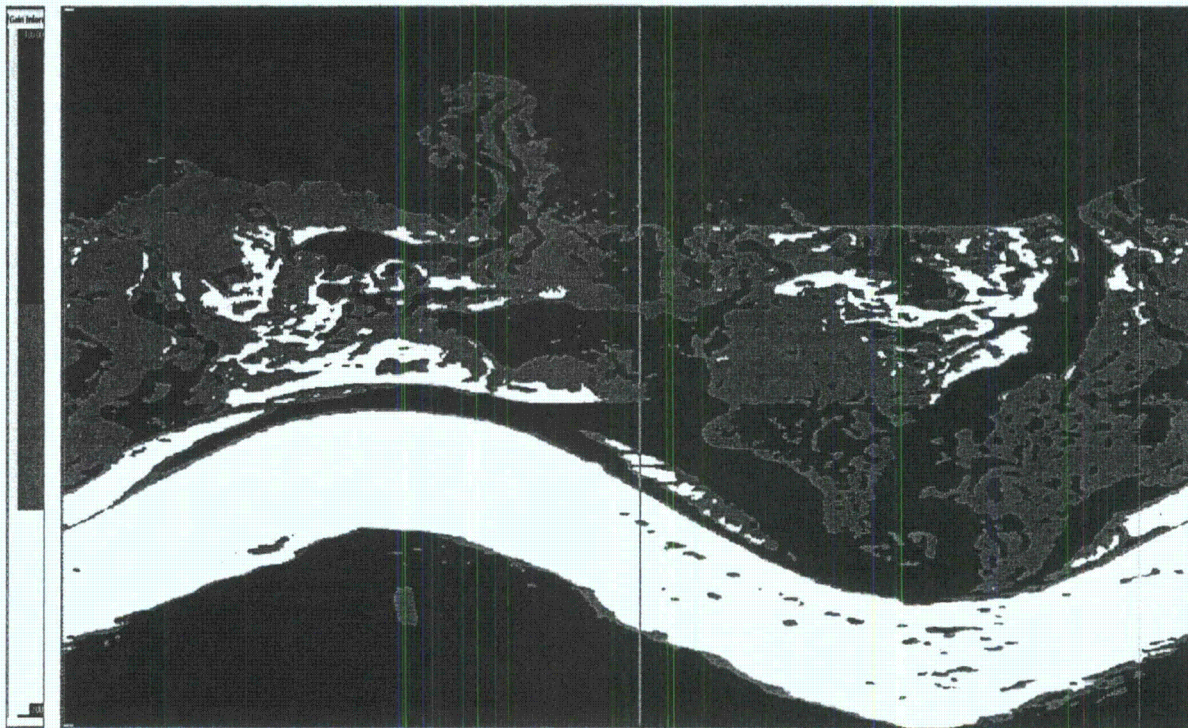
**Figure 5.7 A Tri-Color Representation of the Interference Fit Data. The dark blue represents a leak path or gap, the light blue represents the interference fit and counter bore regions and the white represents the weld and suspected boric acid presence in the interference fit.**

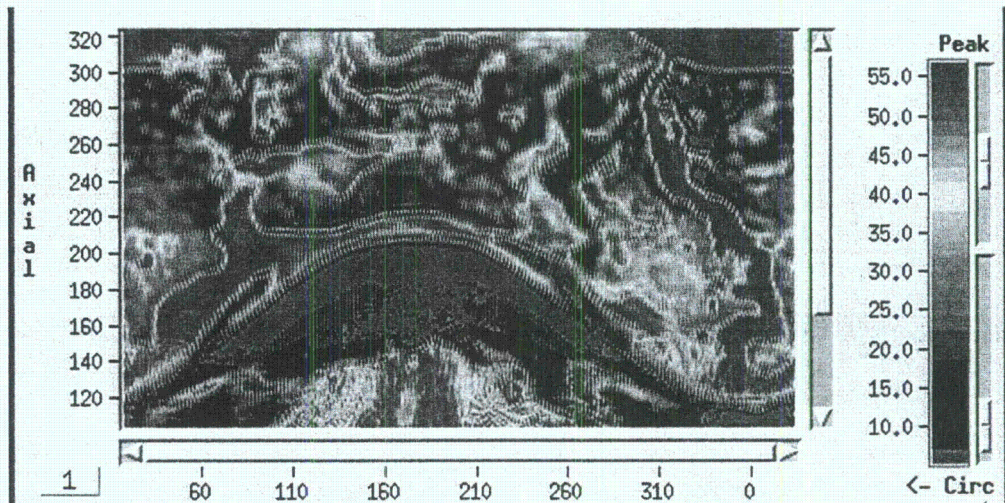
**Figure 5.8** Ultrasonic Data from Nozzle 63 as Obtained by WesDyne International. The image was acquired with a 5-MHz probe. The horizontal axis represents the nozzle circumference in units of degrees. The vertical axis represents the nozzle axis in units of millimeters.

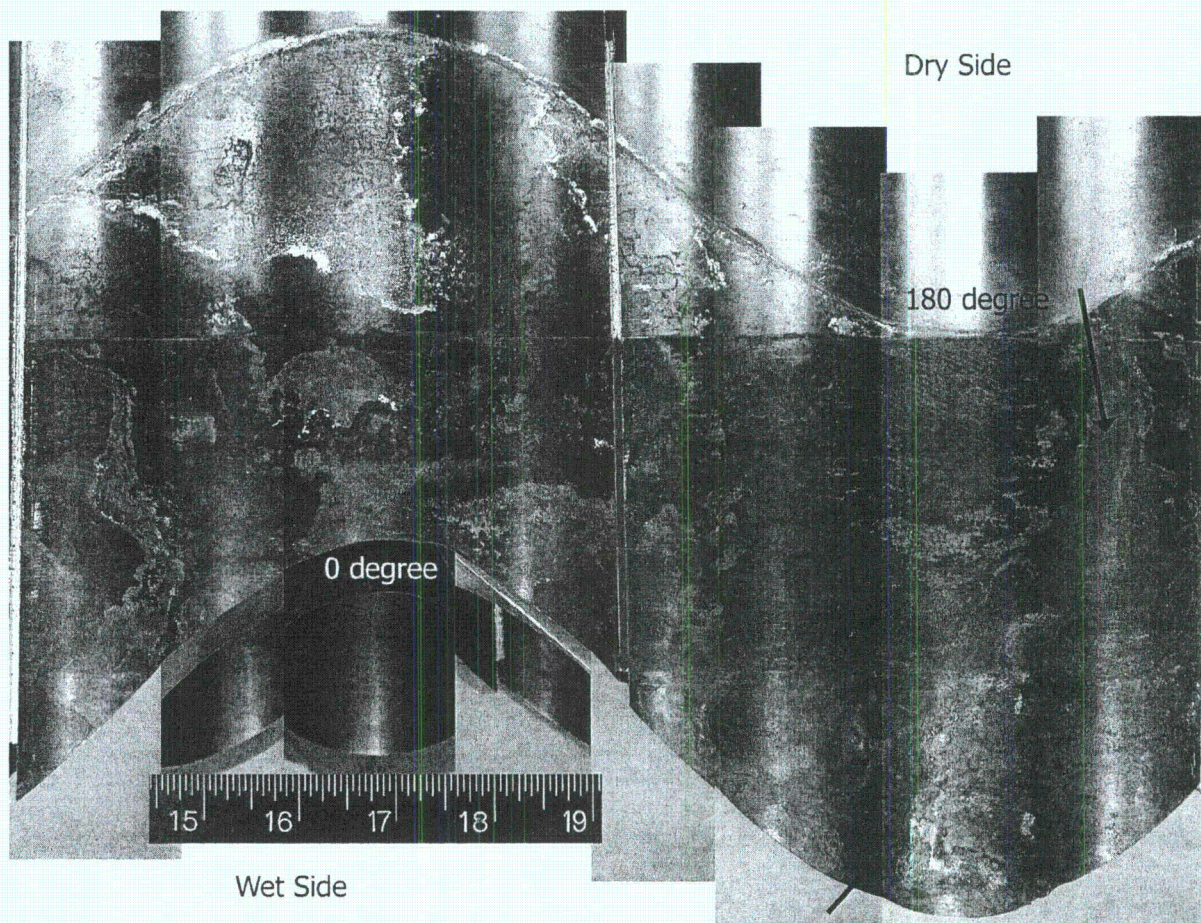
**Figure 7.1 Nozzle Surface.** The red line marks the interference fit region and the two black arrows identify the main leak path.

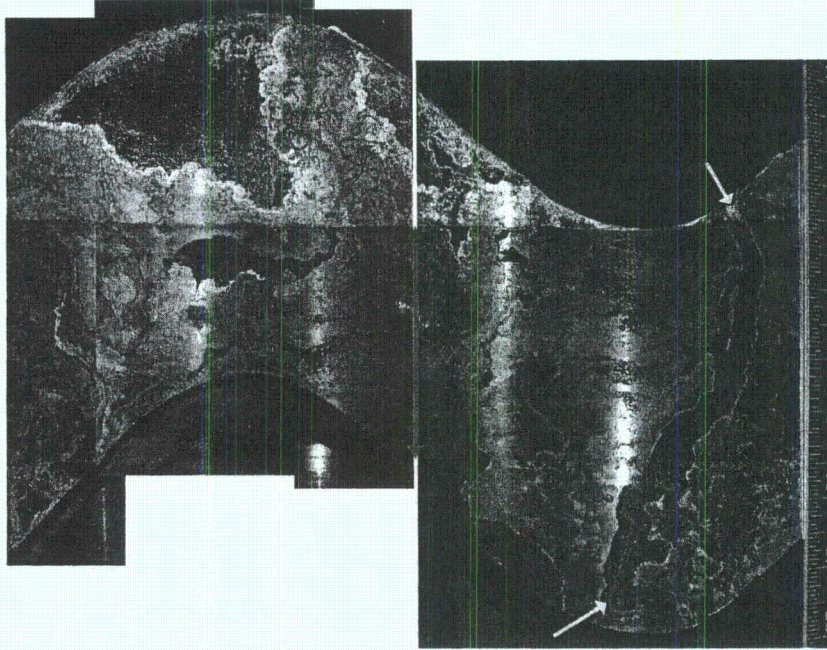
Figure 7.2 RPV Head Surface. The red line marks the interference fit region and the two yellow arrows identify the main leak path.

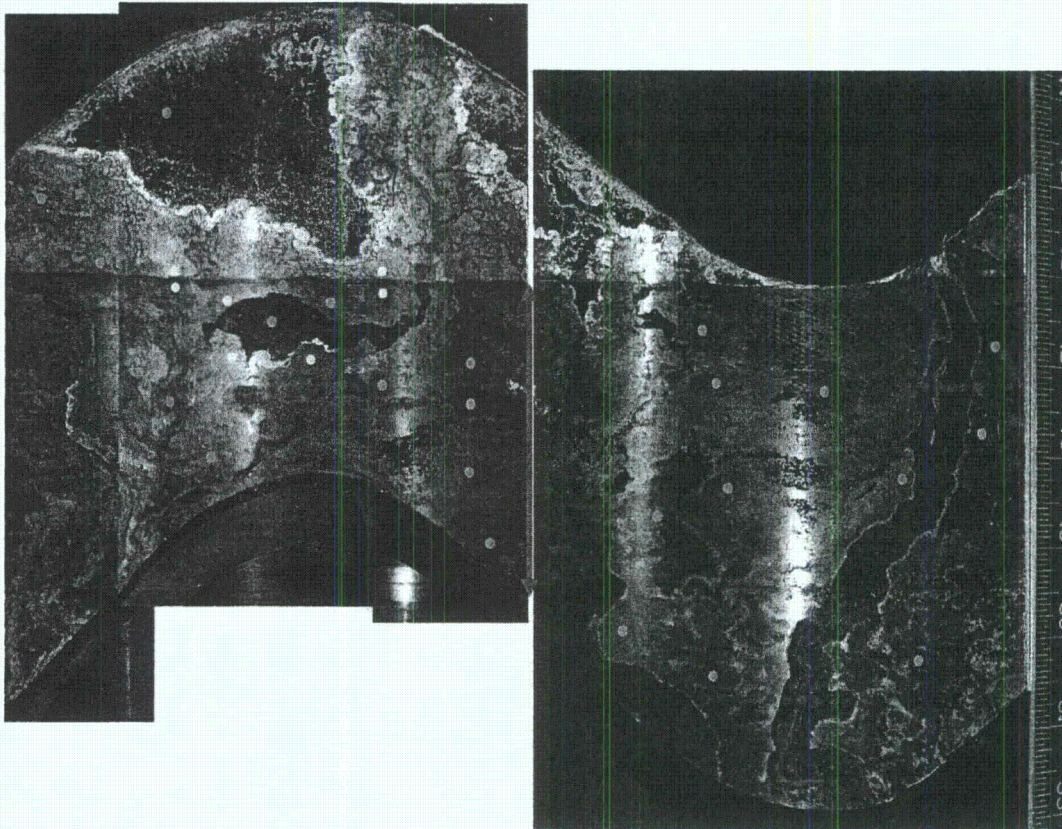
**Figure 8.1 Photograph of the RPV Head Material with Boric Acid Measurement Points. The interference fit region is marked by the red line.**

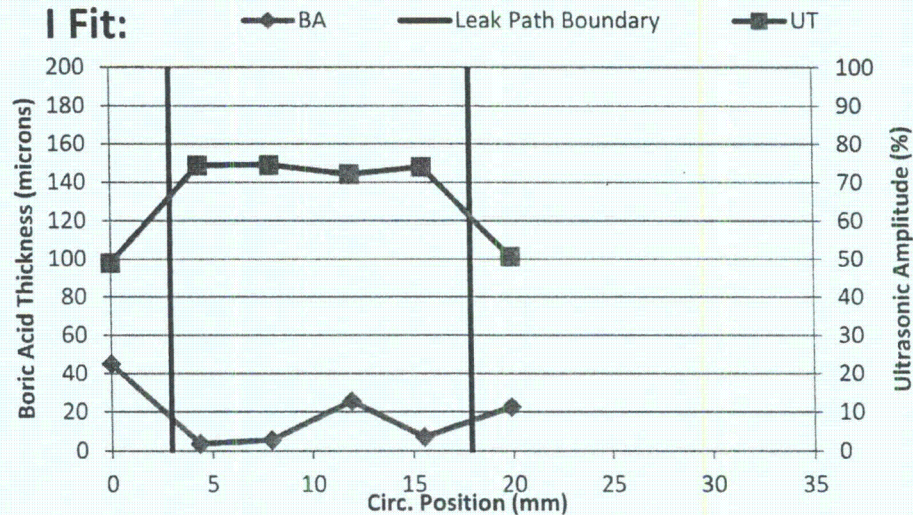
**Figure 8.4 Ultrasonic and Boric Acid/Corrosion Layer Thickness Along a Line Across the Main Leak Path in the Interference (I) Fit**

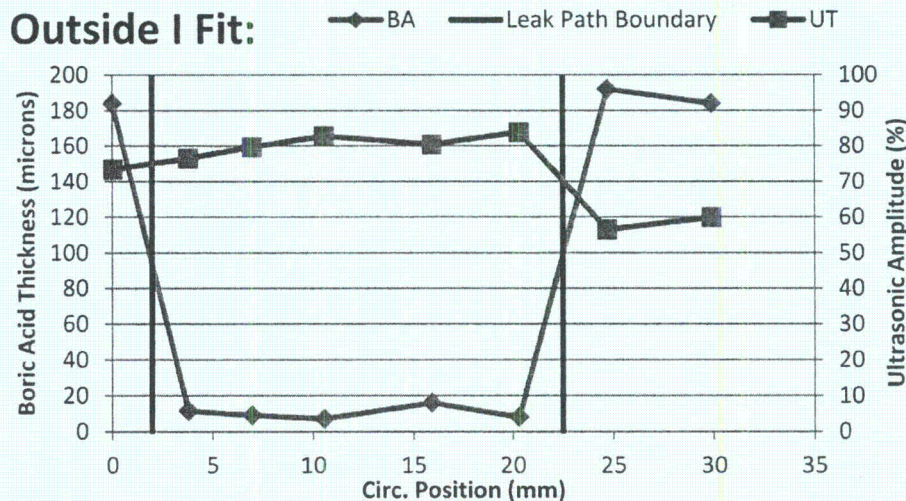
**Figure 8.5 Ultrasonic and Boric Acid/Corrosion Layer Thickness Along a Line Across the Main Leak Path Outside the Interference Fit**

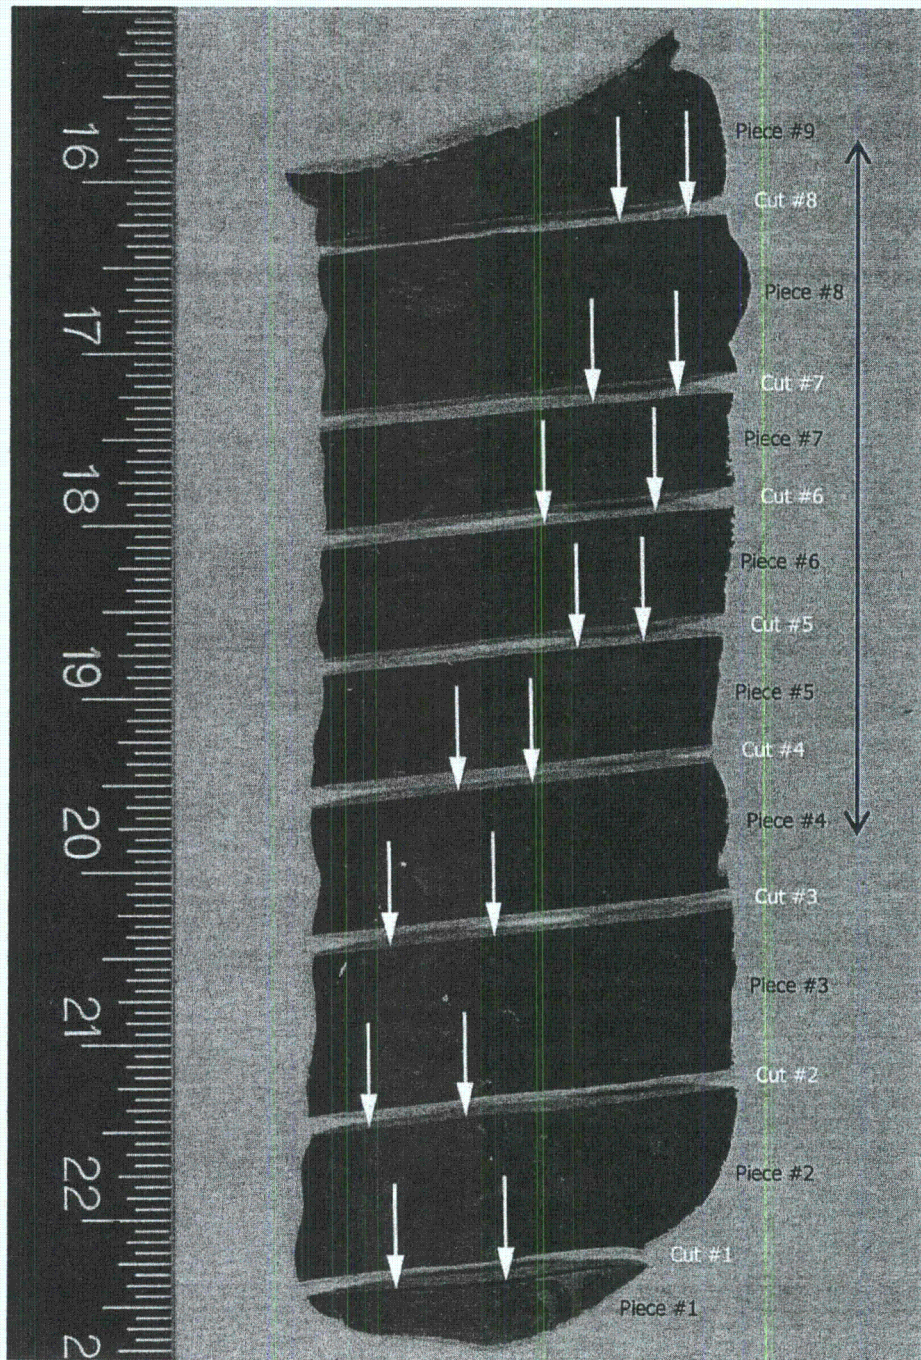
Figure 8.10 Leak Path Replica with Cuts and Pieces Identified. The interference fit region is noted with the black line and is contained in pieces 4 through 9.

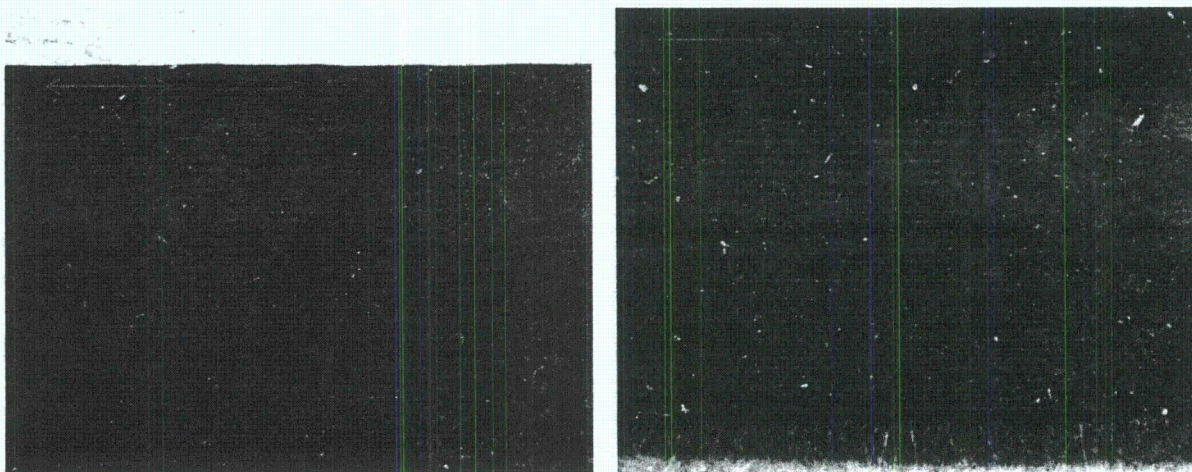
**Figure 8.11 Staining Streaks in the Leak Path Below the Interference Fit from Replica Pieces 2 and 3, Left and Right, Respectively. The red line represents 2.0 mm (0.80 in.) in length.**

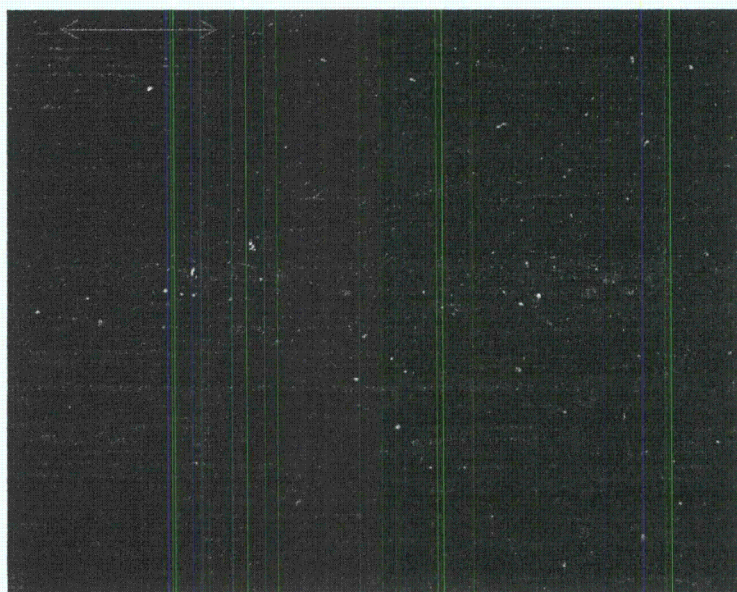
**Figure 8.12 Transition from Below the Interference Fit to the Interference Fit Region. Machining marks are evident in this replica piece 4. The red line represents 2.0 mm (0.80 in.) in length.**

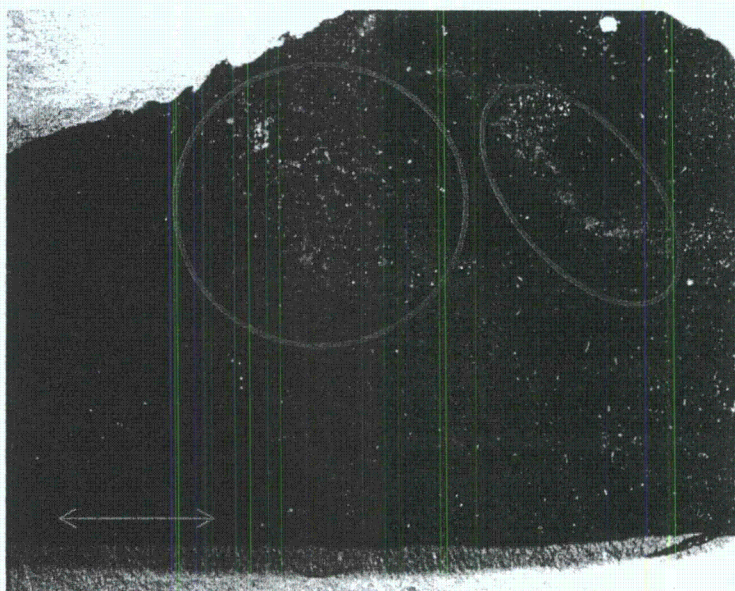
**Figure 8.14** Corrosion Areas Observed Above the Interference Fit Region. The red line represents 2.0 mm (0.80 in.) in length.
