## Comparison of an Ultrasonic Phased Array Evaluation with Destructive Analysis of a Documented Leak Path in a Nozzle Removed from Service

AD Cinson, SL Crawford, PJ MacFarlan, BD Hanson, and RA Mathews  
Pacific Northwest National Laboratory<sup>1</sup>, Richland, WA, USA

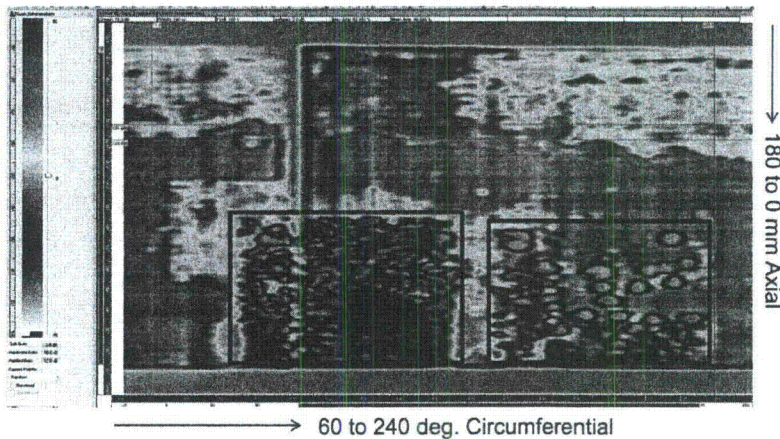
Figure 4 – C-scan plan view of the boric acid deposits in the interference fit region. The horizontal axis represents the circumferential range of 60–240 degrees.

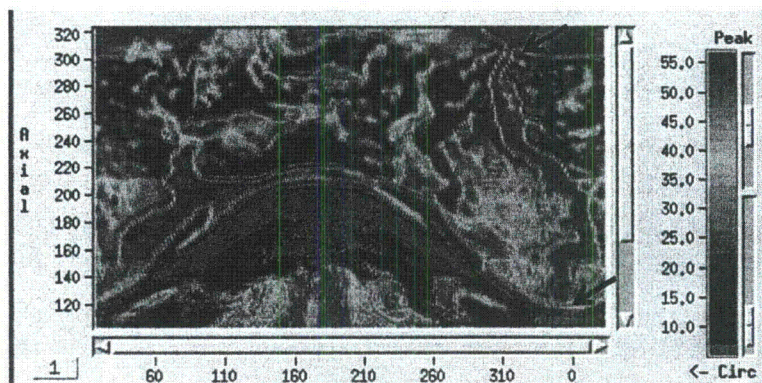
Standard ultrasonic evaluation techniques used by ISI vendors include time-of-flight diffraction (TOFD) for detecting cracks in both the circumferential and axial orientation and zero-degree PE for an interference fit examination. An examination conducted by ISI vendor, WesDyne International (data supplied by John P. Lareau), discovered a probable leak path in Nozzle 63 during the 2002 outage. The data acquired with an industry-standard 5.0-MHz probe are shown in Figure 5. The data set indicates a leak path at the downhill position, traveling upward through the interference fit and is marked by the two black arrows in the figure.

Figure 5 – Ultrasonic Data from Nozzle 63 as Obtained by WesDyne International (courtesy of John P. Lareau). The image was acquired with a 5-MHz probe. The horizontal axis represents the nozzle circumference in units of degrees. The vertical axis represents the nozzle axis in units of millimeters. The leak path is indicated by the black arrows.

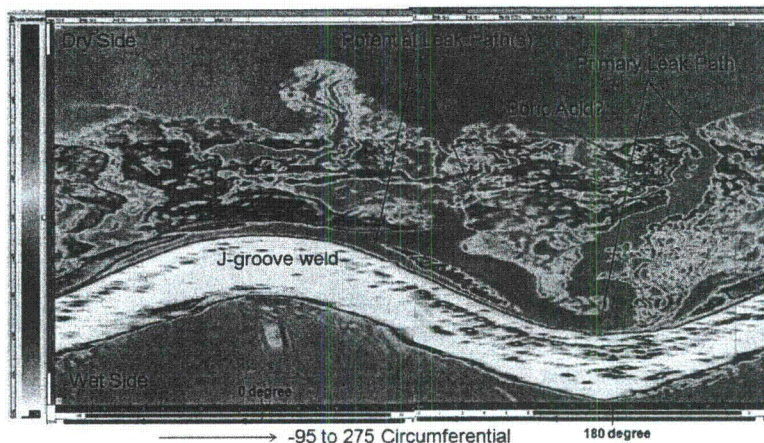
The investigation of the interference fit region on Nozzle 63 shows a large variety in the reflected ultrasonic responses. Some responses are strong in amplitude, indicating an air gap and noted as red-orange in color, while others are weak in reflected amplitude, indicating a tight interference fit and noted as white-blue. A search in the data image for a high-amplitude river pattern connecting the weld to the top of the interference fit region reveals the primary leak path. This leak path originates at approximately the 180-degree location (downhill point on the nozzle) and is marked in Figure 6. The lower amplitude

Figure 6 – A composite 360-degree ultrasonic data image from Nozzle 63. The vertical axis represents 360 mm (14.17 in.)

(blue) cluster regions near the leak path in the interference fit indicate the potential presence of boric acid as was observed in the calibration specimen. Boric acid deposits have been noted in actively leaking nozzles [1, 2].

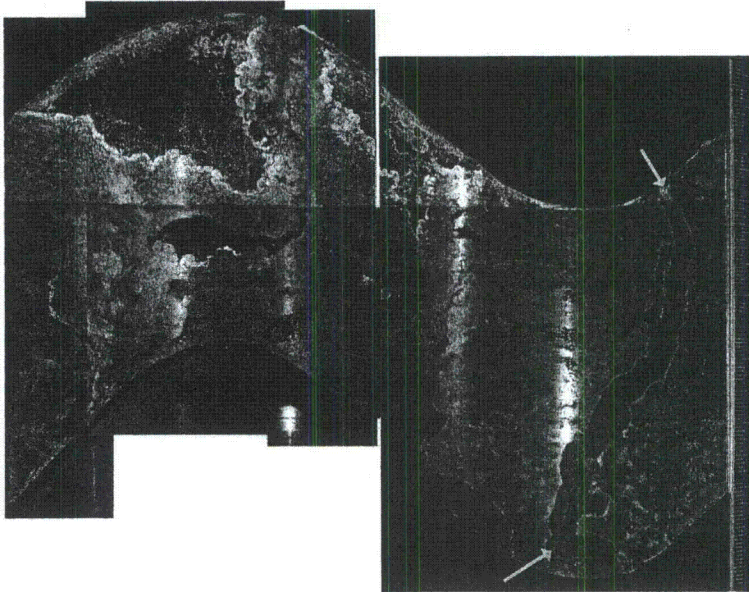
The exposed reactor pressure vessel (RPV) head was photographed and the composite image is displayed in Figure 7. The main leak path (yellow arrows) and other features observed in the ultrasonic images are clearly evident. Boric acid deposits are visible in white and corrosion products in the rust color. The interference fit band is apparent in the photograph and is marked with the red line. For comparison to the ultrasonic data, refer to Figure 6. The ultrasonic features well match the features seen visually on the RPV head annulus. Clearly, the main leak path was precisely imaged and other partial leak paths are evident.

Figure 7 – RPV head surface. The red line marks the interference fit region and the two yellow arrows identify the main leak path.

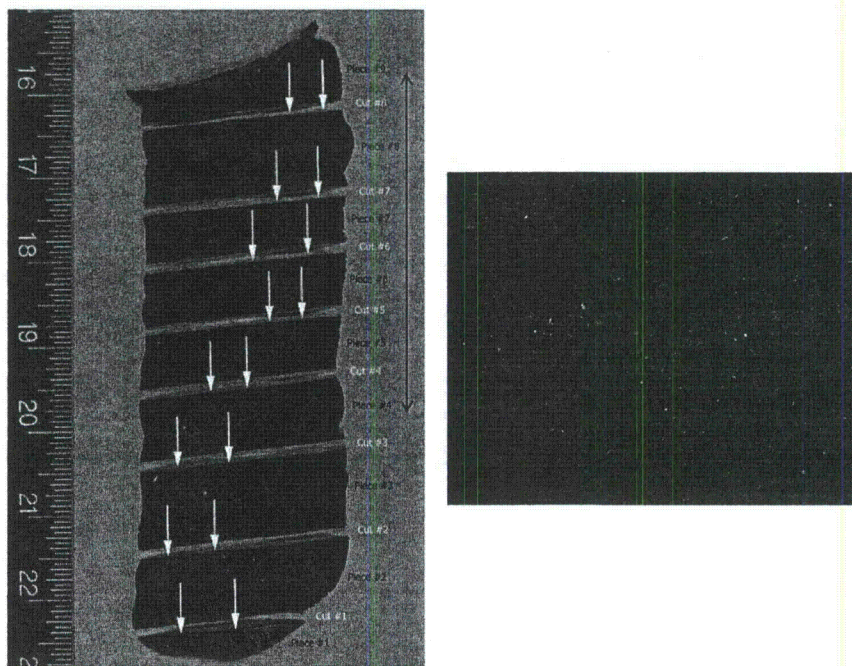
Lastly, replicated surfaces were viewed with a stereomicroscope to better document the surface conditions and to attempt to quantify the corrosion or erosion of the low-alloy steel in the annulus region. The replica of the main leak path is displayed on the left in Figure 8. Machining marks were observed on the replicated surfaces indicating minimal corrosion, erosion, or wastage throughout the leak path region. Piece 4 obtained at the transition from below the interference fit to the interference fit shows the surface machining marks still present as seen on the right in Figure 8. It was estimated that the finish within the interference fit region was equivalent to a turned finish of 1.6 micro-meters (63  $\mu$ in.) while the finish below the interference fit was equivalent to a milled 1.6 micro-meter- (63  $\mu$ in.-) finish. A noted corroded area was visible at the exit point of the main leak path at the top of the head. It covered an area approximately 12.7 by 1.6 mm (0.5 by 0.06 in.) and had a depth of 0.25 mm (0.01 in.). These replica observations indicated a low flow rate through the annulus during plant operation.

Figure 8 – Replicated leak path on the left and piece 4 on the right with machining marks evident. The red line on the right represents 2.0 mm (0.80 in.) in length.
