## ANO-1 STEAM GENERATOR TUBE INSPECTION DISCUSSION POINTS

May 10, 2013

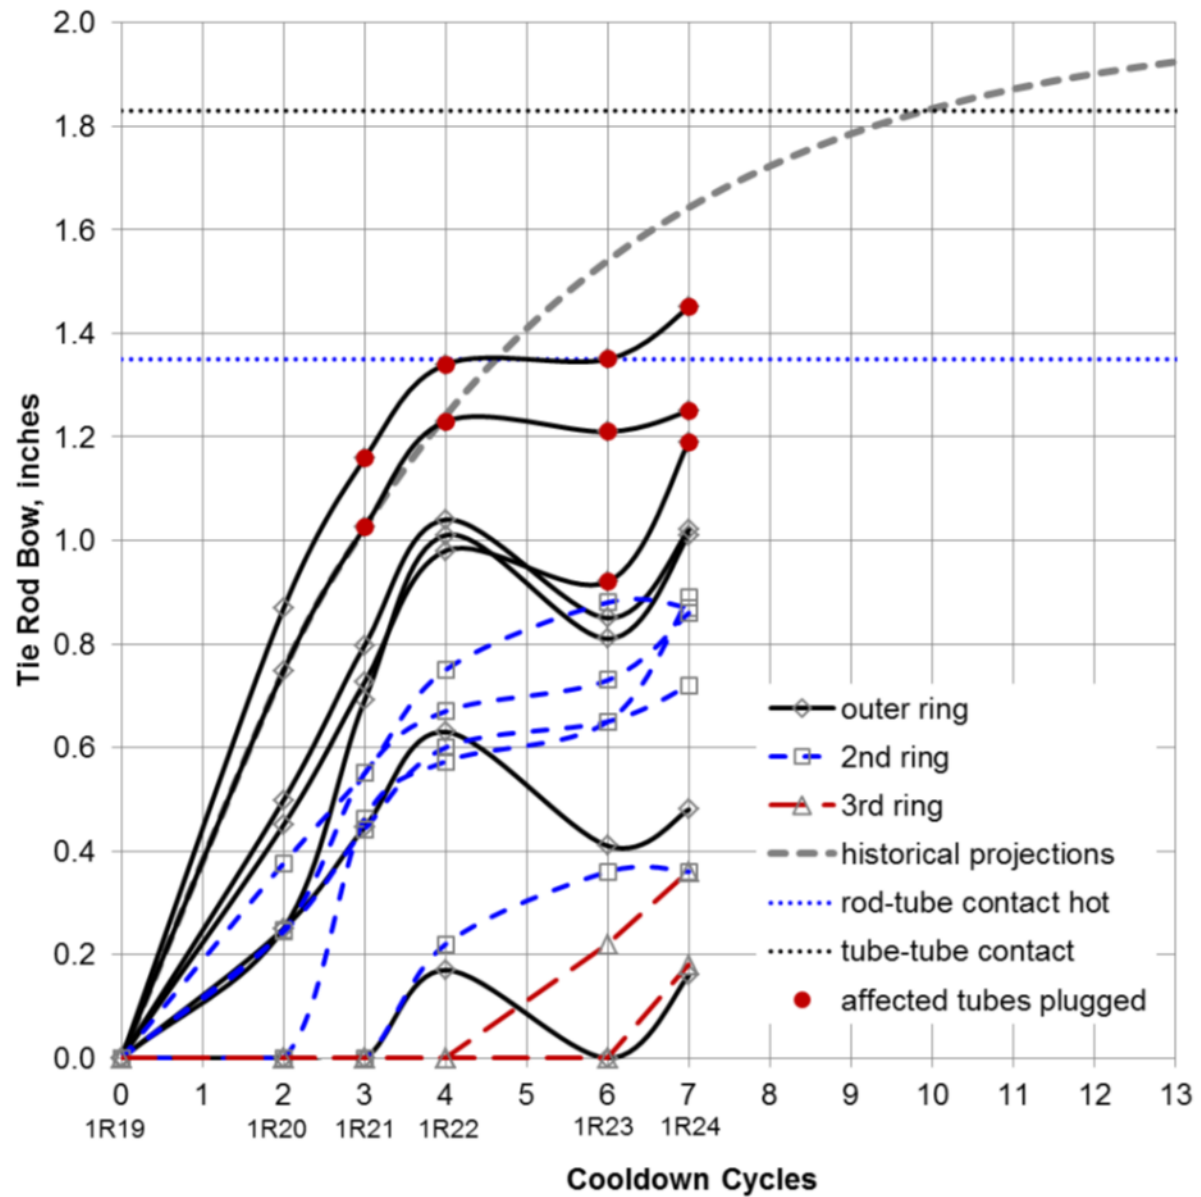
# **SG A - First Span Tie Rod Bow Projections (14 tie rods, 1 span, 3 rings)**

1. The first is associated with tie rod bowing. If the extent of the bowing has increased, additional tubes will need to be inspected to bound the condition.

Tied rod bowing is consistent with the projections prepared. Some additional tubes were examined.

Although not defined as a degradation mode. This inspection was targeted at Tie Rod bowing. The following indication counts were identified in each SG

SG A	SG B
PTB (prox. to tube and tie rod)	11	5
PTU (prox. to tube)	30	9
PTR (prox. to tie rod)	35	17

Preventive Plugging and stabilization was performed in SG A.  
A total of seven tubes were plugged and Stabilized Full Length associated with Tie Rod Bowing.
