May 8, 2013

Re: Docket No. 40-2259, License No. SUA-672 / Tailings Groundwater Path Forward / AL-1  
Well assay discussion

**Groundwater Analysis History Charts**  
**Monitor Wells**

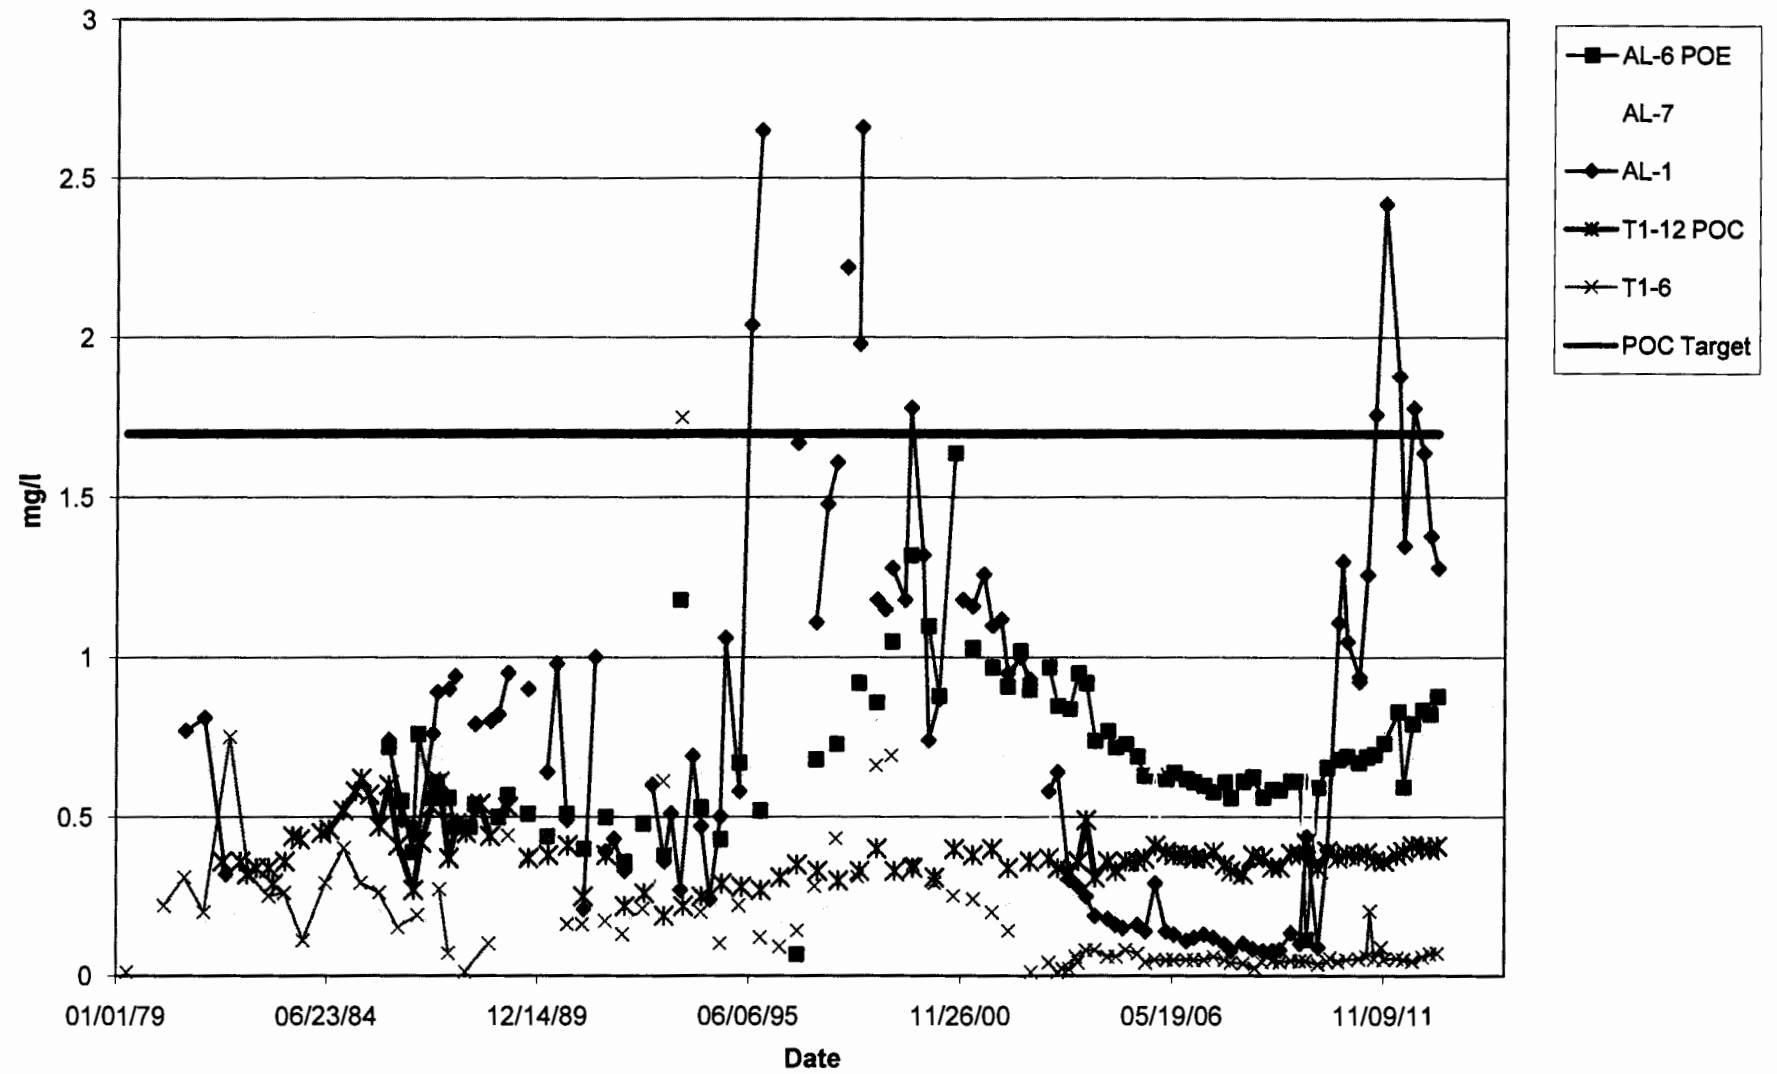
# Unat (mg/l)

Of primary concern expressed by the NRC about the water quality trends at the Lucky Mc site has been the increase in uranium values in well AL-1 beginning in the 3qtr 2010 sample notably peaking at 2.42mg/l in the sample taken 11-17-2011. Although the historical values for this well show at times great variability in this constituent; since late in 2003 the values had been relatively stable in a range typically below 0.20mg/l until the sample taken 5-30-2010 in which a trend of generally increasing values began which ended in the peak mentioned above. Since that peak in late 2011 the next 6 samples have shown a generally steep declining trend with the latest sample taken 4-1-2013 indicating a value of 1.28mg/l. See the attached Figures.

During roughly the same timeframe the uranium values in well AL-6, the POE location, also show a parallel increase, though much more modest, from approximately 0.6mg/l to roughly 0.8mg/l noticed in five of the past six samples. Well AL-7 is located approximately midway between AL-1 and AL-6 and has exhibited no obvious trend.

- 3.1. Pathfinder recommends maintaining the current sampling program noting that the values for Uranium in well AL-1 continue to show a declining trend roughly a steep as the previous ascending trend tends to confirm the above hypothesis that the cause is temporary and is in the process of resolving. Currently all constituent values for the POC location of well T1-12 are easily within the defined target limits and that all values for all other sampling locations on the site are also performing within the same target limits even in the hypothetical case of extension to other well location and have been for some extended time.

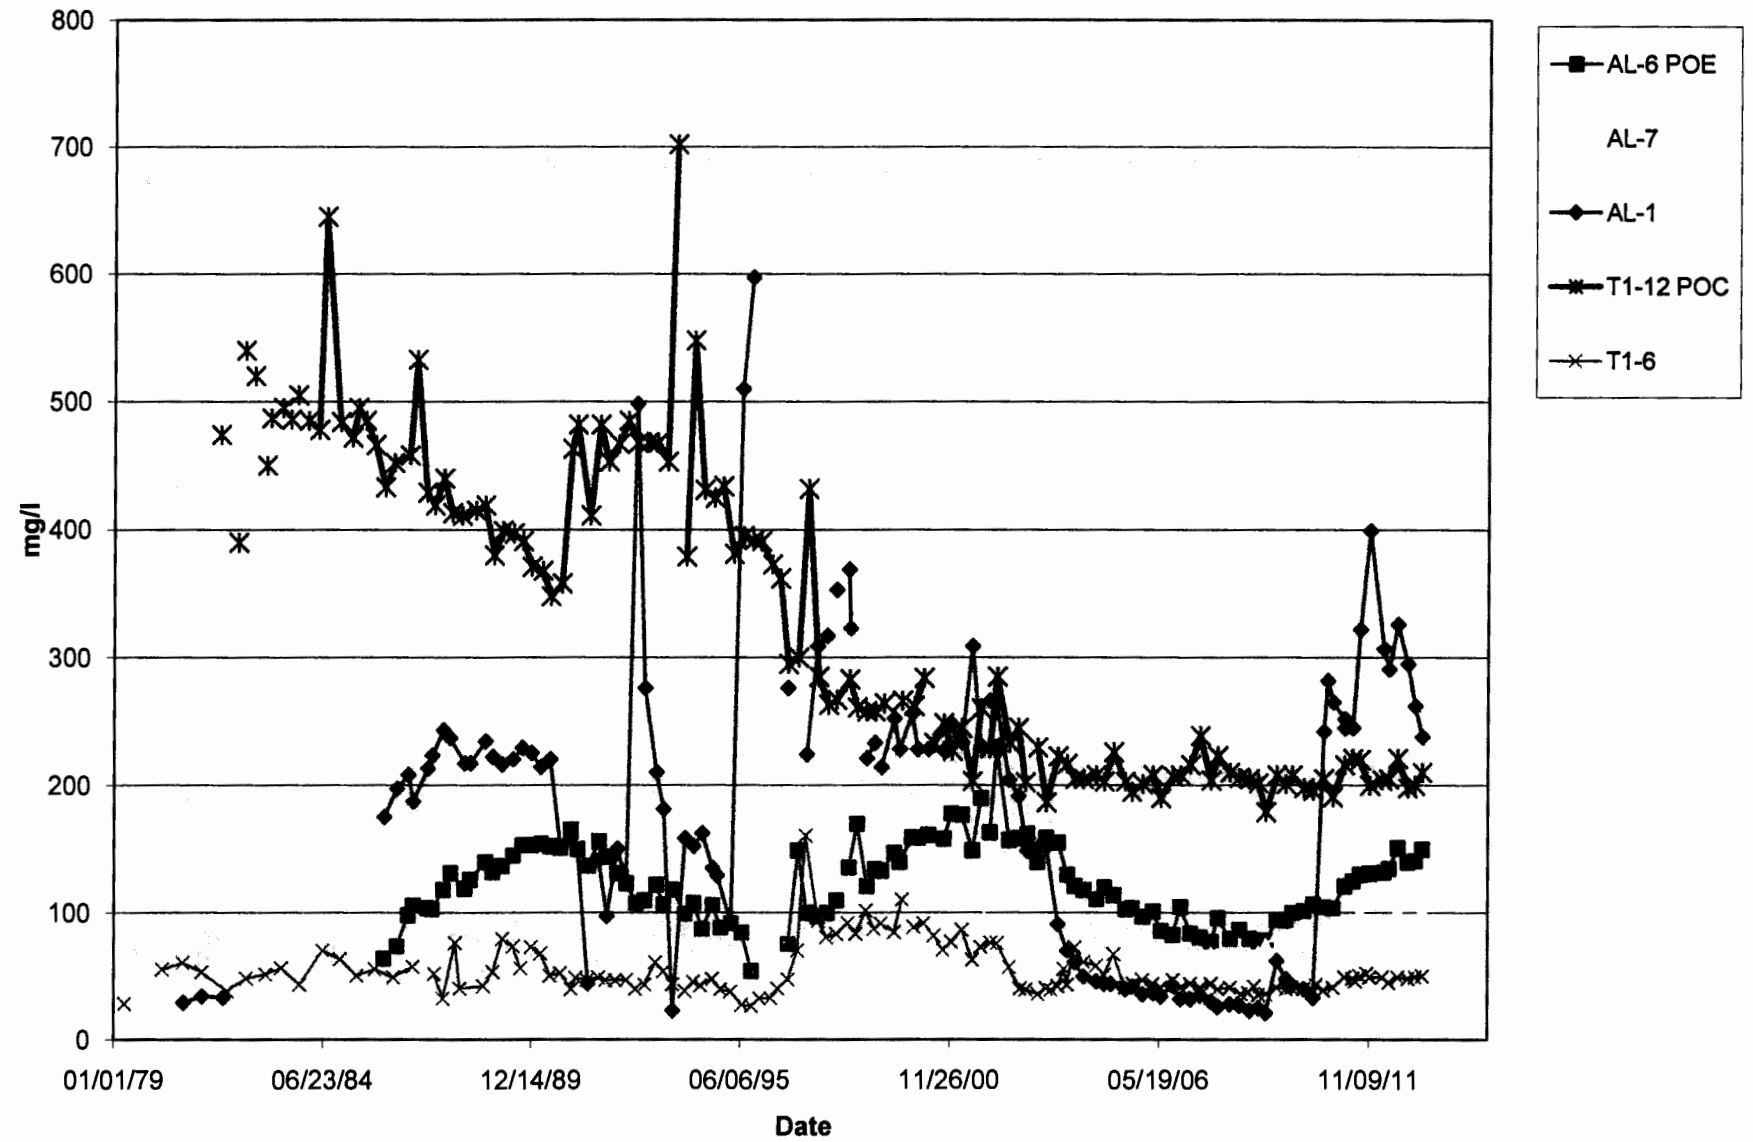
Cl (mg/l)

Examination of the relevant assay data reveals that there is a likely association with increased Chloride values also noted during the period of elevated values for U. This is not unexpected as the primary reason for monitoring Chloride is its use as an indicator assay. In addition considering the long history of assays for well AL-1, there is also a probable correlation between the elevation of the water sampled and uranium values. See the attached figures.

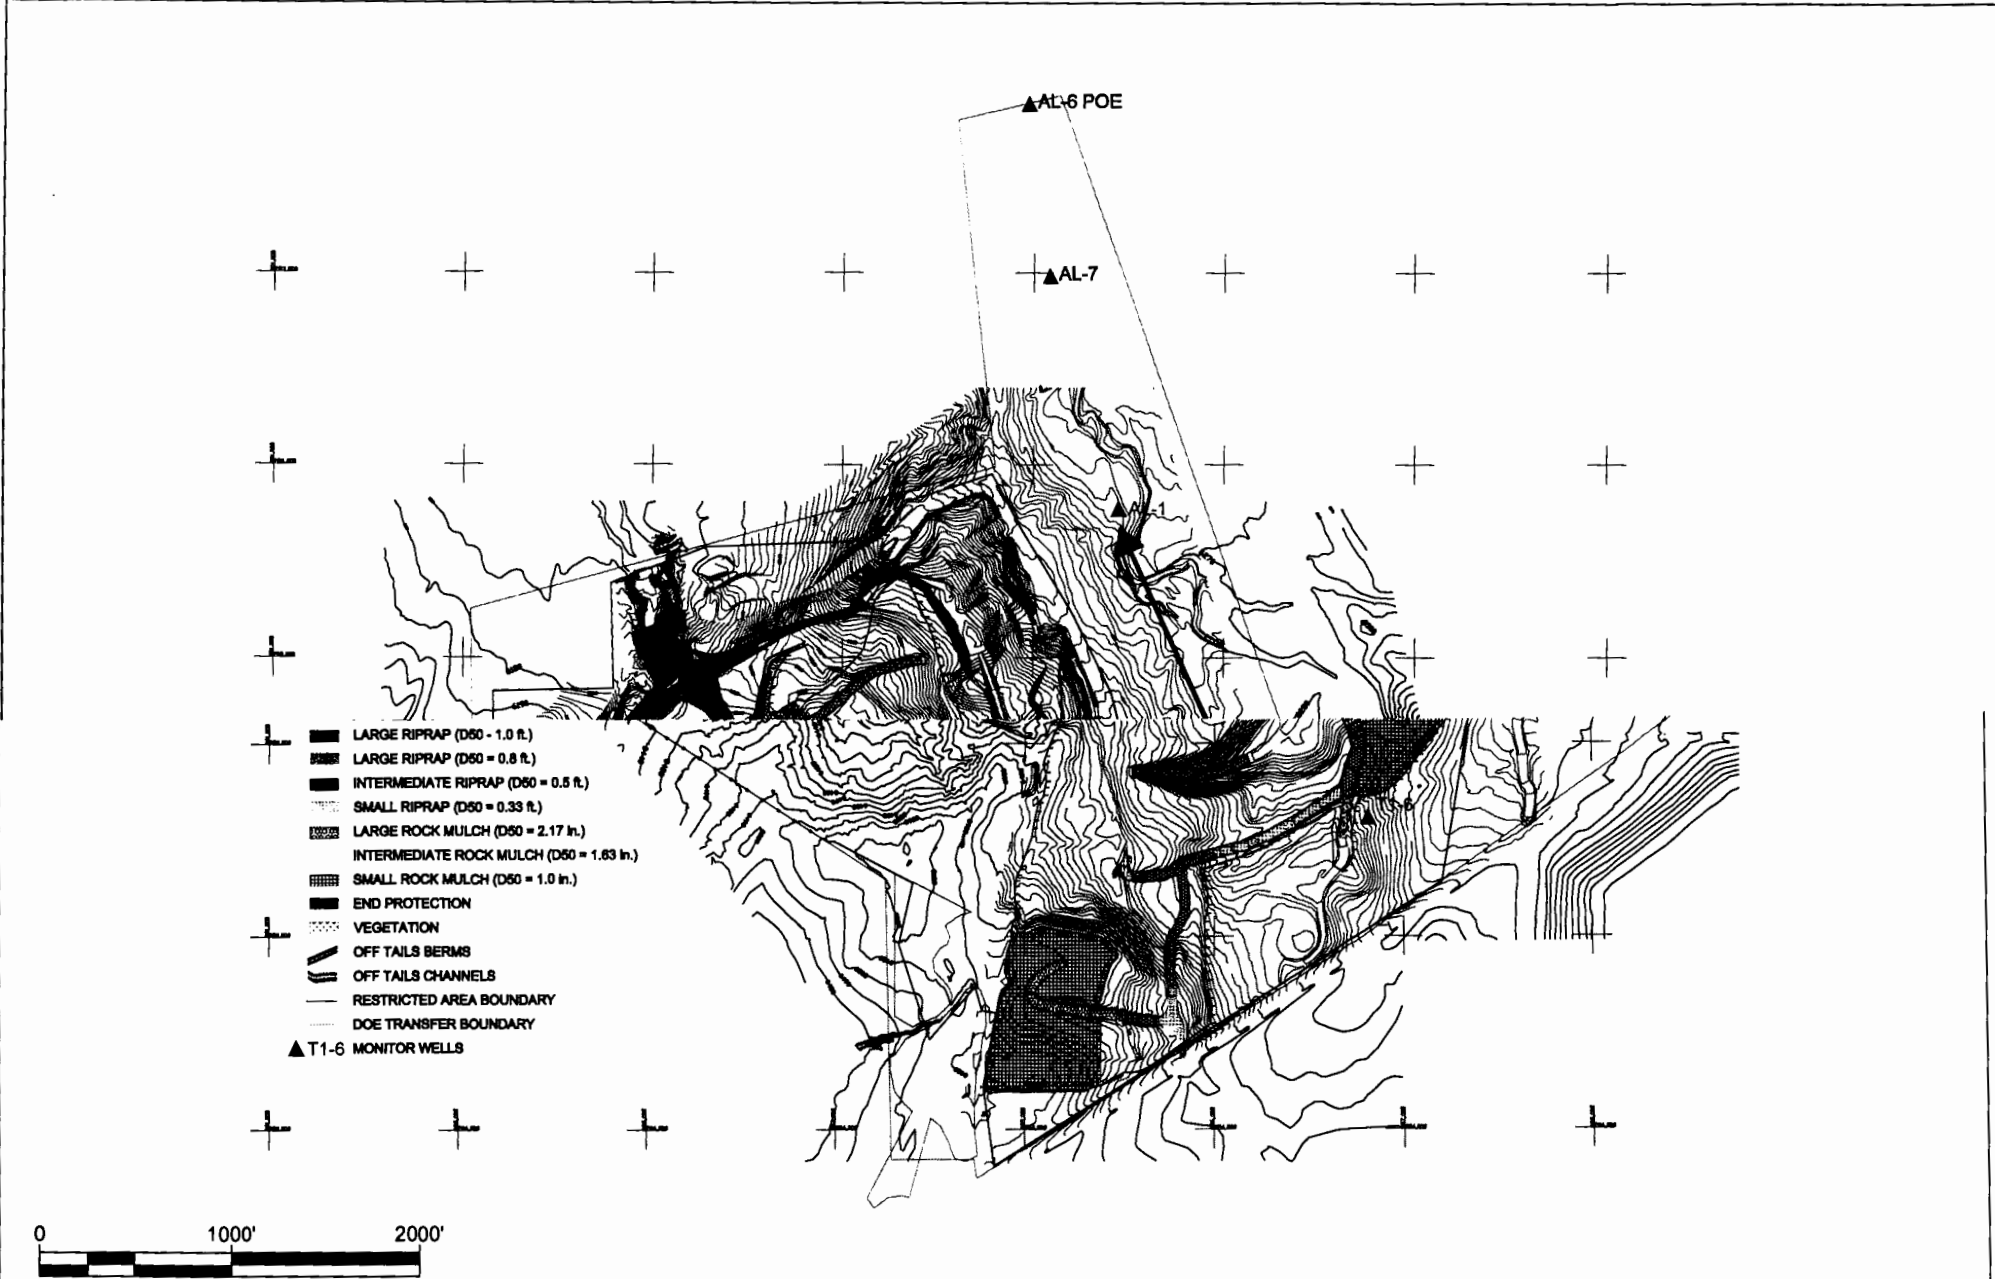
Potential Residual Contaminant Flowpath

Pathfinder considers that the most likely source of the waters recently sampled with higher Uranium values, is remnant contamination originally sourced in the direction of the former remediation effort located near well T1-12 approximately 5,400ft SSE of well AL-1. This presumed contamination that possibly bypassed the corrective action effort or resulted from temporary disturbance caused by the cessation of corrective action has taken significant time to arrive at AL-1 since the termination of activities in the early 2000's. Another possibility is a similar source located somewhere east of the original tailings deposition pond potentially 7,500ft from AL-1. See the attached figures.

Both source potentials would involve a relatively small pool of contaminated water that has slowly migrated along the flank of Fraser draw. The timing of this occurrence matches well with the typical velocity of 1 to 10 ft/day if it is assumed that the migration began roughly around the time that the corrective action program was terminated following approval of the ACL for the site, in late 2002.

Recent improving values at well AL-1 and the slow but low amplitude parallel (possibly delayed) response in the nearby well AL-6 indicate that the probability of this being the true source is high.

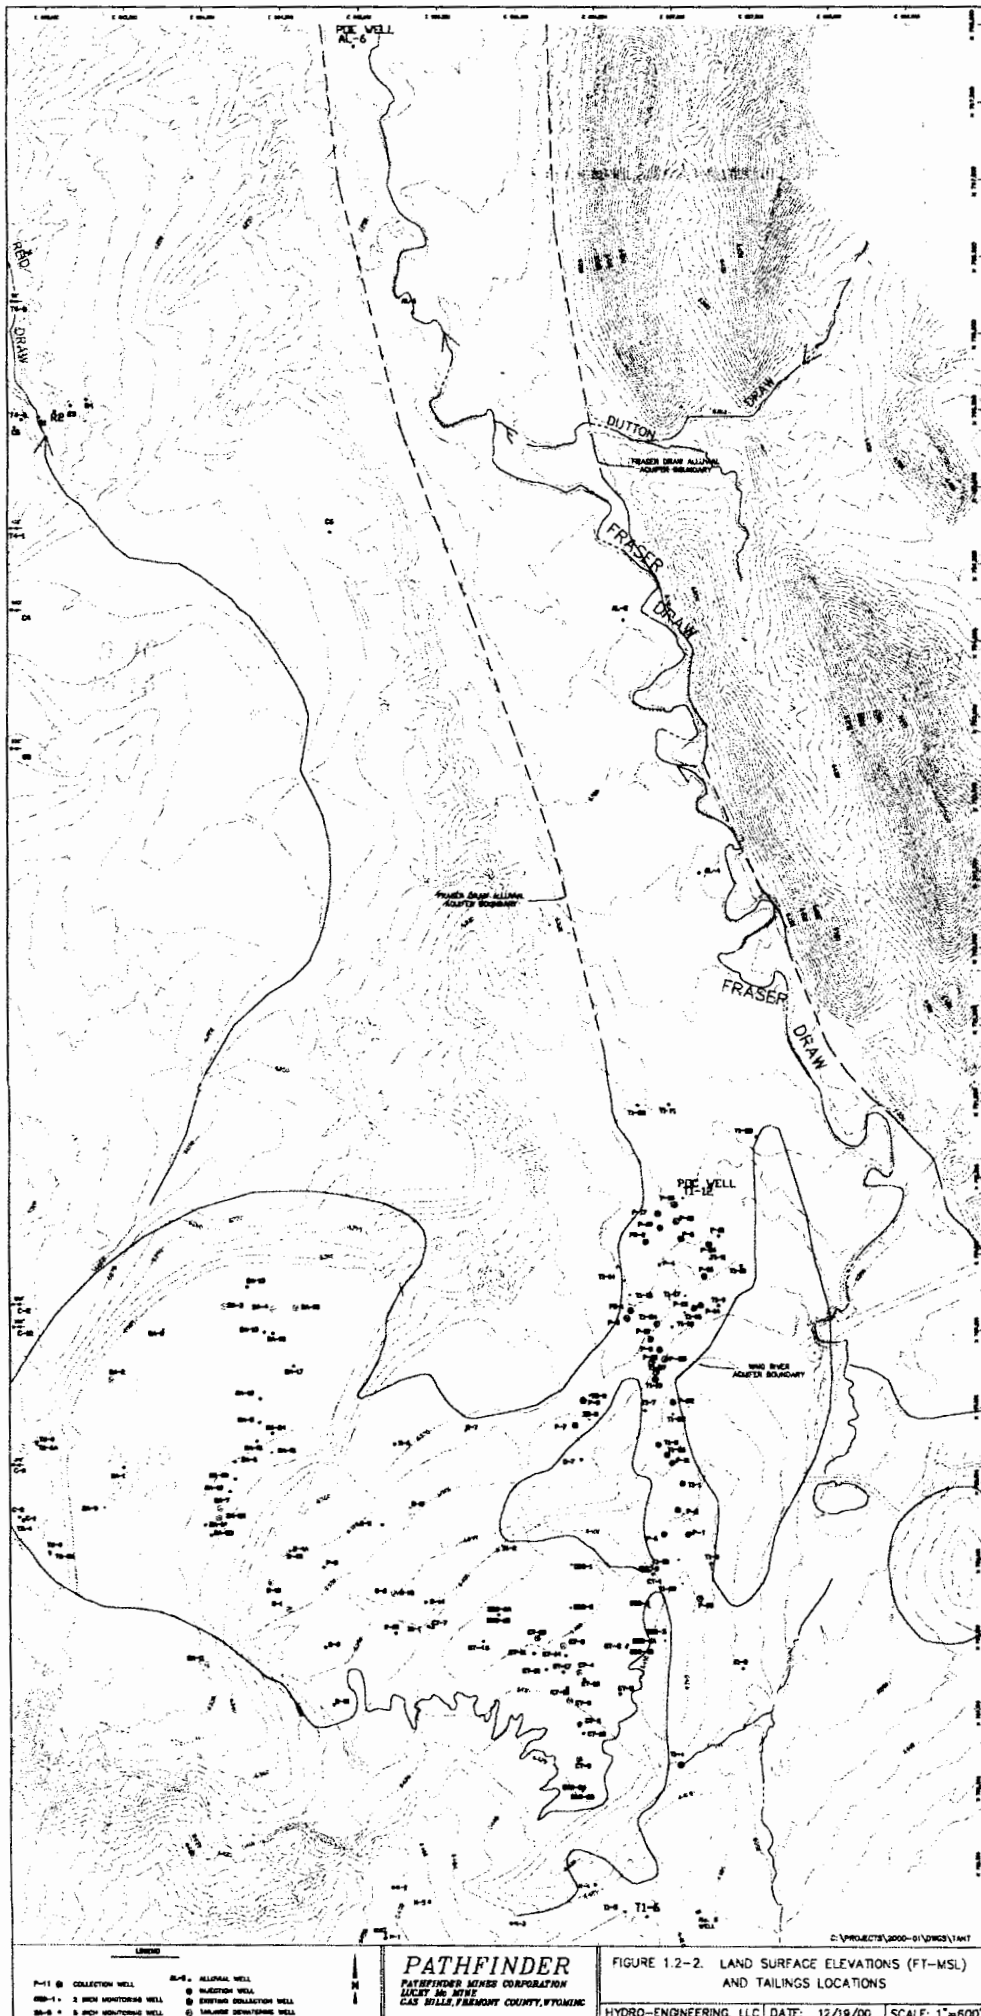
ACL Figure 1.2-2

The possibility that there is some new source of contamination originating within the tailings system cannot be ignored. The clearly defined flowpaths present in the corrective action area indicate that the only route out of the tailings system is intersected precisely at well T1-12, the POC location, which to date has not seen any increases in assay values for Uranium or other constituents. In fact for most assay items the values for well T1-12 have been flat or slowly decreasing in response since the termination of corrective action. See the above figures for assay values and Figure

Because of the assay history in well T1-12 of generally declining values for all assay constituents this potential is considered unlikely.
