**Seismic Walkdown Checklist (SWC)**

Equipment ID No.   2SIS-MOV867A

Equipment Description   HHSI Isol to Cold Leg Injection

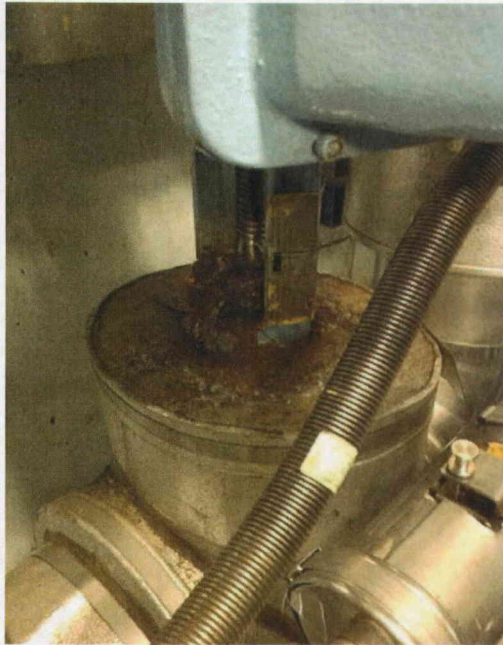
*Both packing nuts observed to have moderate corrosion. CR-2012-14409 written to document this condition.*

File Name: 2SWS-MOV113A(3).jpg  
Description: View of Corroded Packer Nuts

11. Have you looked for and found no other seismic conditions that could adversely affect the safety functions of the equipment?  
*Deficiency tagged as "packing leak" (Notification no. 600716354).*

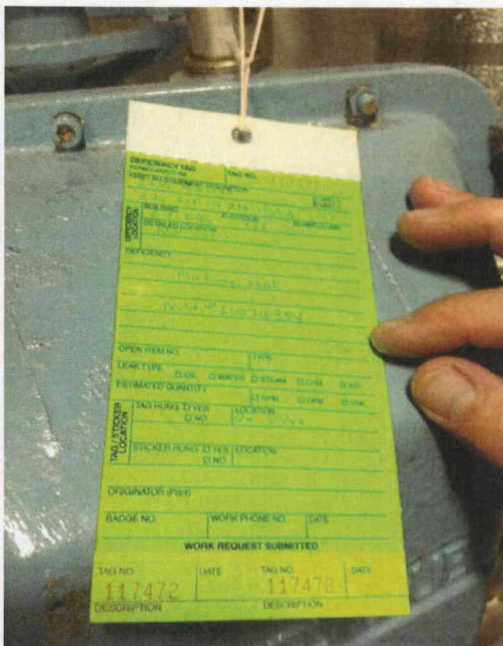
File Name: 2SWS-MOV113A(4).jpg  
Description: Deficiency Tag on Component

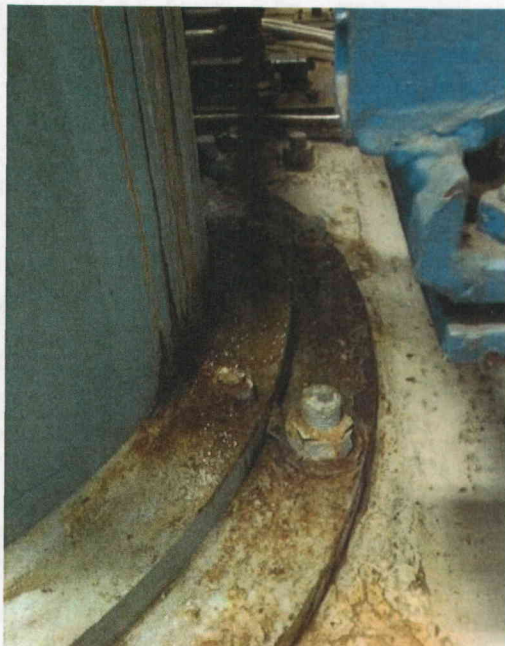
*Pump is leaking oil. Most anchor bolts have minor corrosion, 2 machine bolts have moderate corrosion with material degradation. CR-2012-14408 generated to document this issue.*

File Name: 2SWS-P21A(4).jpg  
Description: View of Corroded Anchorage

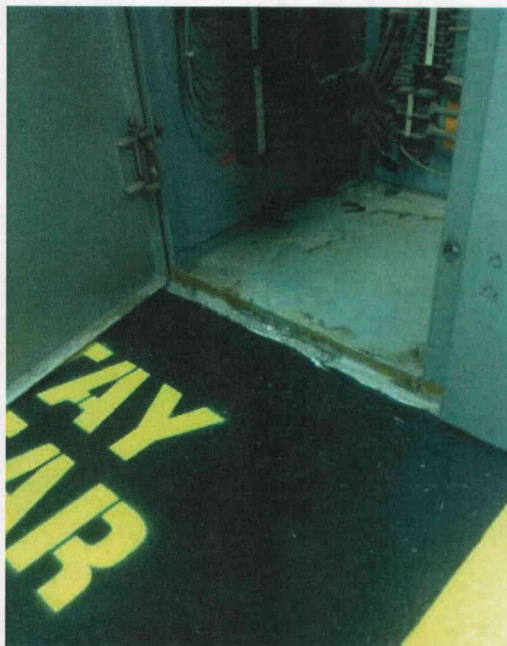
Description: View of Welds at Component Base

*Presence of embedded sill channels indicates that the unit is welded to the embed and therefore no missing or broken anchorage is expected.*

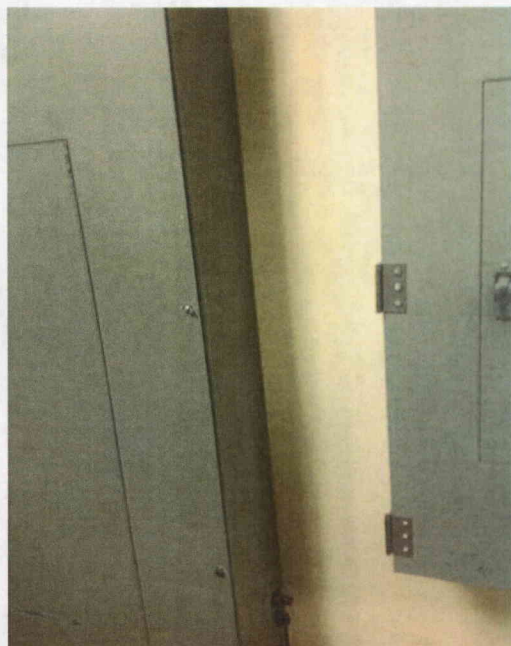
Description: Anchorage Inaccessible
