APPENDIX C: AREA WALK-BY CHECKLISTS (AWCs)

Area Walk-By Checklist (AWC)

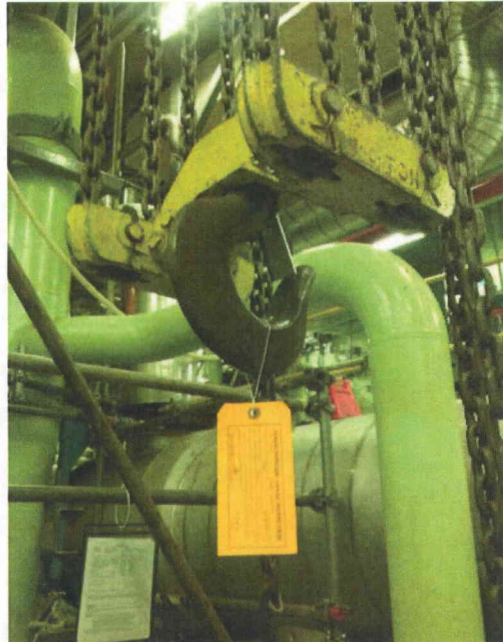
File Name: 1-65-4-3-01.jpeg

Description: Pulley in the area noted to be properly restrained

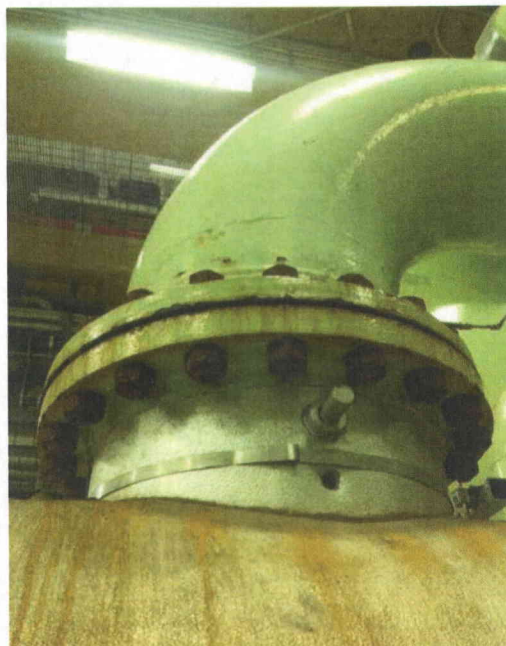
File Name: 1-67-4-3-01.jpeg

Most of 20-1" diam flange nuts at outlet nozzle for HX2CCP-E21C were identified with surface corrosion. CR-2012-14459 was issued to address this finding.

Description: Mild corrosion identified on nuts of 2CCP-E21C outlet nozzle

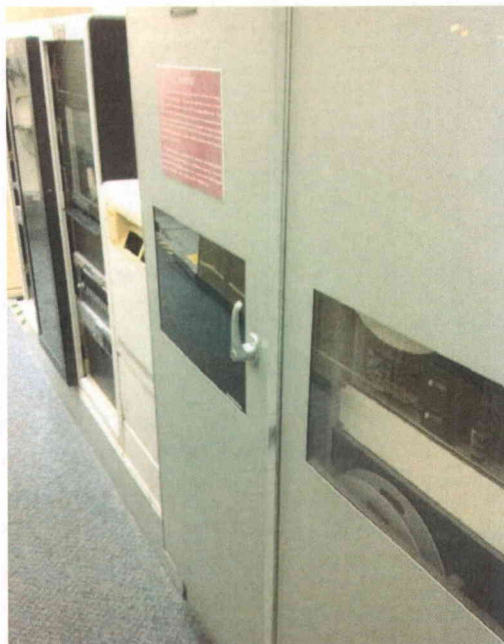
File Name: Control_Rm(1).jpg

Description: View of panel PNL-2FAL-REC was not positively latched.

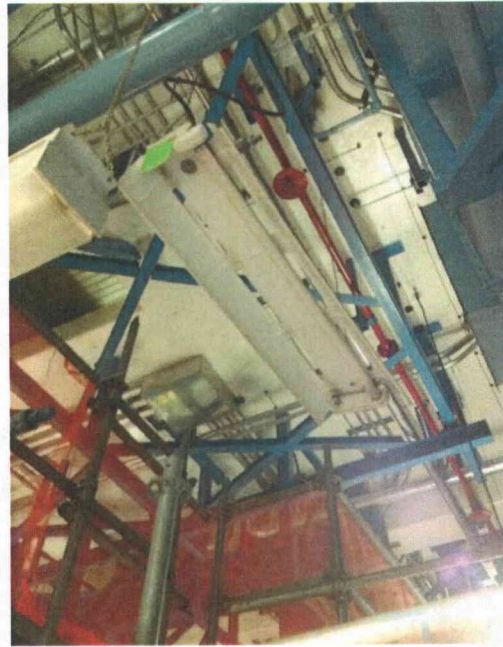
File Name: EDG2-1(9).jpg
Description: View of lighting fixture with missing fluorescent tube.

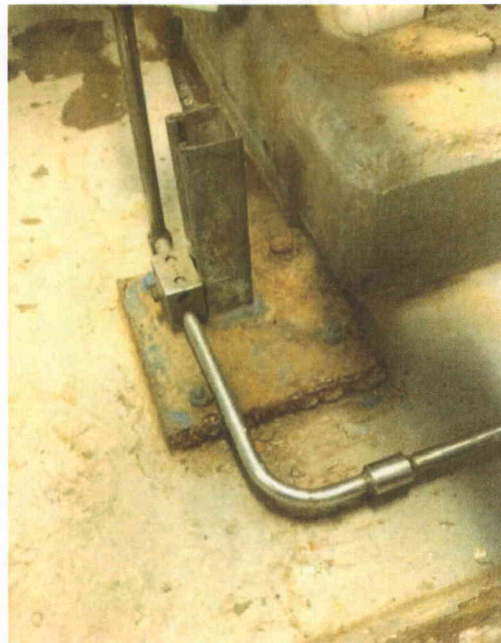
File Name: INTK_CUB_C(4).jpg
Description: Surface rust identified on small pipe support.

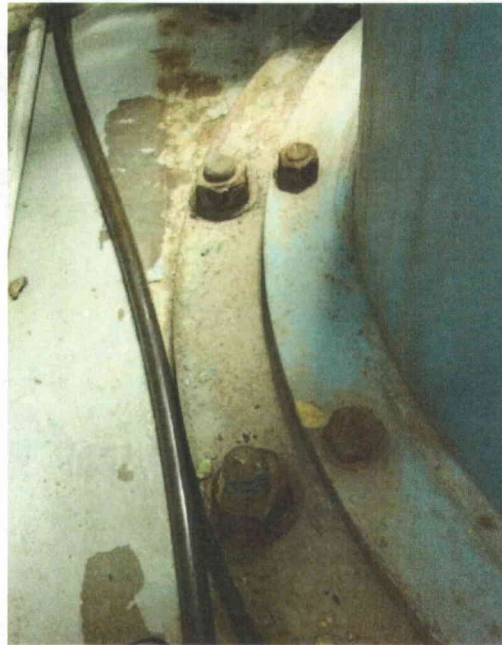
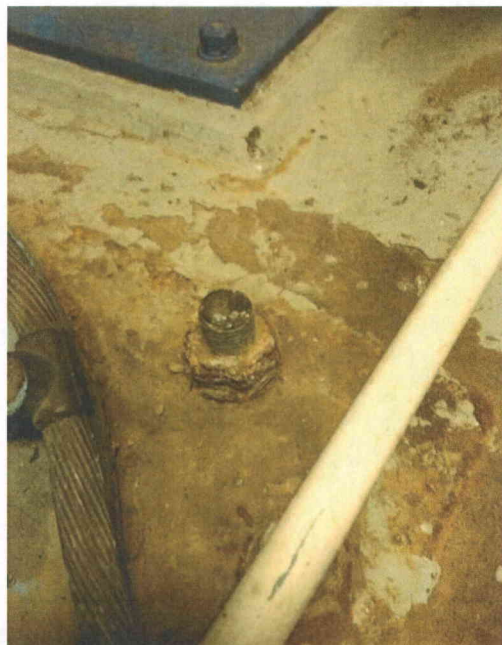
Description: Surface rust identified on bolts for Pump 2SWS-P21B.

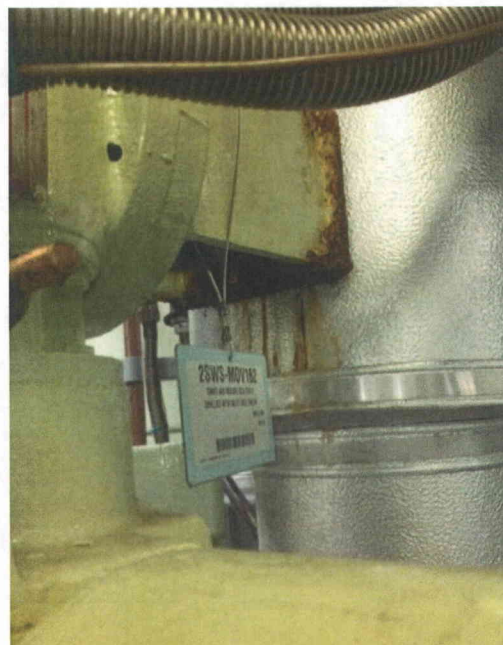
File Name: 1-68-2-3-12.jpeg
Description: Surface rust identified for valve 2SWS-MOV162.
CR-2012-14450 issued for this finding.

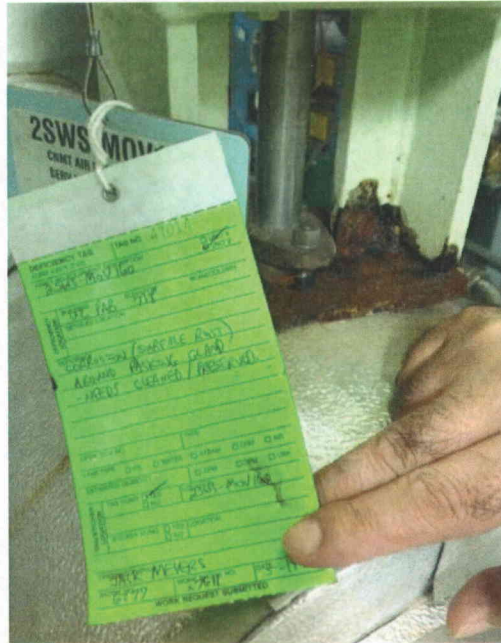
File Name: 1-69-2-3-12.jpeg

Description: Deficiency tag identified for 2SWS-MOV160.
CR-2012-14449 issued for this situation.

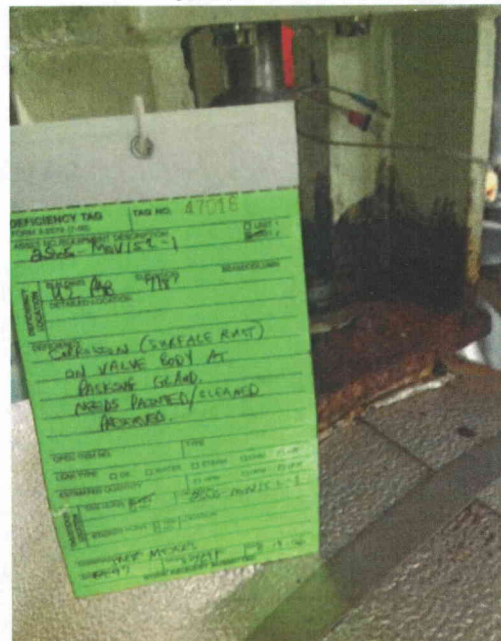
File Name: 1-70-2-3-12.jpeg

Description: Deficiency tag identified for 2SWS-MOV152-1.
CR-2012-14452 issued for this situation.

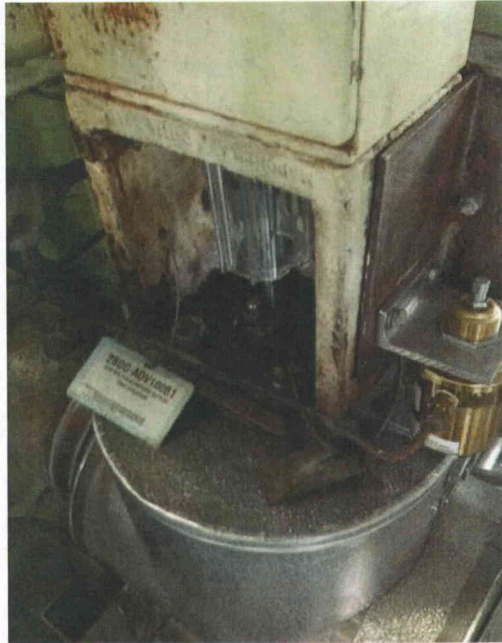
File Name: 1-71-2-3-12.jpeg

Description: Corrosion identified on base of 2BDG-AOV100B1.
Judged not a seismic concern.

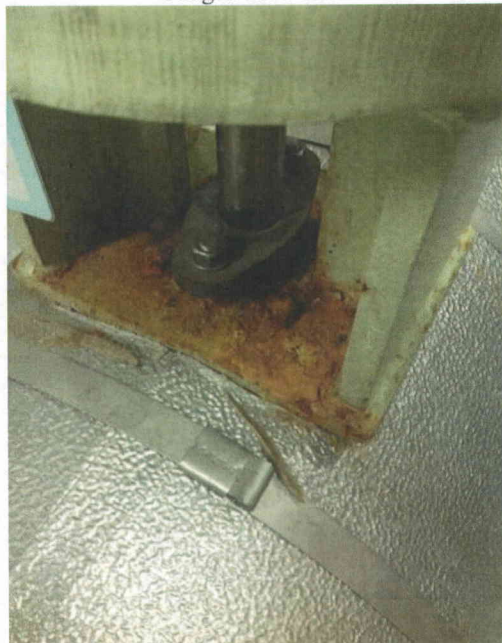
File Name: 1-72-2-3-12.jpeg

Description: Corrosion identified on base of 2SWS-MOV161. Bolts appeared
to be undersized. CR-2012-14455 was issued to address this situation.

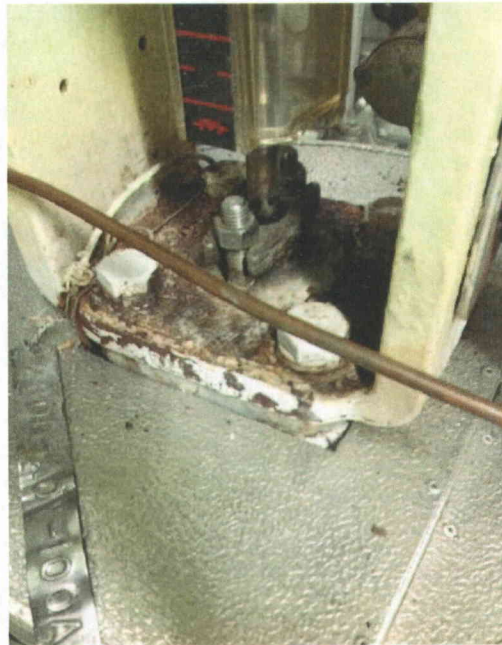
File Name: 1-74-2-3-12.jpeg

Description: 2BDG-AOV-100A identified with mild surface corrosion.
Judged not a seismic concern.

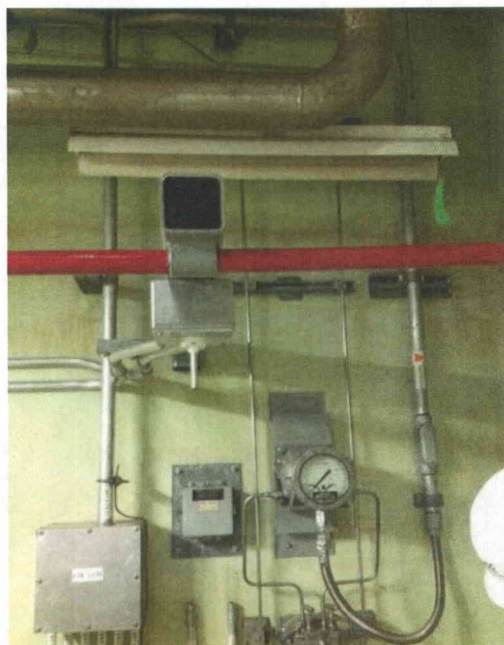
File Name: 1-70-5-3-23.jpeg
Description: Potential falling of light bulb could impact instrument below.
Judged not a significant interaction.

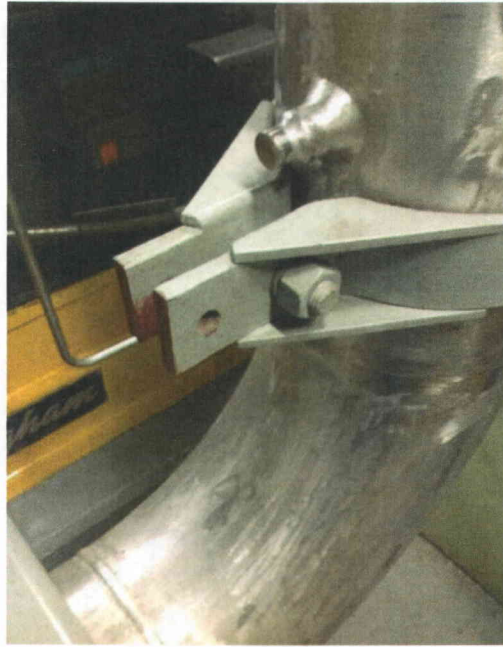
File Name: 1-68-5-4-23.jpeg

Description: View of deleted support rod for 2QSS-P21A discharge nozzle.

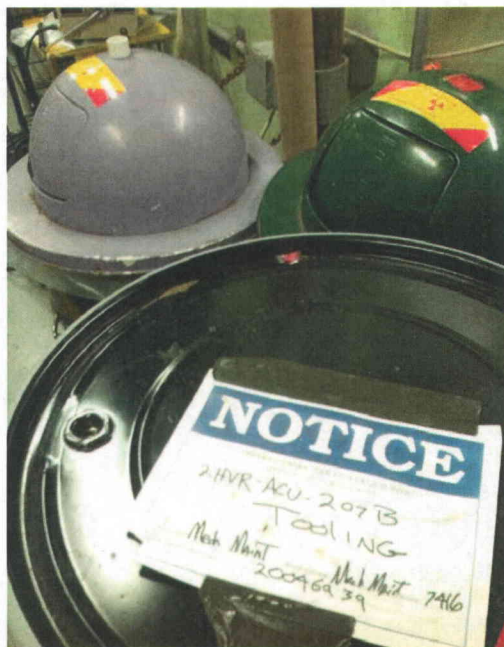
File Name: 1-65-2-3-24.jpeg

Description: Notice label on top of unrestrained drum near MCC.

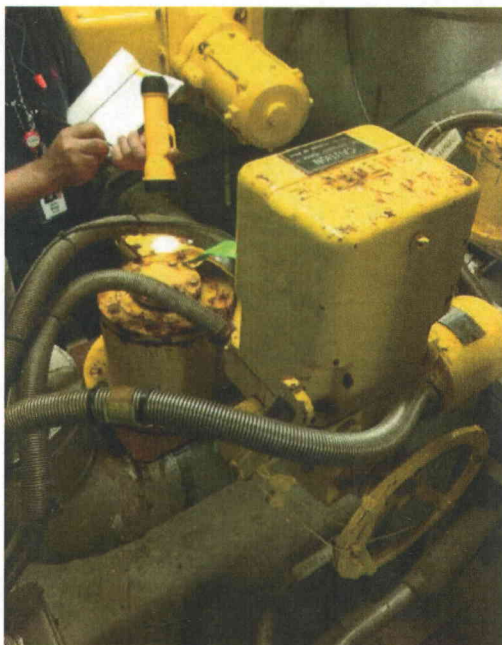
File Name: VLV_PT_A(3).jpg

Description: Surface rust identified on several MOVs in the area.

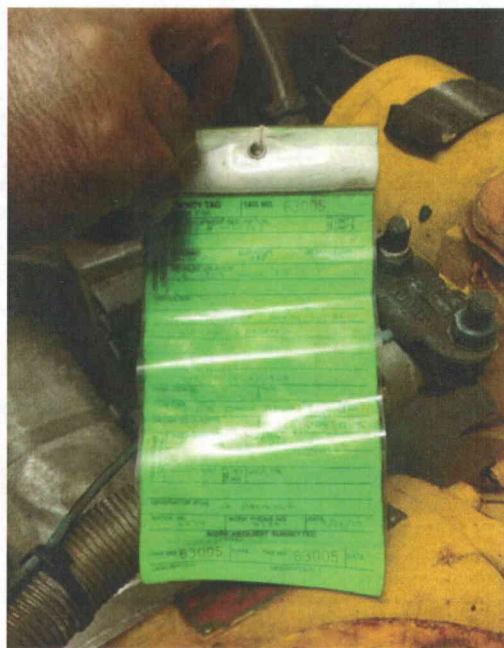
File Name: VLV_PT_A(4).jpg

Description: Deficiency tag requesting cleanup and painting.
CR-2012-14412 issued to address this finding.

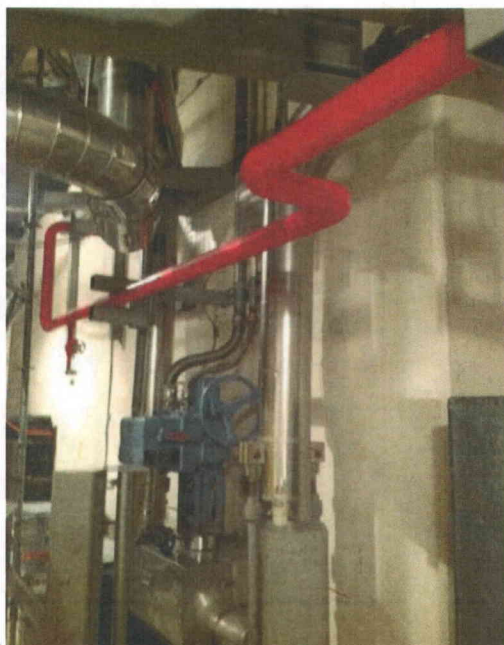
File Name: 1-60-4-3-17.jpeg
Description: Fire line located above 2CHS-MOV310
