APPENDIX C
AREA WALK-BY CHECKLISTS (AWCs)

Area Walk-By Checklist (AWC)

Room 105 Floor El. 545 Bldg. AUXB

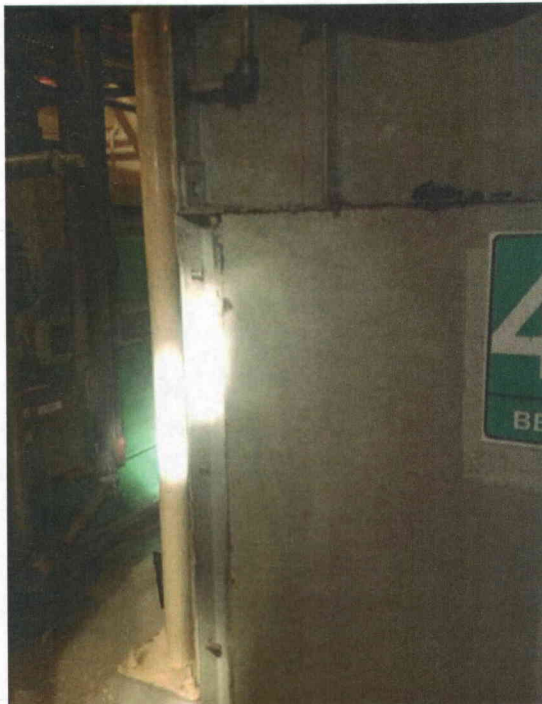
*Anchorage for cover plate of E31-4 does not have nuts, see Photo 2.
Concern has been judged not to represent an adverse condition regarding the component's seismic performance.*

Photo 2
Missing Nuts on Cover of E31-4

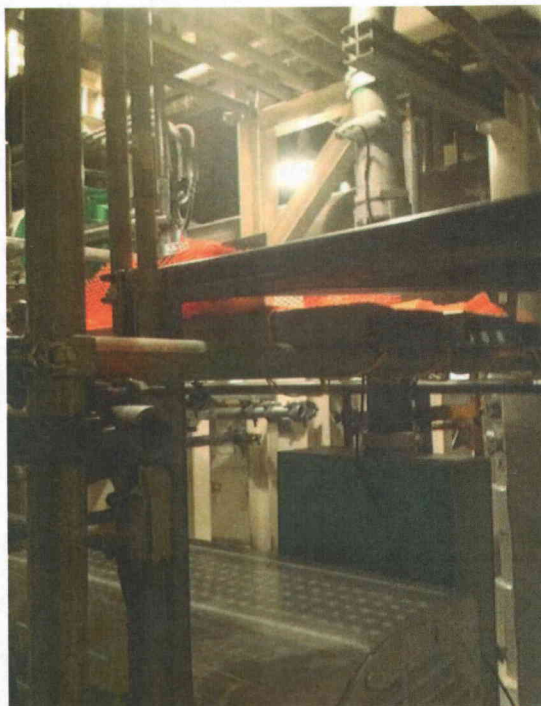
Temporary scaffolding in area appears to be adequately restrained. See Photo 3.

Photo 3
Temporary Scaffolding Restrained

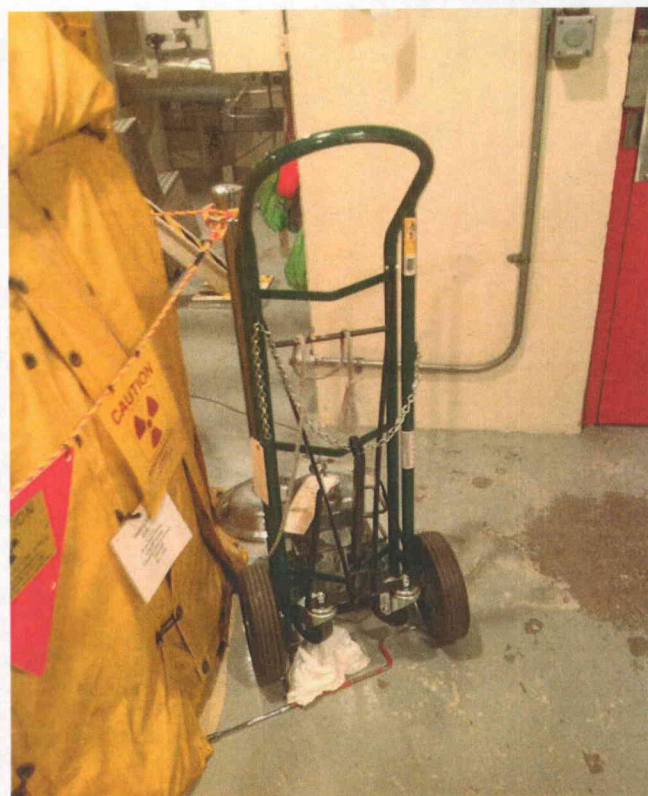
A dolly was found unrestrained in the area. Since the dolly had restraining chains on it, it was judged that it is temporarily located at the position found in the room and will be returned to its storage location and tied when work is done. Also, no sensitive equipment found in the vicinity of this dolly.

Photo 2
Unrestrained Dolly in Area

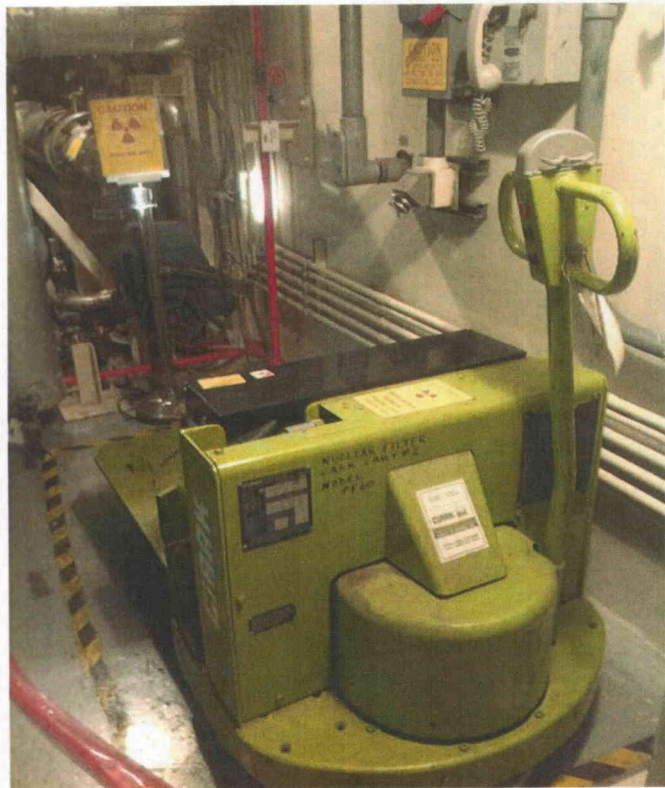
*Nuclear filter cask cart unrestrained adjacent to components.
There are no sensitive equipment in the zone of influence of this cart and it is judged OK. It is also noted that this cart appear to be temporarily in the area.*

Photo 2
Nuclear Filter Cask Cart Not Restrained

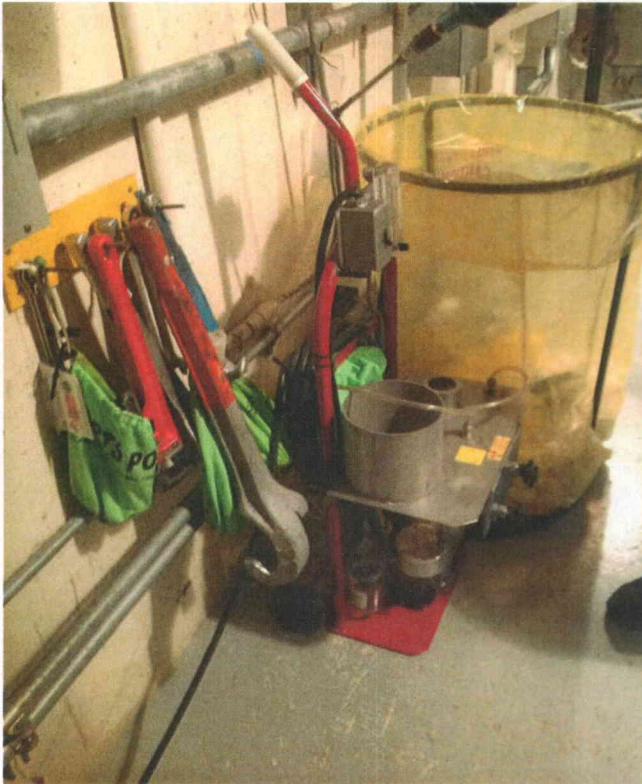
Photo 1
Dolly Not Restrained

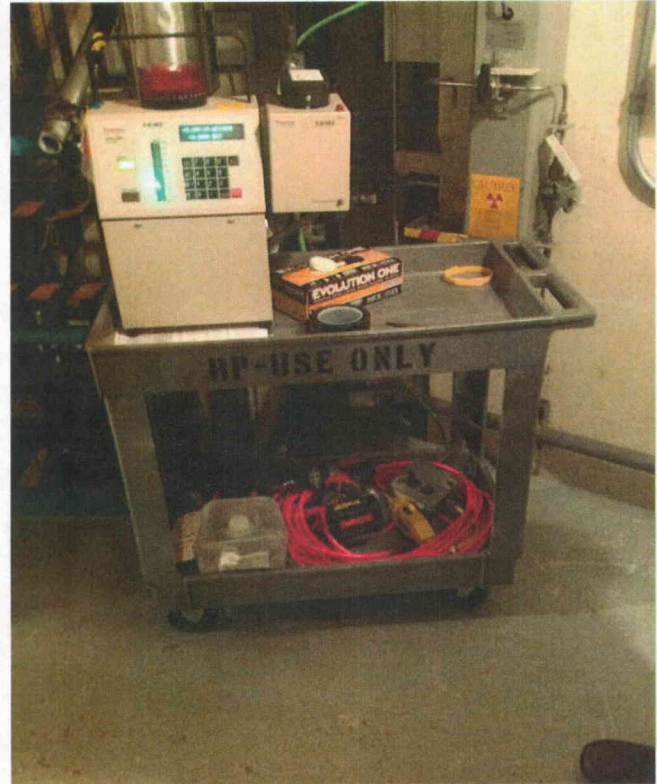
Photo 2
RP Cart Not Restrained

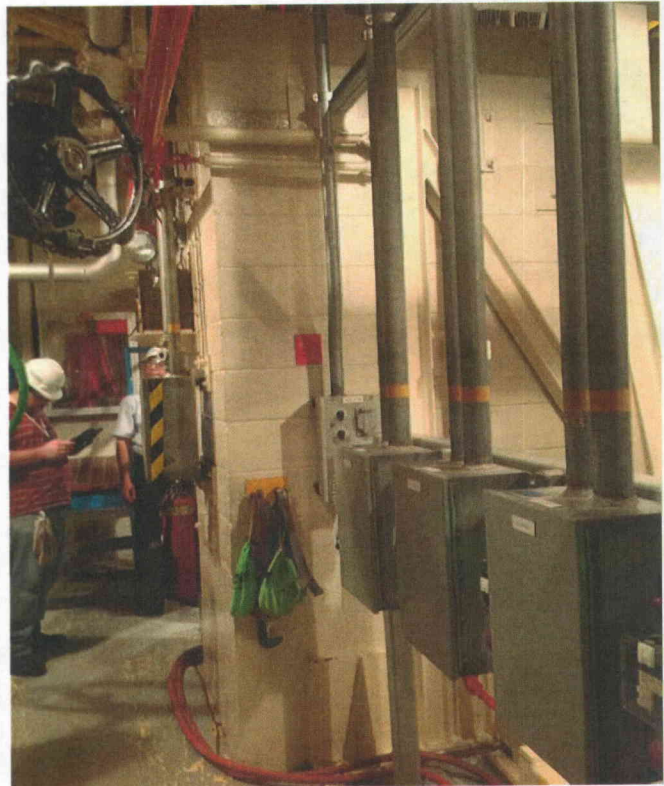
Photo 2
Masonry Wall

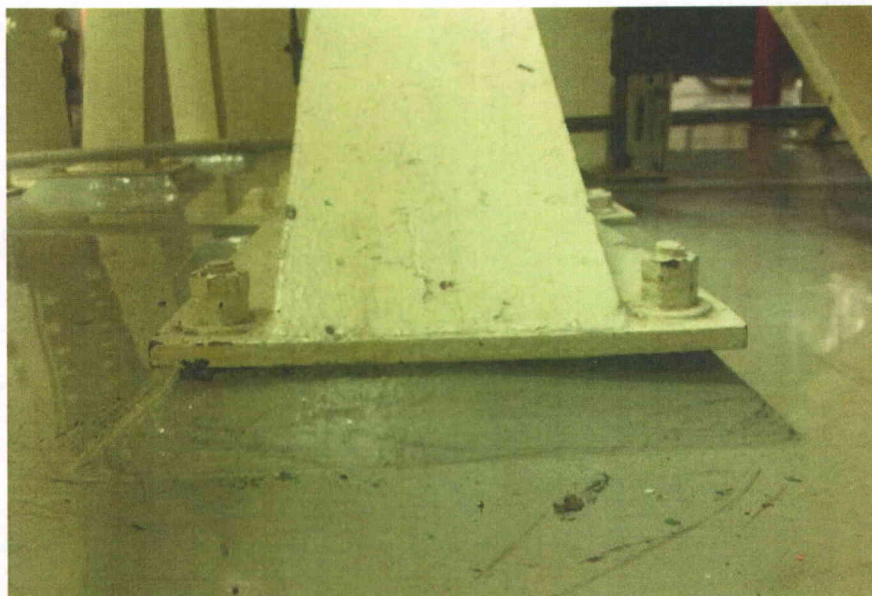
Photo 2
Gap Between Grout and Anchor Plate

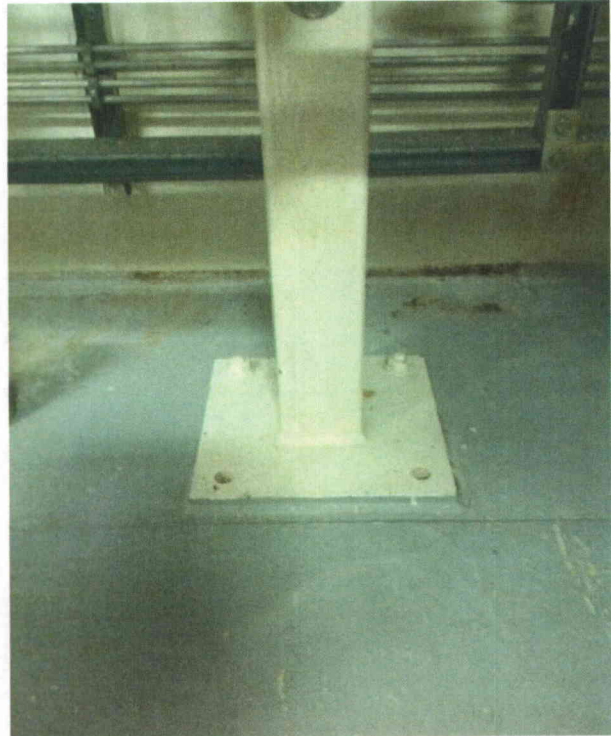
Photo 2
Missing Anchor Bolts

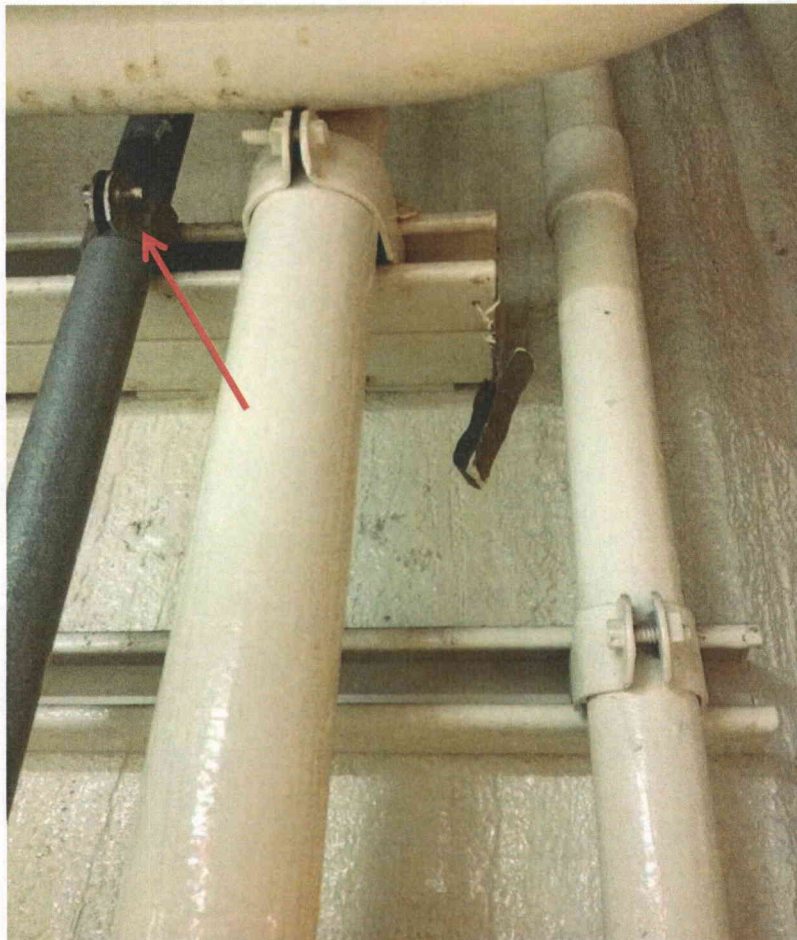
Photo 1
Nut Missing on Conduit

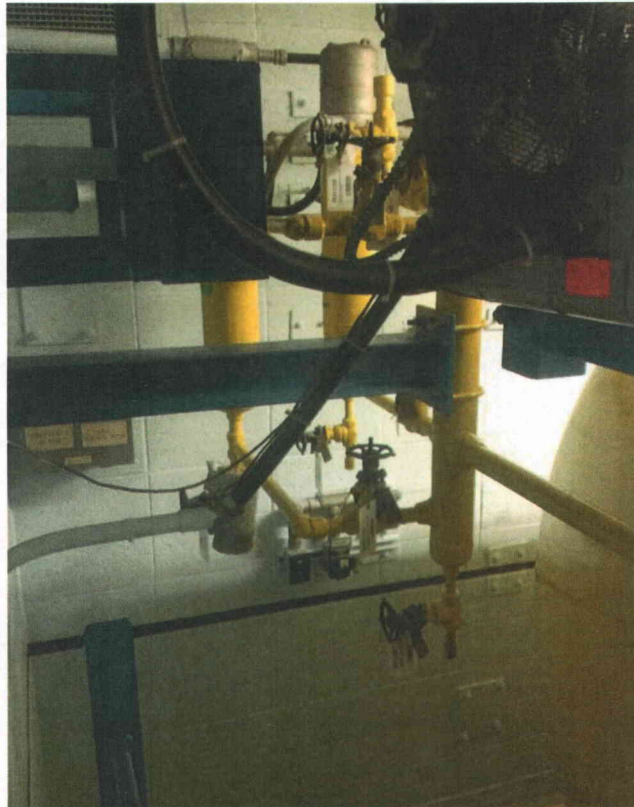
Photo 1
Masonry Wall

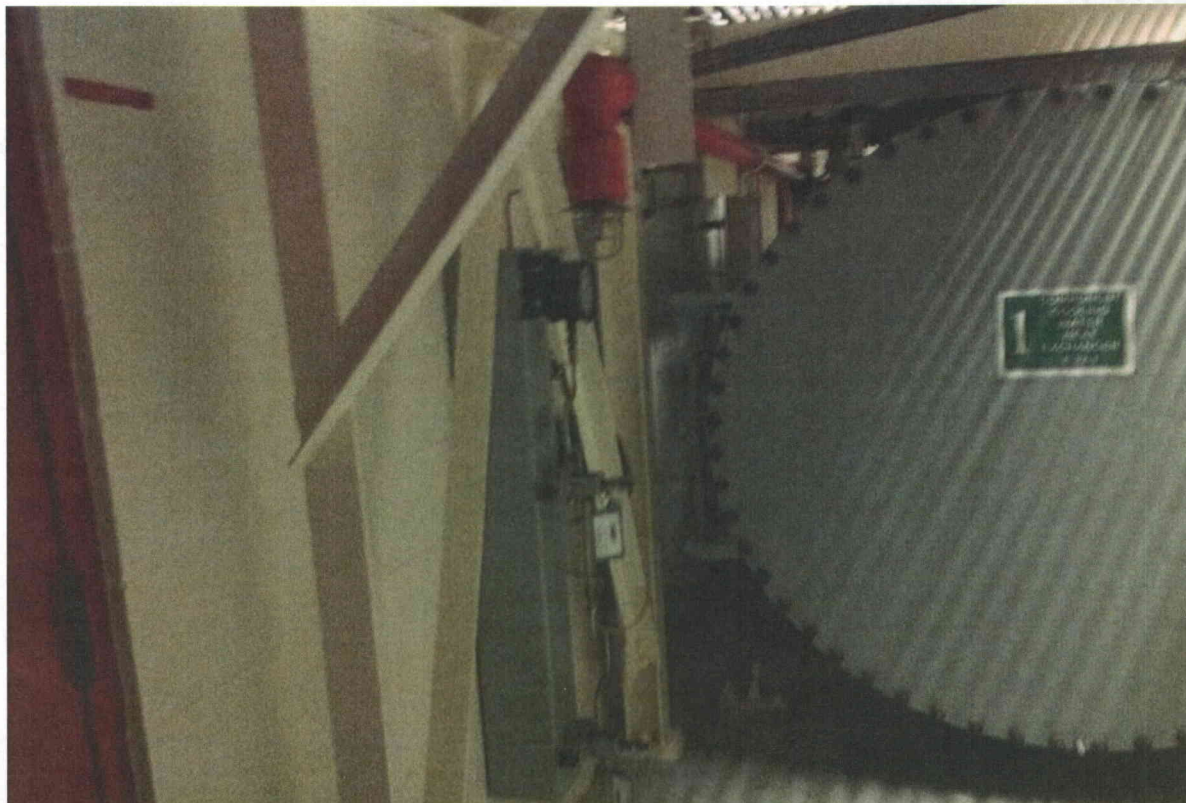
Photo 1
General View of Room 328
Masonry Wall Adjacent to Heat Exchange E22-1

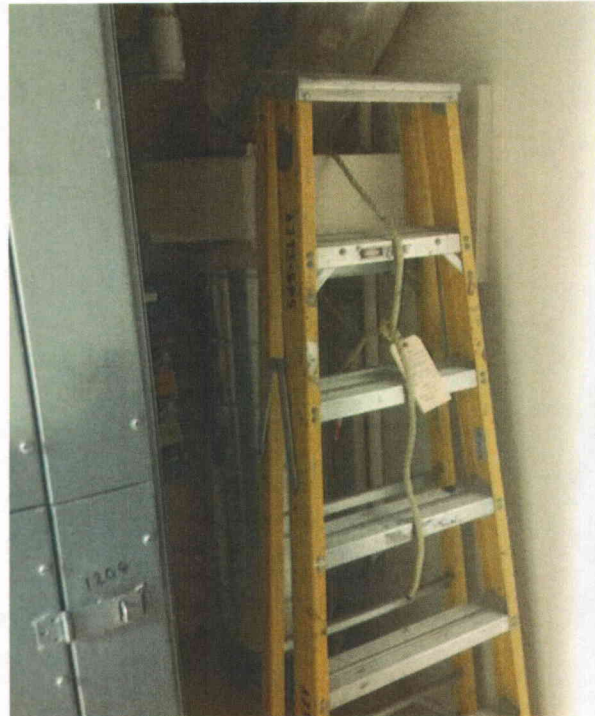
Photo 2
Ladder Loosely Tied Adjacent to MCC F11A

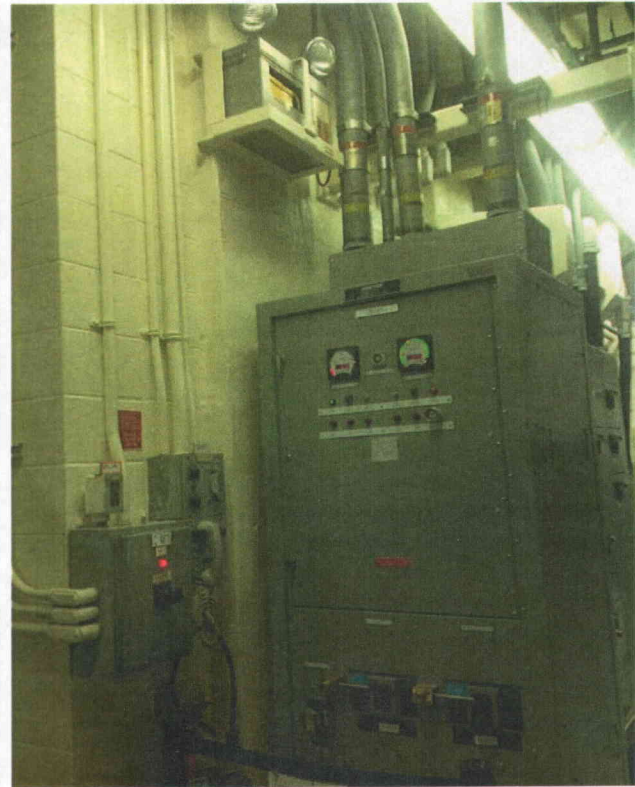
Photo 2
Masonry Wall Adjacent to Components

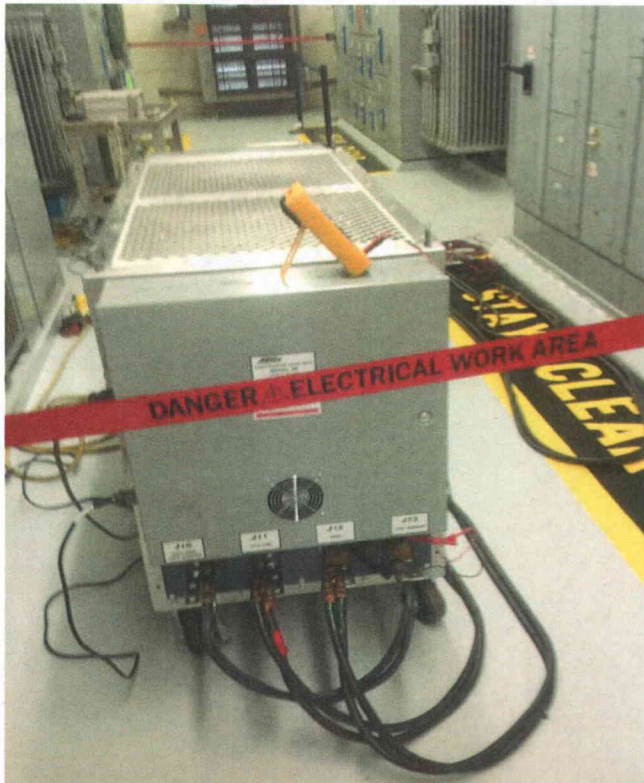
Photo 3
Unrestrained Work Cart

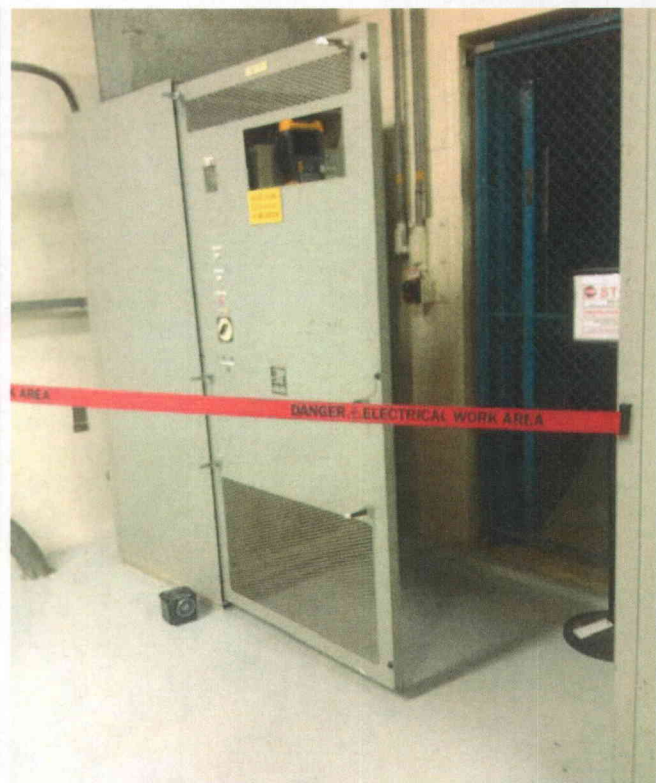
Photo 4
Cabinet DCB-2P Door Left Open

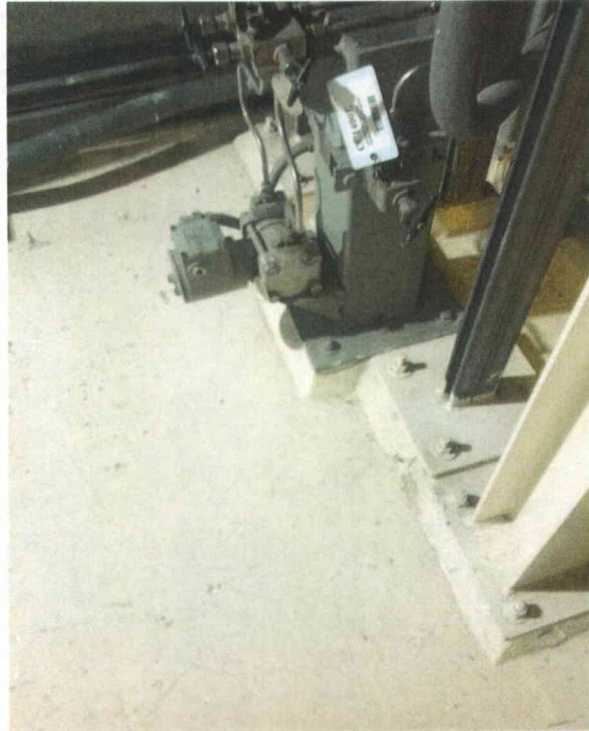
Photo 1
Damaged Grout

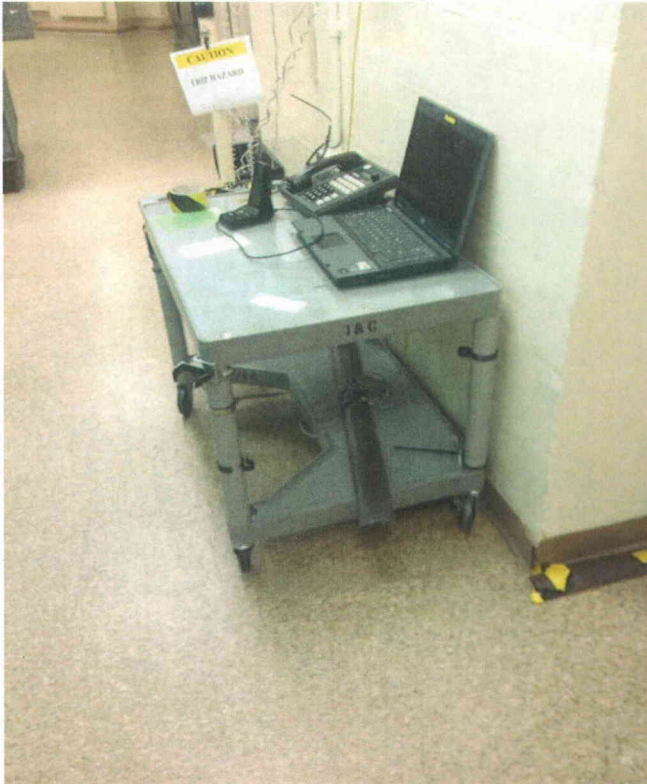
Photo 3
Unrestrained I&C Cart

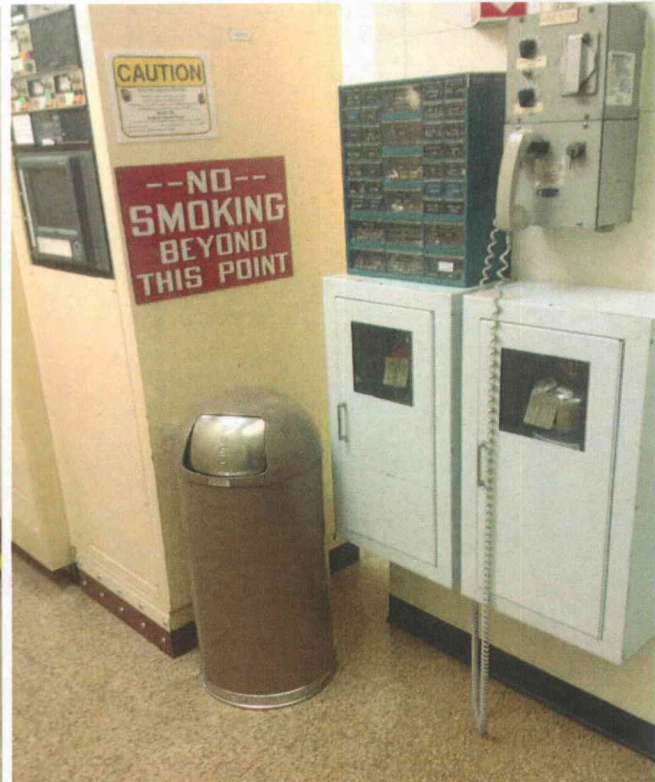
Photo 4
**Unrestrained Trash Can
and Light Bulb Storage**

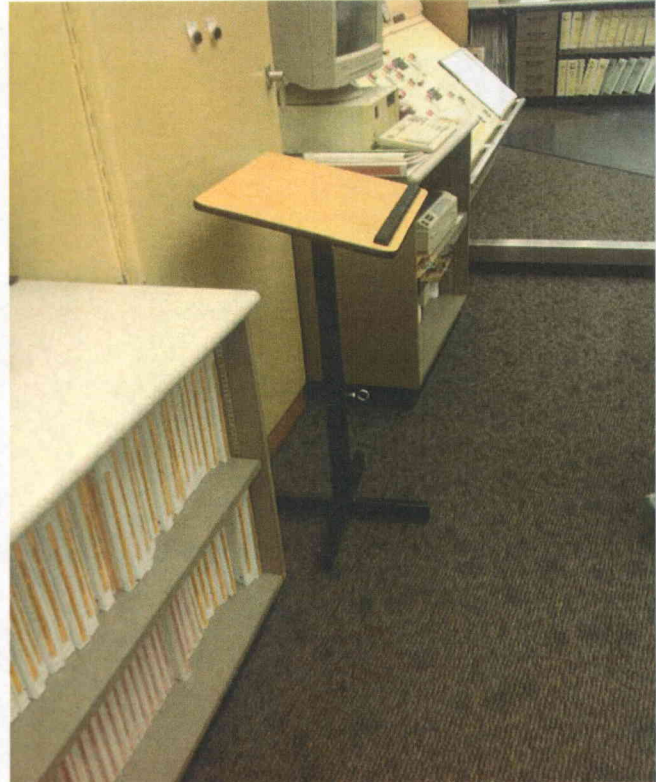
Photo 2
Small Podium Not Anchored

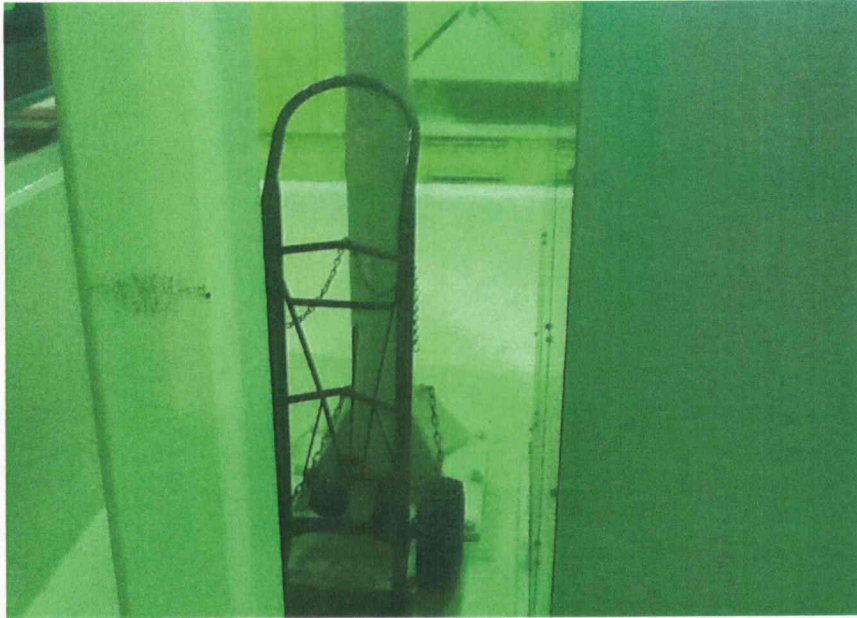
Loosely Tied Dolly in Room 515

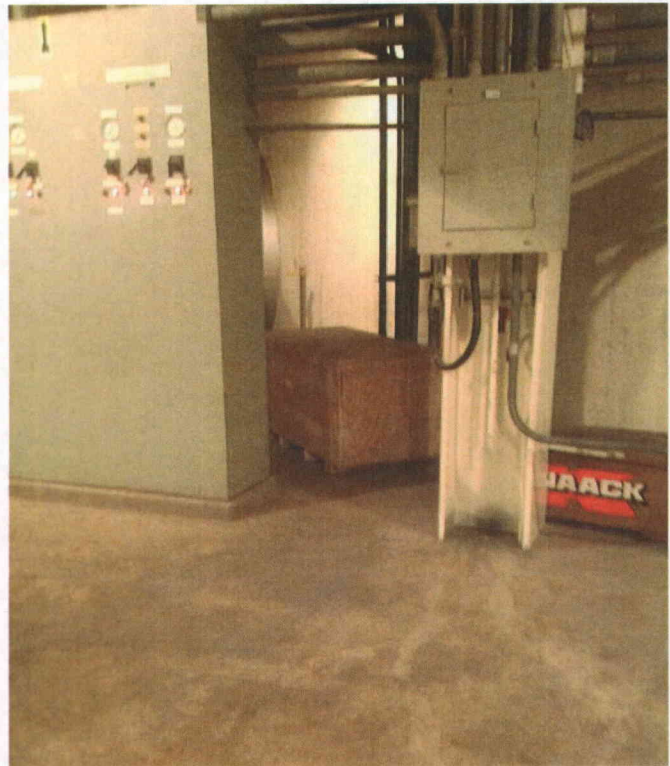
Photo 2
Unrestrained Storage Containers

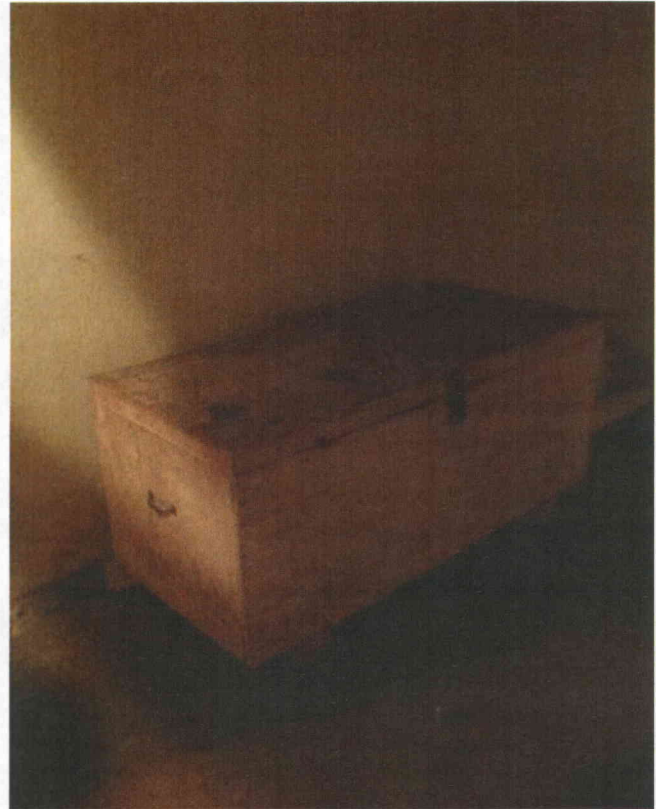
Photo 2
Unrestrained Storage Container

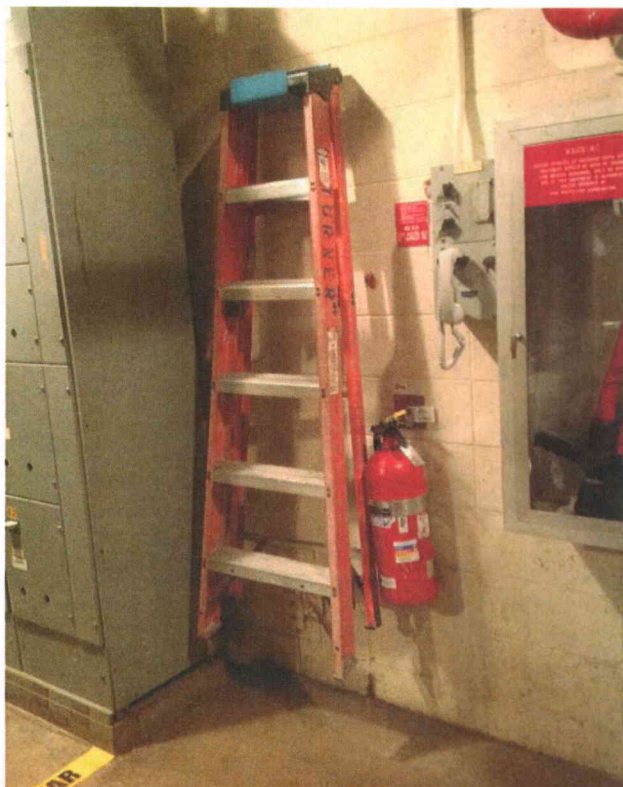
Photo 1
Fire Extinguisher not Restrained
and Masonry Wall

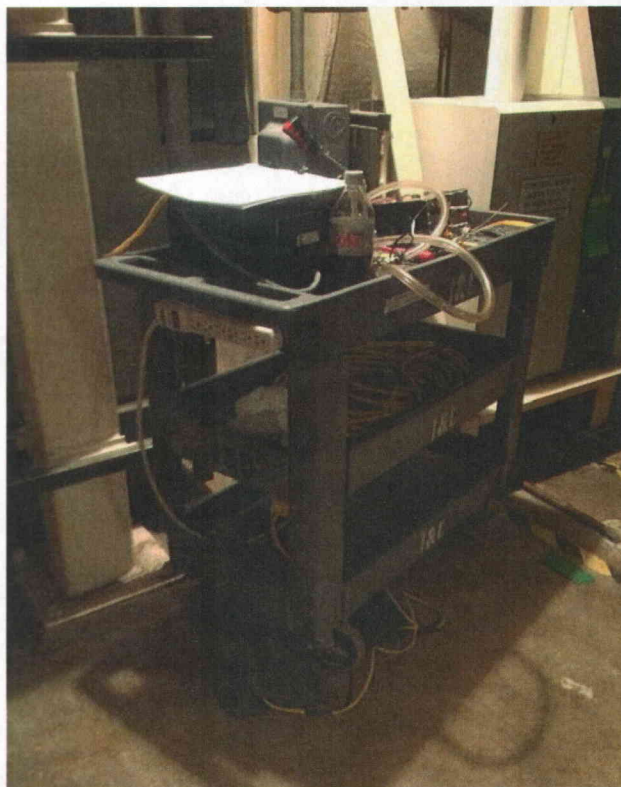
Photo 2
Cart Not Restrained

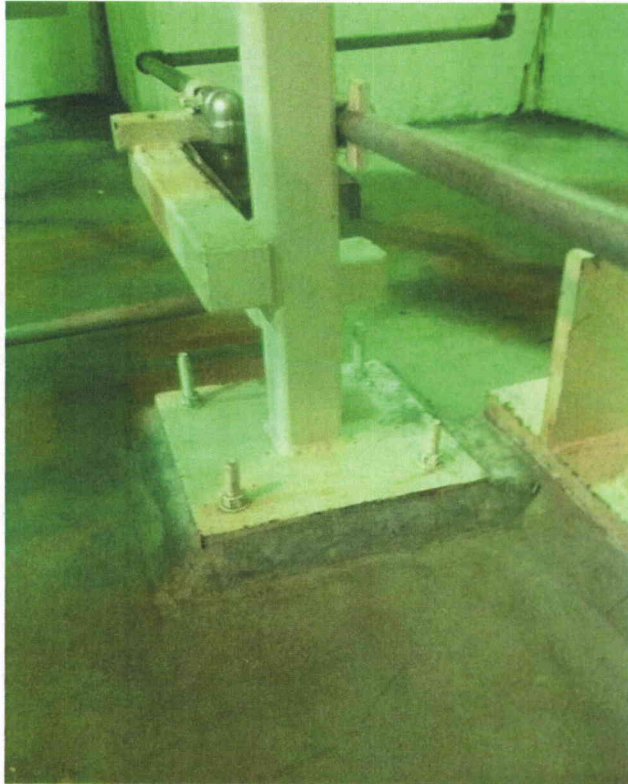
Photo 1
Anchor Threading
Substantially Past Nut

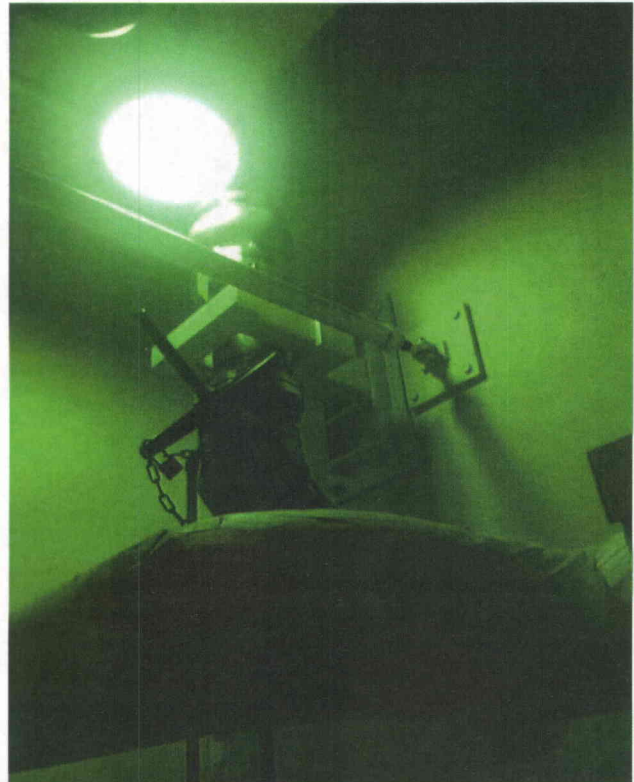
Photo 2
Hanging Light
Touching Component

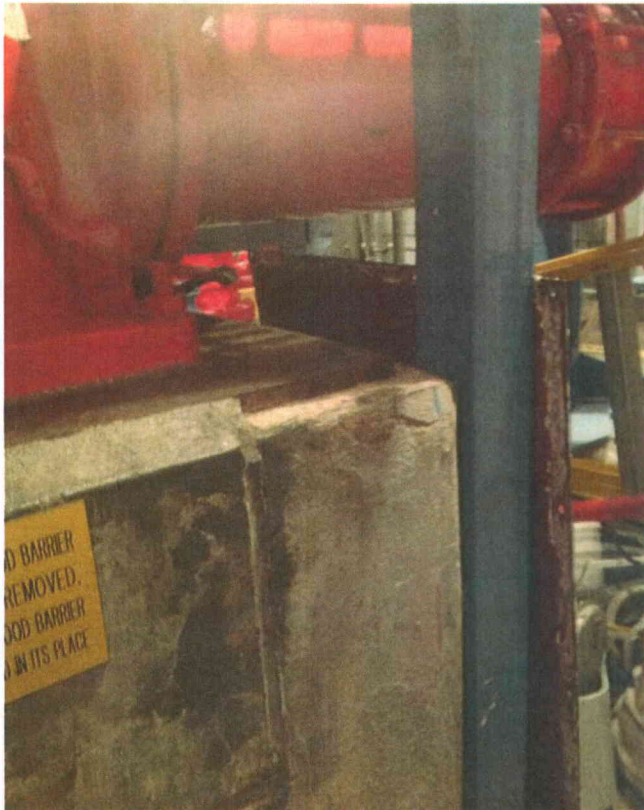
Photo 1
Damaged Grout

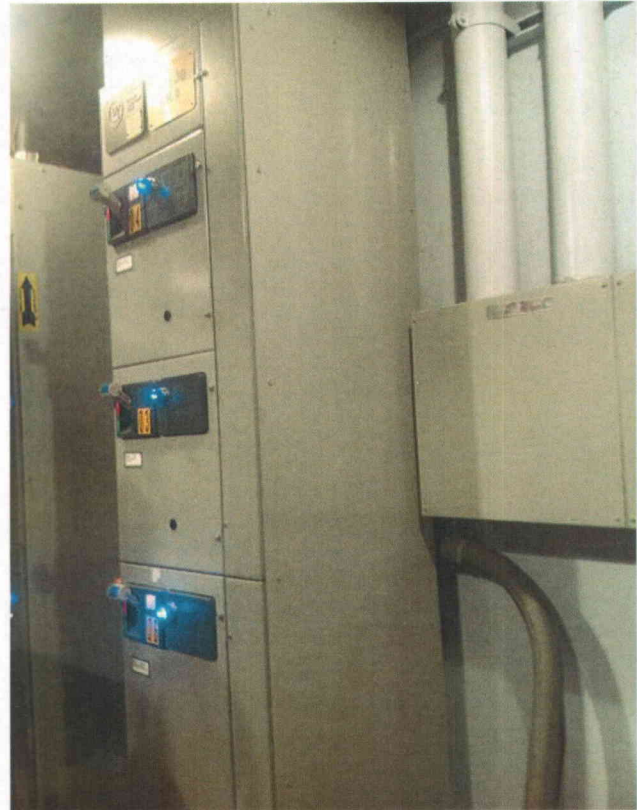
Photo 2
Movement of MCC Restrained
by Adjacent Component

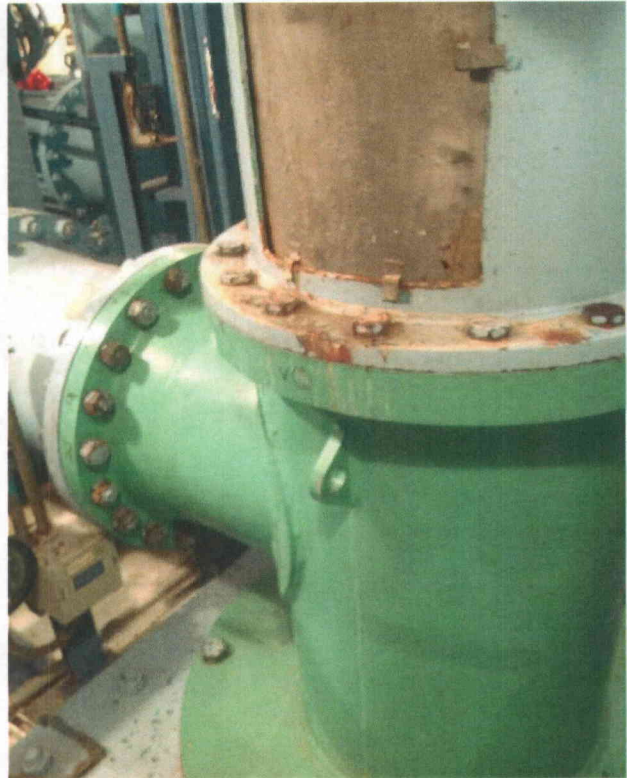
Photo 2
Minor Corrosion of Pump P3-3

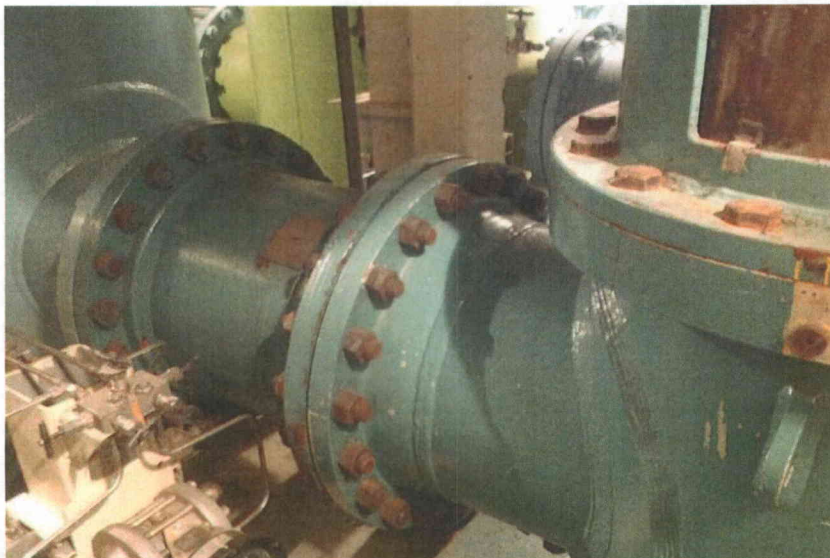
Photo 3
Minor Corrosion of Pump P3-2
