## **APPENDIX B: SEISMIC WALK-DOWN CHECKLISTS (SWCs)**

**Seismic Walkdown Checklist (SWC)**

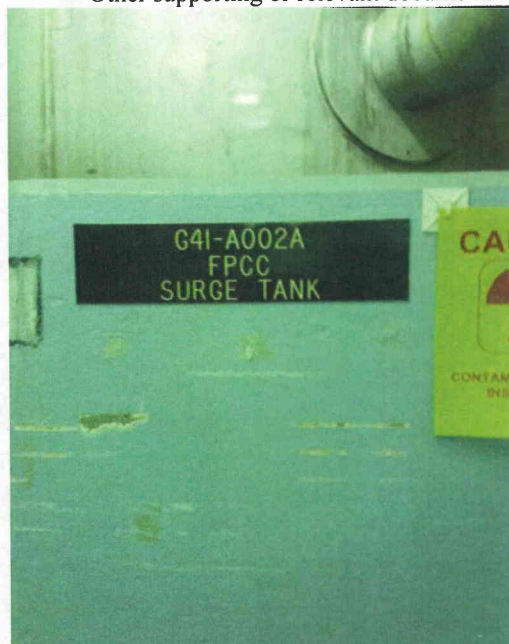
File Name: 2-61-1-4-22.jpeg  
Description: Component Plate ID

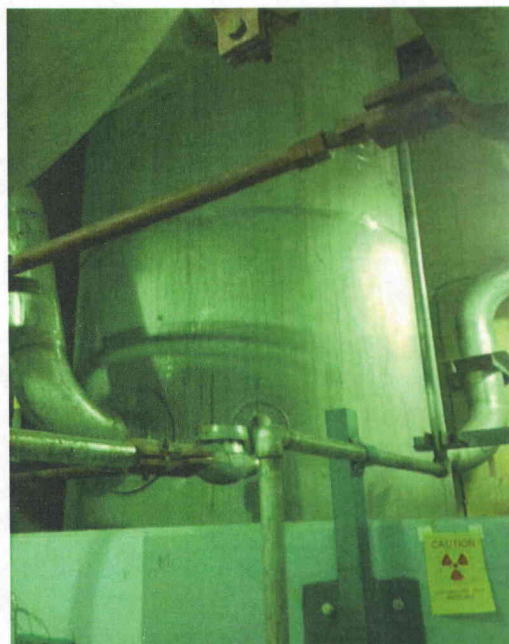
File Name: 2-62-1-4-22.jpeg  
Description: General view of component

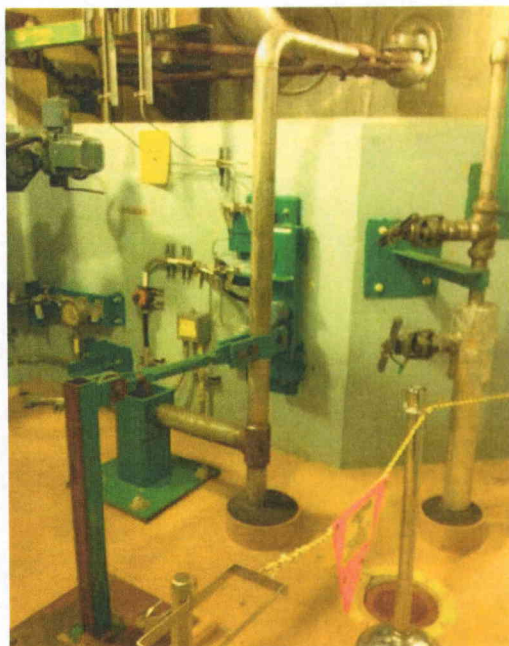
File Name: 2-63-1-4-22.jpeg  
Description: View of attached lines to component

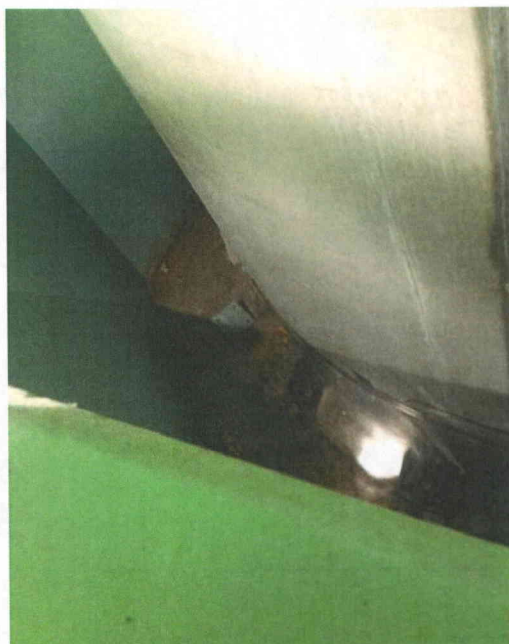
File Name: 2-64-1-4-22.jpeg  
Description: View of component anchorage detail

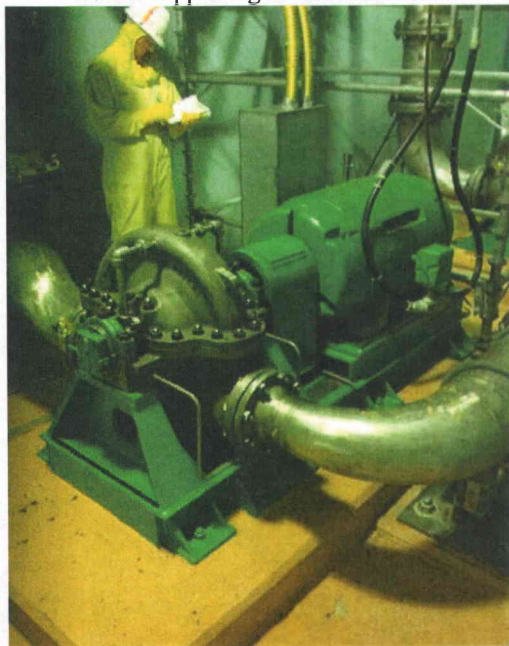
File Name: 2-61-2-4-21.jpeg  
Description: General view of component

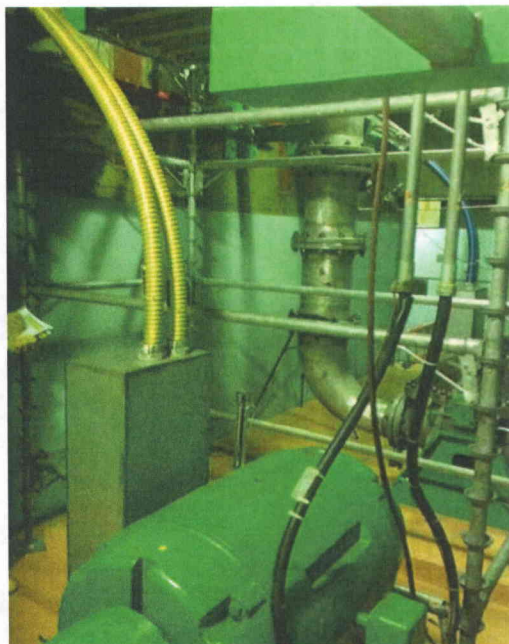
File Name: 2-62-2-4-21.jpeg  
Description: View of attached lines

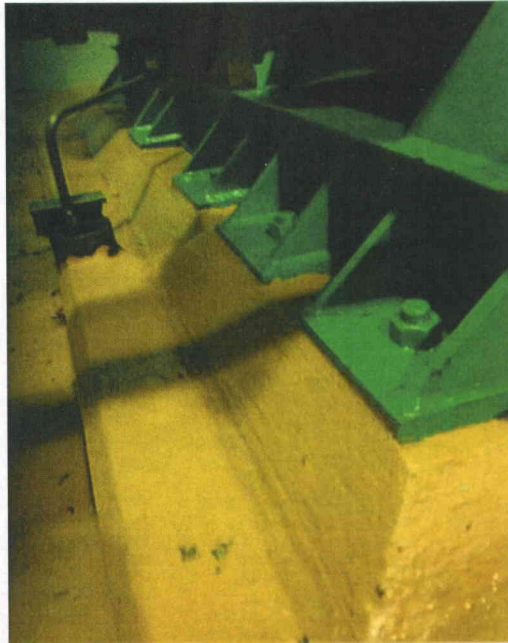
File Name: 2-63-1-4-21.jpeg

Description: View of component anchorage configuration

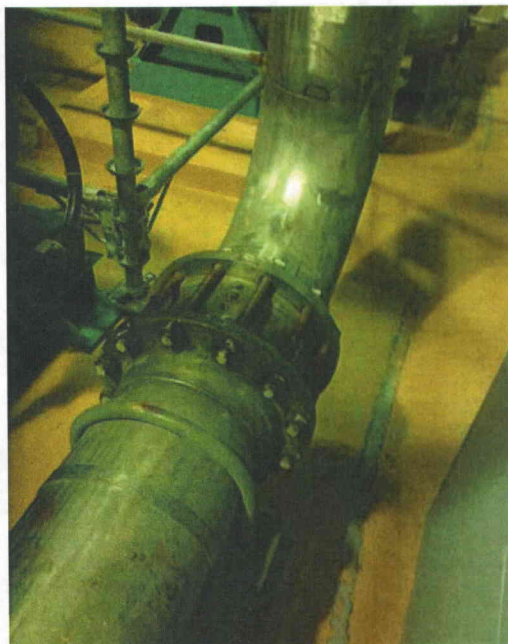
File Name: 2-62-3-4-21.jpeg  
Description: View of valve location in pipe main line

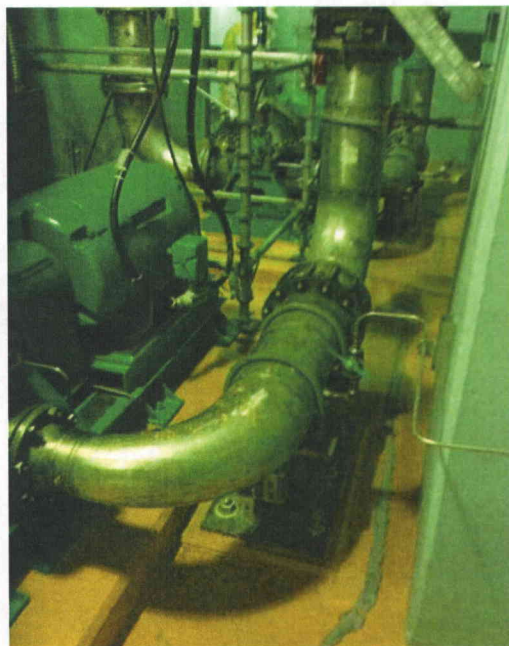
File Name: 2-63-3-4-21.jpeg

Description: View of main pipe line connected to component

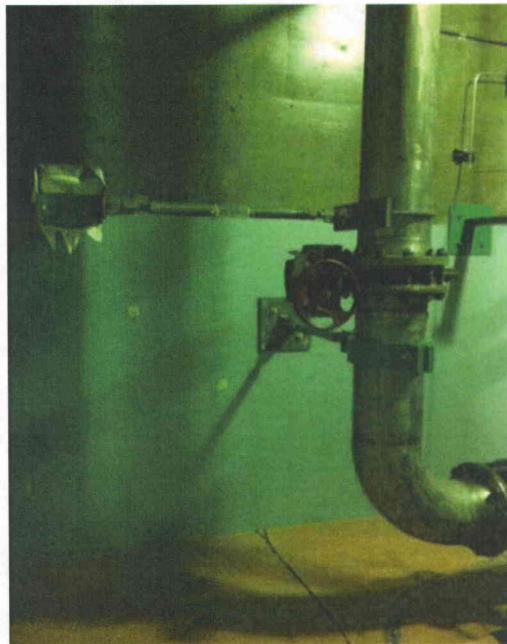
File Name: 2-62-8-1-21.jpeg

Description: View of wall mounted pipe line support

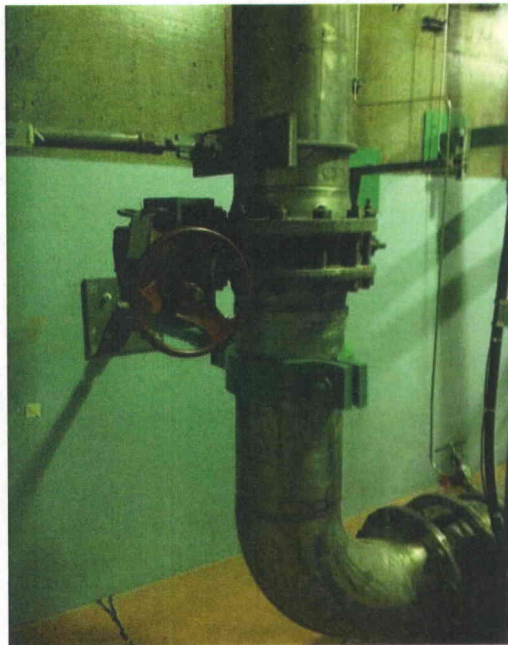
File Name: 2-63-8-1-21.jpeg

Description: View of pipe line support configuration

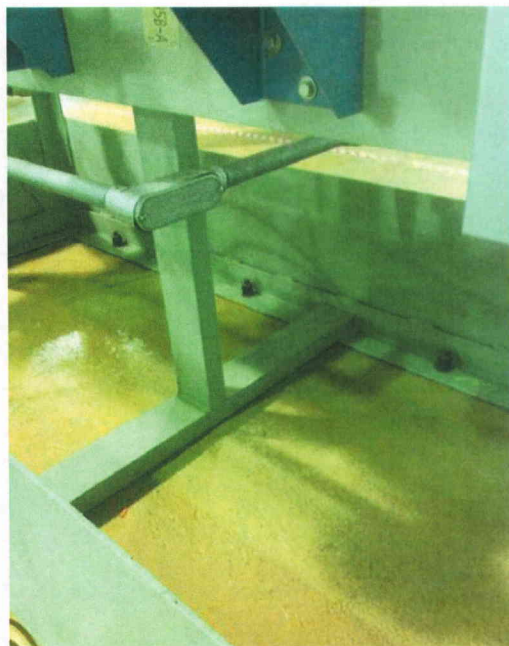
File Name: 2-63-6-4-01.jpeg  
Description: Anchorage view of component

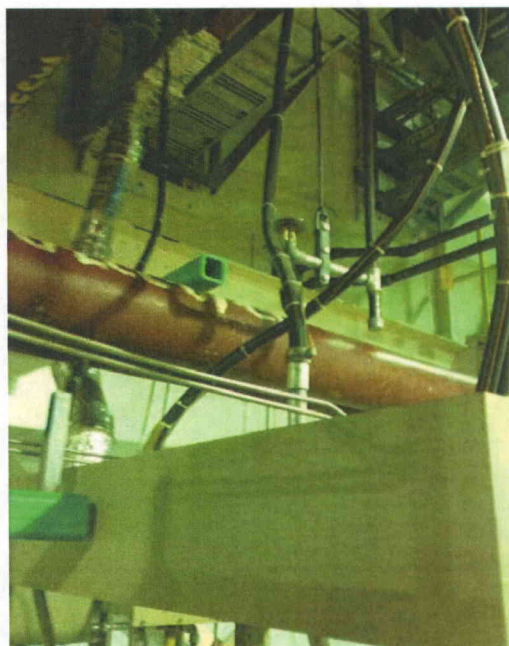
File Name: 2-64-6-4-01.jpeg  
Description: View of attached top lines

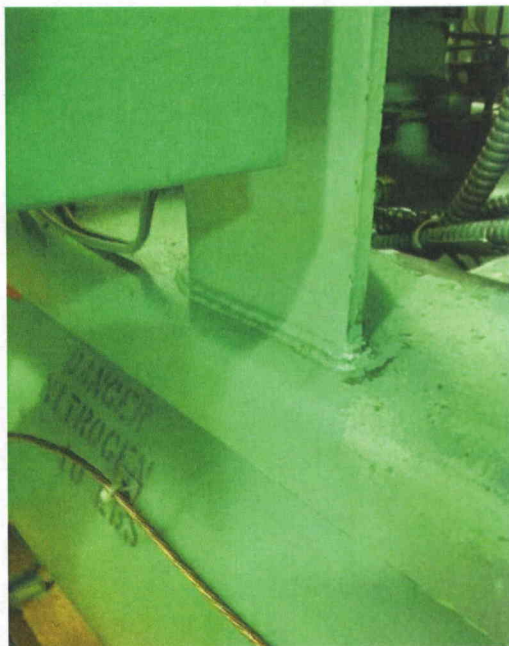
File Name: 2-73-1-1-01.jpeg  
Description: Control panel base weld detail

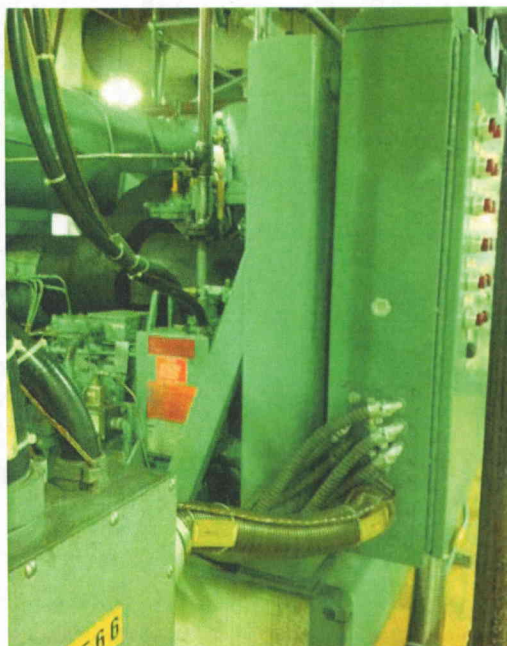
File Name: 2-94-1-1-01.jpeg  
Description: Left side isolators attached to L

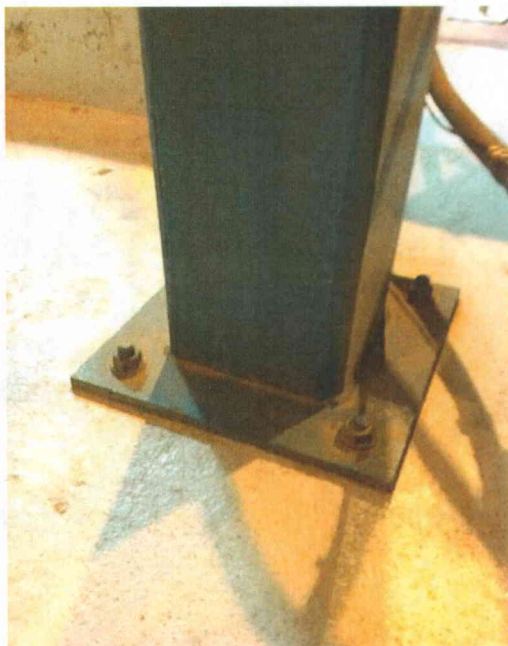
File Name: 2-63-3-1-05.jpeg  
Description: Anchorage view of component

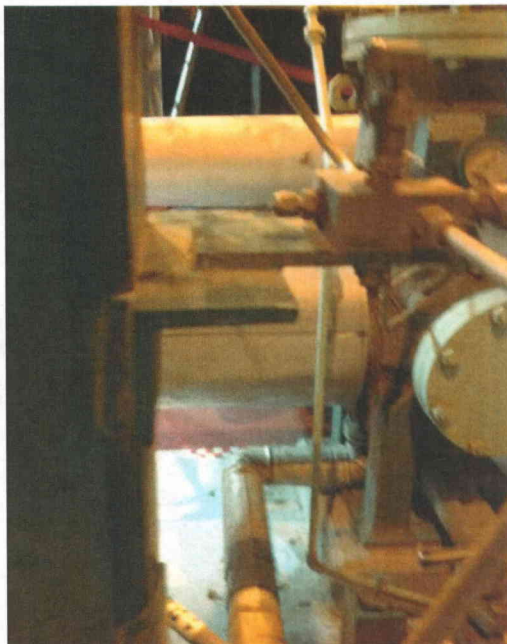
File Name: 2-64-3-1-05.jpeg  
Description: Close up view of angle support

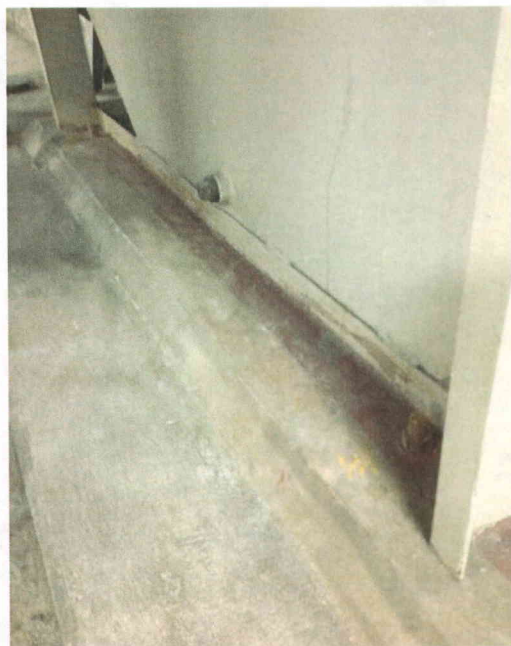
File Name: 2-63-3-4-04.jpeg  
Description: General view of anchorage

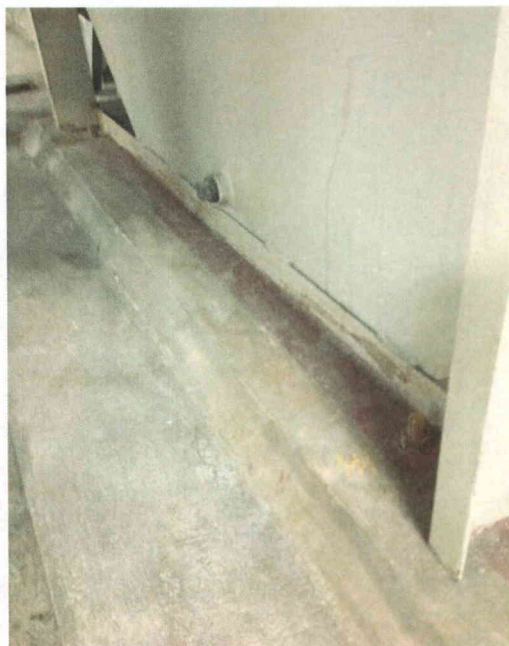
File Name: 2-63-3-4-04.jpeg

Description: General view of anchorage

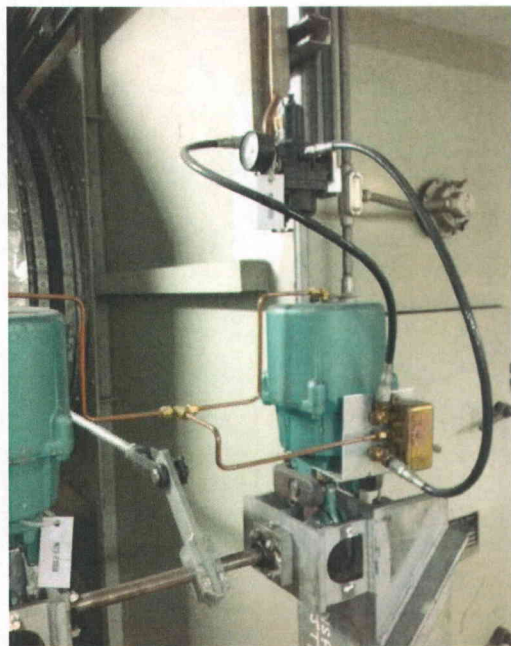
File Name: 2-63-1-4-04.jpeg  
Description: View of attached lines

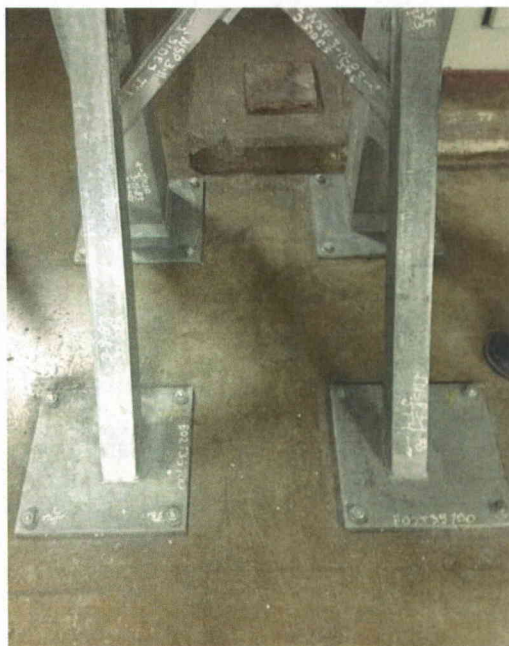
File Name: 2-64-1-4-04.jpeg  
Description: General view of anchorage

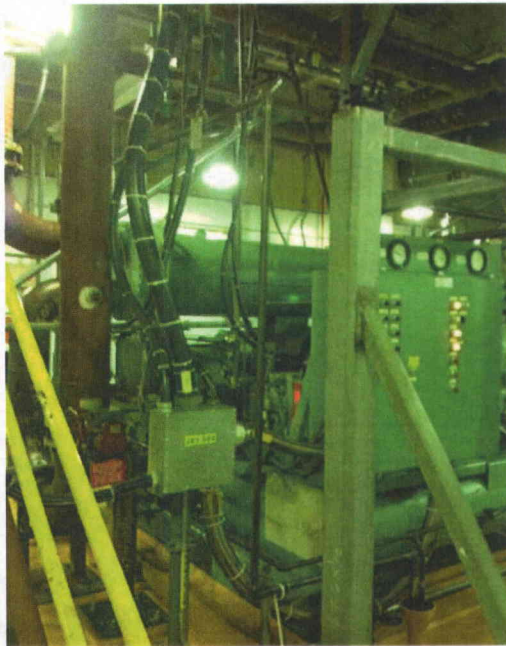
File Name: 2-73-8-4-01.jpeg  
Description: View of flexible attached lines

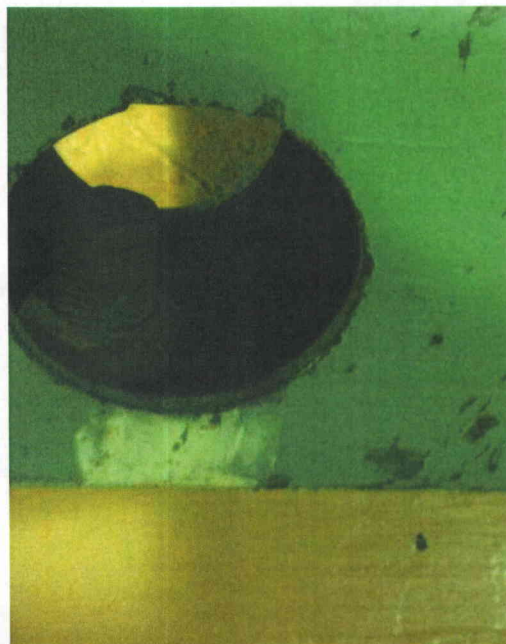
File Name: 2-94-8-4-01.jpeg  
Description: View of anchorage condition

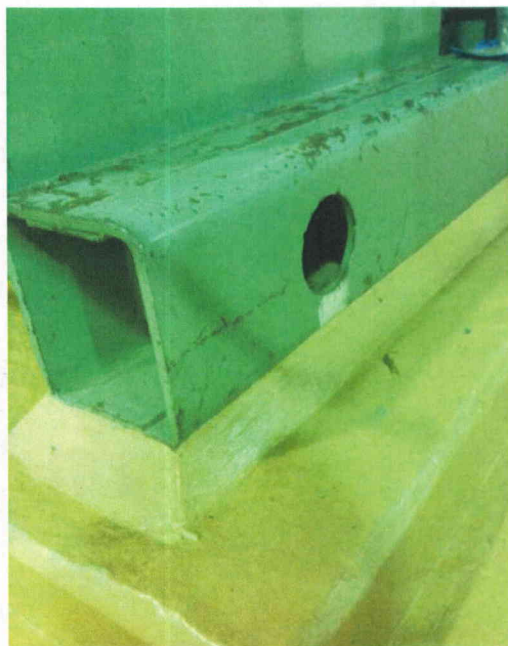
File Name: 2-95-8-4-01.jpeg

Description: View of mounting base detail

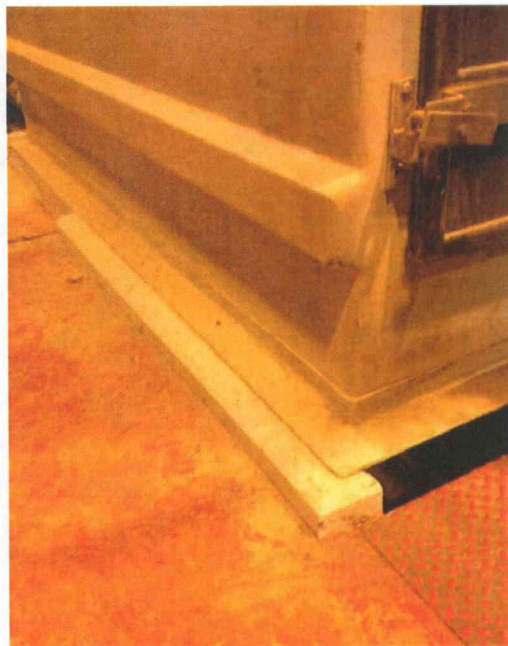
File Name: 2-63-2-4-05.jpeg  
Description: View of component mounting base

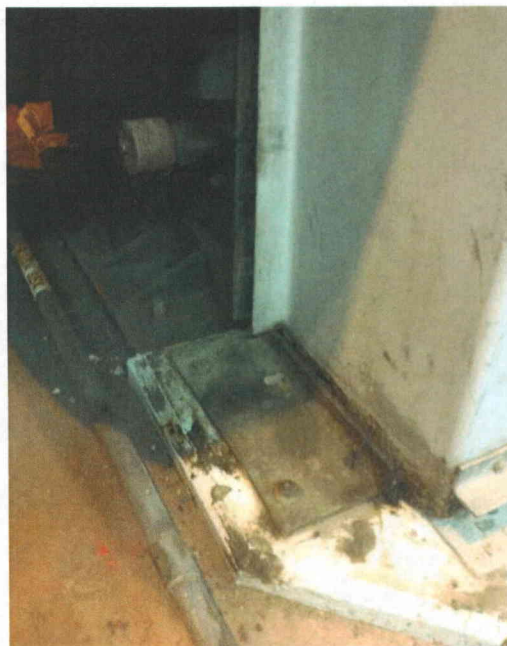
File Name: 2-64-2-4-05.jpeg  
Description: Anchorage view of component

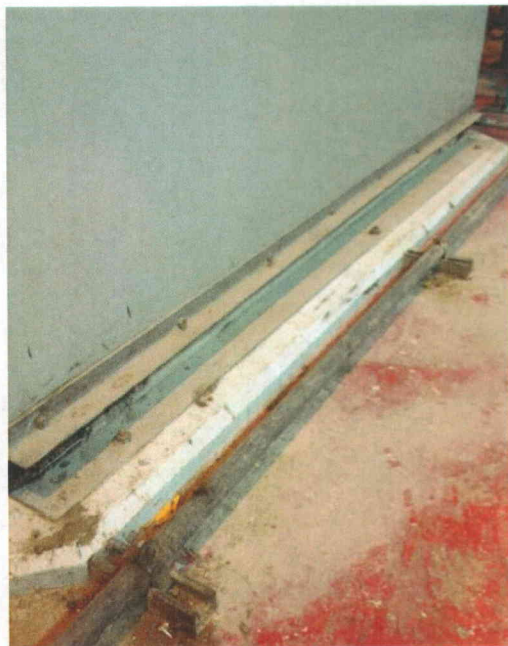
File Name: 2-73-2-4-05.jpeg  
Description: View of anchorage detail

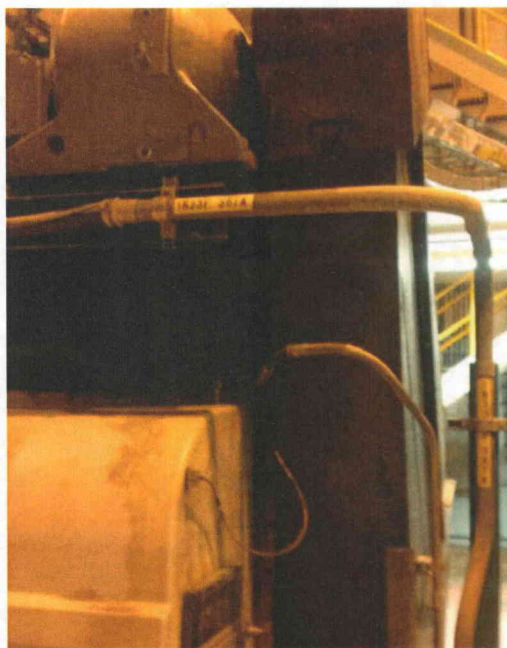
File Name: 2-95-2-4-05.jpeg  
Description: View of attached lines

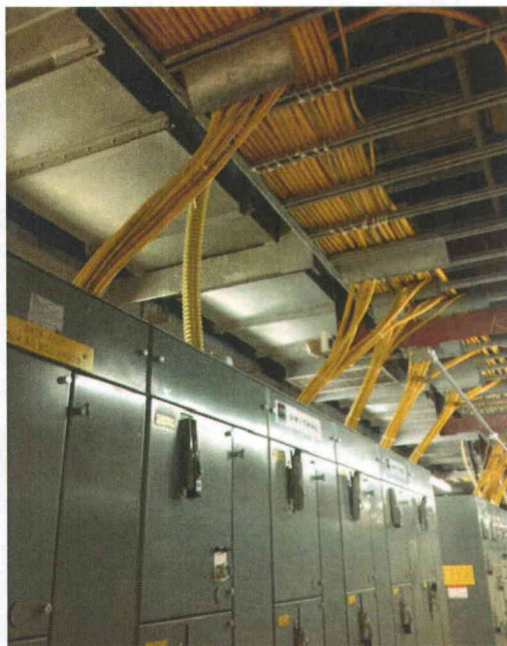
File Name: 2-73-11-4-06.jpeg

Description: View of top attached lines

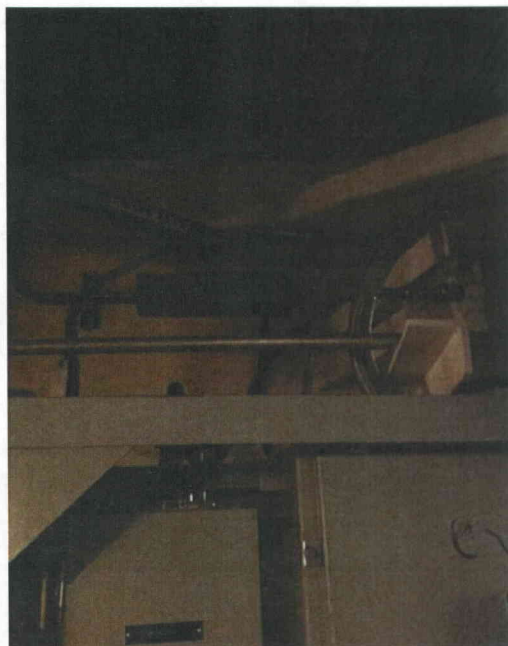
File Name: 2-64-1-4-13.jpeg  
Description: View of top attached lines

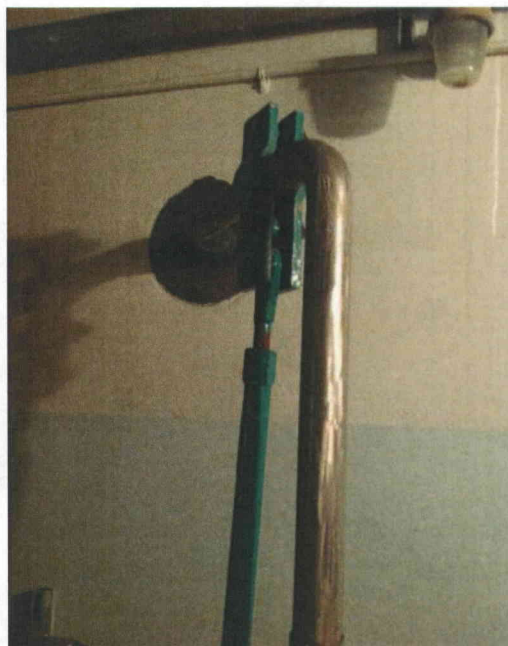
File Name: 2-73-1-4-17.jpeg  
Description: View of pipe line support

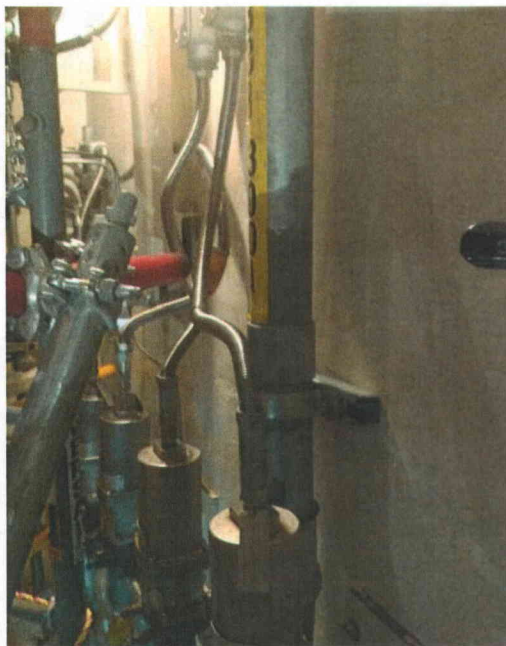
File Name: 2-63-4-4-12.jpeg

Description: View of top attached lines

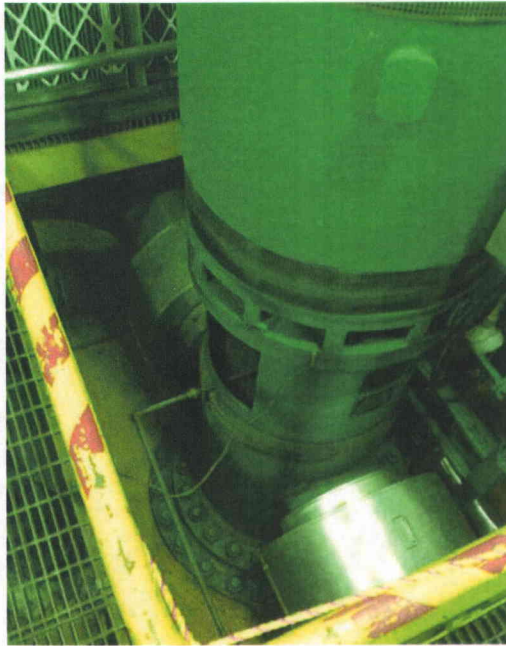
File Name: 2-63-2-4-19.jpeg

Description: View of anchorage configuration

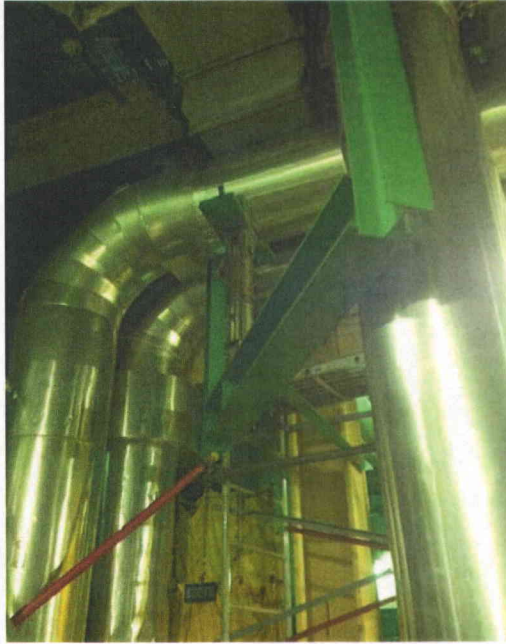
File Name: 2-63-3-4-20.jpeg

Description: View of support condition for pipe line

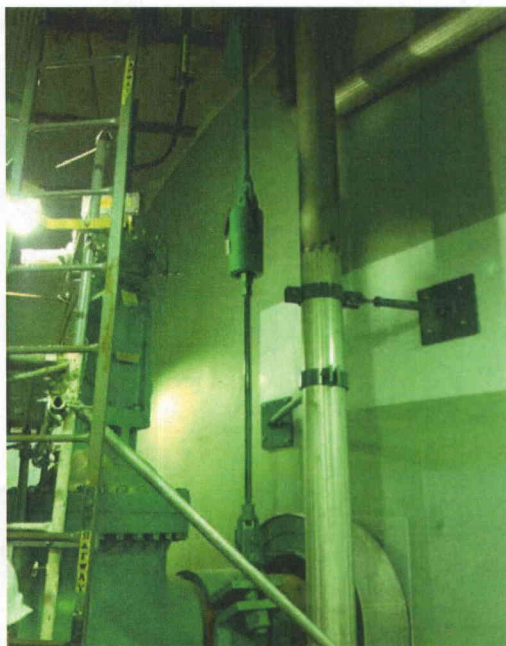
File Name: 2-73-8-4-18.jpeg  
Description: View vertical support for main line

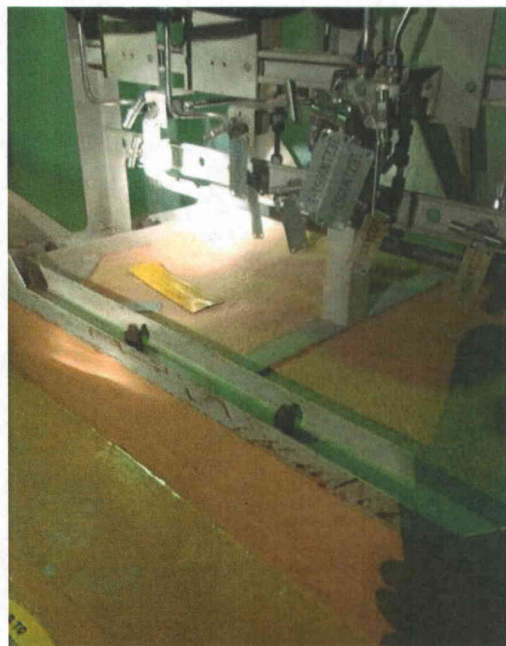
File Name: 2-64-7-4-18.jpeg  
Description: Anchorage configuration for instrument rack

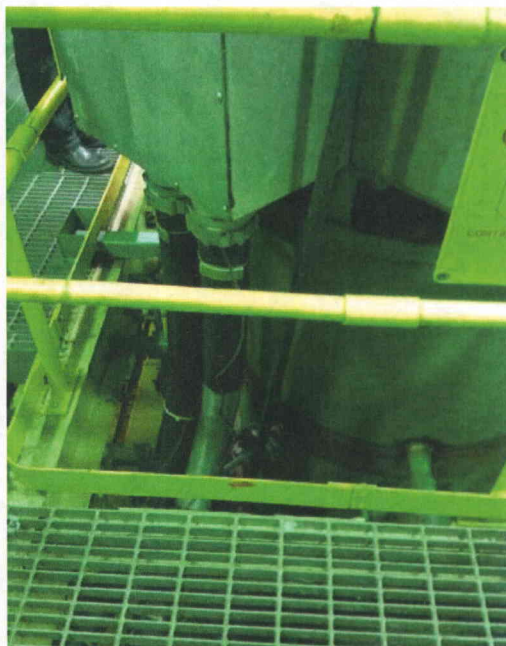
File Name: 2-63-14-4-18.jpeg  
Description: View of attached lines

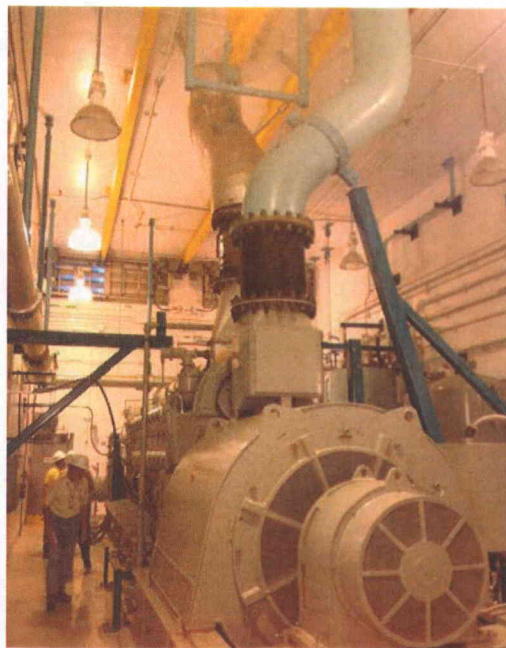
File Name: 2-63-12-4-08.jpeg  
Description: View of top conduits
