**Ultrasonic Phased Array  
Assessment of the Interference  
Fit and Leak Path of the  
North Anna Unit 2 Control Rod  
Drive Mechanism Nozzle 63 with  
Destructive Validation**

Manuscript Completed: January 2012  
Date Published:

Prepared by  
S. L. Crawford, A. D. Cinson, P. J. MacFarlan, B. D. Hanson,  
R. A. Mathews

Pacific Northwest National Laboratory  
P.O. Box 999  
Richland, WA 99352

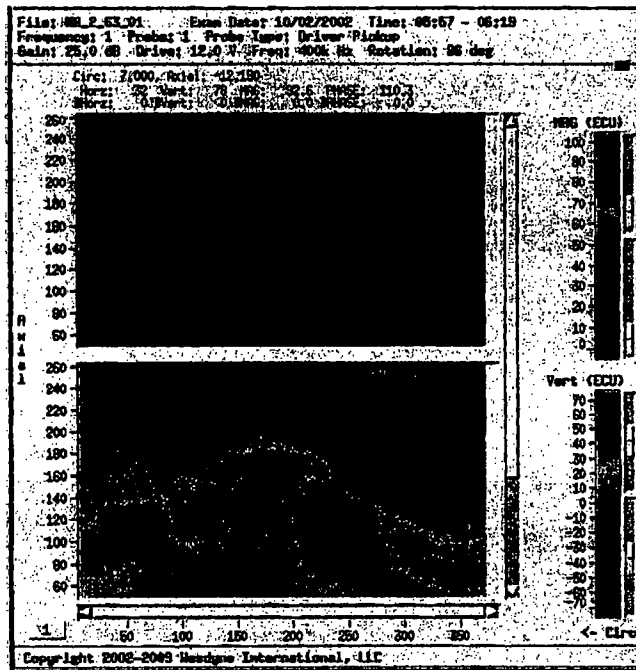
Figure 5.19 Eddy Current Data (Wesdyn International) Showing Two Axial Flaws. The horizontal axis represents the nozzle circumference in degrees. The vertical axis represents the nozzle axis in millimeters.

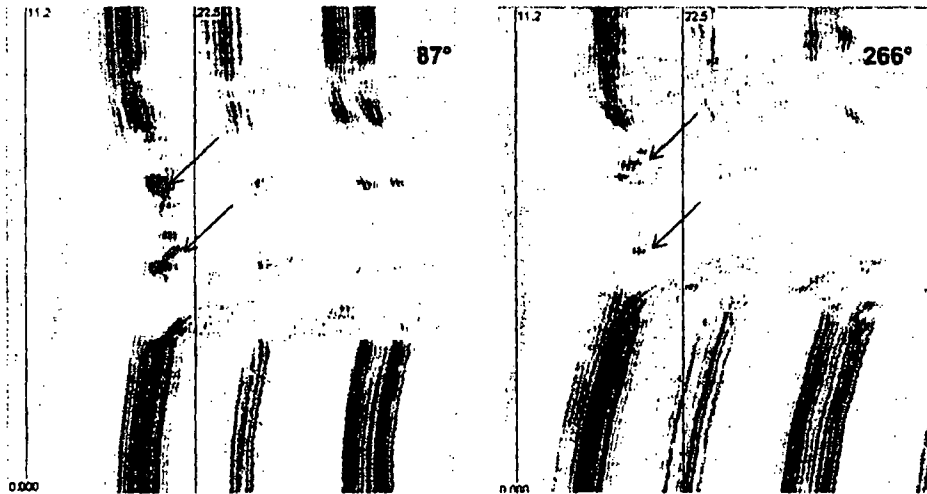
**Figure 8.12 B-scan Views of the Data at 87 Degrees on the Left and 266 Degrees on the Right, Corresponding to the Cut and Exposed Surfaces in Figure 8.9. The horizontal axis in each image represents 40 mm (1.6 in.) in metal and the vertical axis represents 155 mm (6.1 in.) approximately. Flaw indications in the Alloy 600 tube-to-weld interface are noted with arrows.**
