March 13, 2012

SUBJECT: Review of Draft NUREG/CR – XXXX Entitled, "Ultrasonic Phased Array Assessment of the Interference Fit and Leak Path of the North Anna Unit 2 Control Rod Drive Mechanism Nozzle 63 with Destructive Validation"

**Ultrasonic Phased Array
Assessment of the Interference
Fit and Leak Path of the
North Anna Unit 2 Control Rod
Drive Mechanism Nozzle 63 with
Destructive Validation**

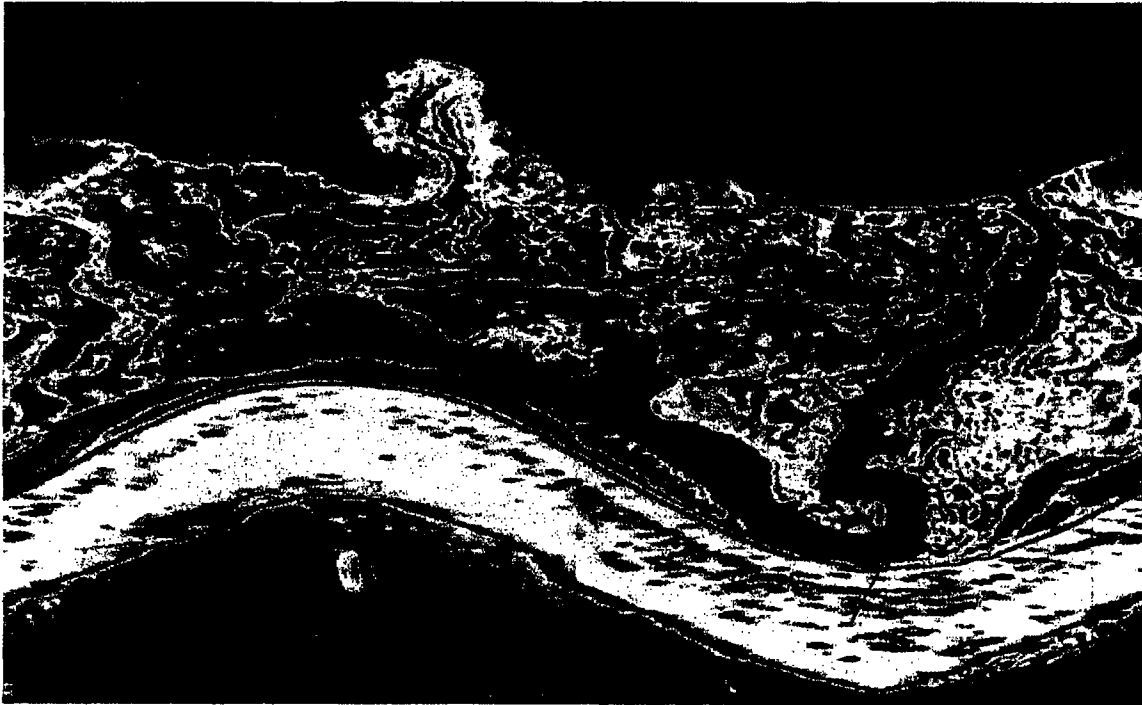
Figure 5.3 PA Ultrasonic Data from the Interference Fit in Nozzle 63 Acquired After the Second Brushing of the Nozzle ID. The horizontal axis represents the full 360-degree area and the vertical axis represents 360 mm (14.17 in.). Black arrows indicate primary leak path. The left edge marks the -90 degree location and the right edge the 270 degree location.

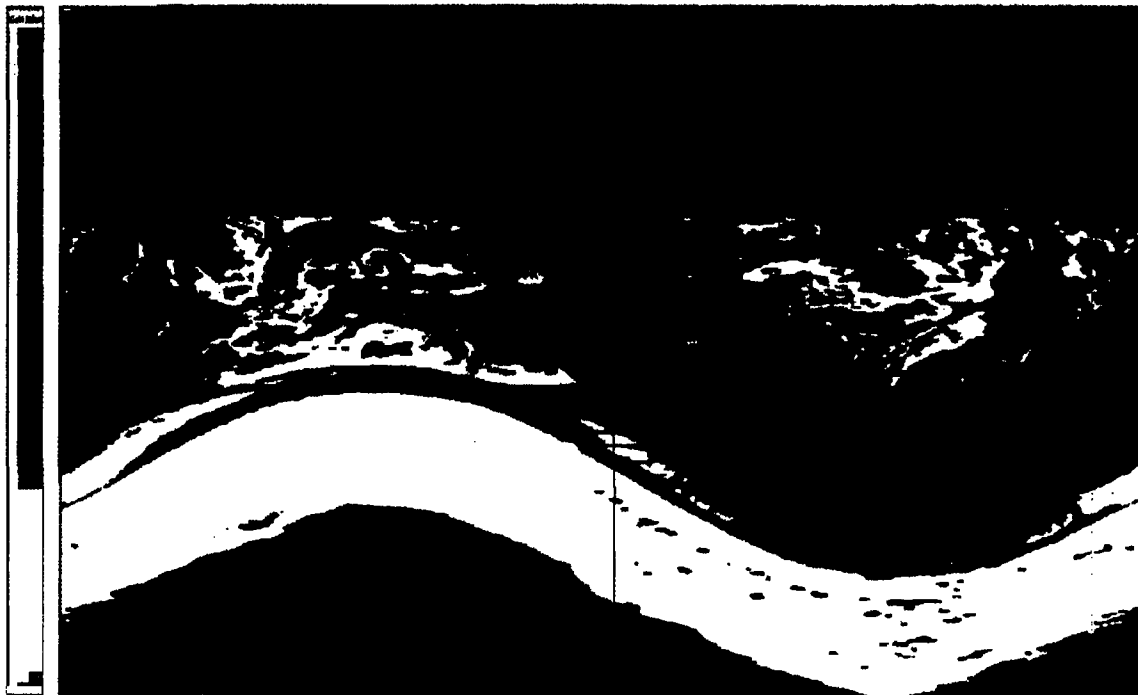
Figure 5.7 A Tri-Color Representation of the Interference Fit Data. The dark blue represents a leak path or gap, the light blue represents the interference fit and counter bore regions and the white represents the weld and suspected boric acid presence in the interference fit.

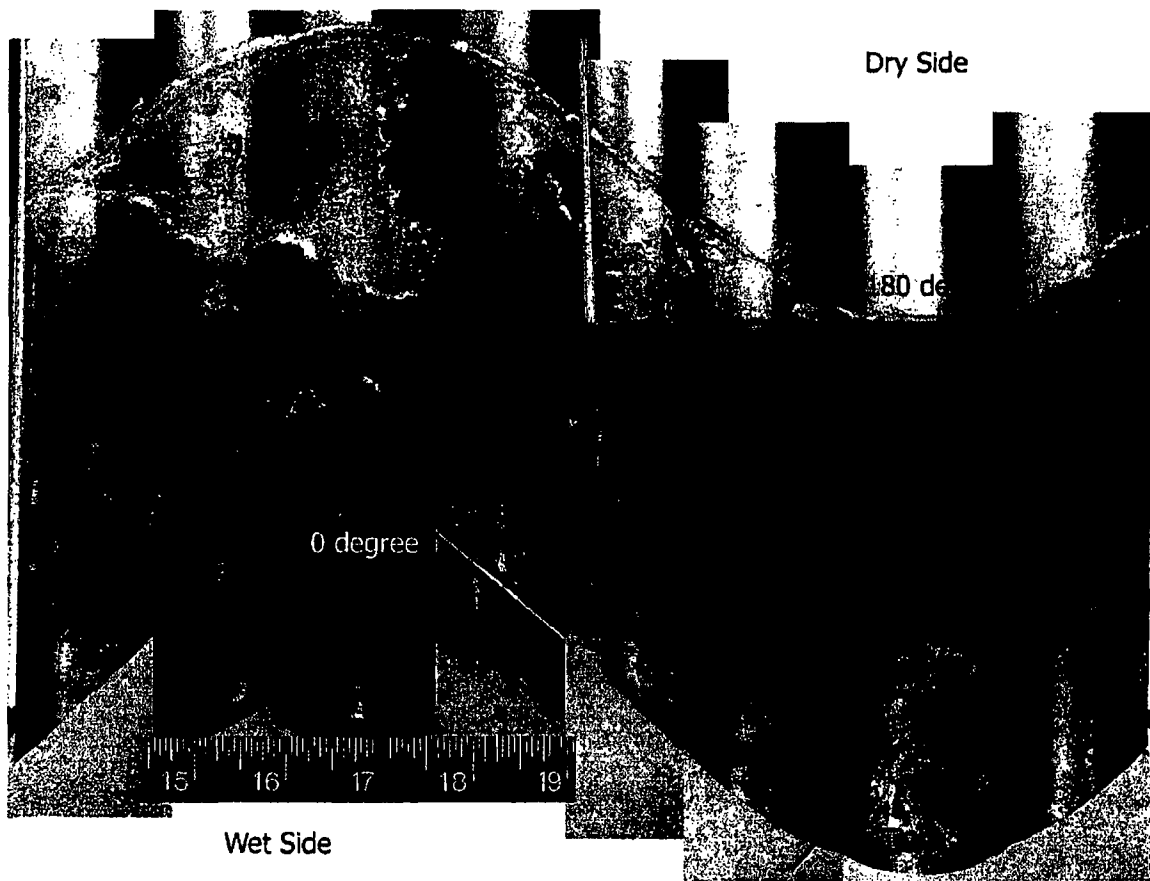
After sectioning of the nozzle assembly to reveal the interference fit and photographing the exposed surfaces, the primary leak path was confirmed. Also confirmed was the excellent agreement of the ultrasonic images and revealed features on the annulus surfaces such as boric acid deposits.

Figure 7.1 Nozzle Surface. The red line marks the interference fit region and the two black arrows identify the main leak path.
