Comparison of an Ultrasonic Phased Array Evaluation with Destructive Analysis of a Documented Leak Path in a Nozzle Removed from Service

AD Cinson, SL Crawford, PJ MacFarlan, BD Hanson, and RA Mathews
Pacific Northwest National Laboratory¹, Richland, WA, USA

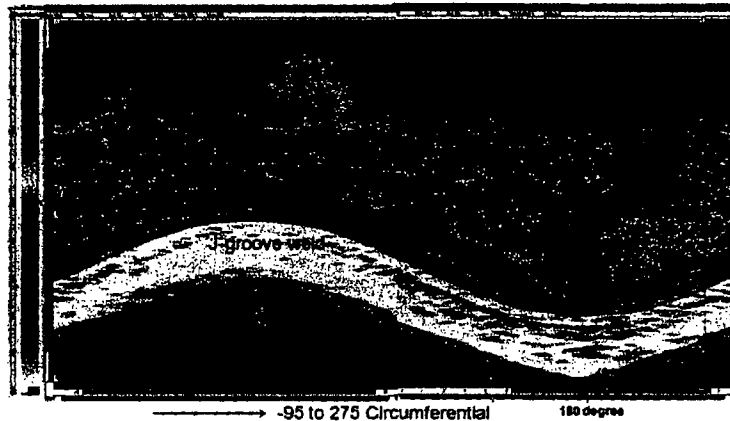
The investigation of the interference fit region on Nozzle 63 shows a large variety in the reflected ultrasonic responses. Some responses are strong in amplitude, indicating an air gap and noted as red-orange in color, while others are weak in reflected amplitude, indicating a tight interference fit and noted as white-blue. A search in the data image for a high-amplitude river pattern connecting the weld to the top of the interference fit region reveals the primary leak path. This leak path originates at approximately the 180-degree location (downhill point on the nozzle) and is marked in Figure 6. The lower amplitude

Figure 6 – A composite 360-degree ultrasonic data image from Nozzle 63. The vertical axis represents 360 mm (14.17 in.)

(blue) cluster regions near the leak path in the interference fit indicate the potential presence of boric acid as was observed in the calibration specimen. Boric acid deposits have been noted in actively leaking nozzles [1, 2].
