An Ultrasonic Leak Path Assessment of a Pressurized Water Reactor Control Rod Drive Mechanism Nozzle

P.G. Oberson,^a D.S. Dunn,^a A.D. Cinson,^b S.L. Crawford,^b P.J. MacFarlan,^b B.D. Hanson^b

ABSTRACT

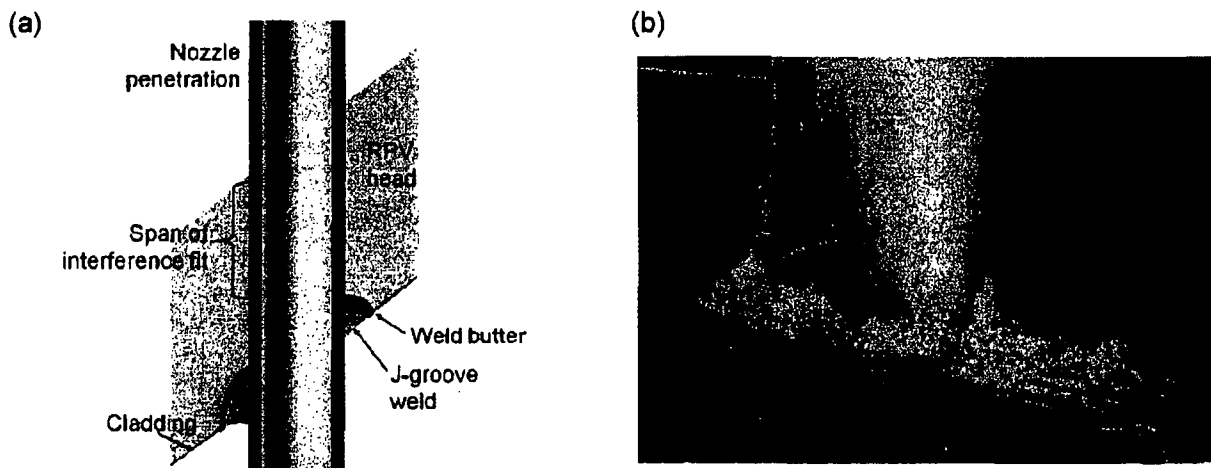
Figure 1. (a) Schematic illustration of CRDM penetration in a PWR, (b) Boric acid deposits on top of a RPV head near a leaking CRDM penetration [6].

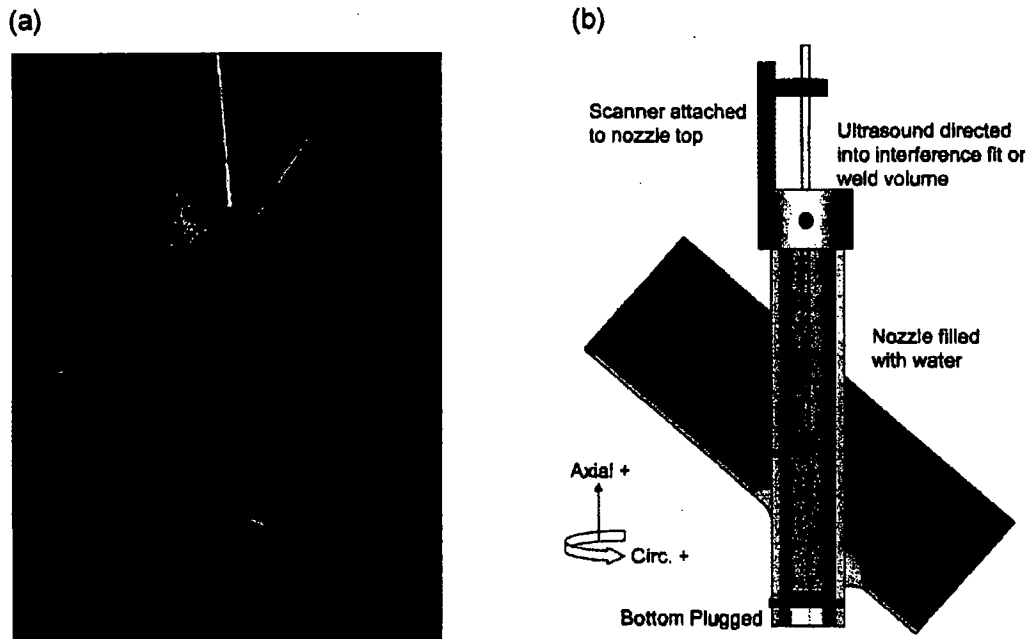
Figure 2. (a) CRDM nozzle 63 used for this investigation, (b) Schematic illustration of ultrasonic scanning setup for Nozzle 63.

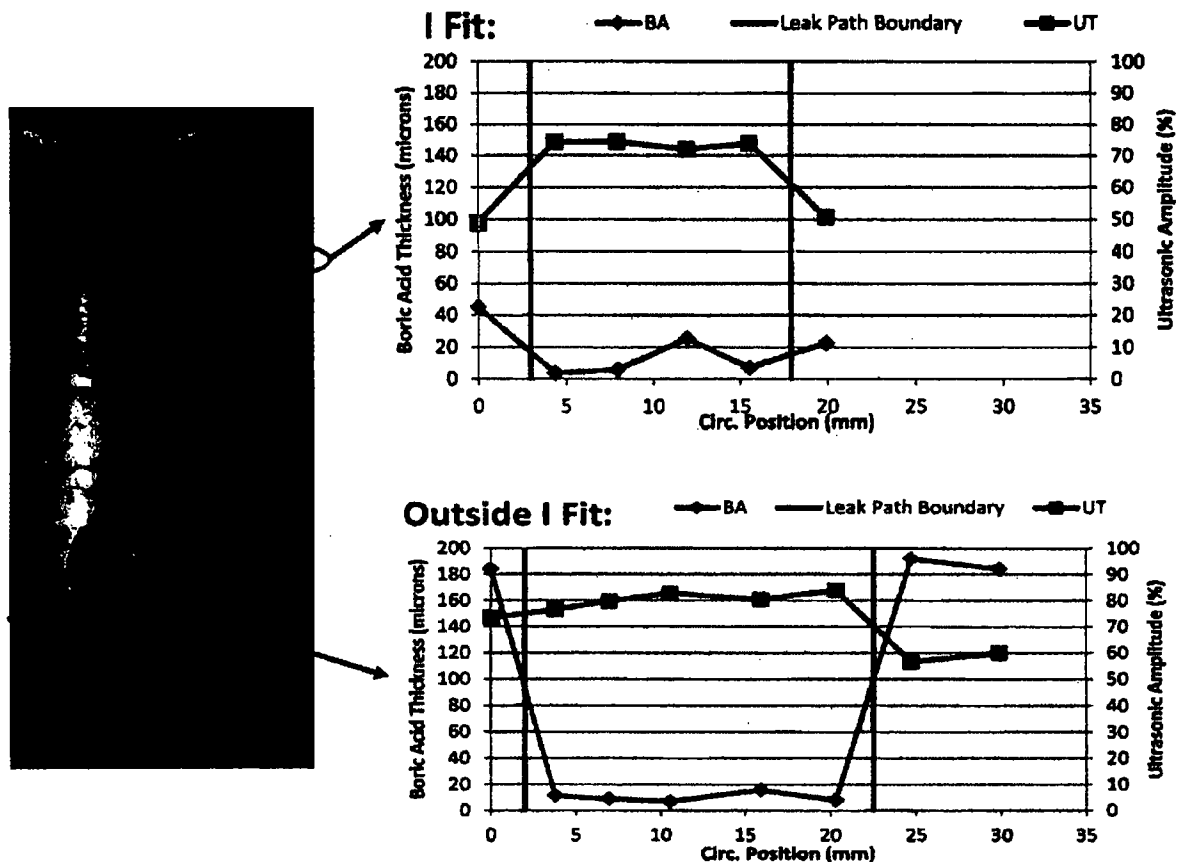
Figure 7 shows the surface deposit thickness measurement and amplitude of the UT response at a number of points across the leak path. The series of measurements across the leak path in the vertical span of the interference fit, (designated "I Fit") in Figure 7, shows that there is minimal deposit thickness within the leak path and the amplitude of the UT response, given as a percentage of full screen height, is relatively high. Outside the leak path, on both sides, the deposits are thicker and the amplitude of the UT response decreases. A similar pattern holds for the measurements across the leak path below the span of the interference fit (designated "Outside I Fit"), though the deposits are somewhat thicker. This response can be explained if it is assumed that the active flow of primary water prevents the formation of deposits directly in the leak path and that the deposits would tend to accumulate to the sides. Because there are no deposits in the leak path, an air gap is maintained between the nozzle OD and the RPV head which gives a high amplitude UT response. Outside the leak path, the deposits serve to couple the nozzle and RPV head, allowing greater transmission of ultrasonic energy, and thus a lower amplitude UT response.

Figure 7. Measurements of the surface deposit thickness (BA) and amplitude of the UT response (UT) across the leak path for locations in the vertical span of the interference fit (I Fit) and below the interference fit (Outside I Fit). The vertical black lines on the graphs represent the side boundaries of the leak path.

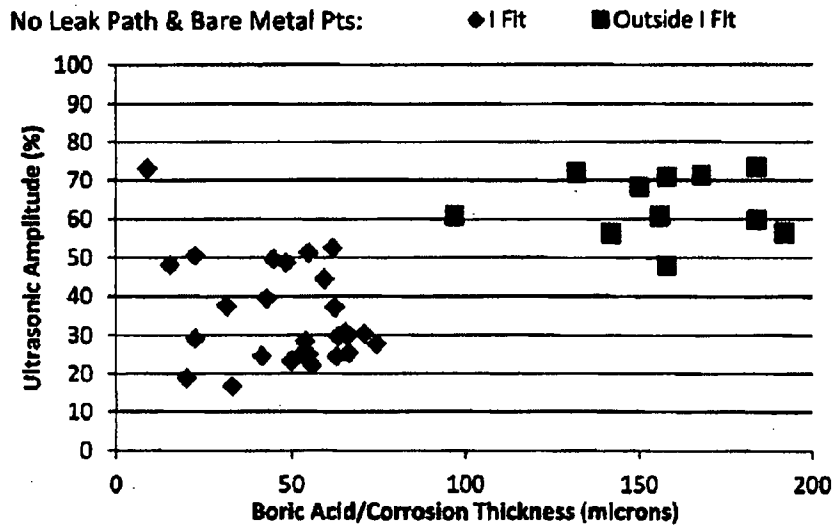
The deposit thicknesses were also measured for various other locations in the annulus, both within and outside the vertical span of the interference fit. The correlation between the deposit thickness and the amplitude of the UT response is shown in Figure 8. The data pattern indicates that within the span of the interference fit, the deposits tend to be thinner, with the locations giving a relatively low amplitude UT response. Outside the span of the interference, the deposits are generally thicker, with locations giving higher amplitude UT response. From these responses, it is postulated that at reactor operating temperature, a gap may open in the annulus between the nozzle and RPV head because of differing thermal expansion coefficients. If leakage occurs, primary water may flow throughout the annulus by the path of least resistance. As the reactor cools down, the gap between the nozzle and RPV head will close, trapping primary water that will leave deposits as it evaporates. It is likely that in the span of the interference fit, the gap between the nozzle OD and the RPV head is narrower than outside, which would significantly compact any deposits left behind. Thus deposits in the span of the interference will tend to be thin and dense relative to deposits outside. The thin and dense deposits should more efficiently couple the nozzle and RPV head allowing greater transmission of ultrasonic energy and a lower amplitude UT response.

Figure 8. Measurements of the surface deposit thickness and amplitude of the UT response for points inside and outside the span of the interference fit (I Fit).
